Back in the May 1988 issue of *Import Service*, we gave you an assortment of overhaul and repair tips for Toyota Corolla front wheel drive transaxles. We promised you then that we would return for a close look at the other units in Toyota's front wheel drive transaxle family. So we're back this month with an overhaul overview of the four-speed automatic transaxles used in Toyota's Camry models.

Toyota A140

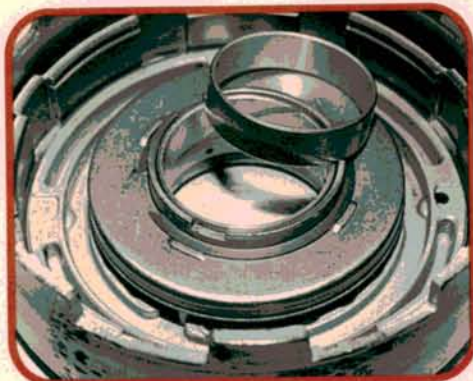
1

Early A140s used babbitt-style bushings in the clutch drums and oil pump bushings. Worn babbitt bushings are one of the main reasons early A140 transaxles fail. Later A140s have longer wearing bronze bushings. Aftermarket bronze replacement bushings are available to repair early A140s.

As we'll describe in our photo captions, worn bushings are responsible for many early A140 problems. If you're lucky, your customer will bring you his car before bushing wear has completely disabled his transaxle. If he does, the transaxle may have any of the following symptoms:

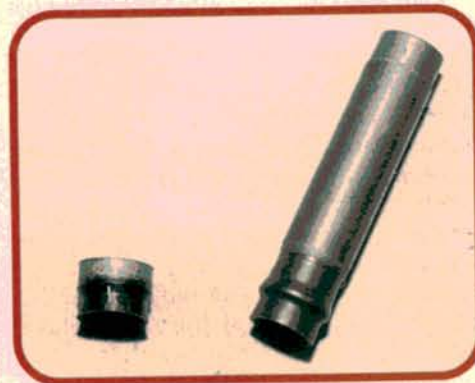
6

Later B2 seals (right) have an extension which reaches almost to the bottom of the valve body and prevents the seal from backing out. Some techs had problems with the early seal (left) because they installed it either too deep or too shallow. Both mistakes will cause pressure loss to the B2 circuit.

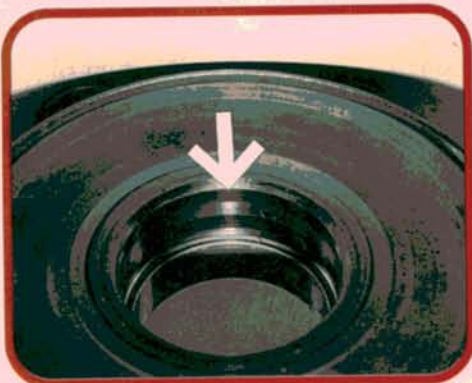
7

Check each clutch drum for wear in the area where the sealing rings ride (arrow). Dirty fluid combined with the Teflon sealing rings can wear grooves in the drum's sealing surface. High mileage transaxles may also show this wear, even with clean fluid. Clutch drum replacement is the only fix.

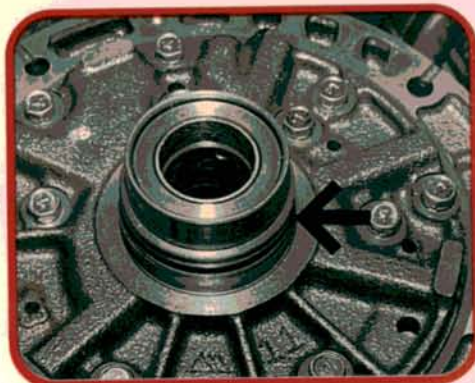
8

Also check all sealing ring lands for wear. Worn bushings or fluid contamination can round off or damage the ring lands' sharp edges. Sloppy ring lands can make for loose fitting Teflon sealing rings. Damaged ring lands can also keep the sealing rings from turning or sealing properly.

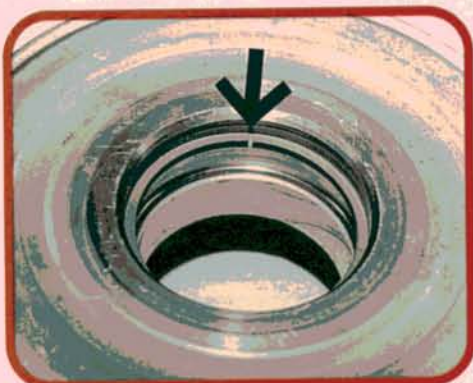
9

Measure the new sealing ring end gap before installation. Stretch the new seals by hand first, then place them inside the clutch drum in their installed position. Measure the seal's end gap the same way you measure piston ring end gap. Maximum allowable seal end gap is 1 mm (0.040 in).

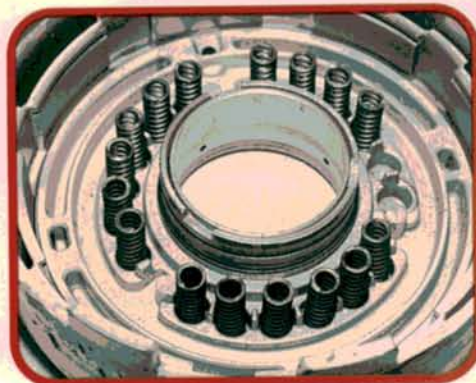
10

Keep a close eye on the number and location of the clutch drum release springs (we've already removed two here). Different length springs are used in each of the clutch drums. Either disassemble your clutch drums one at a time, or make sure you keep each set of release springs in a separate place.

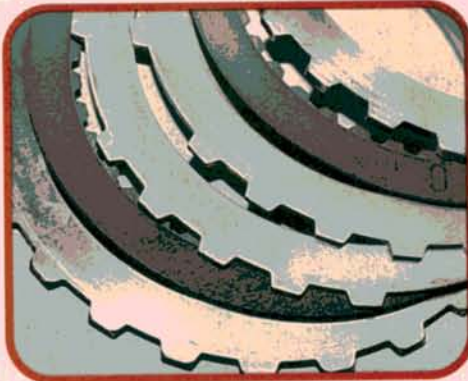
13

If the fiber faced plates in clutch packs or brakes are burnt and you also find clutch material in the pan, suspect the torque converter clutch. Friction material from the clutch may flake off and clog the transaxle's pressure regulator. The stuck regulator lowers line pressure, causing the clutches to burn.

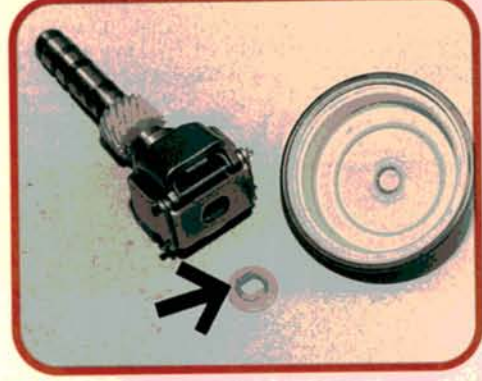
14

This nylon thrust bushing sits on top of the governor to keep the governor located in the case on A140L transaxles. If the bushing wears out or is lost during an overhaul, the governor will walk out of the case, gouging the governor cover and causing a loss of governor circuit pressure.

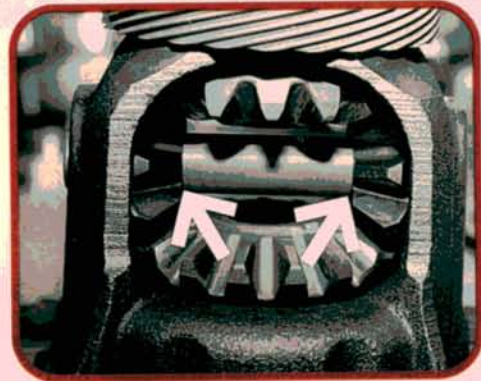
16

While you have the roll pin out, carefully inspect the spider gear shaft. Early, gray colored shafts may become worn in the area where the spider gears ride. Later models have a gold colored shaft which seems to hold up better. Gold shafts may be installed on early transaxles.

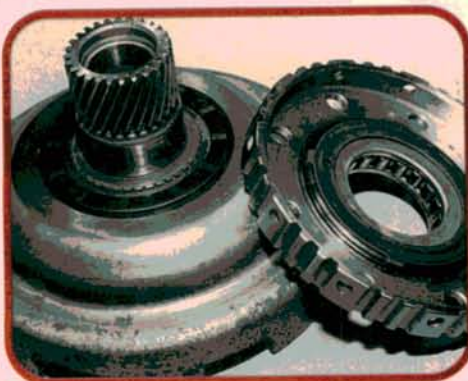
17

Pay careful attention to the intermediate sprag's installation direction. The sprag should turn freely in a clockwise direction when it's installed correctly. The whole transaxle will lock up when it tries to shift to third gear if the sprag is installed backward.
