Bottoms Up

Last month we started our Toyota Cressida 5M-GE twin-cam six overhaul Head First with a complete reconditioning of the cylinder head and related components. This month we're ready to turn the Cressida's straight six Bottoms Up so that we can concentrate on lower engine inspection, overhaul, and assembly techniques.

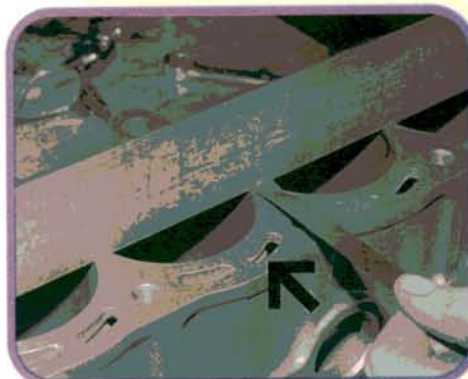
2

Next we checked for block deck warpage. Toyota doesn't permit deck resurfacing on the 5M-GE. Deck warpage was within the 0.05 mm (0.0020 in) specification. A new head gasket that includes formed-in-place sealing beads will seal the minor surface erosion surrounding the cooling system passages (arrow).

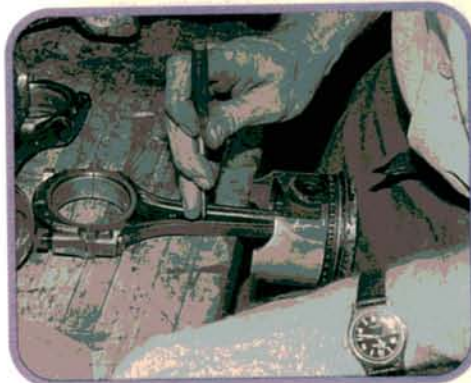
8

For proper valve clearance, the pistons must be installed with their notches facing forward. To assure correct piston and rod reassembly, look for an identifying mark on the connecting rod before removing the old piston. If there are no identifying marks, mark the rods with a punch as we did.

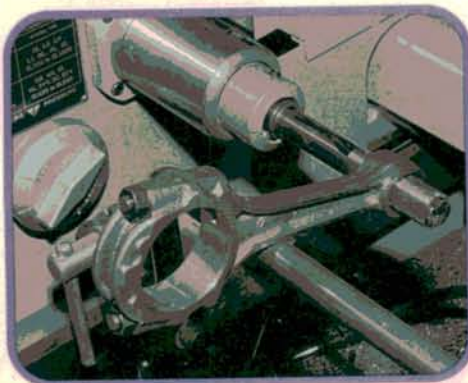
11

We measured a new piston pin to determine the connecting rod bushing oil clearance. We expected the rod bushings to be worn oversize. Five rod bushings were within specifications, while the sixth was slightly undersized. A light honing brought the sixth bushing to the 0.005 to 0.011 mm oil clearance.

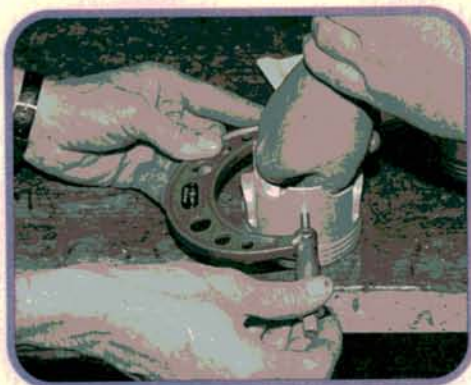
13

To determine the proper cylinder boring dimension, measure piston diameter 90 degrees away from the piston pin at the recommended distance from the top or bottom of the piston. The pistons must be at room temperature because the aluminum piston diameter will change with temperature.

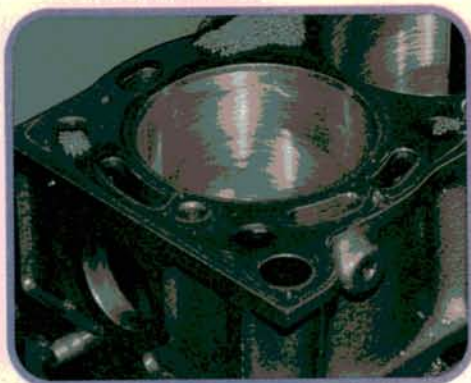
15

The crosshatch angle should be between 20 and 60 degrees. The smoothness of the cylinder wall finish is actually more important than the crosshatch angle. Use a 220 grit stone for finish honing with cast iron and chrome rings and a 280 grit stone for moly piston rings.

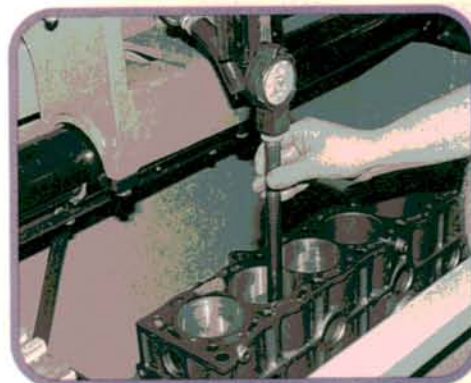
16

The finished cylinder dimension should be within 0.013 mm (0.0005 inch) for out-of-round and taper measurements. Some blocks require a deck plate during boring and honing. The deck plate simulates the stress caused by bolting the head to the block which may pull the cylinder walls slightly out of round.

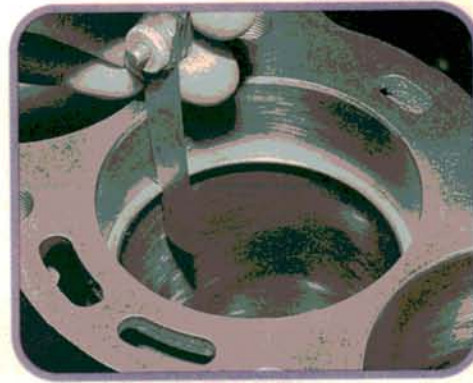
18

Use an inverted piston to square a ring in the cylinder bore to measure ring end gap. Toyota recommends ring replacement if ring end gap is incorrect (no filing allowed). Our cylinders were honed to a precise dimension so the rings fit perfectly without modification. Test fit the pistons to their bores.

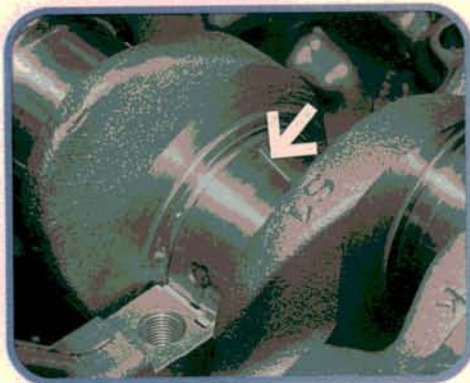
19

Install the crankshaft and bearings. Pay attention to the location of any special bearings or oil holes. The back side of the new bearings and the housing bores in the block must be clean and dry. Lay a strip of Plastigauge across the crankshaft journal to measure the oil clearance (arrow).

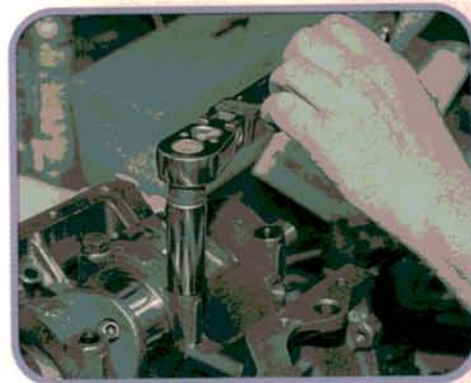
20

The new main bearing and crank journal should be clean and dry for an accurate measurement. Install the main bearing cap, then torque the bolts to specifications. Don't rotate the crankshaft during your measurements. Loosen the bolts, then carefully remove the bearing cap.

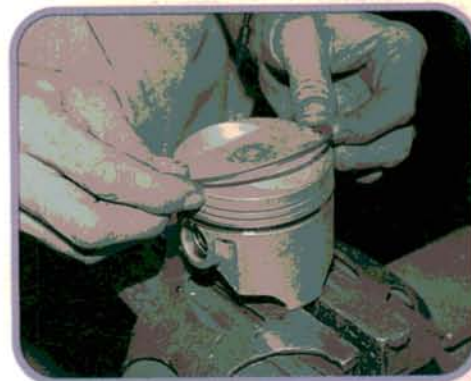
22

Install the new pistons on the connecting rods. Clamp the rods in a soft jawed vice, then install the new piston rings. These low tension rings slipped over the piston without a ring expander. Follow the manufacturer's recommendations for proper ring end gap positioning.

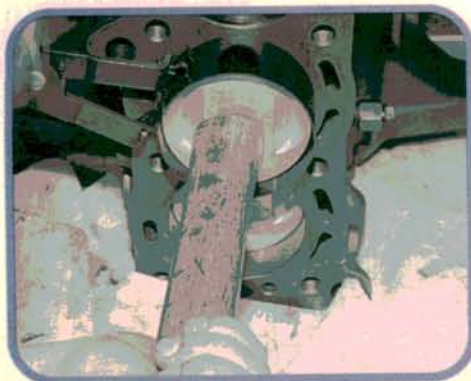
23

Place protective sleeves over the connecting rod bolts to avoid scratching the crank pins. Install the upper rod bearing. Dip the piston in oil. Compress the rings with a ring compressor, then carefully push the piston into the cylinder. Make sure the rod bolts straddle the crank pin.

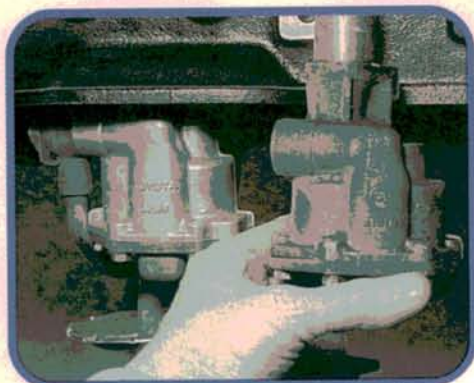
25

Toyota enlarged the oil pump capacity on later production 5M-GEs. The smaller original pump (on right) is no longer available. A deeper oil pan must be installed to clear the new oil pump's larger gear set and deeper housing. The new pump delivers more oil to the improved camshaft lubrication system.

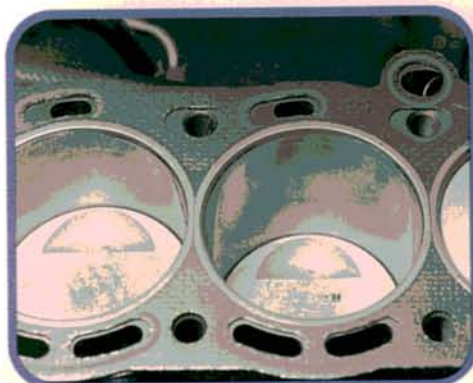
26

The slightly oversize sealing rings on this Fel-Pro head gasket will accommodate up to a 1 mm (0.040 in) cylinder overbore and chamfer. This design ensures proper clearance and prevents detonation or pre-ignition caused by the head gasket sealing rings protruding into the combustion chambers.

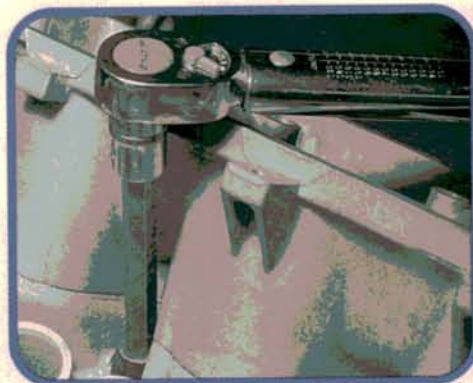
28

Move the pistons away from TDC to prevent valve interference. Install the head, then torque the lubricated head bolts using a three step process. The dense head gasket material doesn't compress and will hold the original torque specification. We rechecked the bolt torque several days later and found no change.

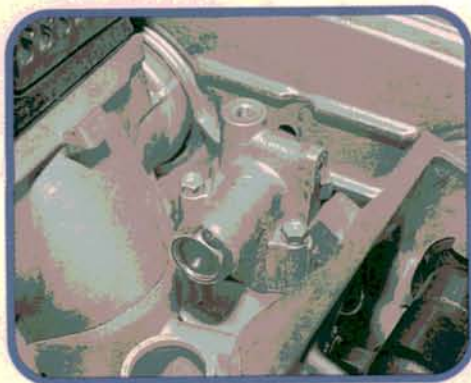
29

The oil pressure regulator (arrow) is a very important part of the upper engine lubrication system. We disassembled the regulator for cleaning and found the regulator valve was stuck solid. A stuck regulator will starve the upper engine for oil and will cause noisy lash adjuster operation.
