# Bum Steer

We decided to ask a man who rebuilds power steering racks for import vehicles to share his many years of experience in this area with our readers. Dale Lumby at Maval Manufacturing took us on a guided tour through bins of bad steering racks, stopping here and there to point out problem areas. Mr. Lumby knows racks.

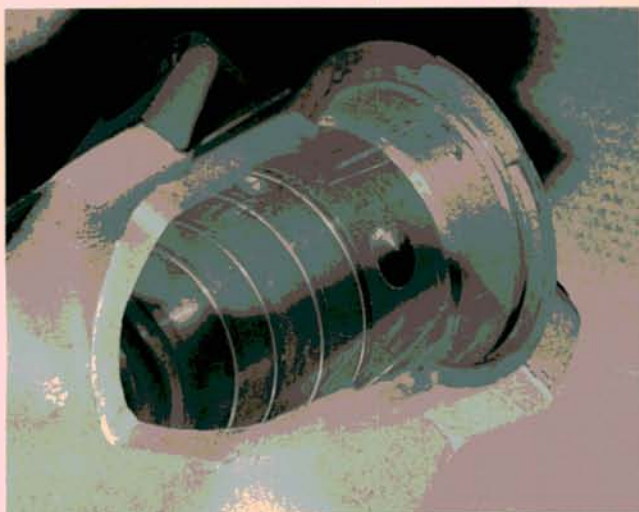
Saabs use a GM style steering rack. You domestic car techs are familiar with the term "morning sickness," an ailment common in GM produced Saginaw steering gears. The pinion shaft spool valve seals in units of this design rotate inside the aluminum bore of the pinion housing. The sealing rings on the spools have a high fiberglass content and as a result they are very abrasive. Over time they wear deep grooves in the housing bore. The grooves allow fluid pressure to leak past the sealing rings, especially when the fluid is cold.

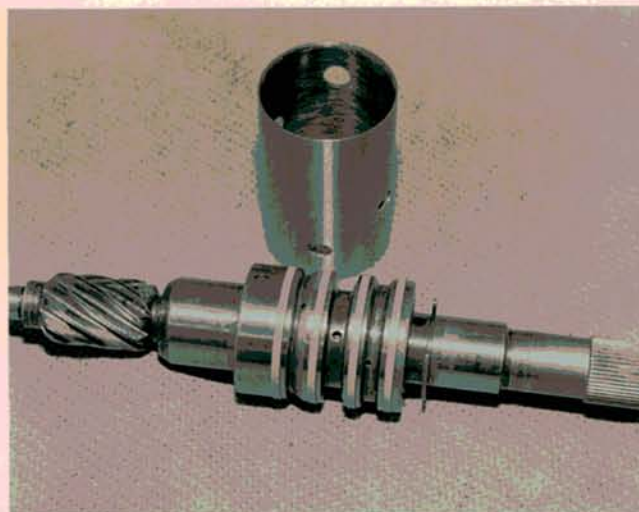
When the owner of the car starts it in the morning, everything is of course, cold. Until the unit heats up, fluid pressure leaks past the sealing rings, resulting in reduced power assist. That's why this condition has been nicknamed Morning Sickness. As things heat up and expand, steering assist increases. In badly worn units, however, even warm racks will have less assist than normal, and eventually all assist is lost. Rebuilders bore the housings and install steel sleeves to eliminate this problem.

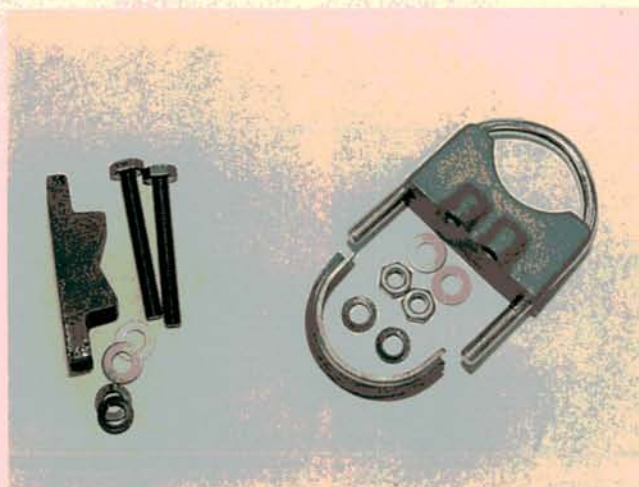
Volvo replacement racks can be confusing, since a total of six different rack configurations were installed in 1979-88 Volvo 240-260 models. If the replacement rack doesn't look like the old rack, don't panic until you check the instructions which should be in the box with the new rack. You may be forced to change mounting hardware (mounting blocks, u-bolts, and different nuts and washers), but any one of the six styles will fit, regardless of the appearance of the old rack.

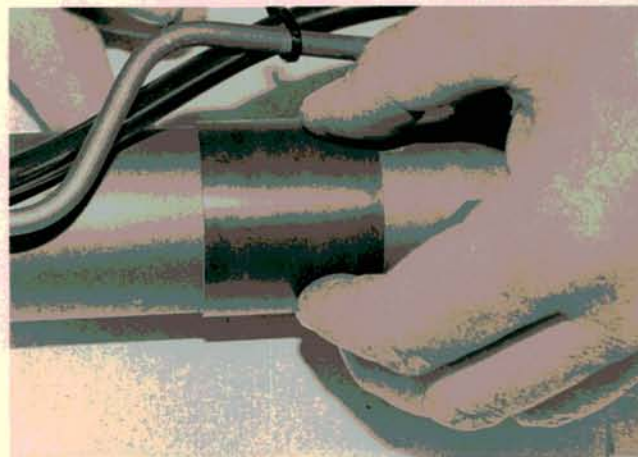
For 1985-88 Nissan Maximas, there are only two choices. The two racks are the same except for a slight difference in rack tube diameter. The rack with the larger diameter tube has an aluminum end cap. If the replacement rack is the same as the one on the car, no modifications are necessary. If you're replacing a larger diameter rack with a smaller one, install adhesive backed neoprene strips on the rack tube beneath the mount brackets. If you're replacing a thin tube with a thick one, remove the old spacer strips from the mounting brackets.

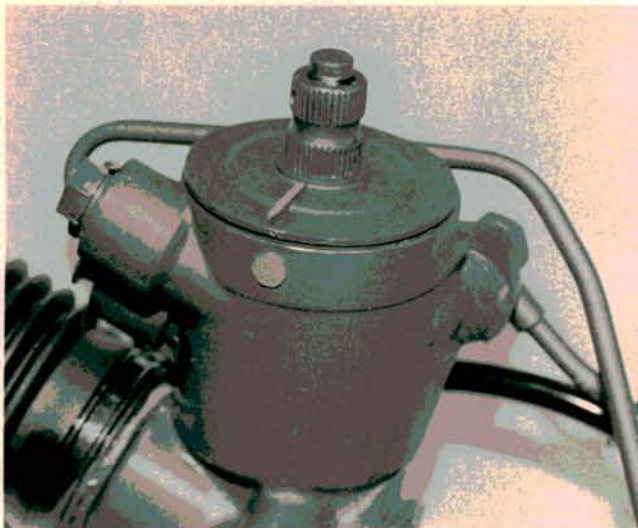
**5** More on the Maxima racks. Your rack should come from the factory in the centered position. If someone turns the rack off center, count the number of turns lock to lock. Turn the rack back from full lock half that distance and finally center the rack using the indicator mark on the pinion dust cover. Be very careful not to overtighten the hydraulic fittings when you install the pressure and return lines. Torque them to the prescribed 15 ft-lb and no more, or you'll crack the thin walled housings.

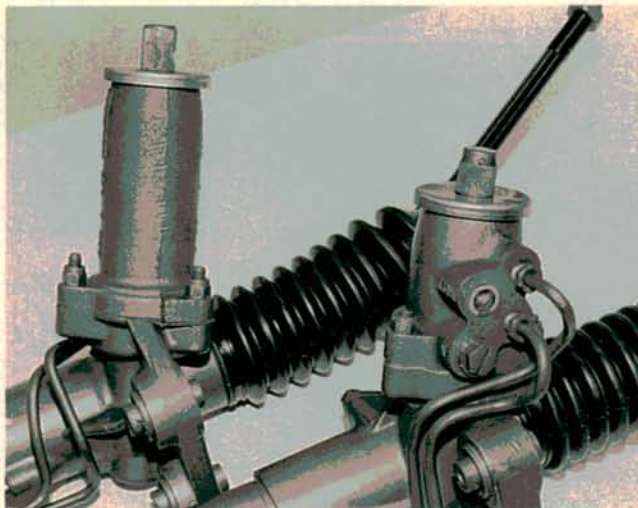
**7** Jaguar racks present similar problems for the installer. Racks in 1973 through 1977 Jaguars have a taller pinion housing than those used in 1978 through 1982½ cars. Both use 16 mm tie rods. Racks used from 1982½ through 1987 are also short tower units, but they have 14 mm tie rod ends. Tall tower units can be replaced with an early style short tower if a new steering coupler is installed. If you use a late style short tower to replace a tall tower, replace the coupler and also use 14 mm tie rod ends.

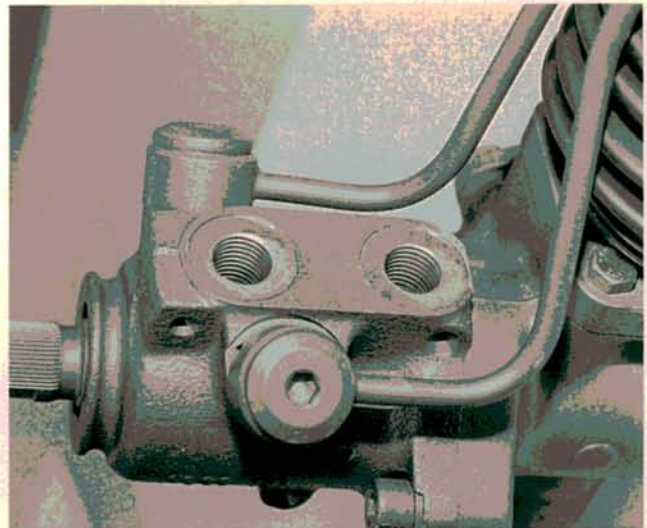
**6** Steering racks on 1984-88 Audi 5000 models present a different problem. This is a very high pressure system (over 2000 PSI). The low and high side pressure connections at the rack are the SAME size fittings. It is possible to reverse the connections as a result. Then the fun starts. The nose of the pinion shaft sticks through the firewall below the dash. If you reverse the lines, the first time you turn the steering wheel with the engine running, that ton of pressure blows out the pinion shaft seal and sprays oil all over that fancy interior. Guess where you don't want to be sitting just then.

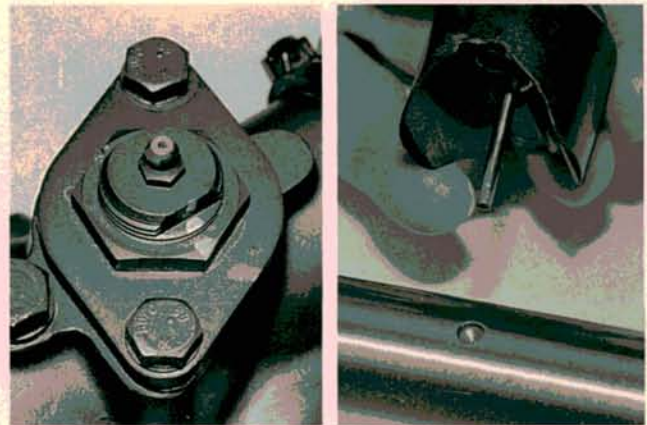
**8** When Jaguar racks were originally assembled, there was no set procedure for indexing the pinch bolt groove on the splined pinion shaft. The rebuilder has no idea which way it points on the old rack. So the odds are high that the steering wheel will be off center after you connect the lower steering universal to the pinion. Before attempting to straighten the steering wheel, make sure the rack is dead centered by removing this grease fitting and installing a pin which will fall into a locator hole in the rack when the rack is centered.

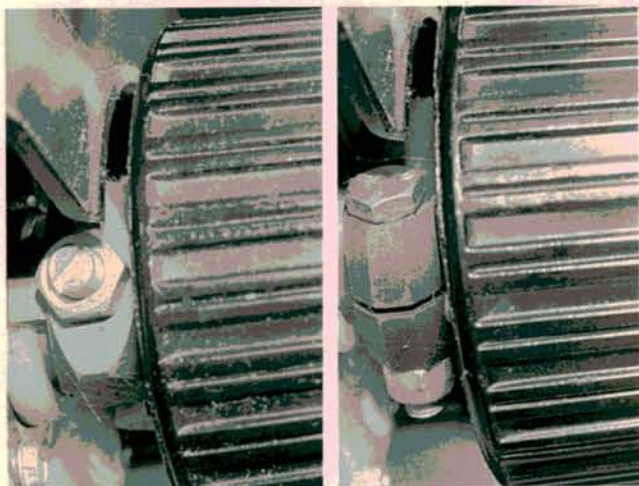
**9** The Jaguar steering column is a unique set up. A Jag specialist showed us the easiest way to recenter a steering wheel. Drop the lower steering column panel. You'll see a through bolt and a slotted head set screw with a jam nut. Remove the through bolt. Loosen the jam nut on the slotted head screw and back it off two or three turns. Pull the entire steering wheel/upper column assembly out of its splines in the lower shaft. Turn the wheel to recenter it and slide it back into the lower shaft. Reinstall the through bolt, and tighten the pinch bolt and its jam nut.

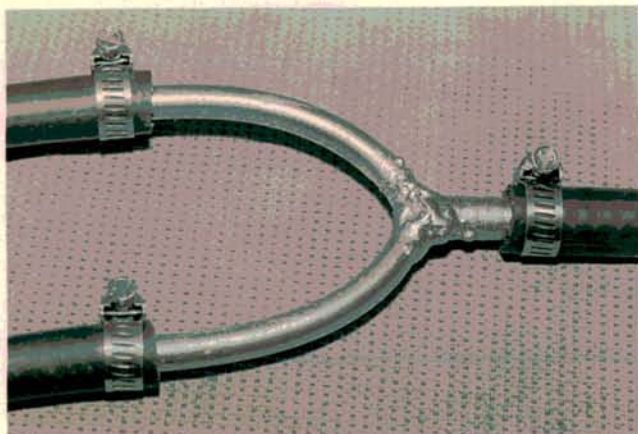
**11** If you have a car with too much assist at road speed, is it because the pump gears in the speed sensor are so worn that they can't pump enough oil? Or is there another problem? To check the speed sensor, simply bypass it. Tee the two smaller hoses into the large return line. Then with the car sitting still and the engine running, attach a fish scale to the steering wheel. If it takes less than an 11 pound pull to move the steering wheel, the problem isn't the speed sensor. Look for a restricted hose, stuck pressure relief in the main pump, or a defective steering gear.

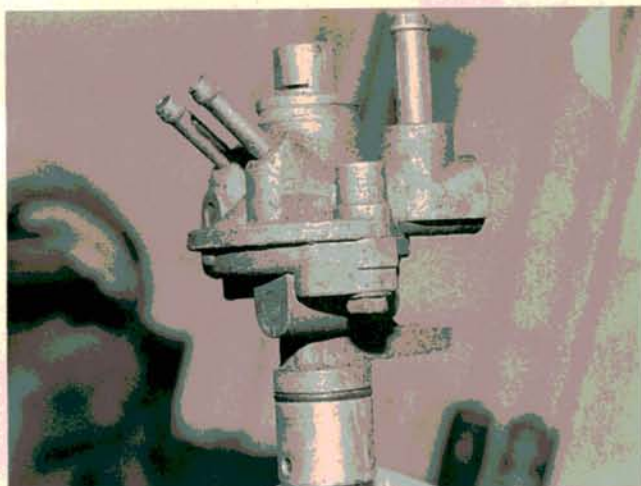
**10** A speed sensor is used in this Honda Accord to control the amount of power assist based on vehicle speed. Its internal pump is driven by the final drive and also does double duty as the drive for the speedometer cable. With the vehicle stationary, pressure flow through the sensor is blocked by the pump gear. When the vehicle drives away, the speed sensor reduces pressure at the cut off valve by pumping fluid the other way—to the fluid reservoir. This reduces pressure at the cut off valve. The faster the vehicle goes, the faster the pump turns, further reducing pressure, further reducing assist.
