One Thing Can...

Lead To Another

We decided to randomly select a candidate with a leaking head gasket, and let the chips fall where they might. Our victim is a carbureted 1985 Mazda 626 with 128,000 miles on the clock. The head gasket is leaking coolant down the front of the engine block, behind the catalytic converter. A tough leak to spot from the top, but unmistakable from down below.

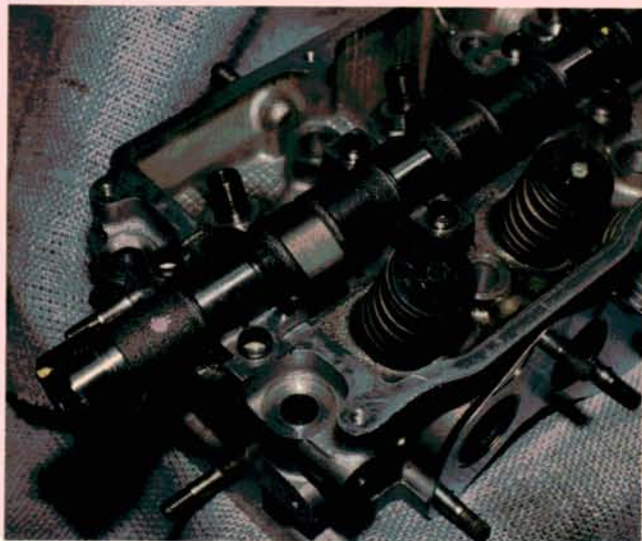
Replacing the cam, lash adjusting screws, and rocker arm shafts without using new rocker arms is also a discretion call. We'll warn you that some people insist that cam and rockers be replaced as sets. But the rockers themselves were in almost-new condition. Our engine runs as quietly as a new one, 10,000 miles after this repair was completed. As we've already noted, knowing the characteristics of a given engine type can be a big help in knowing what you can or can't get away with.

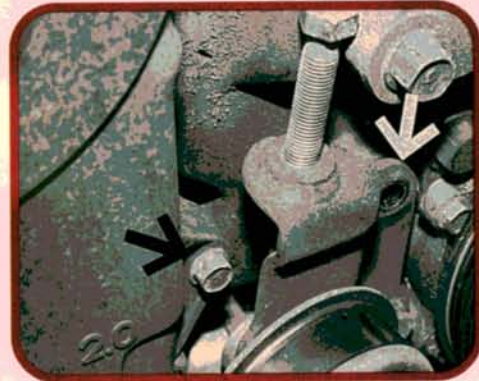
2

Three of the four upper timing cover bolts are easy to reach. One is hidden behind the A/C compressor belt idler. Back off the tensioner and move the belt off the idler. Remove the upper idler mount bolt (white arrow), loosen the lower one. Pivot the tensioner forward. Remove the last bolt (black arrow).

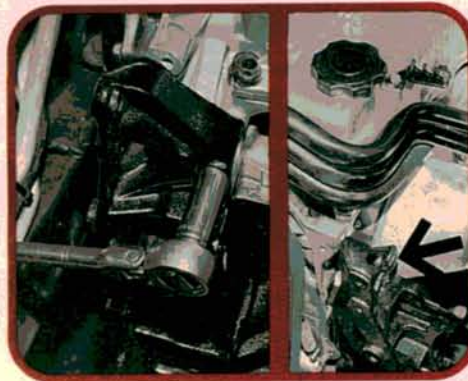
3

Remove the alternator. The cast bracket (arrow) in our photo is the mount for both the alternator and the A/C compressor. You don't need to remove the entire bracket from the block. You will need to remove the bolt which holds the bracket to the cylinder head, however.

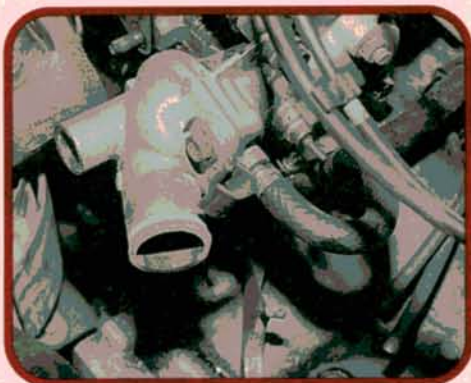
5

We're leaving the oxygen sensor in the manifold since we're removing the thermostat housing. One or the other has to go to get the manifold heat shield off. Unplug the wires for the temp sensor sending unit and coolant fan switch on the 'stat housing. Disconnect the main upper hose and small bypass hose.

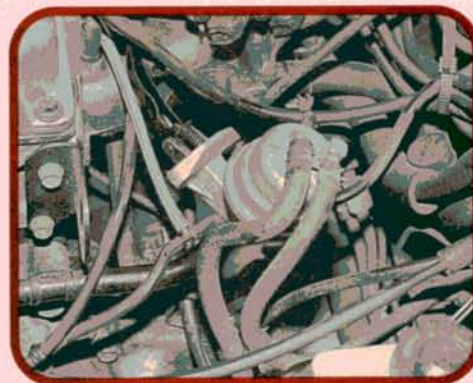
8

Remove the intake manifold and carb as an assembly. That way you don't need to fuss with the remaining vacuum hoses. Disconnect the hose between the fuel pump and carb, and remove the pump. With the pump pulled back, it's easier to get at the intake manifold nuts and bolts located on the pump side of the intake.

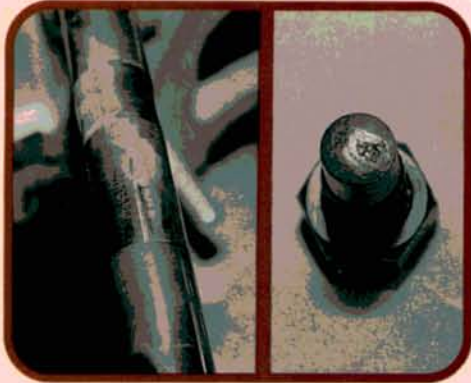
11

As you can see, one thing IS leading to another. A closer look at the rocker shaft assemblies shows that while the rocker arms are in very good condition, the heads of the adjustment screws are badly pitted. The underside of the rocker shafts where the rocker arms ride are also badly gouged and worn.

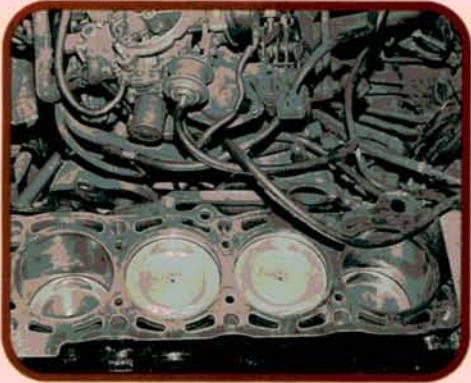
13

As we cleaned off old gasket material and carbon, we noticed that the cylinder head locator sleeves weren't in the block. These thin-walled tubes drive into two of the head bolt holes at the rear corners of the deck to help locate the gasket and head on the deck. Where'd they go?

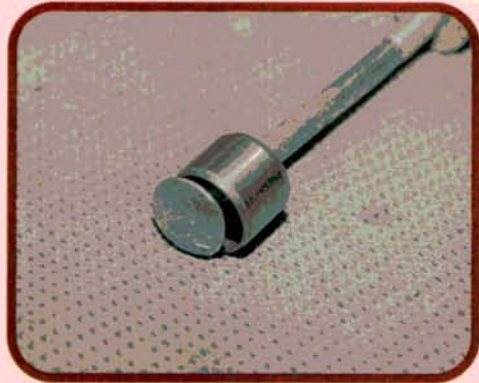
14

We find the sleeves pushed all the way into the mating holes in the head. Removing them with pliers usually means they end up oblong or dented. A good removal tool is a carriage head bolt inserted into the sleeve as shown. Use the bolt head to catch one side of the sleeve and slide hammer it free.

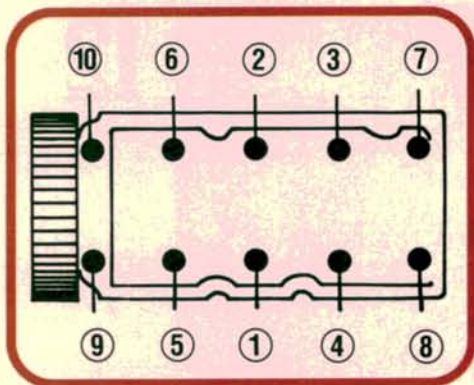
17

Here's a diagram showing the head bolt tightening sequence. Make sure the head bolt threads are clean and lightly lubed. Follow this sequence and tighten the bolts in steps to a final torque of 82-88 Nm (59-65 ft-lb). Don't forget to use all the flat washers for the head bolts.

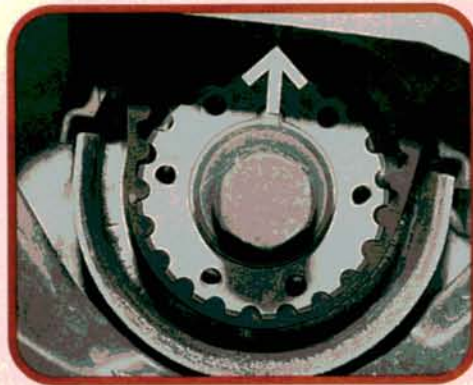
18

We use these marks to set our Number 1 piston at TDC. If you don't remove the crank pulley as we did, simply use the timing marks on the lower cover and crank pulley to set the engine at TDC. Either way, make sure the belt teeth are fully seated in the crank sprocket.

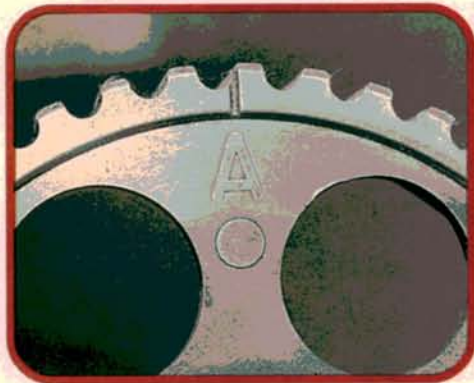
19

The correct cam timing mark for the 626 is the one marked with the letter A. With crank and camshaft in position, pull all the slack from the side of the belt away from the tensioner. Slide the belt onto the cam sprocket teeth and loop the slack side over the tensioner pulley.

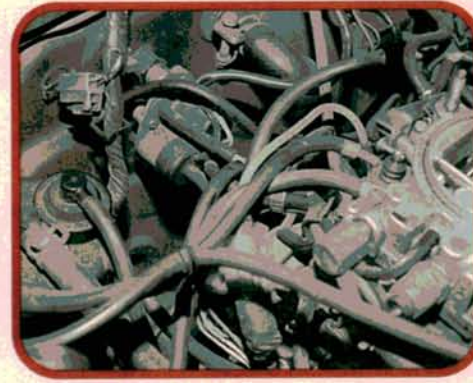
22

Reinstall all the other goodies we've removed in reverse order. Please take an extra moment to double check the vacuum hose connections at the back of the carburetor. I have seen many of these cars stumbling around with an assortment of driveability problems caused by dangling vacuum hoses.

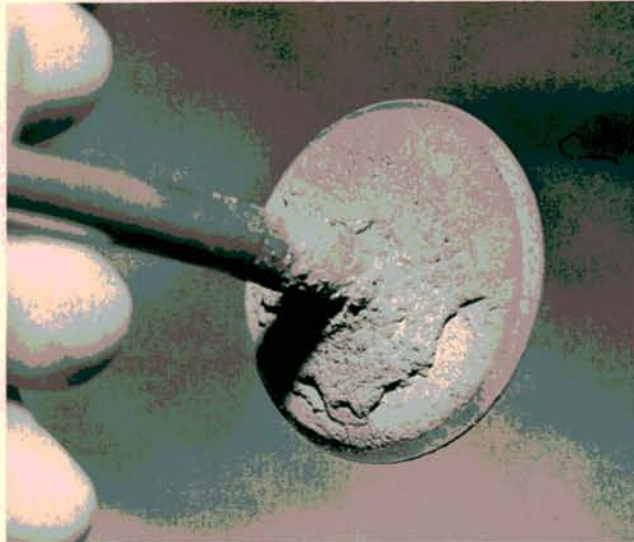
Talk about intake valve deposits on fuel injected cars! This car is carbureted. You'd think these were exhaust valves 'fer cryin' out loud. Amazingly, valve stems are okay, and valve stem-to-valve guide clearance is still within factory specs. Valve seal replacement is a snap at this point.

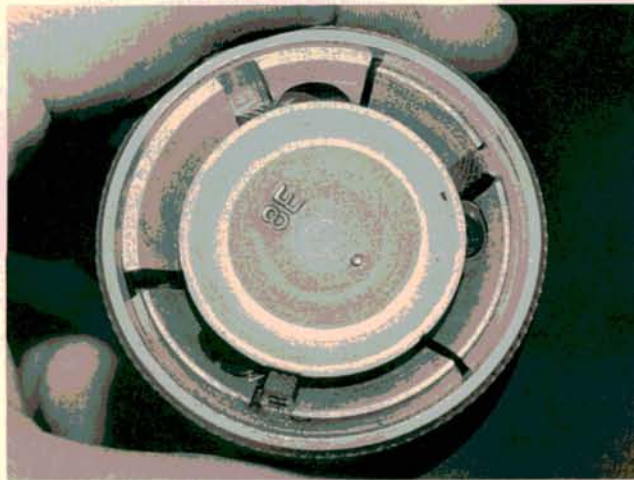
The valve seats need attention, but they're hardly beyond refacing. We'll cut the seats with our Neway cutters. The Neway valve refacing tool cuts a nice new face on the intake valves, which clean up well. Unfortunately, by the time the faces of the exhausts clean up, they're below spec for valve margin. We have no choice but to spring for new exhaust valves.

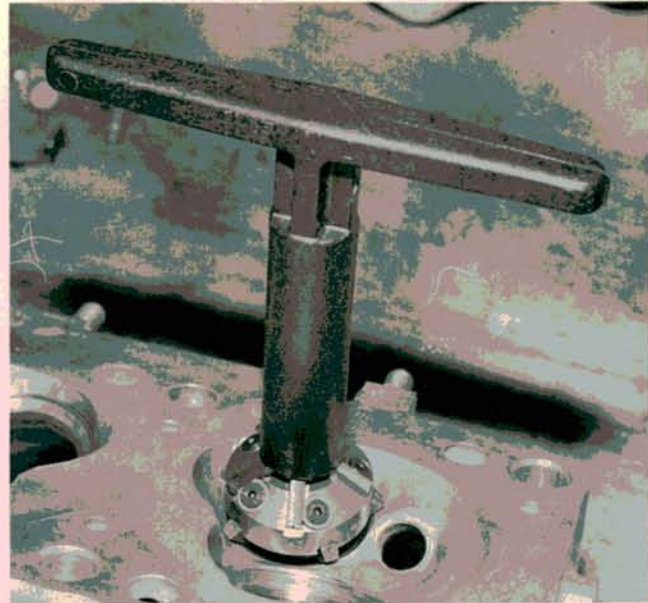
Since we're cutting both the intake valves and their respective valve seats, we need to be careful to remove as little metal as possible and still get a good finish. If we cut too far, the valves end up sitting too deep in their holes. Then the stems stick up too high, ruining valve geometry.
