Mazda's front wheel drive version of the 626 has been with us since the 1983 model year with various changes and modifications since its introduction. This article will concentrate on some common repair procedures and focus on a real 1985 model with an assortment of problems. Among the repairs and adjustments needed on this particular car were several items which fall into a category which might have a heading of "common" or "frequent."

—By Ralph Birnbaum

# Mazda 626

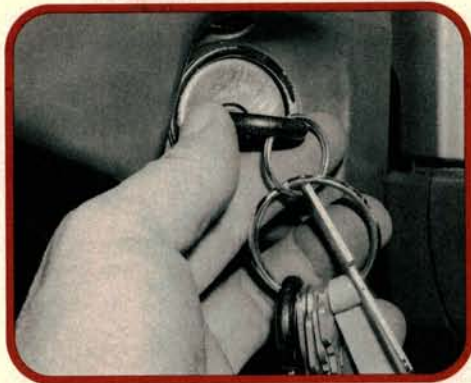
**1**

The occasional “no crank” is doing what any self-respecting intermittent problem does—it’s laying low. For us, the car cranks first time, every time. We clean and service the battery, check, clean, inspect, and test the main cable and solenoid wire. As you’ll see later, there’s more to this story, however.

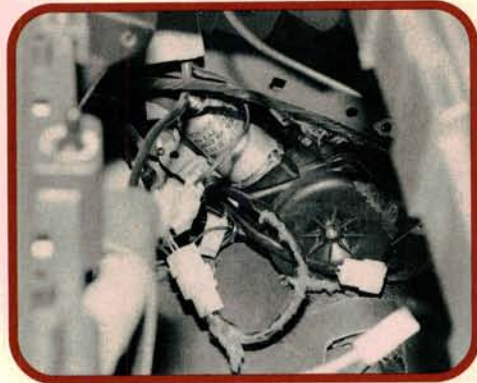
**2**

Let’s move on to the broken mast on the power antenna. On this model, the mast is located in the right A pillar, and the motor is well hidden behind the blower motor housing. Later models put the mast in the left A pillar. To replace the mast, start by removing the glove box (four screws) and the underdash panel.

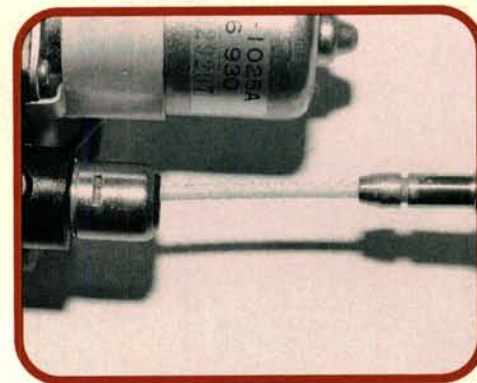
**6**

Tape the antenna lead to the mast tube, and fish the mast back down the A pillar. (For now, slide the protective boot up the mast a few inches.) Insert the new drive rope so the teeth are in line with the motor’s drive gear. Run the motor, by turning the ignition ON and the radio OFF. This will wind the rope into the reel.

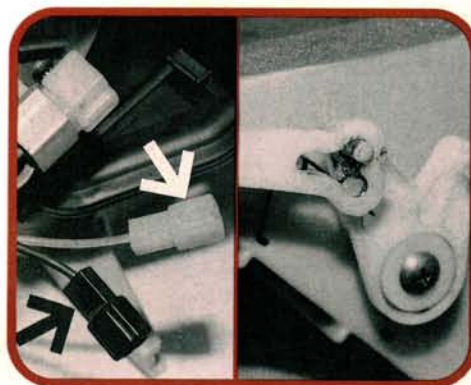
8

First, there are two connectors (one black, one white) coming FROM the blower. There is only one car side connector (black). If the car has A/C use the black motor connector. No A/C? Use the white one. Second, adjust the air inlet cable so the door snaps into the lock position when the lever is pulled to "recirculation."

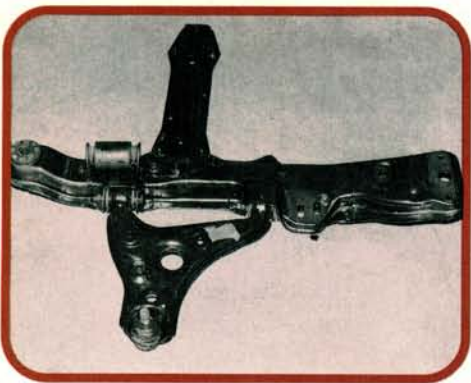
11

The new ball joint comes as part of an entire control arm assembly. Removal of the old arm wouldn't be so bad, but the steel sleeves in the control arm bushings love to rust and become one with the bolts. We support the engine and remove the entire right side support member (the support is also the right motor mount perch).

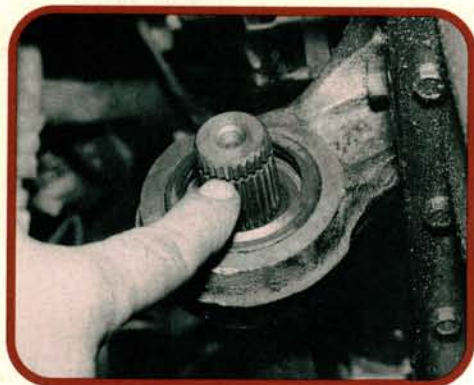
## 13

The right axle is driven by a splined intermediate shaft which spins in a pillow block mounted on the engine. The inner CV joint is held on the shaft by an internal snap ring. A large pry bar and a whack with a mallet separate them. Check the seal and bearing at the pillow block and clean the snap ring groove. Install a new ring.

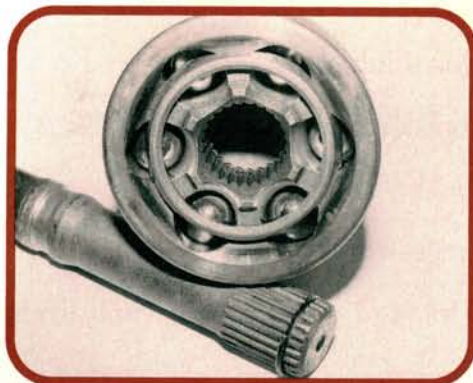
## 14

Mazda's replacement outer joint comes with a new axle shaft attached. This might lead you to suspect that you can't remove the outer joint from the axle for cleaning. But once again, an internal snap ring is all that holds them together. Using a brass drift, we drive the joint off the shaft. Again, replace the snap ring.

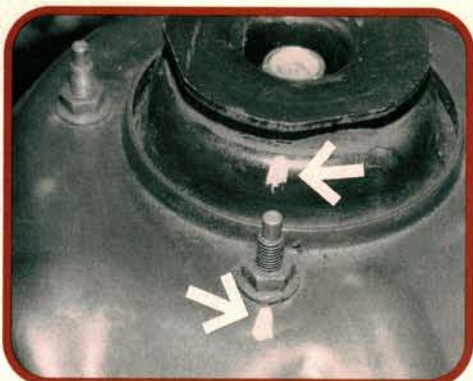
## 16

Struts are easy to replace. One caution. We don't want to change the alignment, so we mark the strut mounts for index. By rotating the mount in the perch, we can change caster or camber (or both) by a preset amount. If proper adjustment isn't possible within the limits of adjustment look for bent or broken suspension parts.

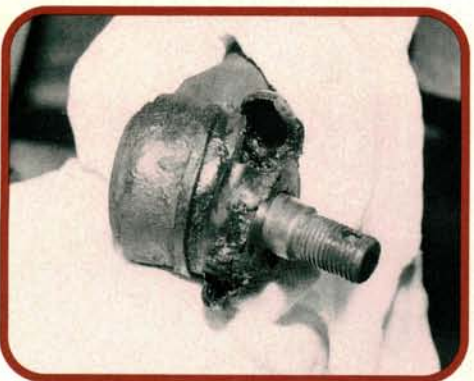
## 17

As we move over to the left side of the car, we find that the boot for the left tie rod end is totally shot. But the tie rod end itself is just fine. Replacement boots are available. Many ball joints and tie rod ends could be saved if customers had the boots checked more often, and replaced as necessary.

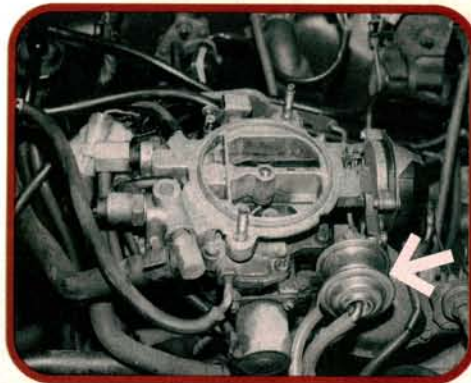
20

Compared to many newer cars, the fuel feedback system on the carbureted 626 is fairly simple and very dependable. Bad choke unloaders seem to be a fairly common problem, and the choke plate and choke shaft should be cleaned and lubed at each service to keep the plate from sticking part way open when cold.

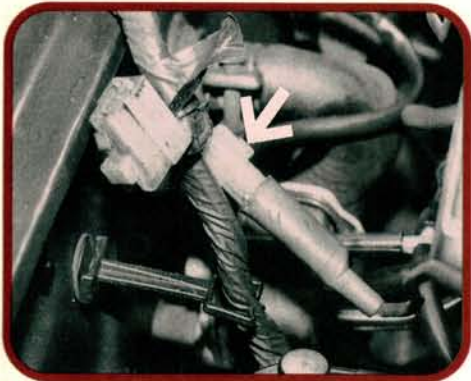
21

In most cases, tests and minor adjustments of the feedback carb system can be done with your DVOM and a dwell meter (90 degree scale). Connect the dwell meter to this test connector in the engine (brown and yellow wire) on the firewall. With the engine warm, we run the engine at about 2000 RPM to warm things up.

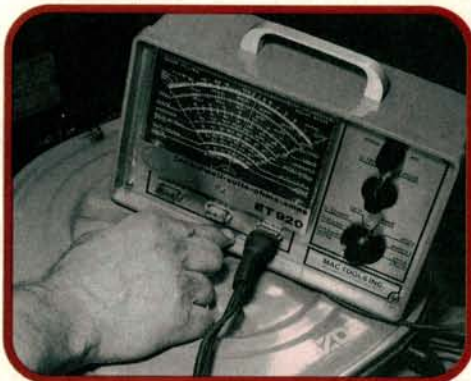
22

Our dwell is "stuck" at 27 degrees. Before we go any further, we check for vacuum leaks, and find two small leaks. In spite of the fixed duty, the car runs well. We tap into the wire at the O<sub>2</sub> sensor with our DVOM, and find that we have high, fairly steady voltage from the O<sub>2</sub> sensor. The mixture is too rich.

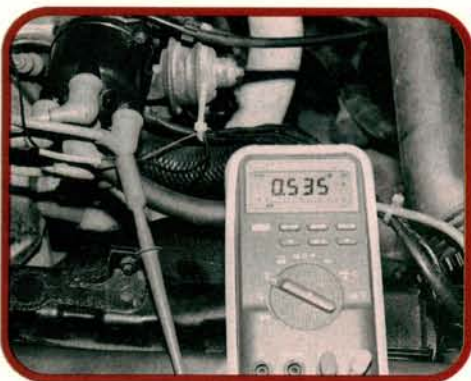
24

Sure enough. We screw the MAS clockwise to lean the mixture, and run the engine at 2000 RPM again. Back at idle, we see that the O<sub>2</sub> sensor is doing its thing. Readings are changing high to low as the sensor responds. The dwell meter begins to fluctuate. The recommended adjustment is 36 degrees of dwell.

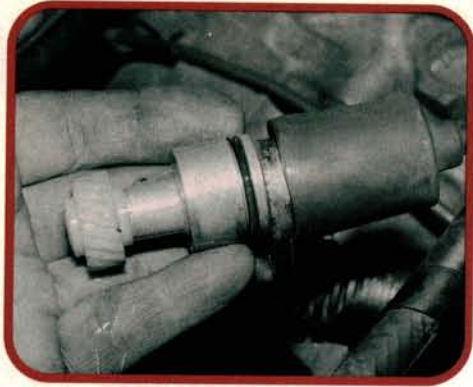
## 25

The speedometer drive gear is also the dipstick in this manual tranny. These can seize in the transmission, and some tranny cases have been ruined when force was used to free them. You may find either ATF or 80W 90 in these transmissions. They'll take either depending on the climate where they're driven.

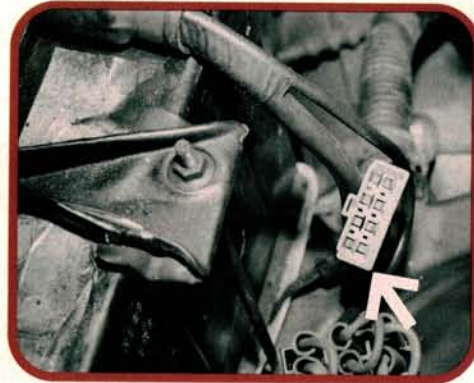
## 28

Remember that no-crank problem? We get lucky and it acts up. The wiring diagram points to a likely candidate, a large connector on the left inner fender, right behind the battery. By testing here, we find out that the ignition switch is working. We also find that the connector has become an electrical dead end.

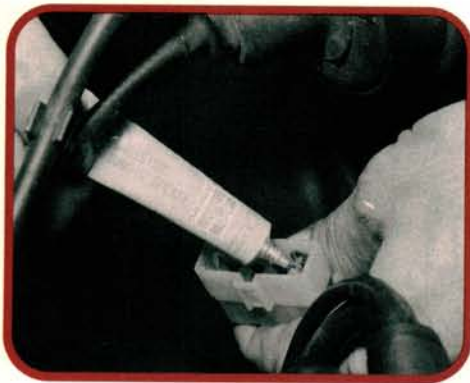
## 29

The connector is so full of salt, and so badly corroded that it doesn't want to come apart. We flush the connector with spray contact cleaner, and put a slight twist on the male terminal ends to ensure a tight fit. Then we apply silicone grease to all terminals, and we're back in business. That's all.
