Take The 5th

Have you been taking the Fifth Amendment? Has unfamiliarity with Volkswagen and Audi five cylinder engines prevented you from handling your customers' service questions about these engines on the grounds that your answers might incriminate you? You're not on trial here, so don't be afraid to answer yes if necessary.

To help make your next cross-examination a success, we've assembled an assortment of repair information for this unique engine that's more than a four, but not quite a six. But before we begin, some five cylinder engine history is in order.

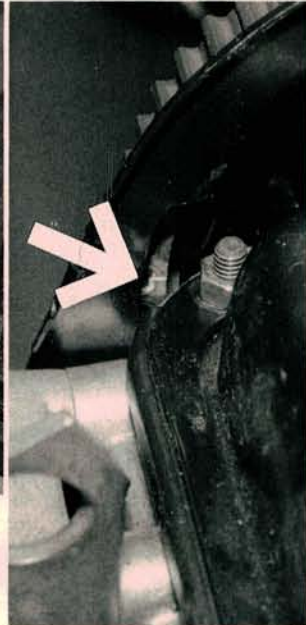
The cam sprocket timing mark is on the back side of the pulley. Line up the mark with the top edge of the cylinder head. The mark is very easy to see with the belt shield removed (left photo). An access window in the belt shield (right photo) allows a glimpse of the timing mark when the shield is installed.

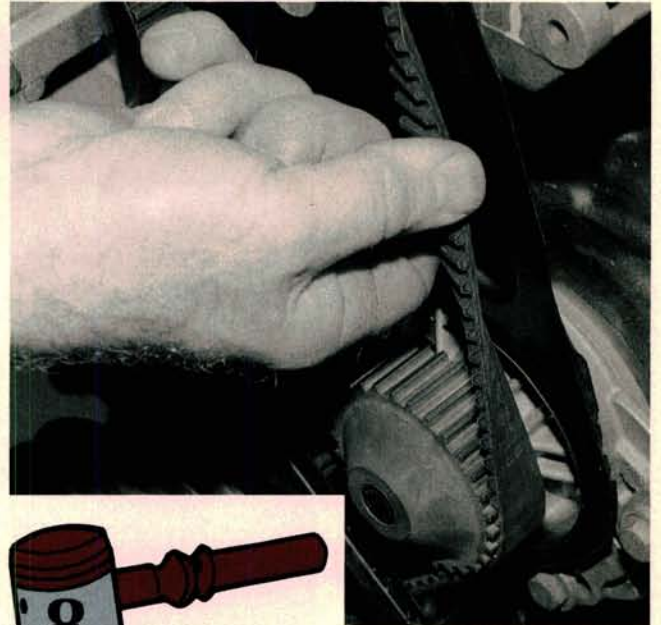
A belt tension gauge isn't needed to set the timing belt tension. Adjust the belt tension by pivoting the water pump counterclockwise. The belt is properly adjusted when it can be twisted about 90 degrees at the midpoint between the camshaft and water pump sprockets. Tighten the water pump bolts to 20 Nm (15 ft-lb).

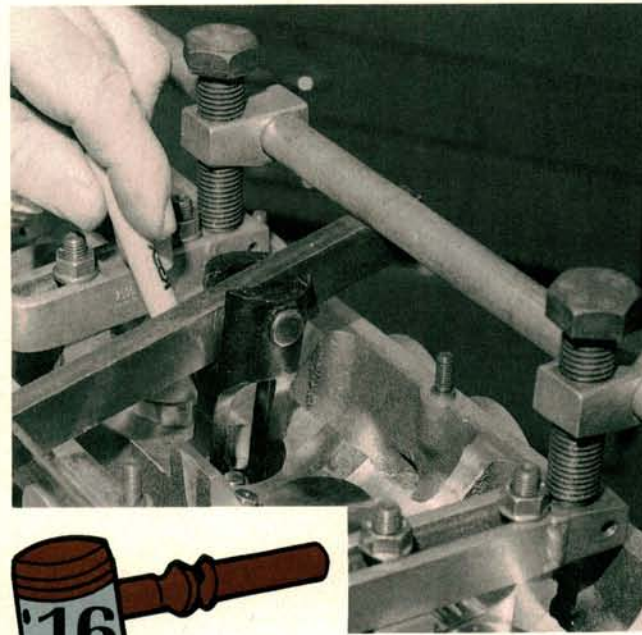
A bridge style valve spring compressor will reach the recessed valve springs and valve seals while the head is installed on the block. The hollow bucket below the tool's lever arm reaches into the well to compress the recessed valve spring. Depress the spring, then remove the keepers with a pocket magnet.

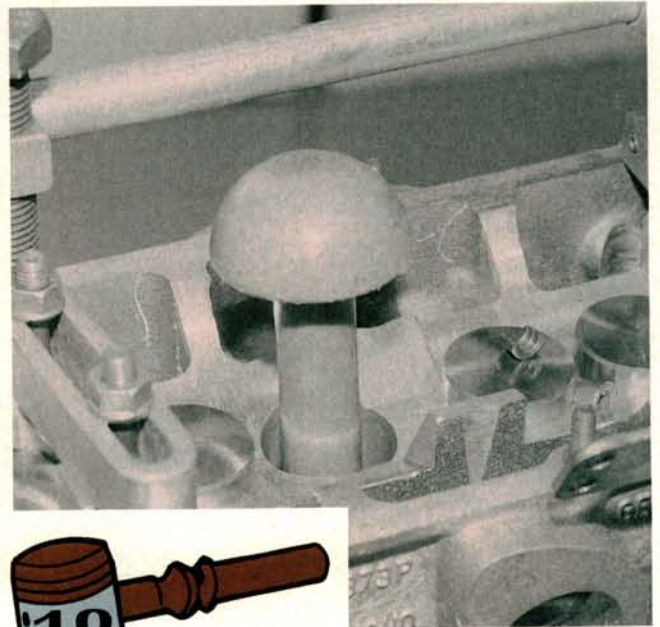
Installing the new valve seal requires one last special tool. This mushroom shaped tool slips over the valve stem and installs the valve seal using hand pressure. Use the small plastic sleeve that's packaged with the valve seals to avoid damaging the new seal as it passes over the valve keeper grooves.
