# Civics Lesson

With the public's confidence in our elected officials at an all time low, we thought you might be ready for a different kind of Civics Lesson. We'll be studying four wheeled Civics, rather than trying to explain how they count the votes in the Electoral College.

We can't hope to cover every Civic model, so this article will focus on the 1984-87 and 1988-91 Civic model series. These are the models that are most likely to be visiting your shop for service. Service information that will help you on one model series will rarely apply to its successor. To avoid confusion, all of the information contained in this article is divided into the model year groups listed above.

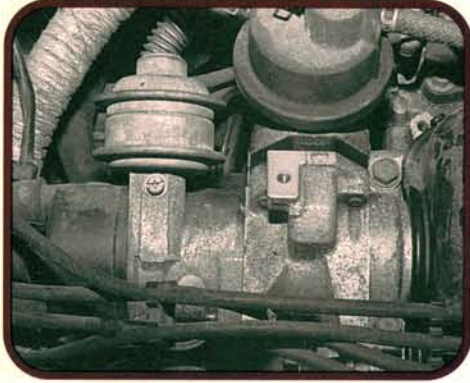
**1**

Always set the ignition timing with the distributor vacuum advance hoses connected. Look for a vacuum advance problem if the adjusting slot doesn't seem long enough to properly set the timing. Advancing the timing to compensate for a vacuum advance failure can cause detonation damage.

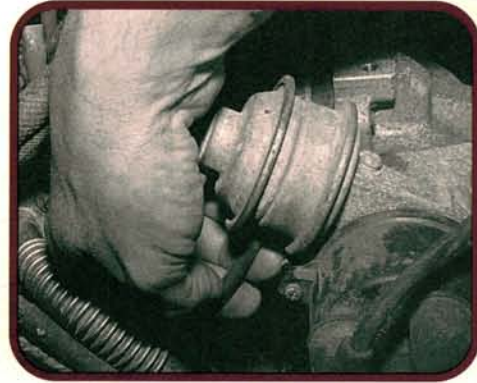
**2**

To test the distributor advance system, warm up the engine and disconnect both vacuum hoses. There should be vacuum at the inside hose but not the outside hose. Plug the hoses and make sure the timing is 3-4 degrees before TDC. If not, check for a sticking advance mechanism or a faulty advance diaphragm.

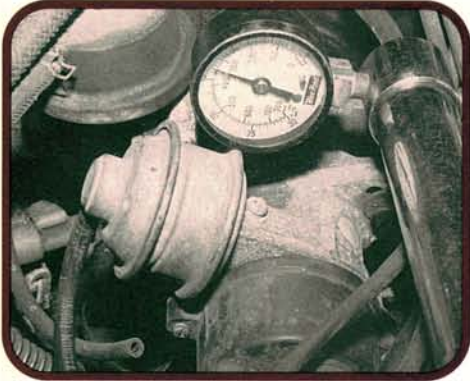
**3**

Reconnect the inside hose. Check the inside advance diaphragm if the timing doesn't advance to the red timing mark. Apply vacuum to the outside diaphragm. The timing should advance an extra 4-6 degrees. If not, check the outside advance diaphragm. Reconnect the outside hose and set the timing to specifications.

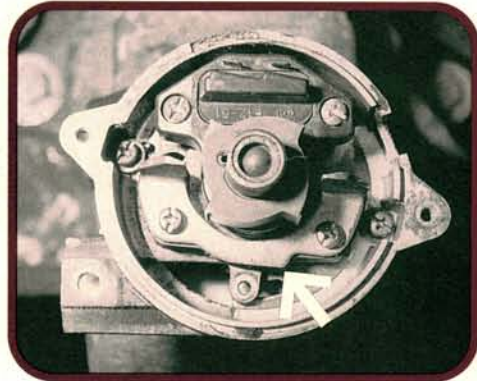
**4**

Distributor assembly can be tricky. The reluctor must be installed with its letter code facing upward. Incorrect installation will cause ignition timing problems. Also, the distributor stator and magnet have the same shape. The magnet is properly installed when the magnet contour aligns with the stator.

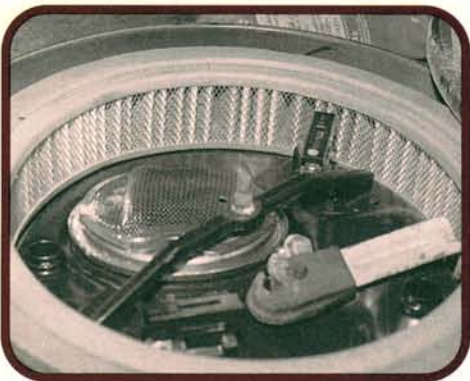
**5**

Some air filters aren't big enough to make a tight seal inside the filter housing. This allows dirt to enter the carburetor and may cause the secondary throttle plate or choke plate to stick. Hard starting may result if the choke plate can't close. A stuck secondary will cause a fast idle when warm.

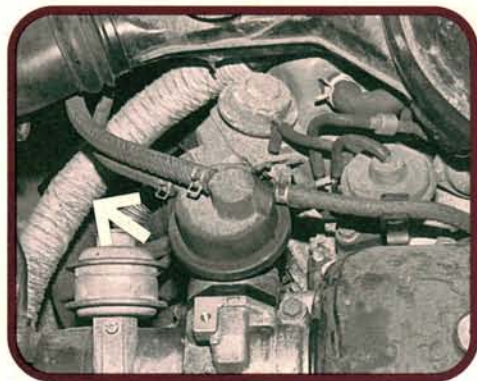
**6**

Check the condition of the air cleaner preheat tube and thermostatic switch. A broken carburetor preheat system may cause carburetor icing and stalling problems when the air temperature hovers around the freezing mark. The cold damp inlet air freezes and clogs the carburetor throat.

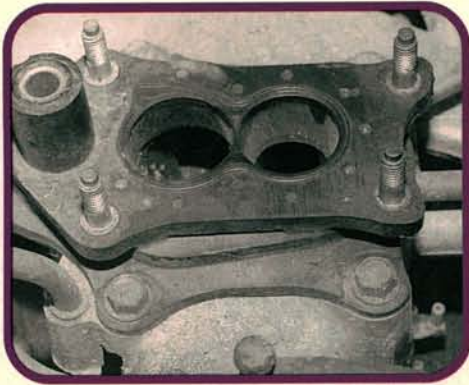
# 7

A worn rubber carburetor insulator may cause stalling problems, especially when the engine is cold. The ribbed sealing surface of the insulator flattens out over time, creating vacuum leaks. To test for insulator leaks, aim propane around the edges of the insulator and watch for an increase in engine RPM.

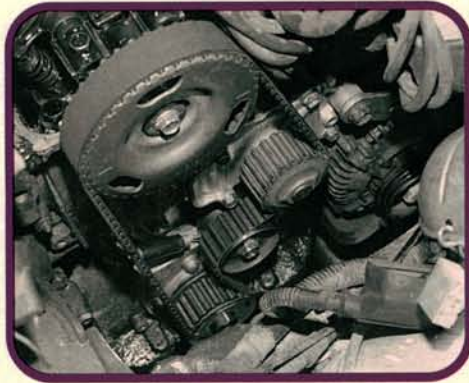
# 9

Timing belts and water pumps are especially important on 1984-87 models because these engines are valve benders. The timing belt also drives the water pump and a seized pump can jam the belt and take out several valves. These problems are so common that good used engines are often hard to come by.

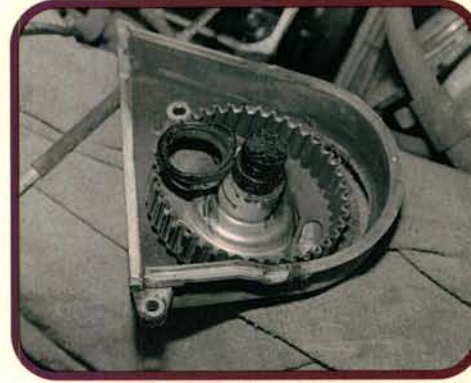
# 10

Another cause of engine death is oil starvation. Problems occur when the engine is run low on oil or when oil change intervals are ignored. Camshaft breakage caused by an oil starved number one cam bearing killed this engine. The cam bearings aren't replaceable, so the whole head is a write off.

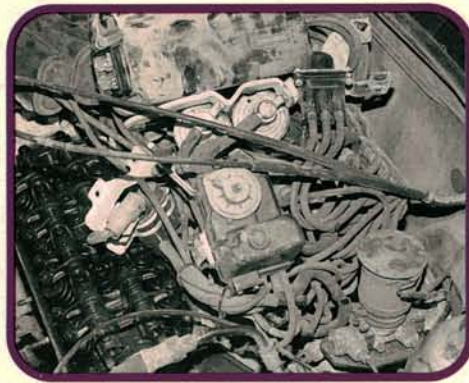
# 11

When removing the cylinder head, think twice about disconnecting all of the vacuum hoses. Nobody uses more hoses than Honda. It's less confusing to unbolt the various vacuum components from their mounting points around the engine compartment. Stack them on top of the head, then remove everything with the head.

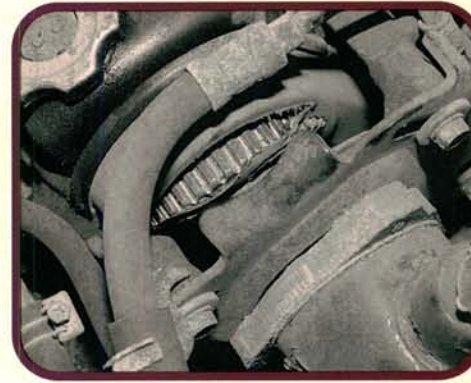
# 12

Good luck if the engine is equipped with power steering. The pump straddles the timing belt cover and must be moved out of the way to access the belt cover or remove the head. The cast iron mounting brackets are bolted to the head and block and must also be removed before removing the head.

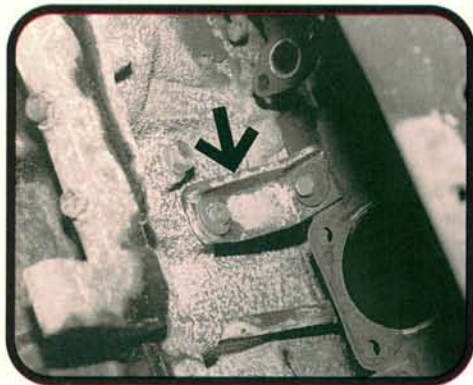
**13**

Don't start lifting yet. Hidden brackets secure the exhaust manifold to the block. Remove the exhaust manifold heat shield to access the catalytic converter mounting bolts. Drop the converter out of the way, then remove the manifold bracket bolts. A bracket at the rear of the engine secures the intake manifold.

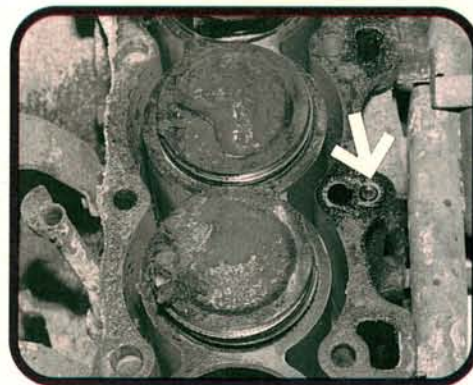
**14**

Poor head gasket sealing may cause an oil leak at the rear of the engine, near the center. The oil supply passage to the head is located here. Since the oil filter and oil pressure sending switch are both located just below, these parts may be incorrectly blamed for the gasket leak.

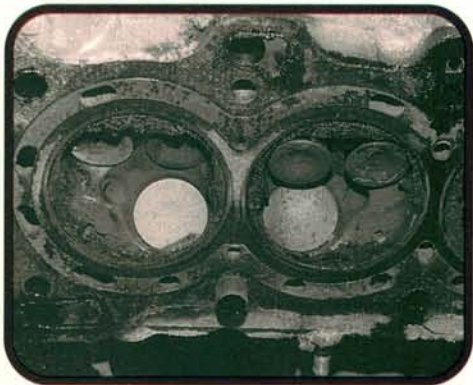
**15**

The pistons kissed a few valves before the engine stopped. Valve carbon buildup can be a problem on these engines, especially if the engine was normally operated at low revs. The carbon may hold the valves open and cause a compression loss. Treatment with carbon cleaner will usually restore the compression.

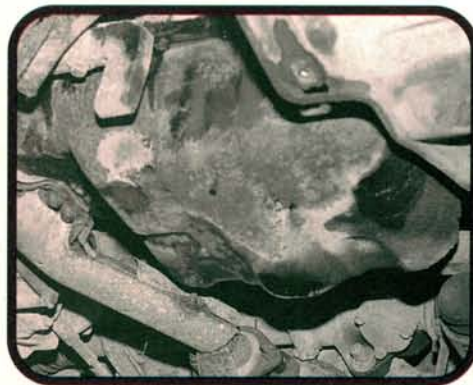
**16**

This 100,000 mile engine will be back in service after a fresh set of rings and rod bearings and some mild cylinder honing. While removing the oil pan, we check it for rust damage. Pans that have been subjected to a lot of stone and salt abuse may begin to leak oil when the pan gets thin.

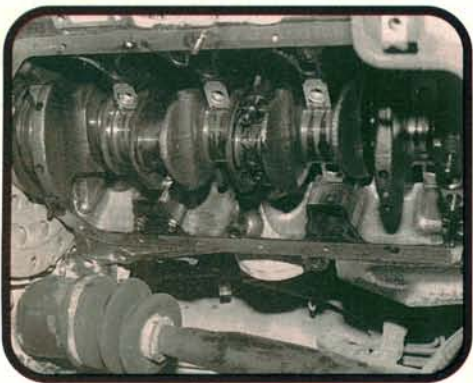
**17**

The aluminum block uses a reinforcing girdle to house the lower main bearing caps. While it's possible to loosen and remove the rod bearing caps without removing the girdle, it's much easier with the girdle out of the way. Otherwise you'll end up cutting yourself on the sharp edges trying to work around it.

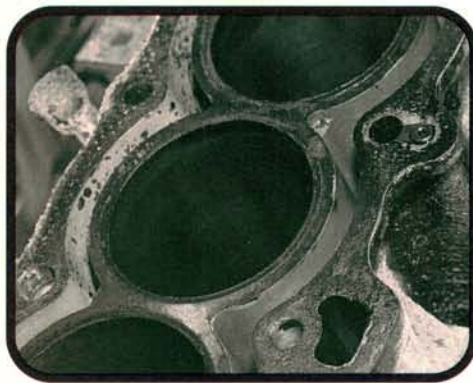
**18**

Next we remove the pistons and check for damage. The valves knocked the carbon off the piston heads, but did no further damage. The oil control rings on all four pistons were stuck in their ring grooves. The cylinder wall crosshatch is still visible and no cylinder scoring is found.

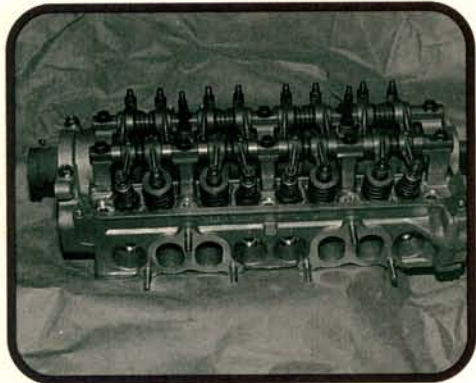
# 19

Installing a fully assembled cylinder head is an economical alternative to buying the parts one at a time. It makes a lot of sense on a high mileage engine, since even undamaged parts may be worn. After swapping the manifolds onto this complete Honda head, it will be ready for reinstallation.

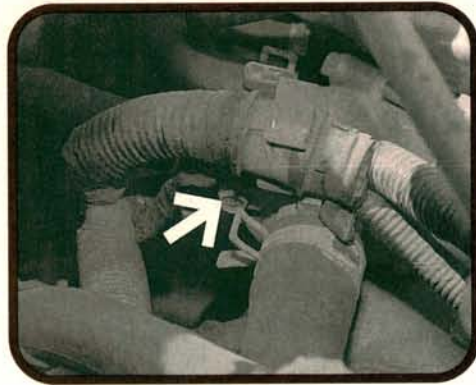
# 20

While 1988 and later Civics aren't valve benders, they do have a few problems of their own. A loose or corroded ground connection at the thermostat housing (arrow) can cause no spark, misfire, surging, erratic tachometer operation, and as many as five different trouble codes.

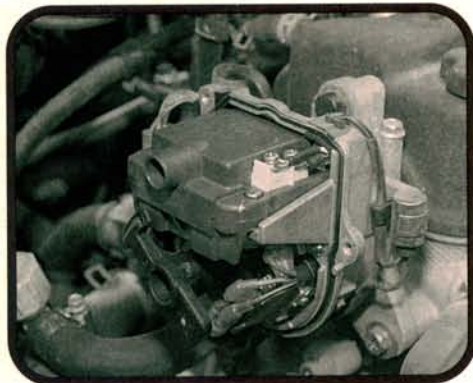
# 21

Distributor igniter failure may be caused by low coil primary resistance. The specification is 0.3 to 0.5 ohms. Replace the coil if its resistance is below specs. The small igniter screws are held in place with thread locker. Heat the screws with a soldering iron to loosen the thread locker.

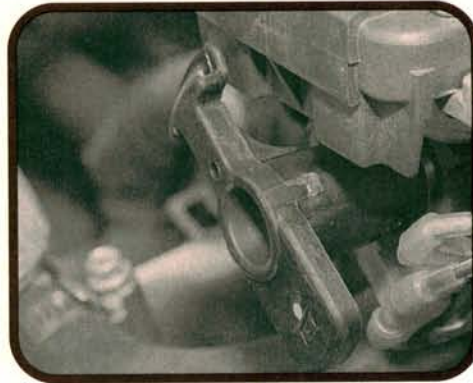
# 22

The secondary spark may burn a hole through the distributor rotor's center electrode, allowing the spark to ground at the distributor shaft. The burn mark may be difficult to see. Remove the rotor for a careful inspection of the underside of the rotor.

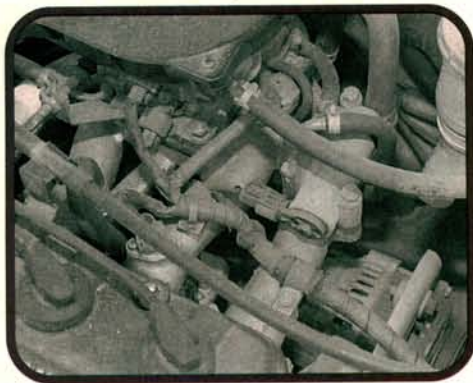
# 23

If there's no spark, the injector(s) may continue to fire when the engine is cranked. The unburned fuel can wash down the cylinder walls and cause a compression loss. After repairing the ignition, add oil through the PCV system while cranking the engine to restore the lost compression.
