J-Type Overdrive

Volvo overdrive units are made in England by Laycock. There are two types, the P-Type and the J-Type. Although not identical, they are very similar. This month, we'll tear down, inspect, and repair a J-Type overdrive.

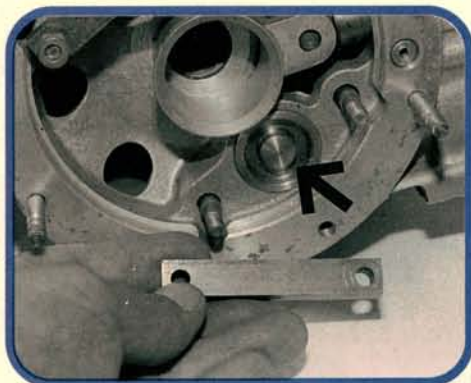
1

This overdrive isn't working. We remove it from the car and clean it. To separate the two housings, start by alternately loosening and then removing the nuts holding the piston bridges over each of the two hydraulic clutch pistons. Remove the bridges and the pistons (arrow) beneath them with a pliers.

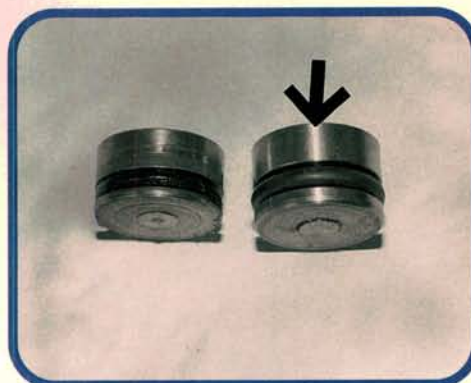
2

We've just started our teardown, and it seems we've already uncovered a major (and common) problem. The sealing o-rings on the clutch pistons are so loose in their bores that the pistons fall out. The piston bores aren't damaged in any way. Our photo shows both old and new (arrow) pistons.

All seals are available as replacement parts, although new pistons with the improved larger seals are a recommended upgrade for any overdrive being rebuilt. Please note that new style clutch pistons must be used when upgrading the seals since the seal groove is now wider.

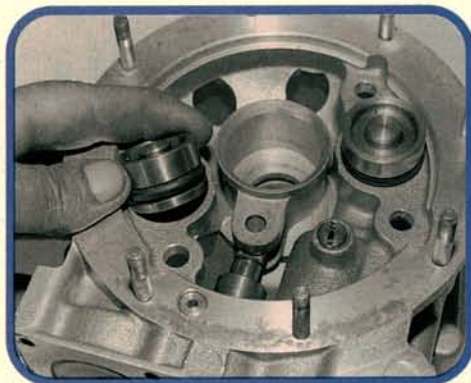
3

The clutch pistons in our unit are old. They were replaced in 1985 with pistons using a combined seal and Teflon ring. Another supersession was made in 1988. We now have these new style pistons which have a wider o-ring groove, and a big fat rubber o-ring for improved sealing.

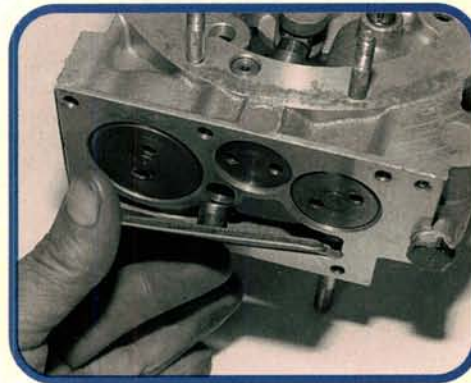
4

Remove the nuts holding the housings together and separate the front and rear housings. Now we're ready to begin our teardown and inspection of the front section. Remove the valve body cover which is held in place by six bolts. Beneath the cover, you'll find a small filter. Twist and pull to remove it.

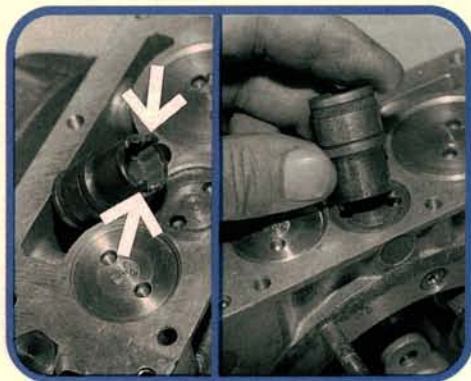
5

Volvo has a special tool available (P/N 2836) to unscrew the threaded plugs in the valve body section. We made a special tool out of an old 1/2 inch socket. Using this type of tool instead of a punch and hammer will allow us to torque the plugs to 22 Nm (16 ft-lb) when we replace them.

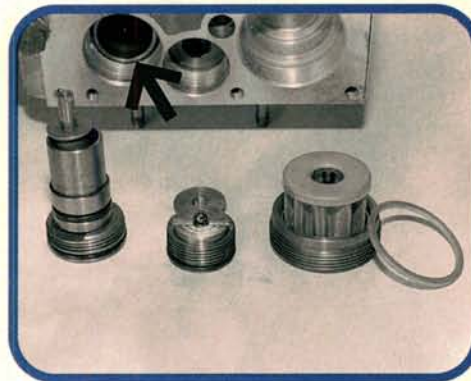
6

Here's what we find beneath the plugs. From left to right: (left) the pressure relief valve, (center) the oil pump check ball and seat, and (right) the oil filter. Note that the cylinder (arrow) and the relief valve seat behind it are still stuck in the housing. Volvo has a special tool for removing them.

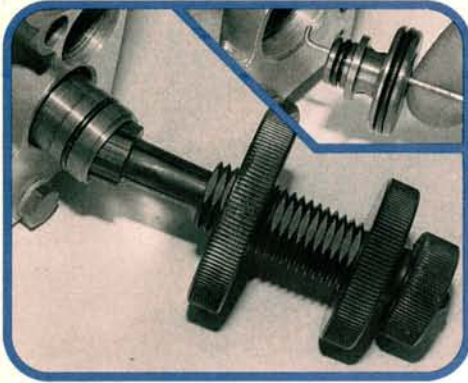
7

We don't have the special tool, but necessity and invention lead us to our Vim universal clutch centering tool. It has expandable plastic jaws which grip the inner surface of the cylinder without leaving any marks. Once the cylinder is removed, we use a small hooked wire to grab the relief valve seat above it.

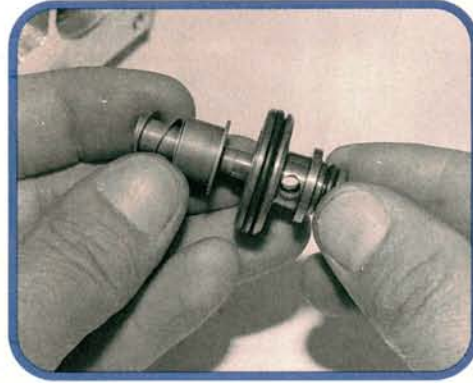
8

Our overdrive unit had been slipping. We check the relief valve and seat for signs of scoring or wear. We also inspect the bore of the cylinder we removed in step 7. All in all, this old relief valve has seen better days. We order an entire relief valve assembly, Volvo P/N 271454-1.

Yes. In fact, the relief valve assembly was replaced in this overhaul. The kit (P/N 271454-1) includes a new relief valve (valve and seat), new springs, a new sleeve, and a new plug.

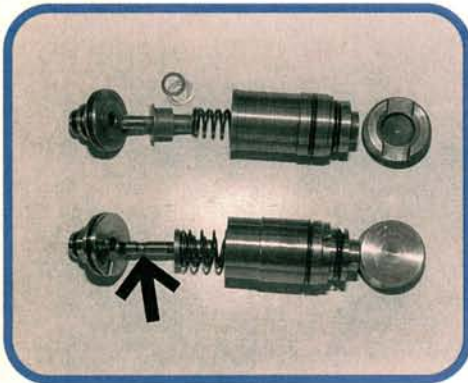
9

Old (top) and new (bottom) pressure relief assemblies. See the shims for the old style valve? If you install only the new style relief valve, (arrow) discard the shims, and install the new inner spring which comes with the new valve. There will be times when a new valve and spring will be all you need.

Yes. But the new valve will come with a replacement inner spring. Use the new spring and discard the shims along with the old relief valve.

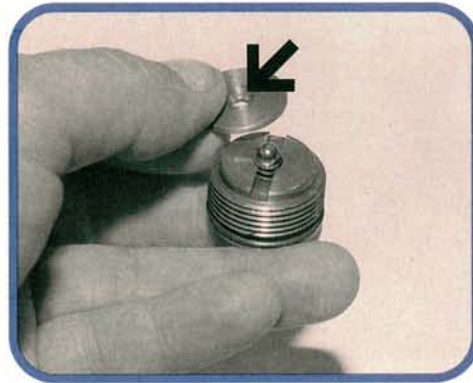
10

The piston type oil pump is driven by an eccentric on the back of the transmission. After removing the concealment plug below the pump, we retrieve the check valve. Blow through the valve. Minor leaks between the ball and seat (arrow) can be fixed by placing the ball in the seat and striking it with a soft mallet.

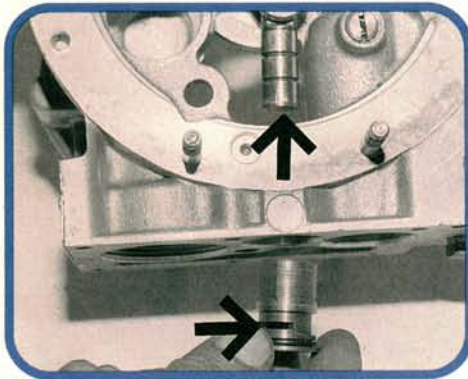
11

Remove the pump body and slide the pump piston up and out. Later, when you reinstall the pump body, make sure the oil inlet slot (arrow) faces toward the inlet filter cavity as shown. Improper installation of the pump body will block the oil passage. The pump will probably make a knocking noise as a result.

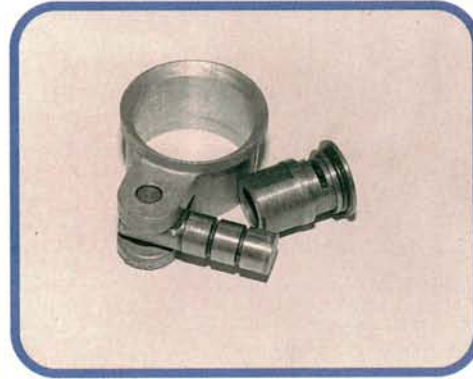
12

Here's a closer look at the pump assembly. Minor surface imperfections on the pump piston can be polished with super fine emery paper. Make sure the piston slides smoothly through the entire length of the pump body. Our pump looks good, and we'll reuse it.

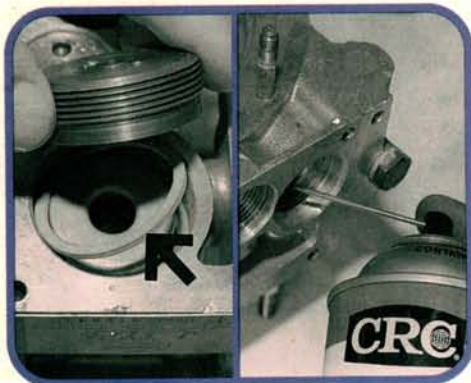
The final bore in the front section contains a cylindrical oil filter. New filters are available. Just pop out the old one and install a new filter and seal (arrow). Flush out all the oil passages with spray cleaner. If you need to dig out stubborn dirt, use a wooden match stick, not a metal pick.

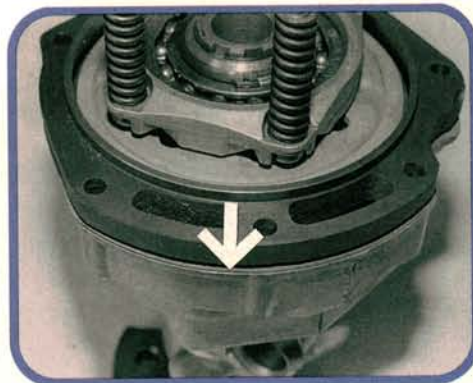
14

Remove the clutch hub from the rear section. The fit between the steel hub and the aluminum rear section may be a tight one. Tap around the perimeter with a plastic mallet. Resist the temptation to drive wedges between the surfaces or you may gouge the aluminum. Always install a new gasket (arrow).

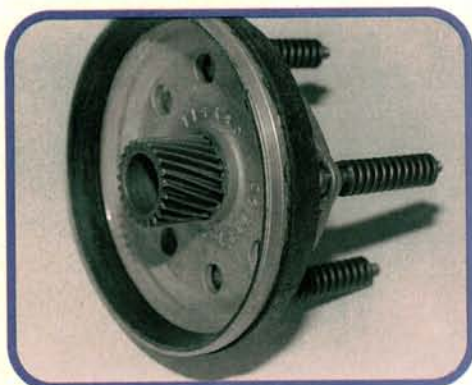
15

Lift the cone clutch assembly up and out of the planetary set. The sun gear is splined to the cone clutch and held in place by a snap ring. Our photo shows the inner and outer clutch linings on the cone. Check them for signs of wear, cracking, or separation from the cone. Check the teeth on the sun gear.

Volvo supplies only non asbestos linings as replacements. Since there is a difference in the width of the linings, always install a new clutch hub when replacing an asbestos clutch with a new, non asbestos replacement. J-Types may have come from the factory with either asbestos or non asbestos linings. Have the transmission serial number handy when you call for parts.

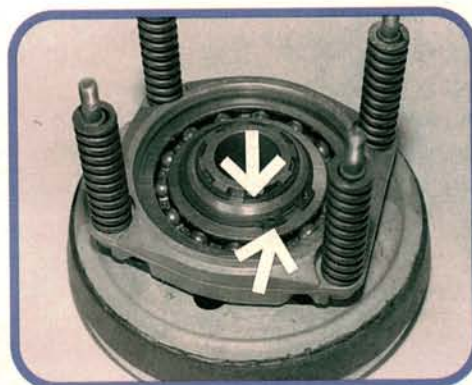
16

Our arrows show the snap rings which hold the bearing assembly and sun gear in place. Remove them to install the bearing carrier and sun gear on a new clutch lining. Measure the free length of the four clutch springs ($55.5 \text{ mm} \pm 1.5 \text{ mm}$). Replace them if they aren't all the same length or are undersized.

Yes. Make sure that the four springs on the cone clutch bearing retainer are still the correct length, and all of equal length. Install new ones if necessary.

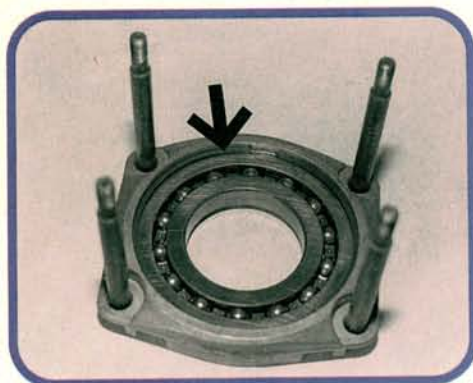
17

Here's the cone clutch bearing assembly removed from the cone clutch. There's one last snap ring to remove if you're replacing the bearing. The noise from a bad cone clutch bearing will be most noticeable in direct drive. For the record, all of the parts in this assembly tested good and were used again.

The bearing on the cone clutch is bad.

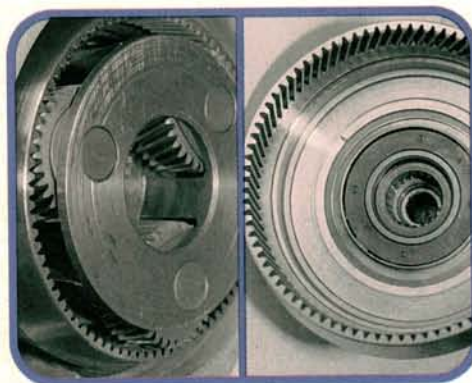
18

Planetary gear sets have long had a good reputation for durability, and these are no exception. As a precaution, we inspect the planet gears for damage, and clean everything up. With the planetary set removed, we carefully clean the ring gear teeth in the output hub.

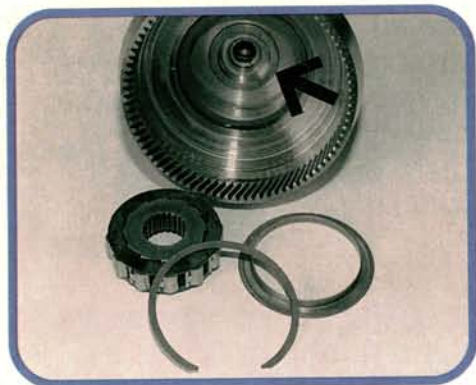
19

To replace a bad one way clutch, remove the snap ring and retainer and install a new one. On J-Types, there's a thrust washer (arrow) below the clutch. Depending on when it was made, the washer will be either 2.5 or 3.8 mm thick. Either one should protrude 0.6 mm above the surrounding surface.

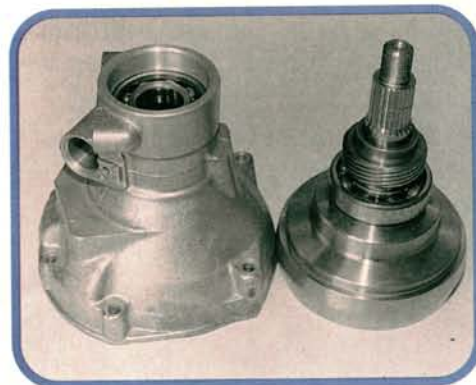
20

To remove the output shaft, remove the output flange nut. Remove the flange, and press the shaft through the rear bearing. Our photo shows the output shaft separated from the case. The rear oil seal has also been removed. The bearing in the case can now be driven out from the inside with a brass drift.

Check both of the output shaft bearings.

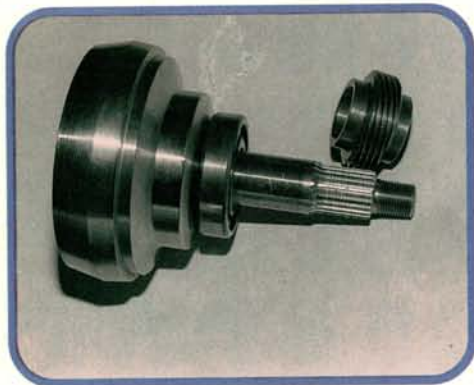
21

Notice that the spacer between the two output shaft bearings is the speedometer drive gear on J-Types. On P-Types there is no speedo gear, and a straight sleeve is used. Bearing replacements are a fairly straightforward press operation. Nothing tricky here either.

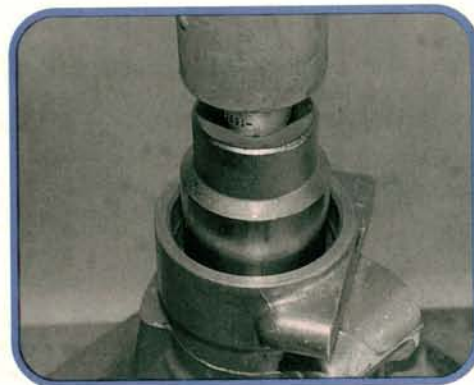
22

Press a new bearing into the case. Lightly lube the bearings with ATF. Install a new oil seal. Slide the threaded end of the output shaft through the bearing, and reinstall the output flange. Hold the flange tight, and tighten the locknut on the shaft to 175 Nm (130 ft-lb).

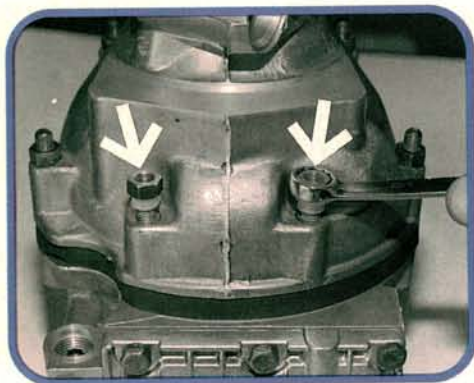
23

Assembly tips. Don't forget the two gaskets (one on either side) of the steel clutch hub. As you reassemble the case halves, draw the housings together evenly by alternately tightening the case nuts. All the nuts use lock washers except the two shown in our photo (arrows). These use nylon sealing washers.

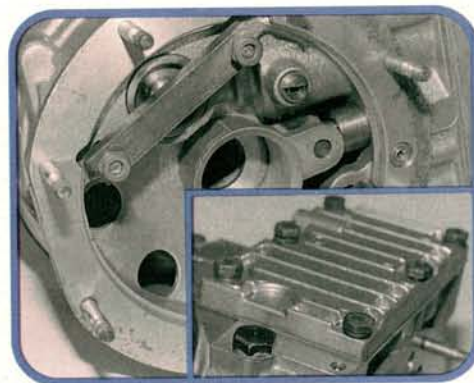
24

When you reinstall the bridges over the hydraulic pistons, use new nuts. Tighten them alternately in a criss cross motion. Final torque for the nuts is 10 Nm (7 ft-lb). Install a new gasket on the oil pump cover (shown in the lower part of our picture). Torque on these bolts is also 10 Nm.
