Alliance

—By Ralph Birnbaum

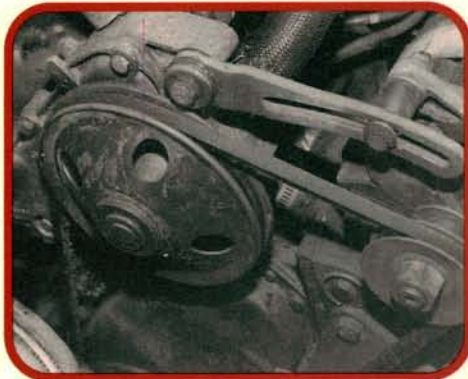
1

Leaking water pumps are a prime cause of head gasket failure. The engine cooling system design doesn't tolerate any fluid loss before it starts pumping air instead of coolant. No cabin heat, and a temp gauge that bobs up and down like a yo-yo are good signs that trouble is brewing—so to speak.

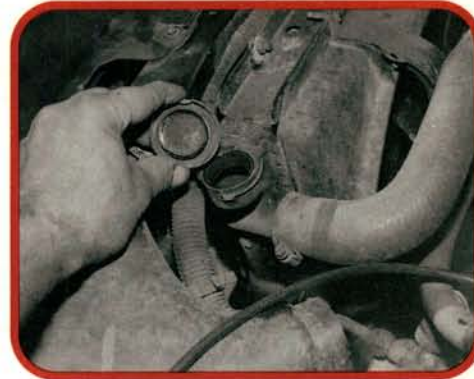
2

Early style cooling systems placed the coolant jug down low in the right inner fender. To fill this system from scratch, remove the radiator cap and fill the radiator. Be careful when removing the radiator caps. The plastic tanks get brittle from heat and the fill necks sometimes twist off with the cap.

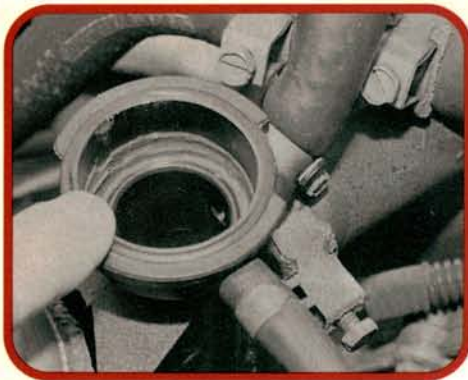
3

There's a lot of air trapped in the hoses above the radiator at this point, even though the radiator is full. Replace the radiator cap and remove the pressure cap at the remote fill neck. The remote fill neck is located on the right inner strut tower, right across from the water pump.

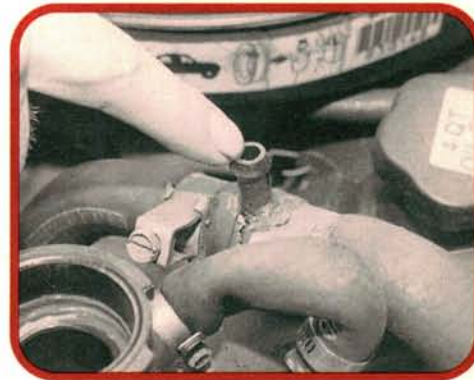
4

Add coolant until the remote fill neck is full. Then remove the short coolant hose to the bleed valve. What we're doing in this bleeding process is forcing any remaining trapped air in the cooling system to the highest point in the cooling system. Trapped air and this system just don't get along.

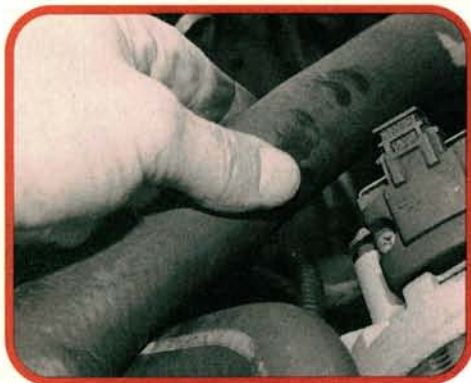
5

Set the cabin heat to HOT. Start squeezing and releasing the upper radiator hose. The thermostat is in the hose, and this process will fill the upper hose, purging most of the air from the upper hose through the thermostat's jiggle valve. Make sure the thermostat's jiggle valve is at 12 o'clock!

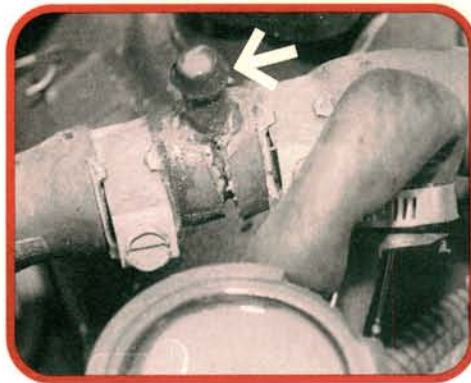
6

As the hose fills with coolant, top off the remote fill neck. Watch for coolant to start flowing from the bleed valve. Start the engine and let it idle. If coolant continues to flow from the bleeding tee, you can reinstall the hose. Keep squeezing and releasing the upper radiator hose to catch any stray bubbles.

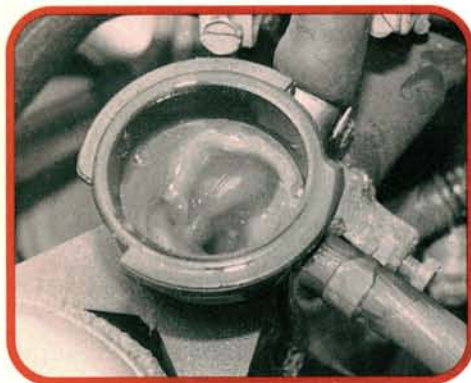
7

If the thermostat is opening as the engine warms, the top radiator hose will get hot. Keep an eye on the temp gauge. If a cooling system in one of these cars is working properly, and you've gotten all the air out, you'll be able to run the engine until the cooling fan cycles before installing the remote cap.

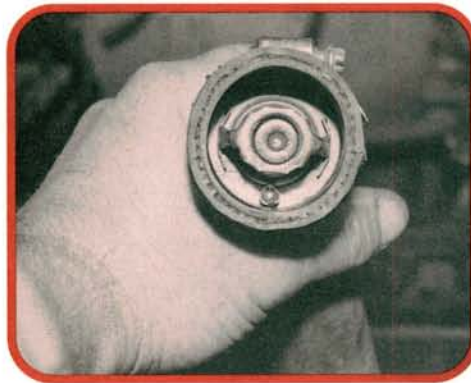
8

If there's air trapped somewhere, or if there's a head gasket problem, the coolant will geyser, so be careful! The thermostat in our test car was installed upside down, and the thermo switch on the radiator had been disconnected. Talk about having a death wish! We'll show you the results in a bit.

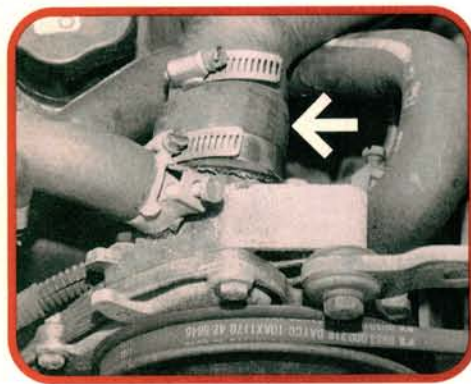
9

Some folks removed the thermostat completely. It should be located in the top hose (arrow). But this also causes problems. The fuel system never gets a HOT signal from the coolant and assumes the car is COLD. It continues to richen the mixture and also keeps the car at high idle thinking the engine is cold.

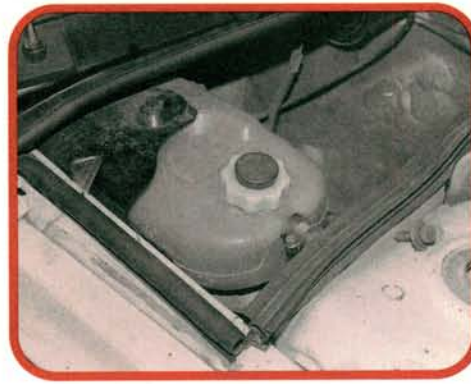
10

Later style cars placed the coolant jug in the water tray higher than the water pump, and the system was supposed to be self bleeding. A large lower hose from the jug fed coolant to the engine, and a smaller hose from the bleeding tee entered the top of the jug. This car has a blown head gasket anyhow.

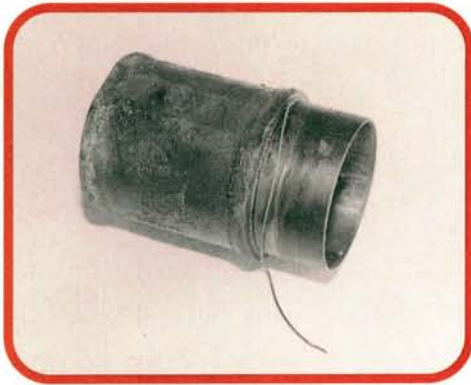
11

Renault used a single o-ring at the cylinder base to seal the cooling jacket from the crankcase. This made cylinder head removal a little tricky. If the head was unbolted and pulled straight up, the cylinders would stick to the head gasket and come along for the ride—breaking the seals.

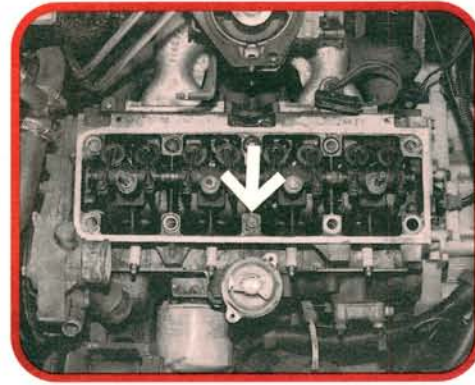
12

As a result, there's a special procedure for removing the head. All but one of the head bolts are removed (cold!). The final bolt at the front/center is loosened but left in place. Then the whole head is rotated about 15 degrees to shear the gasket, before the final head bolt and the head are removed.

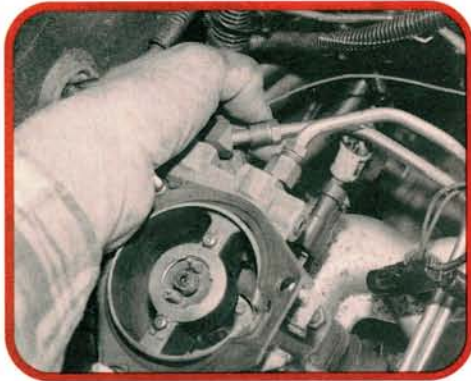
13

You don't need to unbolt the manifolds or remove the distributor to take off the head. Disconnect the fuel lines at the throttle body, all vacuum hoses, cables and electrical connectors. Unbolt the down pipe from the exhaust manifold. I used to remove the rocker shaft to check for plugged oil passages.

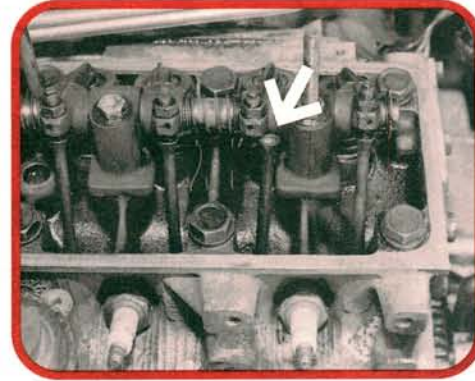
14

A quick note about rocker shafts and push rods while we're here. It was not uncommon to have a bad miss (usually accompanied by a popping in the throttle body) caused when a push rod "launched" (arrow). If the rod isn't damaged, reinstalling it and adjusting the valves usually fixes things.

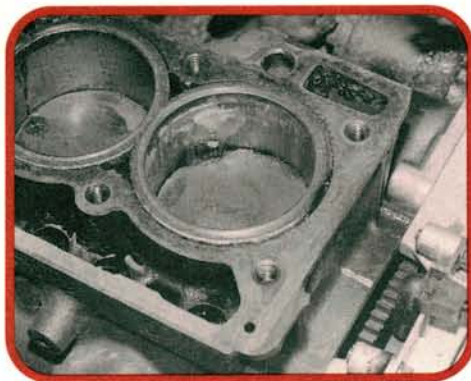
15

With the head removed we find other problems. One cylinder has run very hot. The piston has a hole in it, and part of the aluminum piston is now bonded to the wall of the cylinder. In less severe cases, piston scoring may lead to a "knock" when an engine is started after a head gasket replacement.

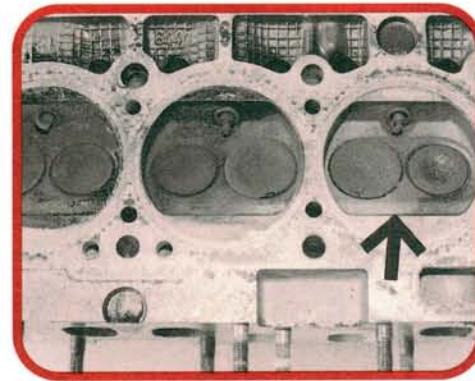
16

The combustion chambers tell another story. The chamber at the right (same one with the trashed piston), has run very lean. A cracked vacuum hose at the intake manifold has leaned the damaged cylinder. The other chambers show how the fuel system richened the mixture to keep the engine running.

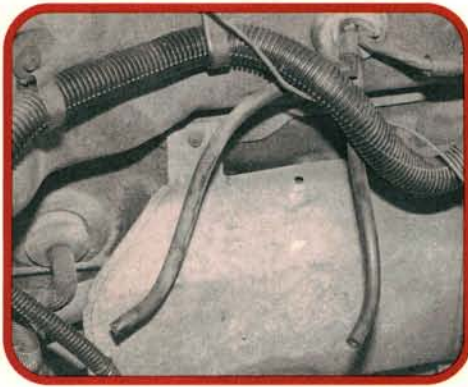
17

With the head removed, we get a better look at the vacuum hoses. On this car, one hose goes to the vacuum can, the other to the map sensor. These hoses cause all sorts of problems when they harden and crack from heat. Always check them and don't hesitate to replace them if they're suspect.

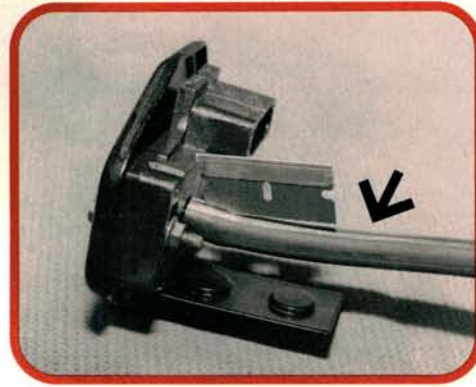
18

Be careful when removing the hose from the MAP sensor (arrow). The hoses might have gotten loose at the manifold, but they stay tight at the sensor end. If you yank on the hose, the sensor may come apart. Take a few extra seconds to slit the hose with a razor blade before removing it.

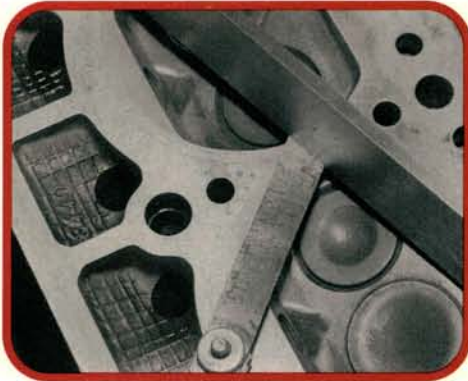
19

The heads have to be straight and true to seal properly. In cases of extreme overheating, cylinder heads will distort. Be careful about minimum head thickness. If this is the second (or even third) head gasket replacement, the head may already be too thin from repeated resurfacing.

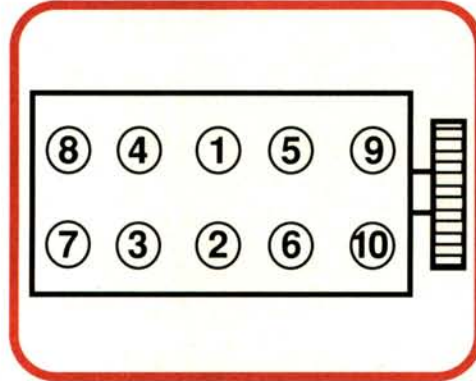
20

This diagram shows the head bolt tightening sequence. Head bolts torque to 55 Nm (40 ft-lb) cold. We always had the customer return in 500 to a 1000 miles to double check the cooling system and retorque the head bolts. Valve lash should be adjusted cold. Adjust intakes to 0.15 mm, exhausts to 0.20 mm.

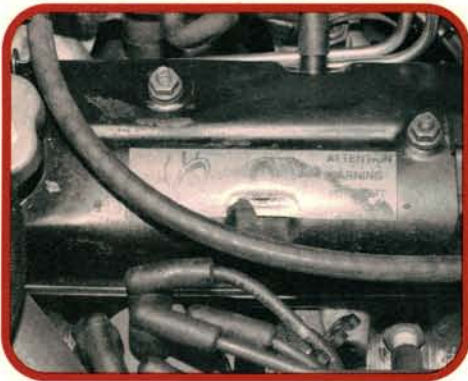
21

Make sure you have the correct oil filter for the engine. We won't give you year applications here since the car may have a bone yard engine already. But be aware that some 1.4 liter engines used a filter with an English thread, while others were metric. Not all engines had stickers on the valve cover.

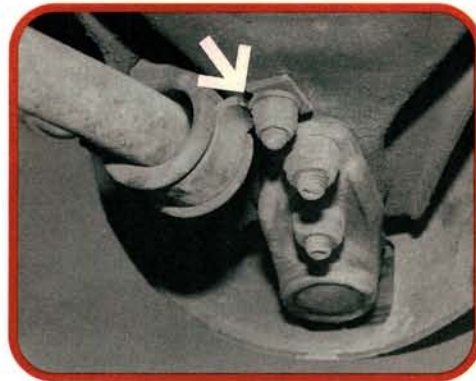
22

Let's move on to some under car problems. The front stabilizer bars had two problems. First, the inboard bushings would get dry and squeak loudly. And the outboard bushing clips at the control arms would break. Our donkey car had one outboard clip missing, and the other was badly cracked (arrow).

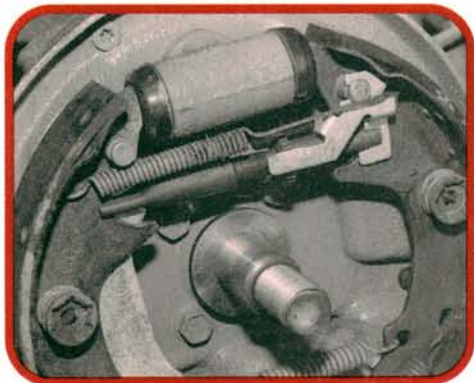
23

Another common problem was abnormal rear brake wear. We saw many cars arrive with uneven wear on the rear shoes. In some cases, one side had no lining left, while the other wheel looked like new. We eventually traced the problem to improperly adjusted hand brake cables.

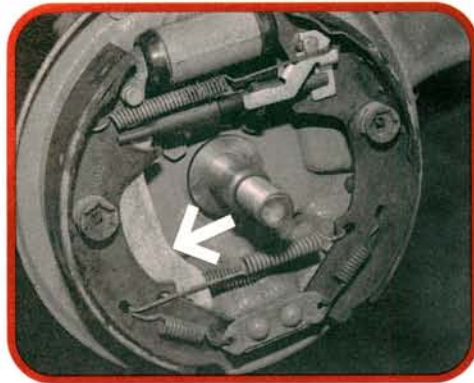
24

The cables were apparently overtightened at the factory. They kept one or both of the hand brake arms pulled forward (arrow). This kept the self adjuster on that wheel from working properly. In fact, some of the star wheels on the adjusters were rubbed toothless and stopped working altogether.

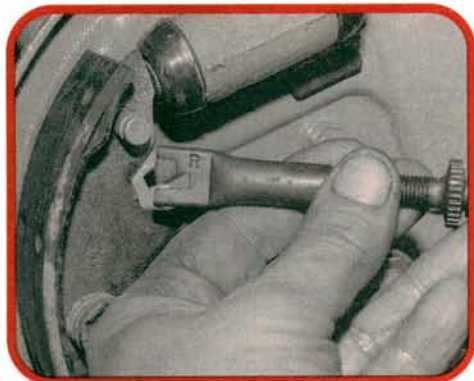
25

Inspect the adjusters. Look for worn or even missing teeth on the star wheel(s). Replace any damaged parts. If the adjusters aren't damaged, clean them and lightly lube the threads. The adjusters are marked for left and right so don't mix them up. Screw the adjusters all the way closed before reinstalling them.

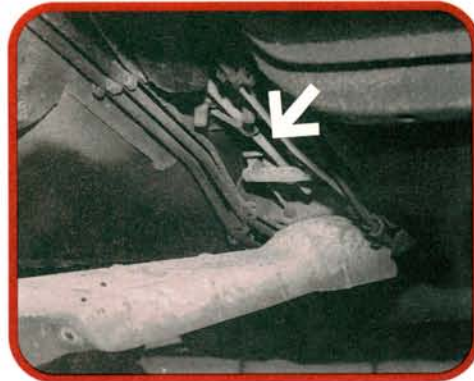
26

With the brake shoes installed, check the hand brake lever arms—both of them. Make sure they're all the way OFF—fully released. If not, check for a sticking cable or cables. If neither is sticking, you'll need to drop the protective shield between the exhaust and the cable mechanism (arrow).

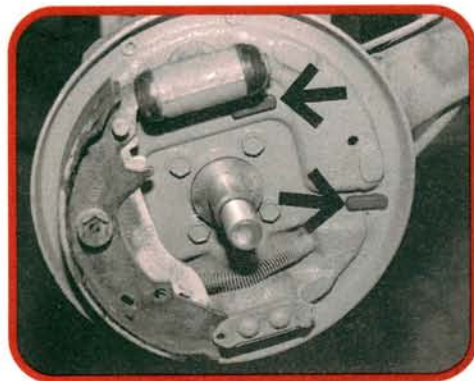
27

Back off the cable adjuster until there's no tension on the arms. Reinstall the drums and adjust the new shoes as you would normally. This photo shows the location of the two rubber plugs in the backing plate—one is for inspection of the lining thickness, the other for manual adjustment of the brake shoes.

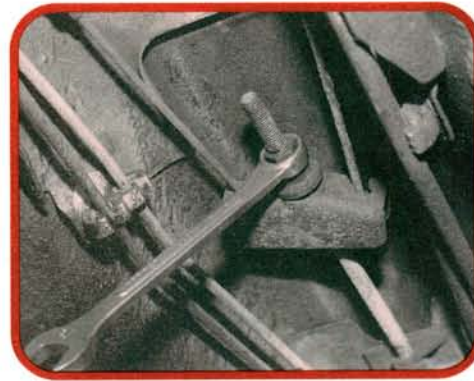
28

With the new shoes adjusted, go back and adjust the hand brake cable until it applies both sets of rear shoes evenly, but fully releases them when the hand brake handle is lowered. This will normally give you about 6 to 8 clicks on the handle until the hand brake is fully applied.
