Van Go

We'll be concentrating on Nissan Van models in this maintenance overview. To begin with, what can you say about a vehicle that never had its own name? Names like "Axxess" and "Quest" seem to imply rather lofty design aspirations, while "Van" does little more than describe what the vehicle is. Nissan called this model the "Prairie" in the home market.

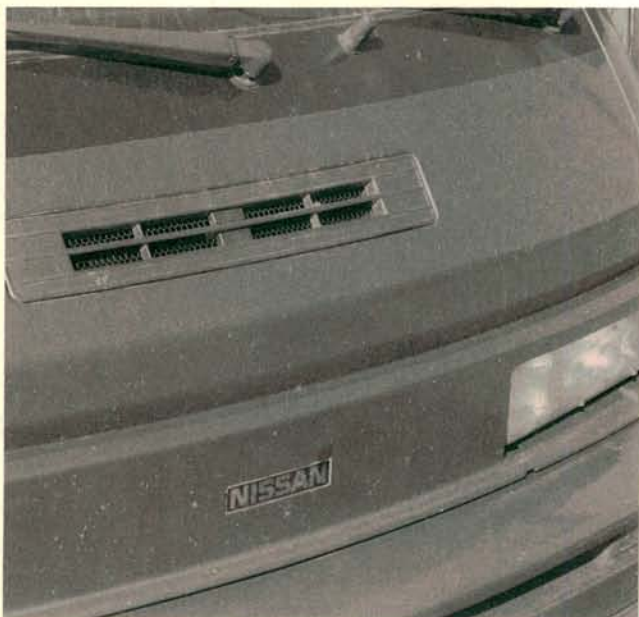
Unlike most front engine minivans, no maintenance other than headlight and wiper blade replacement can be performed from the front of the Van. Everything important must be serviced by working from either inside or below the vehicle. Adjust your labor estimates to reflect the extra time this requires.

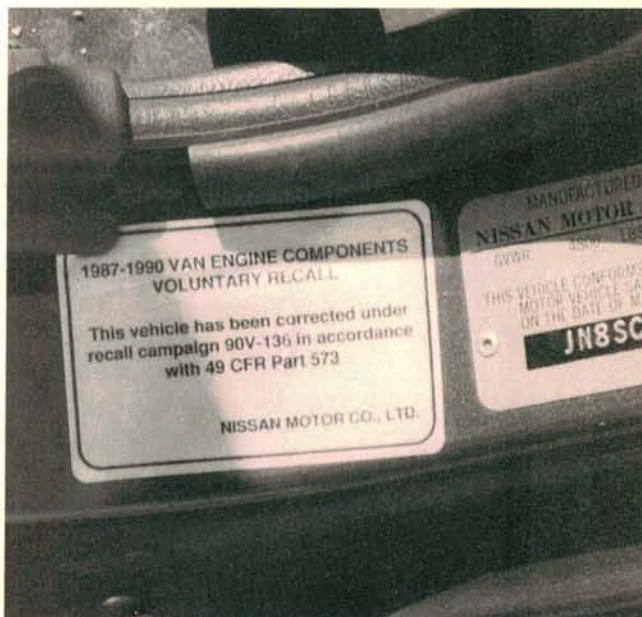
Check the recall sticker before doing anything other than an oil change on a Nissan Van. If you don't find a 90V-136 recall sticker either on the driver's door jam or near the emissions label on the engine cover, have the customer contact a Nissan dealer to determine which updates are needed.

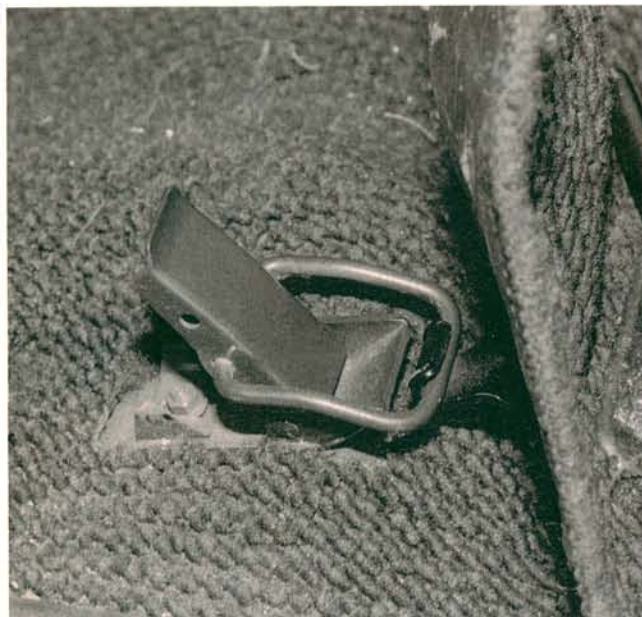
3

Just checking the oil level requires some work. Three latches under the carpeting keep the engine cover closed and keep the driver's seat firmly anchored in place. Two latches are located in front of the driver's seat, the third is near the left front corner of the passenger seat.

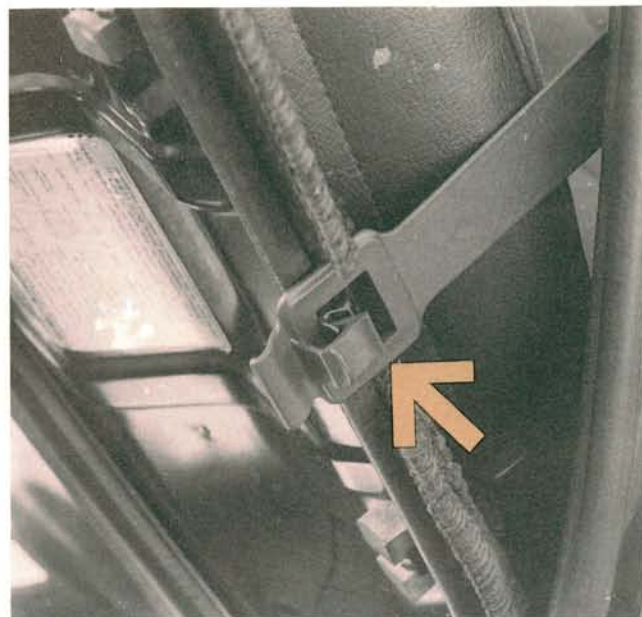
4

To raise the engine cover, slide the driver's seat all the way back so it will clear the steering wheel, then lift the front of the engine cover and driver's seat assembly. Tilt the cover rearward, then keep the cover open by attaching the plastic strap that's mounted to the shoulder belt bolt.

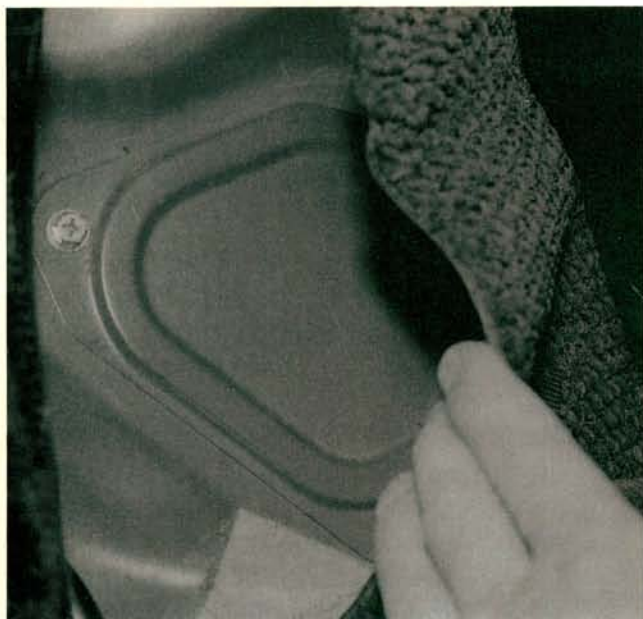
Turn back the carpeting to reach this small access plate behind the left rear corner of the passenger seat. Removing this plate gives you a view of the back side of the throttle housing. If you're double jointed, the automatic transmission dipstick can also be reached through this opening.

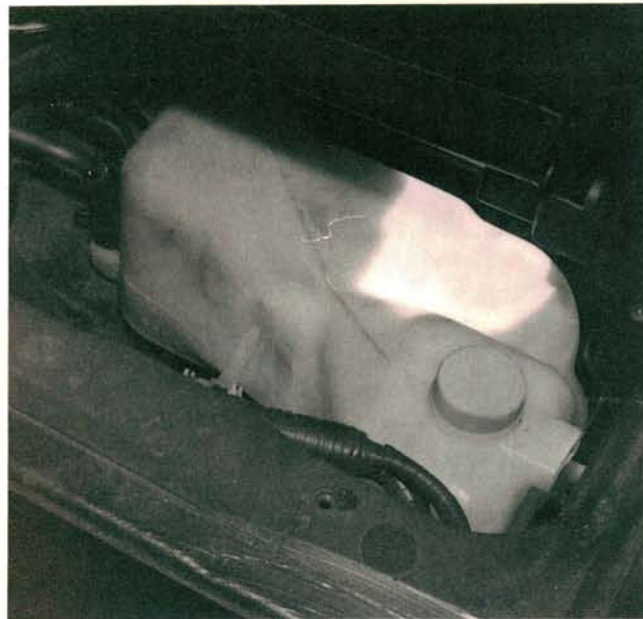
Move the passenger seat all the way forward, then remove the large metal access cover to service the coolant reservoir and fuel filter. Spilled fuel in this enclosed area is a fire risk. Relieve the fuel system pressure and clamp off the fuel line before changing the fuel filter.

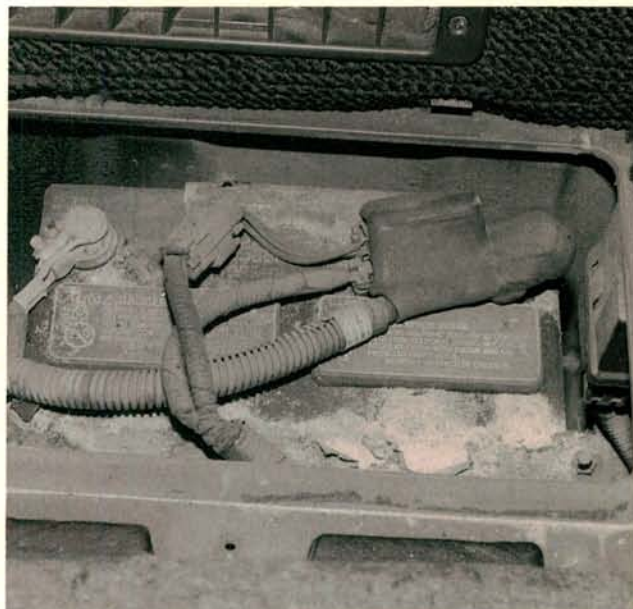
14

Locate the battery symbol on the left side of the rear passenger compartment, then remove the access plate under the carpeting to reach the battery. The battery tray is open to the elements from below. Clean the battery terminals and fusible links regularly to prevent the corrosion damage seen here.

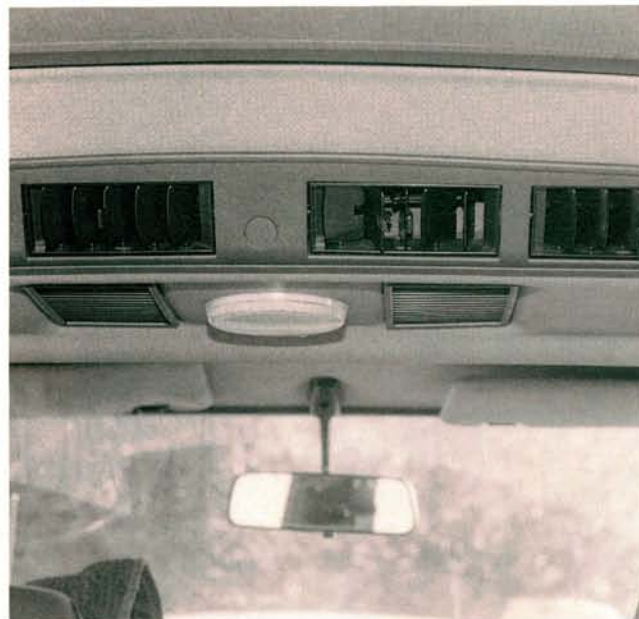
16 Leaks in the Van's front and rear air conditioning system are the ozone layer's worst nightmare. Poor system performance may also be caused by a failure of the electrically controlled switching valve that regulates the flow of refrigerant through the system's two condensers and three evaporators.

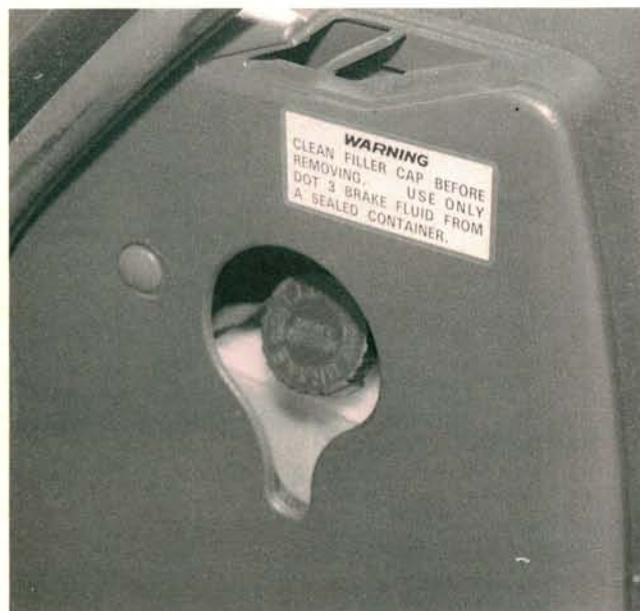
17 Brake fluid is the only fluid level that can be checked or adjusted without removing one of the engine access panels. Use the slotted opening in the left end of the dash board to determine the master cylinder reservoir level.
