# Taken For Granite

Toyota began making a name for itself in this country more than 25 years ago by selling lots of small, inexpensive cars and trucks. Somewhere along the line, someone in the marketing department must have discovered there were also Americans who were looking for a bit more power and luxury in a slightly larger package, and wouldn't mind paying extra for these features. Giving the customer what he wants (or what he thinks he wants) sells cars, so Toyota introduced the Cressida for the 1978 model year.

— By Karl Seyfert

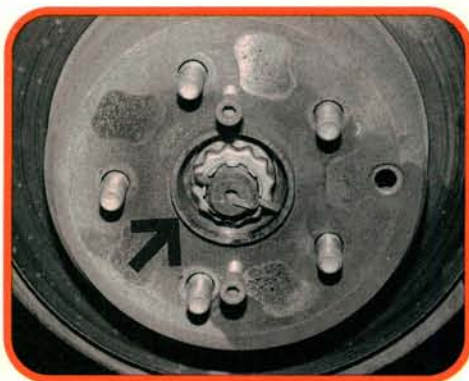
1

Before removing the rear brake rotors for service, clean the axle flange and rotor mating surfaces. Some rotors and flanges were match marked at the factory. Apply antiseize paste to the flange, then return the rotor to its original position after resurfacing to keep rotor runout to a minimum.

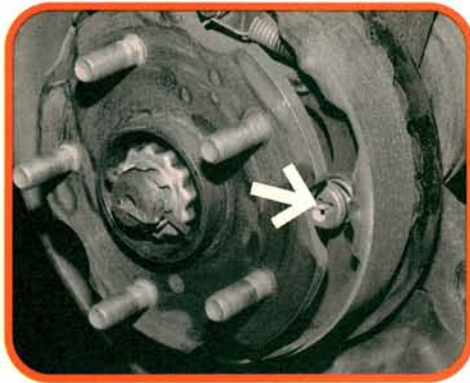
3

On late model Cressidas, noises from the rear suspension when driving over rough surfaces may be caused by loose emergency brake shoes. Updated rear shoe hold down springs hold the rear shoe against the backing plate with greater force to eliminate the noise. The front hold down springs aren't changed.

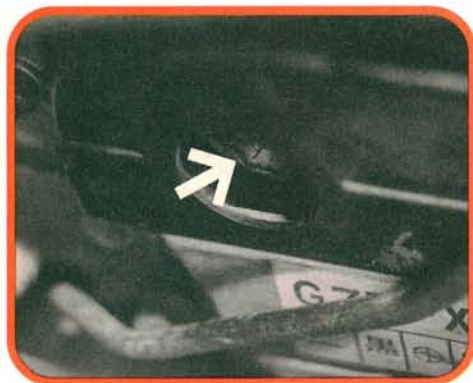
11

The recommended timing belt replacement interval is 60,000 miles. The tensioner bolt on 7M-GE engines is accessible through a hole in the front cover. Periodically loosening and retightening this bolt lets the tensioner remove any belt slack that may develop during the life of the belt.

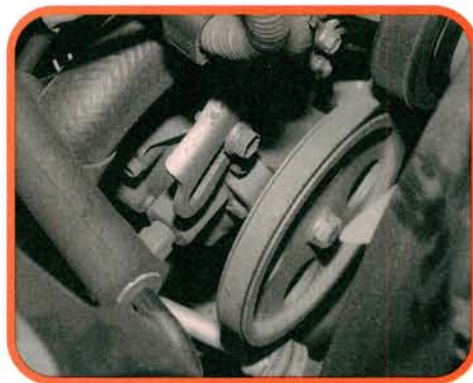
12

All three drive belts can be reached for adjustment or replacement from above. Idle pulleys and adjusting racks make alternator and air conditioning compressor belt adjustment easy. The power steering pump pivots for belt adjustment. Belt tension should be checked with a belt tension gauge.

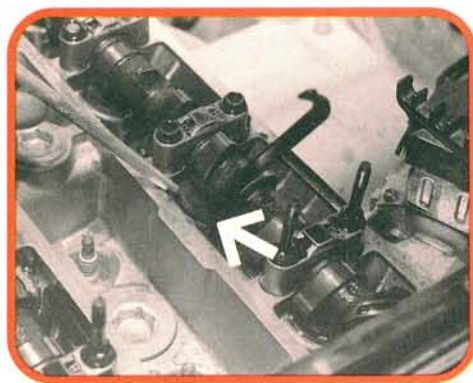
13

It might seem like a step backwards, but the four valve per cylinder 7M-GE engine uses selective shims to adjust valve clearances. To change a shim, depress the valve spring with the special tool, then pop the shim out of the bucket. The good news is that this system holds an adjustment for a long time.

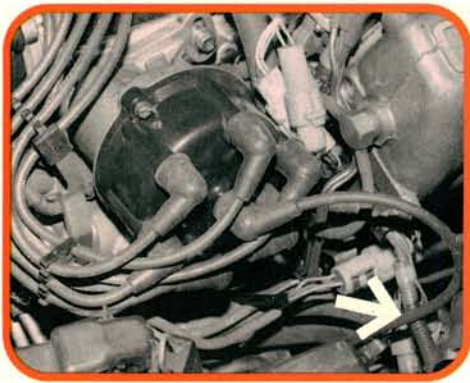
**19**

The 1983-84 Cressidas have connectors for scanner hookup. To retrieve diagnostic codes without a scanner, jumper the two terminal Check Connector on the left side of the engine. Attach a voltmeter to Diagnostic Connector terminals VF and E1, turn the ignition on, then count the voltage swings between 2.5 and 5 volts.

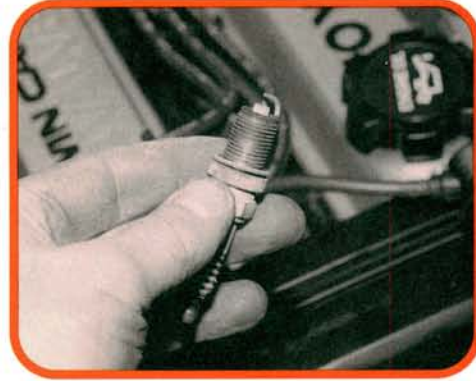
## 24

Platinum tipped spark plugs are factory recommended for both engines. While these plugs are supposed to last 60,000 miles, it's probably a good idea to check them more frequently. Replace the plugs if the gap is incorrect. Don't try to readjust them, the center electrode is easily damaged.

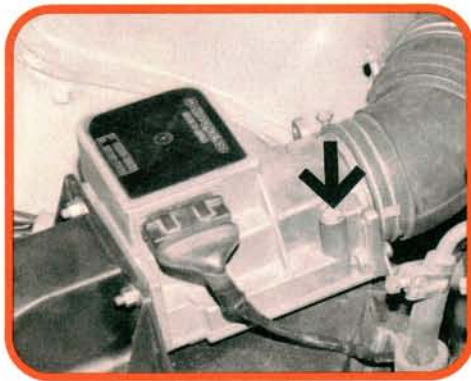
## 25

Both engines use vane style air flow meters. The idle CO percentage can be adjusted when necessary by changing the amount of air bypassing the air flow meter. Carefully remove the anti-tamper plug to access the CO adjustment screw. A new plug keeps dirt out and prevents accidental adjustment.
