## VOLVO DIESEL CHARGING SYSTEMS

## HONDA HEATER CABLES

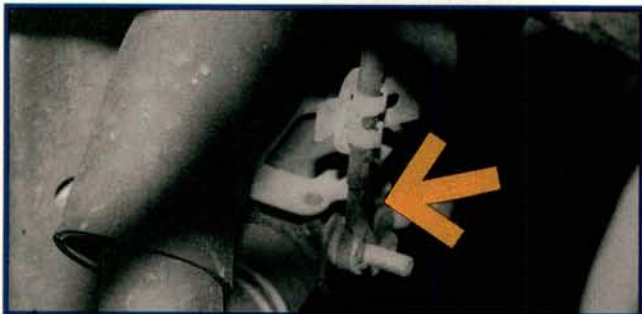
A small helper spring installed at the water control valve can be used to correct a no heat condition on mid to late 1980's Honda Accords. The water control valve meters the flow of coolant through the heater core. The dash mounted temperature control is connected to the water control valve by a cable.

When the temperature control is moved to the full heat position, the cable must push the control lever to open the water control valve on the firewall. As the cable wears, it may tend to kink at the dash control end, rather than opening the water control valve. The water control valve can't open fully, causing the no heat condition.

To correct this problem, attach one end of a small helper spring to the water control valve's lever arm. Attach the other end of the spring to an appropriate spot on the transaxle.

Installing the helper spring may increase the effort needed to close the water control valve, but will reduce the chance of cable kinking when the valve is pushed to the open position. The helper spring also saves you the trouble of dismantling the dash to replace the temperature control cable.
