We've seen Toyotas posing as Chevrolets and Mitsubishi's posing as Chryslers in these pages. Now it's time to look at one of Ford Motor Company's crossover cars—the Mercury Tracer.

Those of you not yet familiar with the Tracer, may be surprised to trace its bloodlines back to the Mazda GLC/323. While Ford has given the little car its own touch of design and styling, beneath the surface the Tracer is very Japanese.

—By Ralph Birnbaum

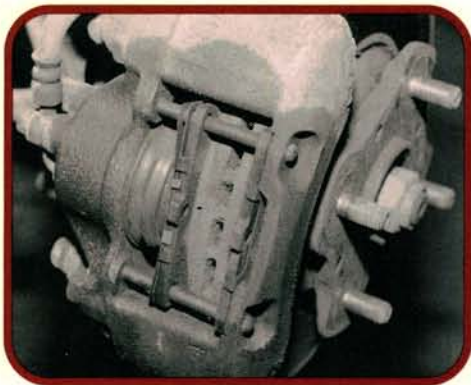
**1**

Let's start under the car with a look at the brakes on our Tracer. Our 1988 car uses the same captive rotor/hub assembly system which dates back to the GLC. There are a few changes: The rotors are vented, and the caliper design is different. But the rotor is still captive!

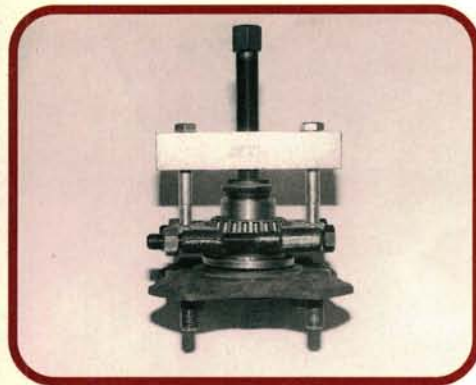
**2**

The drive hub must be removed from the knuckle to replace the rotors. Double taper roller bearings support the hub as they did with the GLC. For a detailed description of bearing and hub service procedures, please refer to the April 1991 issue of *Import Service* entitled "Stop It".

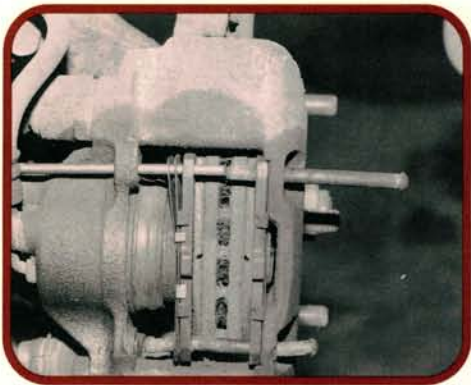
**3**

The caliper assembly on the Tracer is different from the GLC. Simple pad replacement may not be so simple when the brake pad retainer pins are as badly rusted as these were. The brake pad retainer pins in this car had to be forcefully evicted, and were ruined in the process.

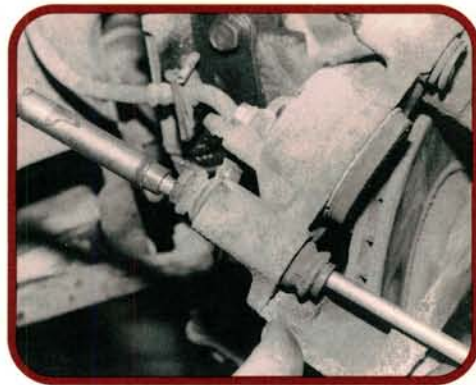
**4**

If you're doing a "pads only" brake job, make sure the caliper isn't frozen on its slides. The calipers bolt to the knuckles. Caliper bolts pass through slide tubes mounted in rubber sleeves in the caliper body. On our car (at 70,000 miles) one of the slide tubes is seized, and must be driven out.

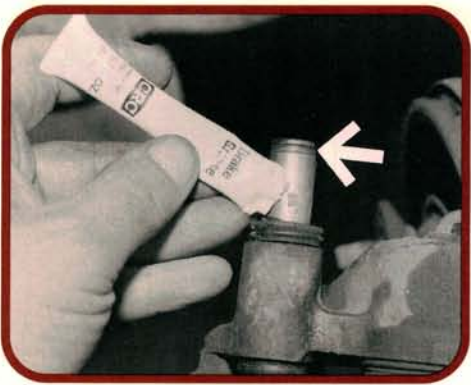
**5**

Fortunately, the slide tube isn't ruined. A good cleaning with a wire brush and an application of brake grease set things right again. Make sure the protective rubber boots on the slides aren't torn before reinstalling the slides. The boots snap into the groove on the slide (arrow) to keep water out.

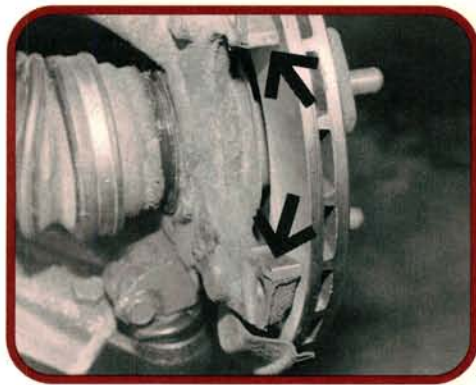
**6**

We talked with several techs and came away with the impression that sticking caliper pistons are not a common problem. But the backing shims for the pads should be replaced if they're damaged. We also take time to clean the knuckle and install new anti-rattle clips (arrows) for the inboard brake pads.

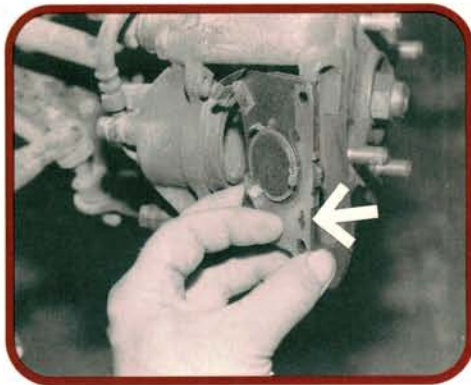
7

Backing shims for the brake pads are marked for installation with an arrow (arrow). Corrosion damage has ruined all the brake hardware. If winter roads in your area are saltier than anchovies, you may want to include all new brake hardware in your repair estimate.

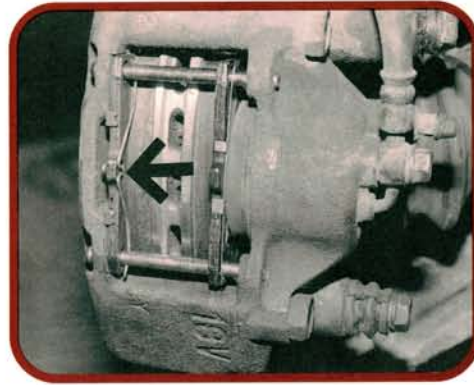
8

Finally, make sure the brake pad pin retainer wire is properly installed as shown (arrow). Torque the caliper bolts, and pump up the pads. Check the brake fluid level before you finish. A low fluid level in the master cylinder reservoir caused by worn pads may be back at the full mark now.

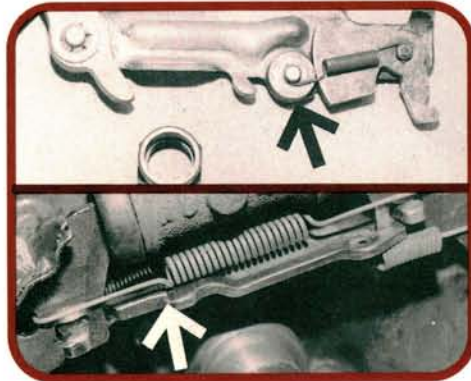
9

The rear drum setup is basically the same as the one on a GLC, with minor modifications. The self adjusting mechanisms work the same, but instead of a toothed arm and roller (arrow) used on the GLC (upper photo), the Tracer eliminates the roller (lower photo).

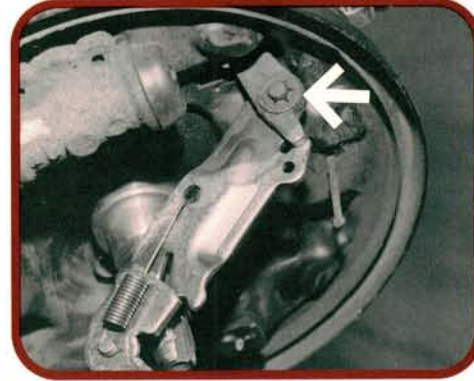
10

Some things never change, even from Mazda to Mercury. The pivots for the hand brake mechanisms which were often overlooked on a simple reline of GLC rear brakes, are frozen with corrosion on the Tracer as well. Clean and lightly lube them until the mechanism pivots smoothly again.

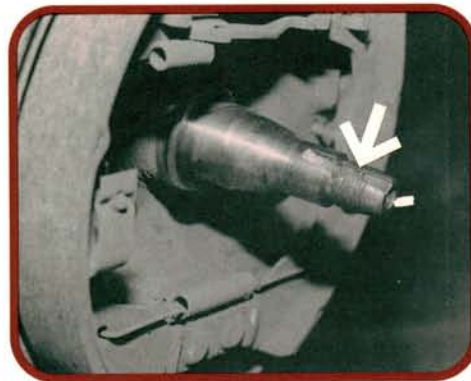
11

Another difference between the GLC and the Tracer has to do with the rear axle nuts. The nuts are staked into a groove in the stub axle to keep them from turning (always replace them). But the Tracer, unlike the GLC, uses one left hand (right side) and one right hand thread (left side) on the axles.

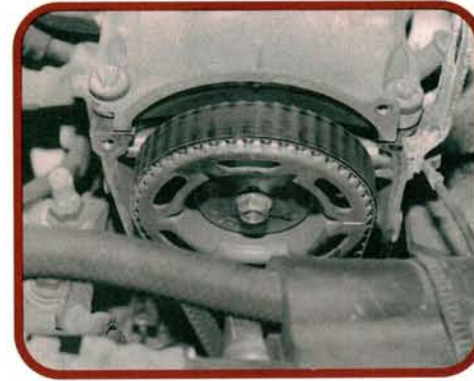
12

Seized camshafts are a problem on both 323 and Tracer 1.6 liter engines. Symptoms go as follows: The engine starts cold, then stalls within the first minute and won't restart. Several dealers told us that this happens most often in very cold weather. Some saw multiple failures on the same day.

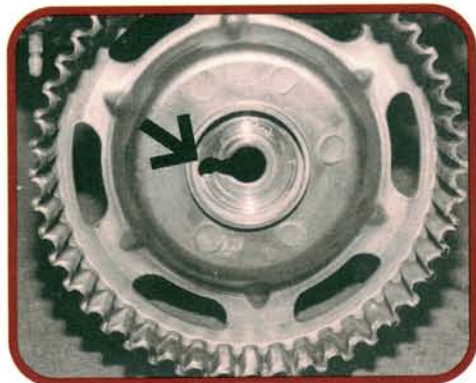
13

When the cams seize, either the timing belt breaks or the stamped cam sprocket spins on the cam snout. If you're having a bad day, you may find both. Something has to give. This sprocket spun. The cam bolt snapped, and the locator dowel in the cam trashed the inside of the sprocket (arrow).

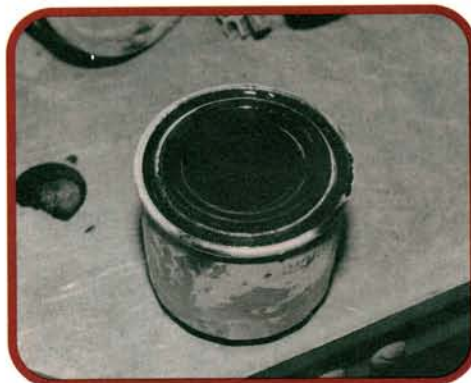
14

Why does this happen? Sorry, but nobody seems to have an answer they'll share with us. The oil filter from this '89 proves that black holes aren't just found in outer space. The engine was asked to go 20,000 miles without an oil change. The asphalt sealer in the crankcase was an invitation to disaster.

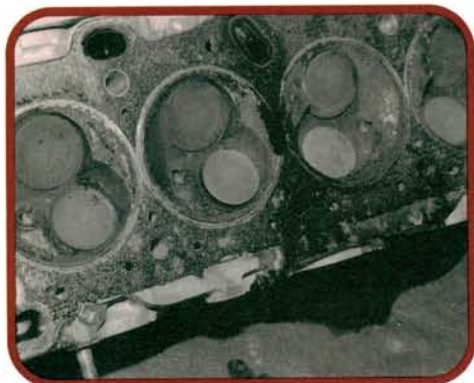
15

The replacement cylinder heads for these engines are modified. The new heads are bare heads. The number of parts you can transplant will depend on their condition. At the least, plan on a valve grind and rocker assembly transplant. This engine has hydraulic lash adjusters which are plugged with sludge.

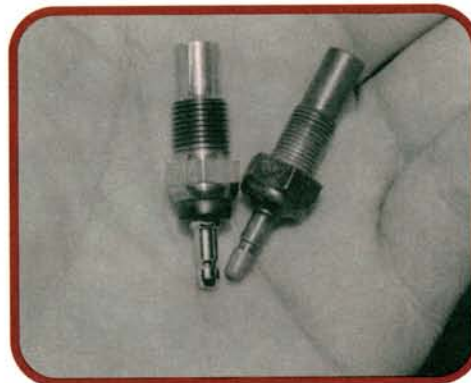
16

If you're installing a new style cylinder head, note that the old temperature sender (right) doesn't fit the new head. The diameter of the old switch is slightly smaller than the tapped hole in the new head. Check with your local parts department for a new switch when you order a head.

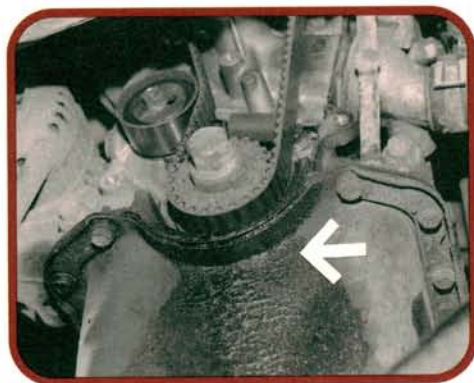
17

This Tracer needs a new crankshaft seal. But don't assume that oil in this area (arrow) has to be coming from the crankshaft. Check inside the cam belt cover for signs of a camshaft oil leak. Oil from the cam can trickle down the front of the engine behind the cover and end up in the same place.

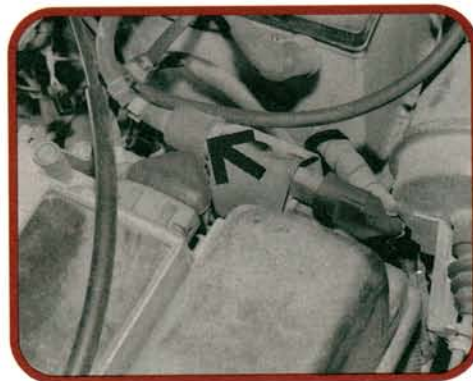
18

The ignition coils on these cars didn't seem to cause any special problems. But we had several reports of no starts accompanied by coil arcing at the coil wire terminal. In most cases, the cause was high plug wire resistance. In damp weather, the coil secondary voltage looks for an easier path to ground.

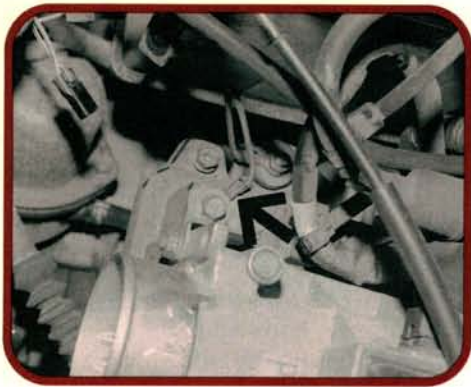
# 19

If you remove the air flow meter for any reason, be sure you reinstall this ground wire. Early 323 models suffered intermittent driveability problems caused by a bad air flow meter ground. Dealer installed ground straps later became factory installed.

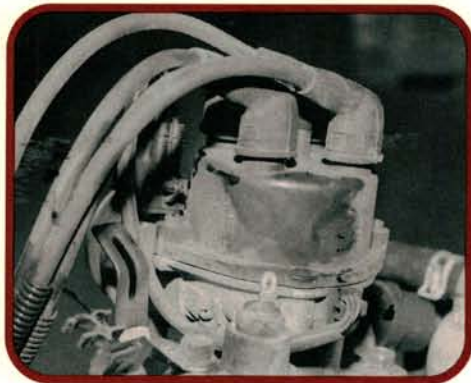
# 20

Caps and rotors are also a good place to look for an intermittent miss or no-start. The same distributor rotor problems found on the 323 can also be found in this Tracer. The rotors do go bad over time, and can either short to ground or simply go open. The problem caused can be intermittent.

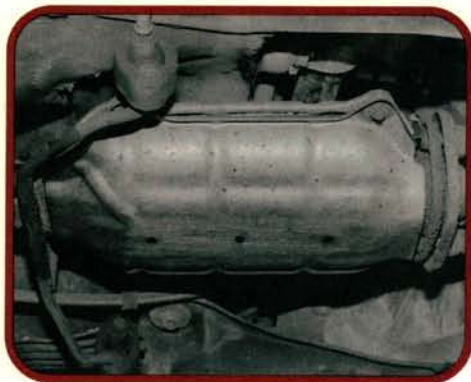
# 21

One final note. Rattling noises from the catalytic converter may lead you to replace the catalyst. The outer catalyst heat shield is made in two pieces which bolt together. But there's another metal shield inside which is welded to the catalyst. If the welds break, the inner shield rattles.
