Porsche cars are among the most highly engineered cars on the road. Some of you will say that “highly engineered” really means “complicated.” You may be right. This month’s look at some common repair items on 944 vehicles is a case in point, so we want to offer a few cautions before we start.

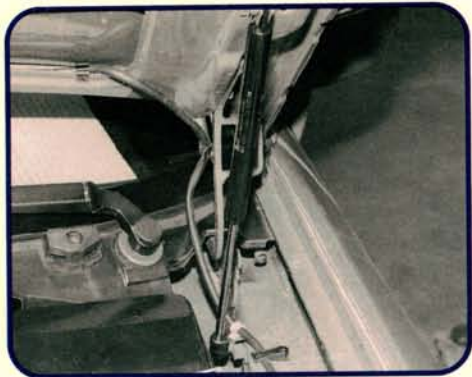
1

Watch out for weak hood supports. You'll raise the hood and start to work. The hood will stay put until you decide to raise the lift. The vibration of the moving lift can cause the hood to drop—suddenly. Any bulky objects you left behind will leave a lasting impression in the sheetmetal.

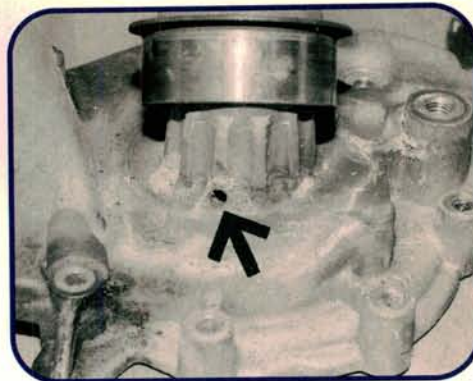
2

There have been a number of bulletins about water pumps. Many pumps were replaced when a small discoloration appeared around the pump housing weep hole (arrow). This dampness does not necessarily mean the pump is bad. Our photo shows a disassembled pump replaced for a more serious leak.

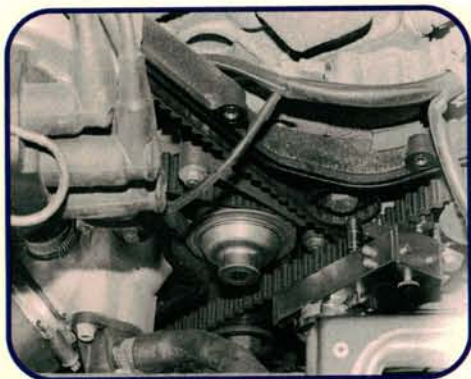
3

Cam, crank, and balance shaft seals may need service as often as every 30,000 miles. Neglected leaks will ruin the cam and balance shaft belts. This is also a good time to replace that suspect water pump, since leaks from a bad pump will run down behind the timing cover and go unnoticed until it's too late.

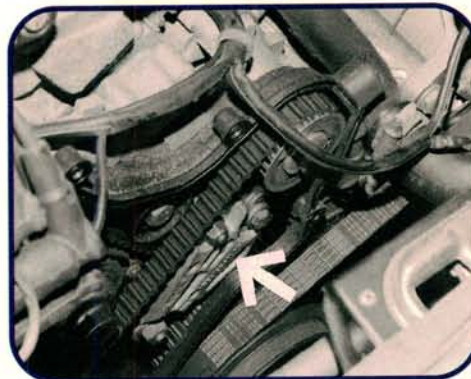
4

This 944 is in for its 15,000 mile cam and balance shaft belt adjustments. The cam belt is adjusted by loosening and then retightening the mounting bolts on the spring tensioner (arrow). Loosening the bolts allows the spring to pull the tensioner toward the belt, removing slack from the belt.

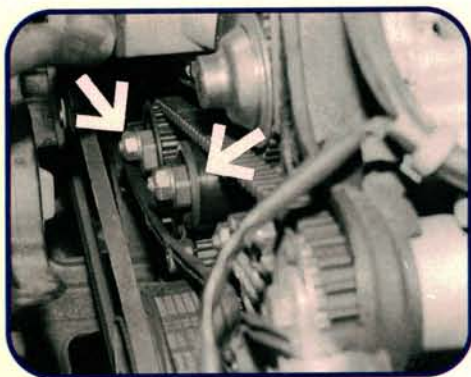
5

Adjust balance shaft tension at this eccentric (left arrow). The idler pulley (right arrow) just barely contacts the center section of a freshly adjusted belt. As the belt stretches, the pulley dampens any "wow and flutter" which will develop in the long belt section between the sprockets.

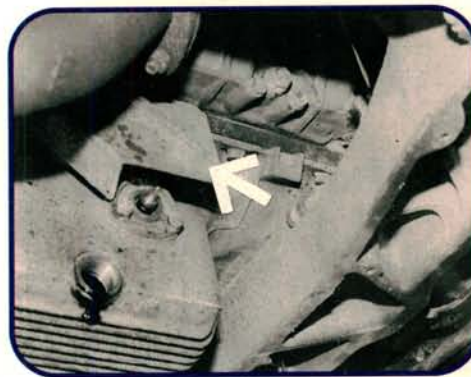
6

Some early engines (up to '86) experienced heavy seepage and overheating caused by leaking head gaskets. There are two other common oil leaks to keep in mind. Rear seals on cam cases should always be checked. Oil pan gaskets on cars without this heat shield (arrow) will crack when over-cooked.

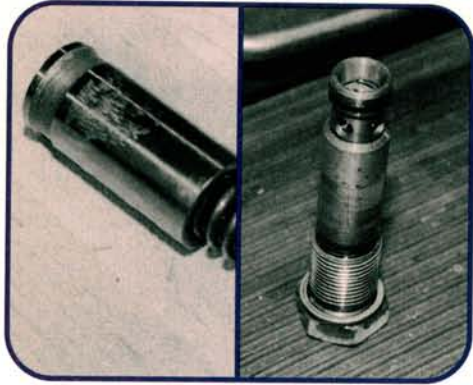
7

Low oil pressure in early engines was sometimes caused by sticking pressure relief valves (left). The steel relief piston/spring in the oil cooler would gall and stick. Porsche later introduced a one piece relief valve into production. It is available as a retrofit for the earlier style valve.

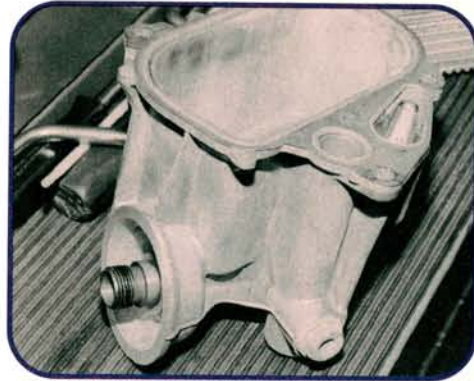
8

Engine oil passes through an oil cooler in the oil filter flange assembly. Engine coolant and oil circulate through the cooler. Seals in the cooler which separate the water and oil can deteriorate, allowing oil and coolant to mix. Improved seals were introduced to correct this problem.

The cooler is like a small radiator. It sits inside the housing shown in photo 8. Replacement seals are green in color (top arrow). The bosses at the other end (bottom arrow) locate and center the cooler between the engine block and housing. Keep track of any shims on the bosses and reinstall them.

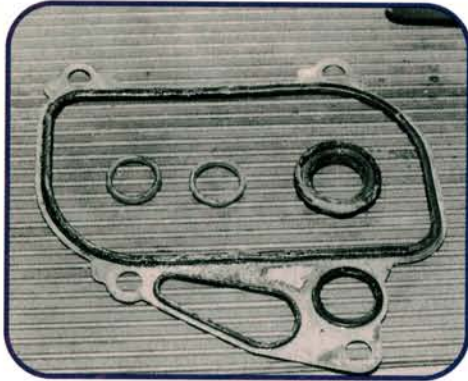
9

Oil cooler leaks were common on '85 1/2 to '88 cars. Failing to correct the problem results in engine bearing damage (commonly number two rod bearing). Increased cooling system pressure, starting with the 1985 1/2 car, only made matters worse. Some 944s with low mileage still have the old seals.

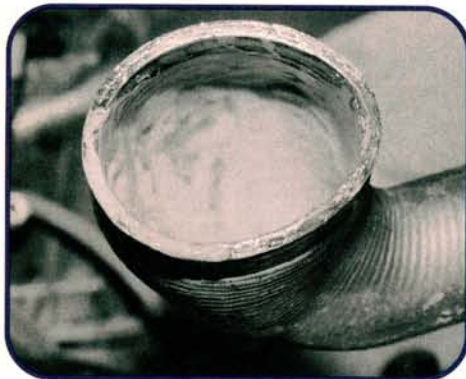
11

Even if the engine hasn't been damaged by the effects of an oil/coolant mix, odds are good that the rubber coolant hoses have been ruined. Hoses will crack on the inside first, even though they may look okay from the outside. Bad hoses will often feel soft and spongy when squeezed.

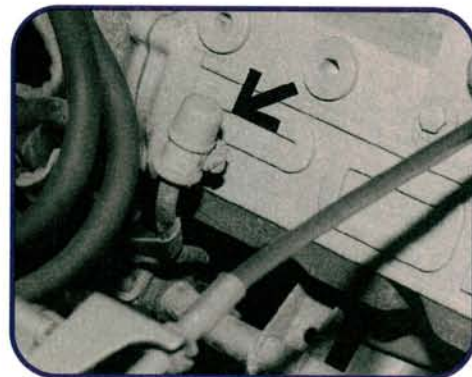
12

The 944 has an upstream test pipe for checking and adjusting CO. Early pipes rusted away, and a retrofit stainless steel pipe was introduced. Make sure you replace a broken pipe. Exhaust pulses will turn the leak into a pulse air system. The extra oxygen sucked into the exhaust will fool the oxygen sensor.

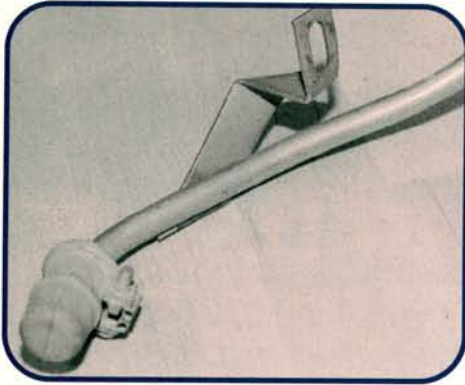
13

Test pipes can break in a number of places. Support brackets (arrow) can vibrate loose, and pipes can crack down low, out of sight—so look sharp. False air and an ignition miss sent some catalysts into melt down. Bang on the cat with a soft mallet to see if the old honeycomb now rattles like a large rock.

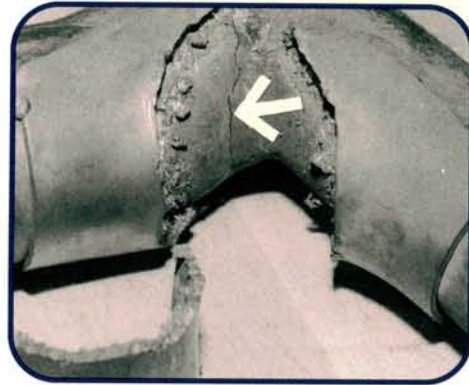
14

False air can also be drawn into a cracked exhaust manifold between cylinders one and four. Early cars had cast iron manifolds. This stamped steel manifold was used starting with the 1985<sup>1/2</sup> models. Expansion and contraction of the pipe leads to a crack in the “crotch” of the pipe (arrow).

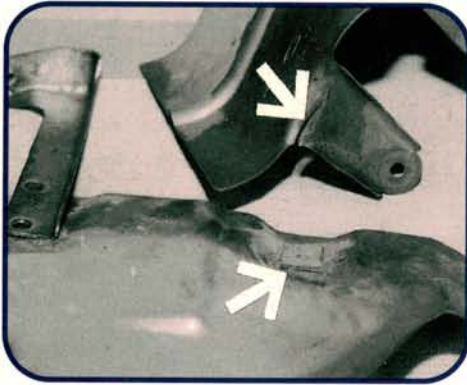
15

A number of heat shields were used to protect components from high exhaust temperatures. The shield at right is a starter shield, and it has cracked (arrow), causing a loud buzzing during downshifts at high RPM. The oil filter housing shield to the left has a missing stand-off bracket.

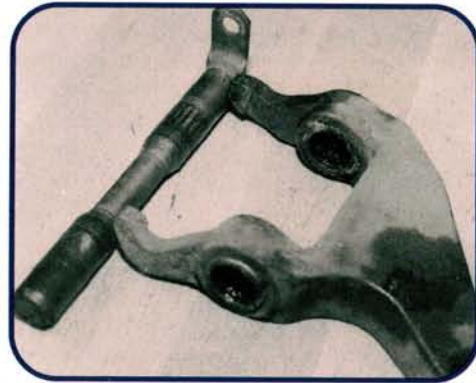
16

Clutch replacements should go beyond a disc and pressure plate. The release bearing is pulled by this release arm. Clutch debris ruins the needle bearings, and the pivot shaft galls like a universal joint on your old Chevy pickup. Failing to correct this will result in notchy clutch application.

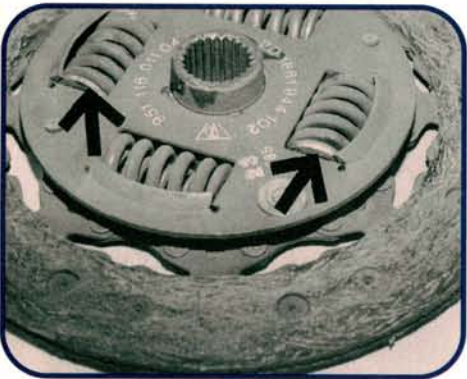
17

Non-turbo cars use a rubber damper hub in the center of the clutch disc which can crack. Then, when you let off the clutch pedal, there's a loud clunk as the center section bangs against its stops. This is the turbo clutch. Its damper springs are so worn, they're spinning (shiny spots, arrows).

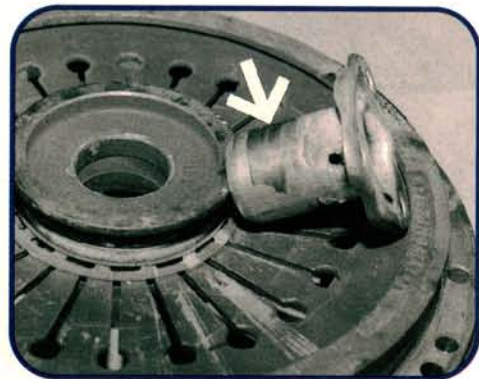
18

This snout centers the release bearing. Note the wear pattern highlighted by our arrow. If you don't replace the snout as part of a complete clutch job, the release bearing can cut all the way through before the next clutch job. Our host shop has found the severed ends inside clutch assemblies.

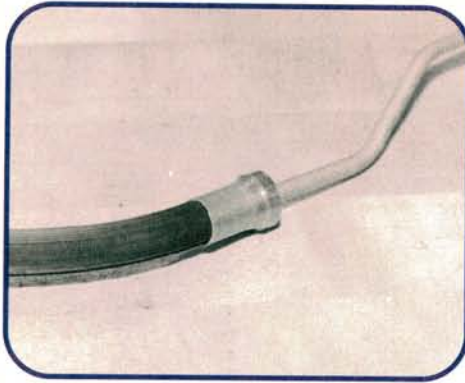
19

Another fairly common clutch related problem has to do with the rubber hose between the clutch master and slave cylinder. The hoses will warn you that they're going bad by leaving a trace of moist brake fluid in the part of the hose right next to the crimped metal ends.

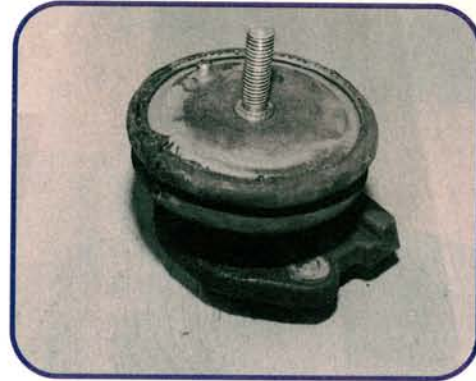
20

Engine mounts are fluid filled to absorb engine vibration. Fatigued or leaking mounts can transmit a nasty vibration through the chassis to the cabin. This vibration may be mistaken for a rough idle, even though the engine may be running just fine. The right side mount seems to be the first to go bad.

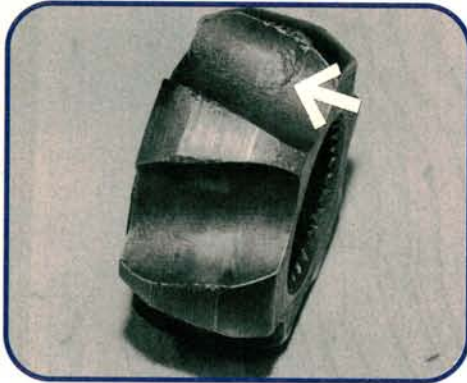
21

Worn constant velocity joints can cause a driveline vibration similar to the shudder caused by a weak center support bearing on car with a two-piece drive-shaft. Lead-footed owners of turbo models may "accelerate" this wear and need replacement joints as soon as 50,000 miles. Play and pay.

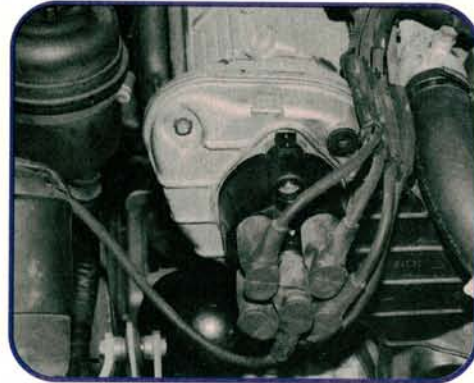
22

Distributor caps and plug wires seem to last, but distributor rotors can cause problems. Some rotors have been known to disintegrate. Surprisingly, they may keep working, but cold driveability problems result. When replacing a rotor, make sure you're using the upgraded part number to avoid problems.

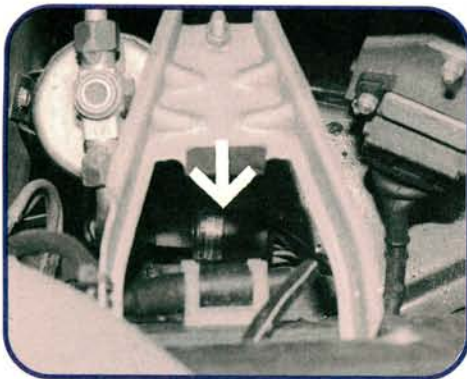
23

If the high pressure A/C hose between the condenser and compressor splits open (or just plain bursts) check the high side pressure when the compressor cycles OFF. A replacement switch with a lower high side pressure is available. It shuts off the compressor before high side pressures get too high.

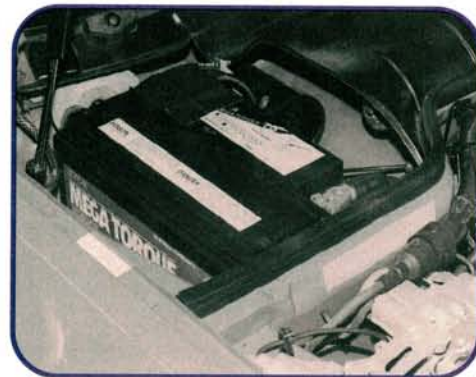
24

Discharged batteries are sometimes caused by an overdose of aftermarket add-on accessories. Bolt in a cellular phone, burglar alarm, 800 giga watt stereo, and a Mr. Coffee, and the battery gets a little stressed out. Parasitic draw should be checked, and ideally stay in the 90 milliamp range.
