— By Karl Seyfert

More or Less

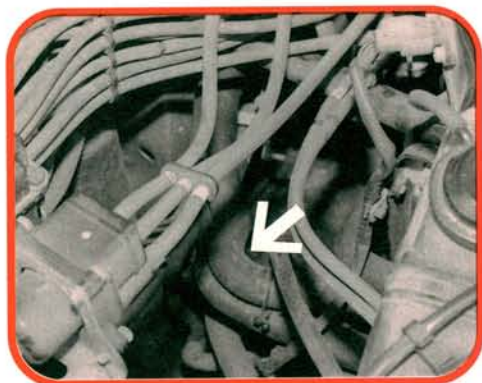
1

This photo can only give you a general idea of where the speed sensor is located (arrow). To avoid hose confusion during a transmission removal, remove the speed sensor from the transmission without disconnecting its hoses. Prop the speed sensor out of the way until you're ready to reinstall it.

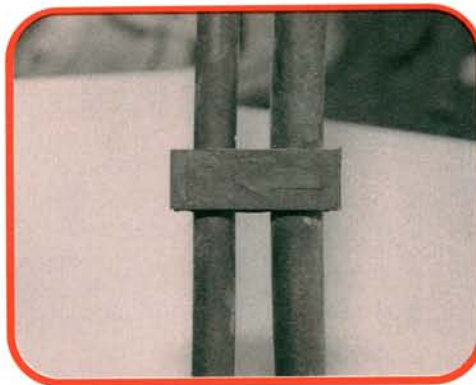
2

Some models have a hose guide with the letter F and an arrow marked on it. If you must remove the speed sensor hoses for any reason, leave the hose guide in position to prevent a mix-up. When the hoses are properly installed, the arrow should face the front of the car.

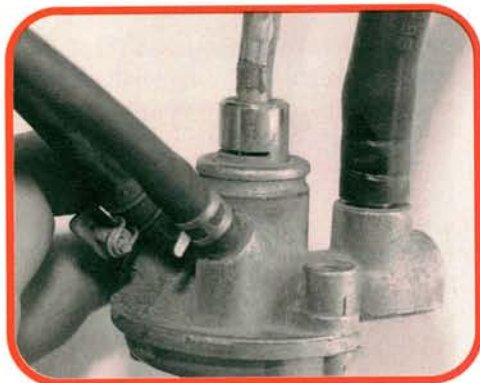
3

We removed this early three hose speed sensor for a better look. The large hose returns fluid to the reservoir. The two smaller hoses supply fluid to the speed sensor pump from the cut-off valve and reaction chamber valves. The small hoses are different sizes, but can be accidentally switched.

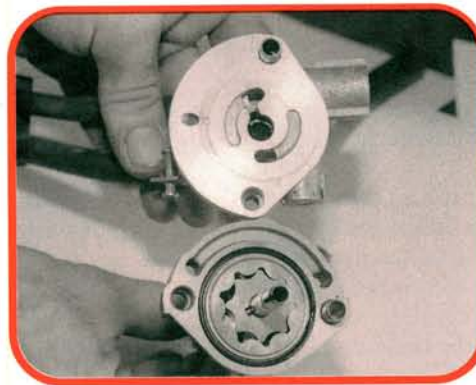
4

We split the speed sensor to reveal the pump. When the vehicle is stopped, no fluid can flow through the pump and full power assist is available. As vehicle speed increases, the spinning speed sensor pump pulls fluid from the cutoff valve, and reaction chamber circuits and power assist is reduced.

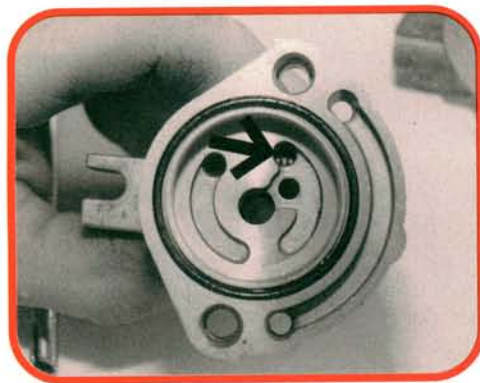
5

To prevent negative pump pressure at high speed, a one way check valve lets the fluid recirculate inside the speed sensor. When driving in reverse the speed sensor pump also turns in reverse. To prevent a loss of power assist in reverse, a second speed sensor relief valve recirculates the fluid.

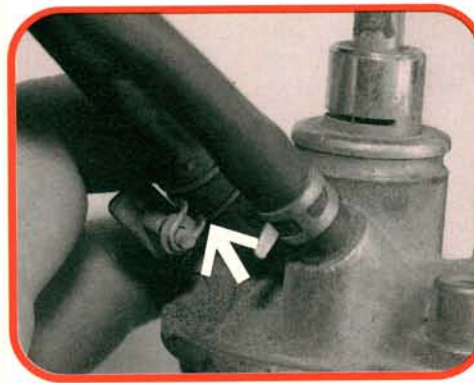
6

If the system has lower than normal power assist at low speeds, test the speed sensor by disconnecting, then plugging the larger of the two small speed sensor hoses and the speed sensor port. If steering effort is reduced, replace the speed sensor. If it stays the same, check the steering rack and pump.

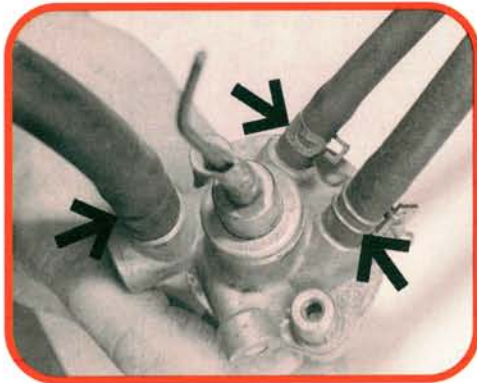
7

To simulate power assist at 30 MPH, disconnect all three hoses from the speed sensor, then connect all three hoses together. This dumps fluid straight to the reservoir and should reduce power assist. If 30 MPH assist was too high but is normal with the speed sensor bypassed, replace the speed sensor.

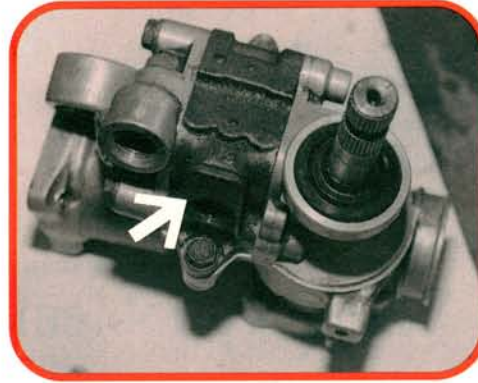
8

The cast iron valve body is bolted to the top (or bottom) of the steering rack. The valve body meters high pressure fluid from the pump to the rack piston. The extra line fitting(s) bleed fluid from the cut-off valve to the speed sensor to reduce steering assist as vehicle speed increases.

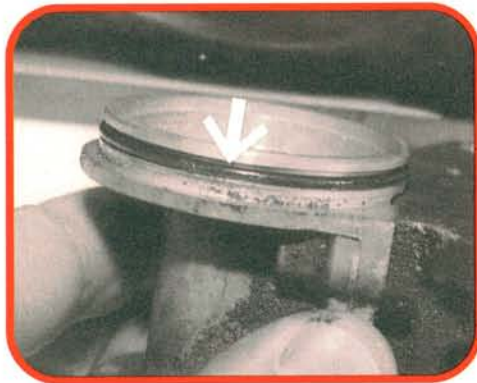
9

Different years and models use similar rack components, but they may be arranged differently. This Integra rack has the valve body mounted on top of the rack, next to the pinion shaft. Gravity being what it is, water may sneak past this large o-ring seal (arrow), and get into the pinion housing.

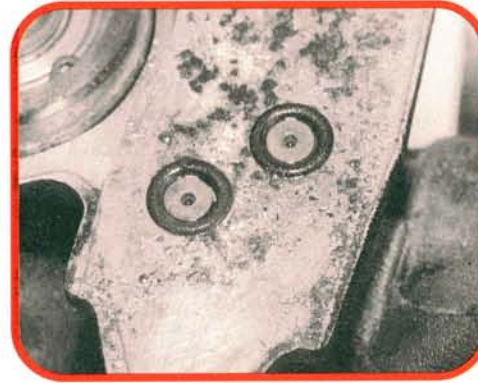
10

Two small o-rings seal the fluid passages between the valve body and the rack housing. Judging by the amount of rust that's present, this is another area for water to accumulate. The valve body can usually be removed for repairs without removing the rack, but it's pretty cramped on some models.

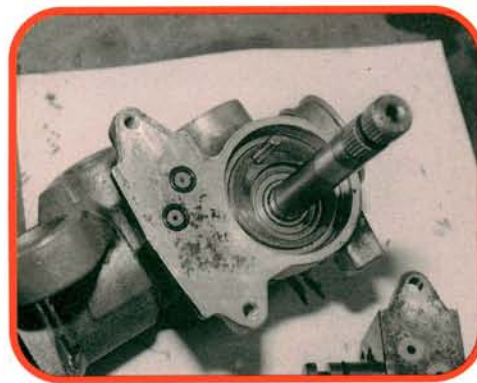
11

Many steering racks use a spool valve on the pinion to regulate power assist. Honda takes a different approach. The pinion is mounted off-center in a pair of bearings, which are mounted in a bearing supported pinion holder. As the pinion turns, its eccentric mounting causes it to move to the side.

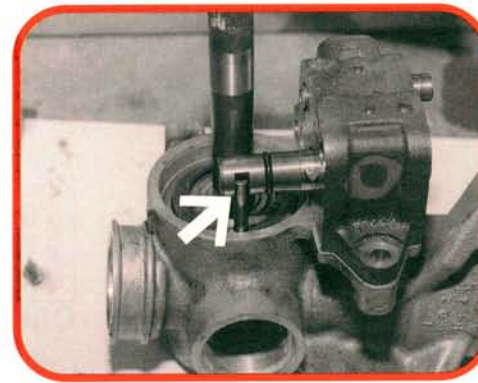
12

The pinion movement is transferred to the pinion holder. We've partially assembled the valve body and pinion assembly to show the pinion holder pin engaging the control valve. The wheels are harder to turn at slow speeds, so the pinion holder moves further as the pinion turns and more power assist is delivered.

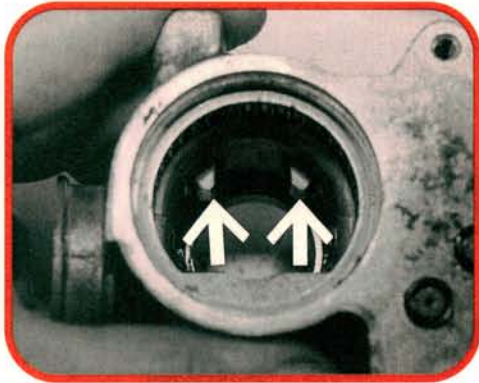
13

The pinion holder pin can move only a few millimeters in either direction. Tabs on the inside of the rack housing (arrows) limit the travel of the pinion holder. When the pinion holder hits a pin in either direction, the control valve is wide open and delivers maximum pressure to the rack piston.

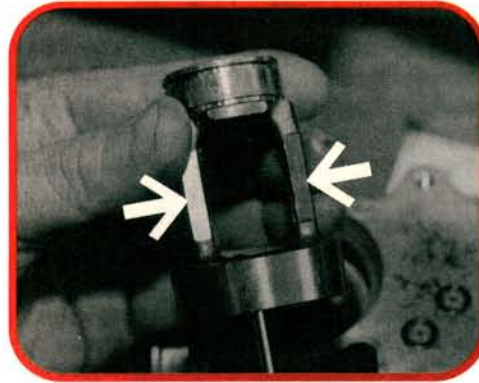
14

As the rack reaches full lock, machined notches on the back side of the pinion holder hit the end of the rack teeth. This causes the pinion holder to rotate back to the neutral position. This reduces pump pressure to keep the idle speed from dropping. The reduced assist also improves steering feel at full lock.

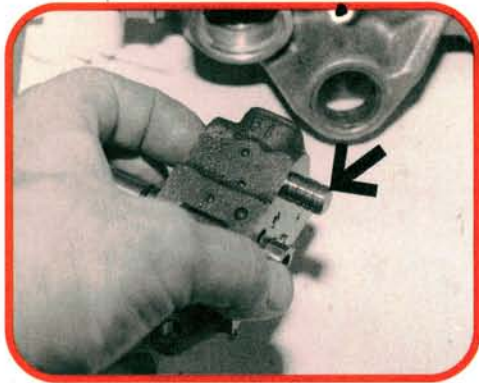
15

Back to the speed sensitive part of the system. The cut-off valve on early systems used the speed sensor input to reduce power assist rather abruptly by about 30 MPH. The gain control valve on later systems uses inputs from the pressure control valve and the speed sensor for a more gradual transition.

If a 1990 and later Accord owner complains of poor power steering assist at low speeds, he may be basing his judgement on other cars he's driven (including other Hondas). To regulate the power assist according to the speed of the car, the 1990 and later Accord power steering system has a Gain Control Valve instead of the more familiar Cut-off Valve used on earlier systems.

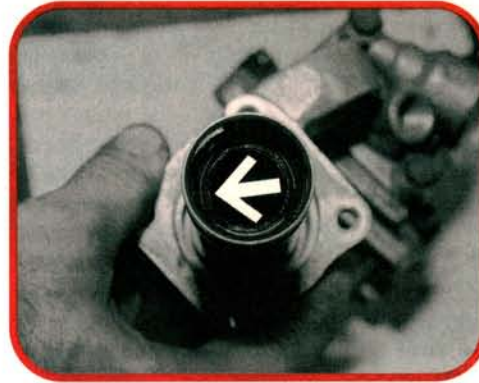
16

The right side cylinder end seal may be a source of leaks and squeaks. Use your fingers or a piece of wood to remove the old seal to avoid damaging the cylinder. Coat the inside surface of the cylinder housing with power steering fluid, then install the new end seal with the groove facing out.

On 1991-92 models, a complete fluid flush and refill with the new fluid should correct the problem. To correct the noise on 1990 models, the steering rack must also be removed to replace the right cylinder housing end seal. Always coat the inside surface of the rack cylinder housing with V-type fluid before installing the new seal.

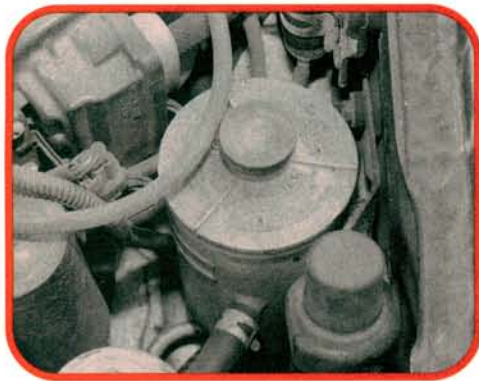
17

Replace the one piece reservoir and filter assembly if the system has been contaminated. Drain all of the old fluid from the system too. Automatic transmission fluid should never be used in the system. For best performance and to avoid system damage, use the recommended Honda fluid.

Hondas and Acuras are very particular about the type of fluid that is used in their power steering systems. Automatic transmission fluid will not get the job done, and in many cases may actually cause problems that weren't there before.

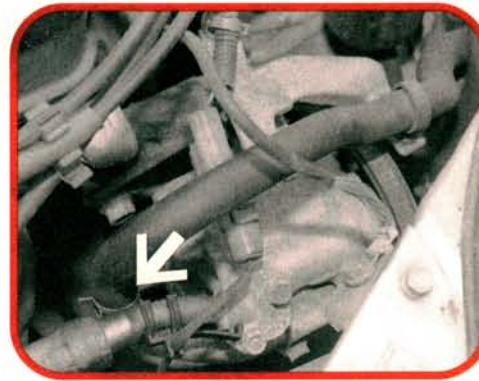
18

The power steering pump seldom causes problems on these systems. High pressure hoses and fittings are used on the supply side hoses. Weak spring clamps may cause fluid leaks on the return side, however. These clamps may begin to leak after they have been removed and reinstalled during service.

Noise from the power steering pump is rarely caused by the pump itself. Before replacing a noisy power steering pump, check the following items in the order that they are listed:
