Driveability Clinic

Process of Elimination

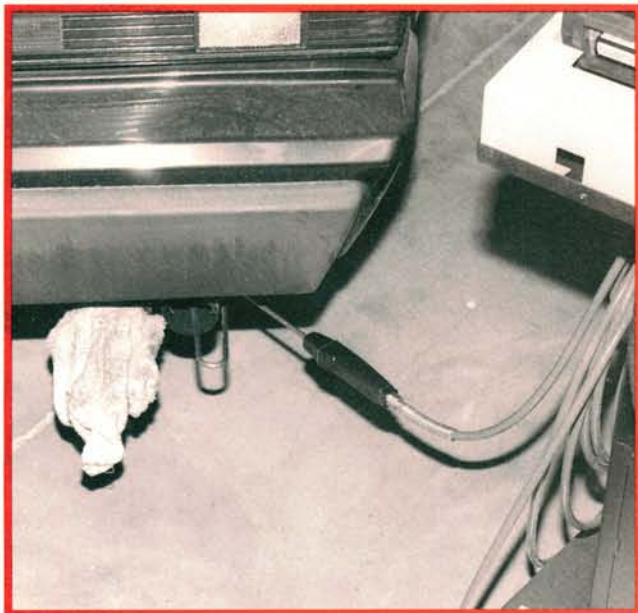
1 We know the car is breaking up under load. But what about its tailpipe emissions at idle? A four gas analyzer test gives a quick indication that things are rich, rich, rich. Both CO and HC are very high. O₂ is uncharacteristically high for a car with a rich mixture. We check, but can't find any vacuum or exhaust leaks.

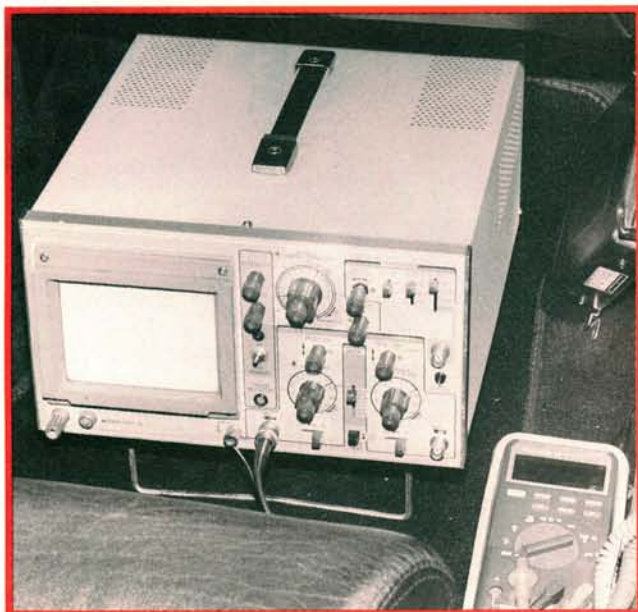
3 Looks like the problem stems from the injectors staying ON too long. A test of the pulse width with an oscilloscope shows that the injectors are being held open way too long. But the signal to the second injector seems to be intermittent. We wiggle the harness to the injector and the signal disappears completely.

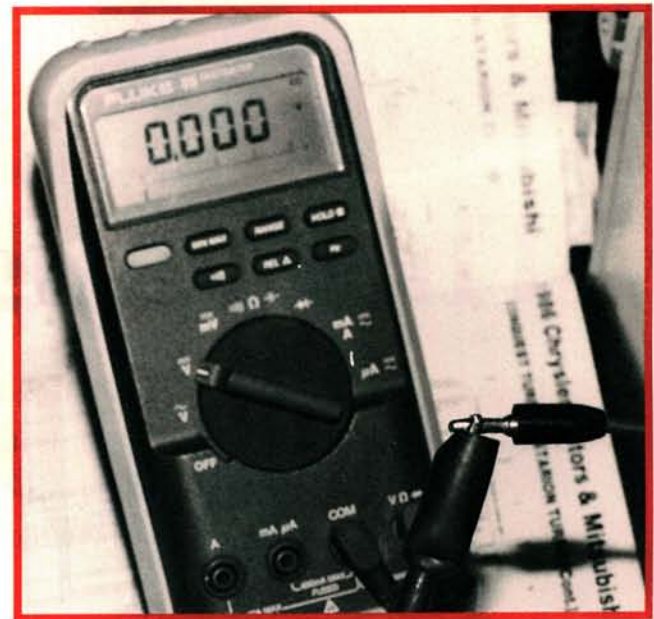
8 Next, we grab a wiring diagram and drop the control unit down. We check all voltage supplies and ground terminals by backprobing at the control unit connections. We're really suspicious of the ground circuits by now, and run a long jumper wire directly to the negative battery post to check the grounds.

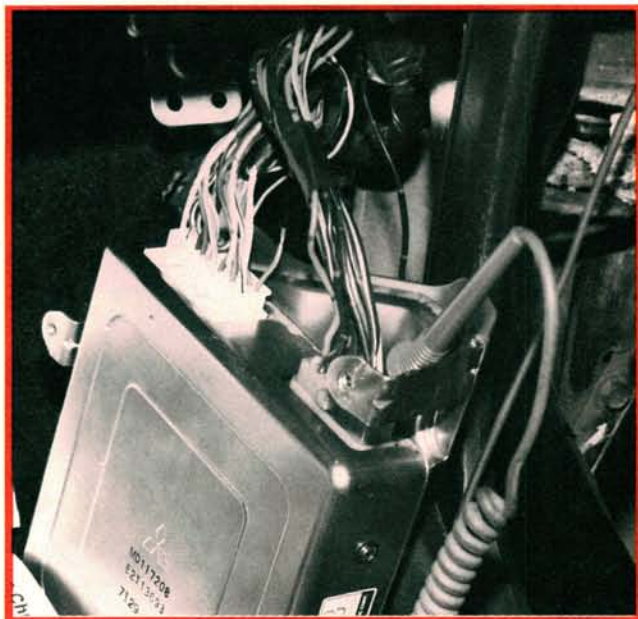
9 Since there's a good chance that the new control unit has been ruined by a poor ground or shorted circuit, we continue with our tests for ground and voltage both with the key ON/engine OFF, and also with the engine running. These tests are conducted first with the engine cold, and also when it gets hot.

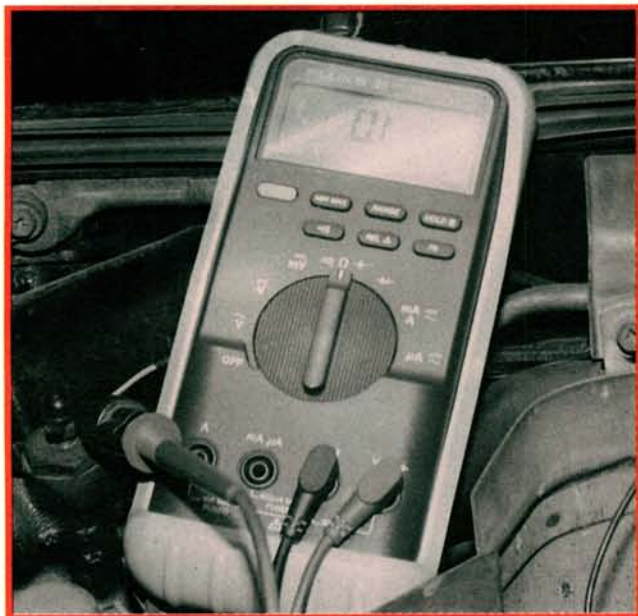
11 The oxygen sensor wire from the control unit is shielded, and the shielding is grounded to the chassis. We've already found enough damaged wiring for one day, and don't want to smoke a new control unit, so we are careful to check for a possible short to ground at the oxygen sensor wire. There isn't any continuity to ground, so we proceed.

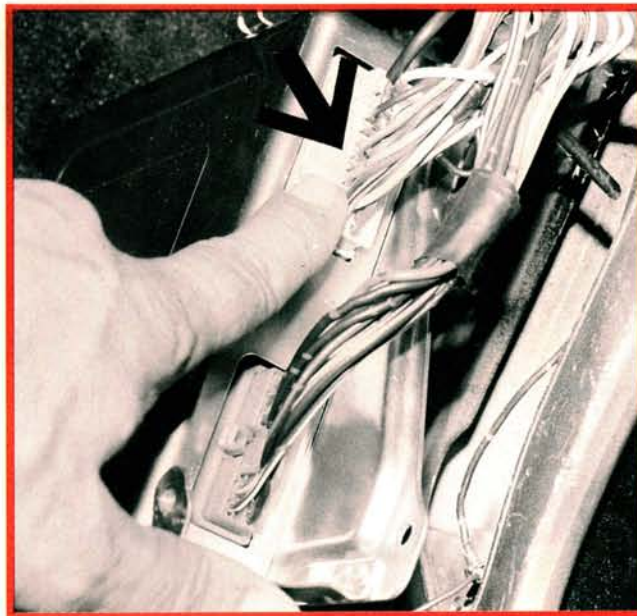
12 We're pretty sure the control unit is bad, but we continue to test at the other main (yellow) plug at the control unit which contains the input and output terminals. We're especially concerned with any inputs which would alter the fuel mixture, like temp sensors, tach, throttle position, air flow meter, and pressure sensor signals.

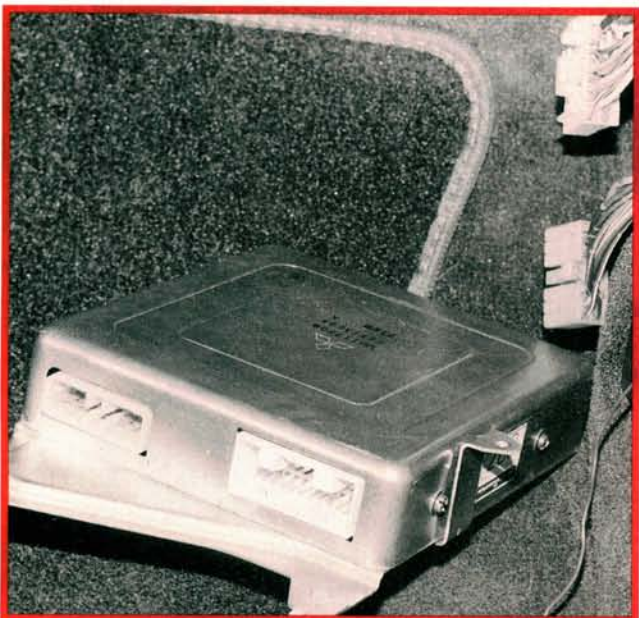
15 It's time to plug in a new control unit. We know that all inputs are correct. We have corrected the problems caused by the chainsaw massacre of the wiring harness. At this point, we have a code stored and two missing outputs from the control unit. By process of elimination, we've determined that the control unit is bad — new or not.

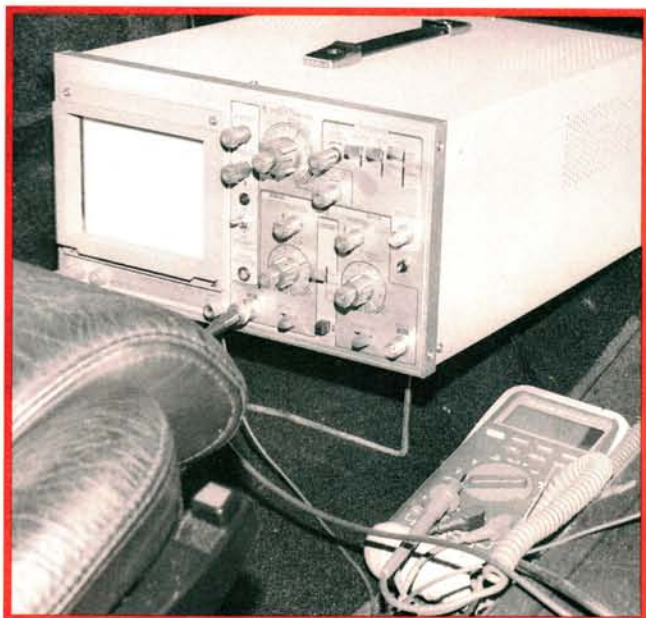
16 With the new control unit installed, the car starts and runs properly. Exhaust emissions come down to normal levels once the fuel-soaked plugs and exhaust system warm up. For a more detailed look at scope testing for similar problems, see this month's Part One of Vince Fischelli's article, Trace Elements.
