Cheap Spills

Toyota has produced thousands of Tercels since this economy model was introduced during the 1980 model year. The majority of these inexpensive cars are still on the road, and have earned a good reputation among their owners for predictability and reliability. So besides the unavoidable necessities like brakes, exhaust, and tune up work, what could possibly annoy a Tercel owner enough to bring his car in for some unscheduled maintenance?

For the purposes of this article, we'll be sticking with second generation Tercels in the 1983-87 model range. These models are equipped with a longitudinally mounted engine from the 3A engine family. Several tips that are applicable to four wheel drive Tercel wagon models of the same vintage are also included.

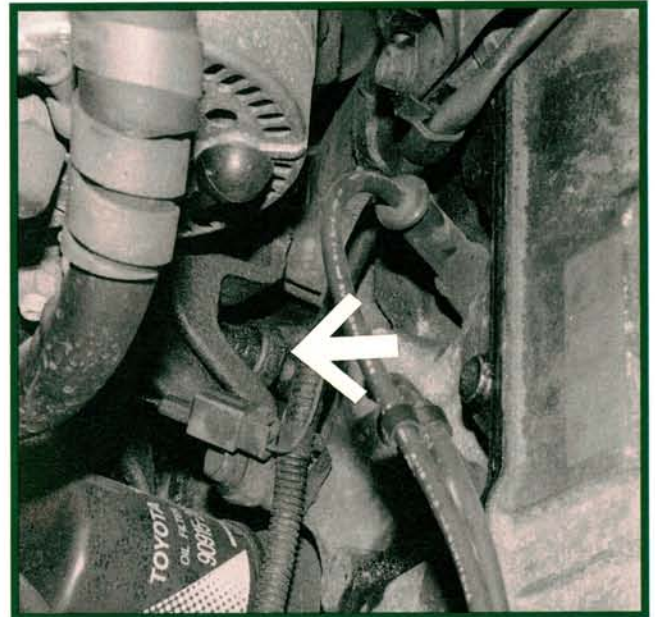
1 Yes, that is the oil pressure sending unit under there. It's buried next to the A/C compressor bracket, below the alternator. Leaks here usually start small, but can grow to catastrophic proportion as life-sustaining lubrication is pumped onto the pavement. Have you priced a new engine lately?

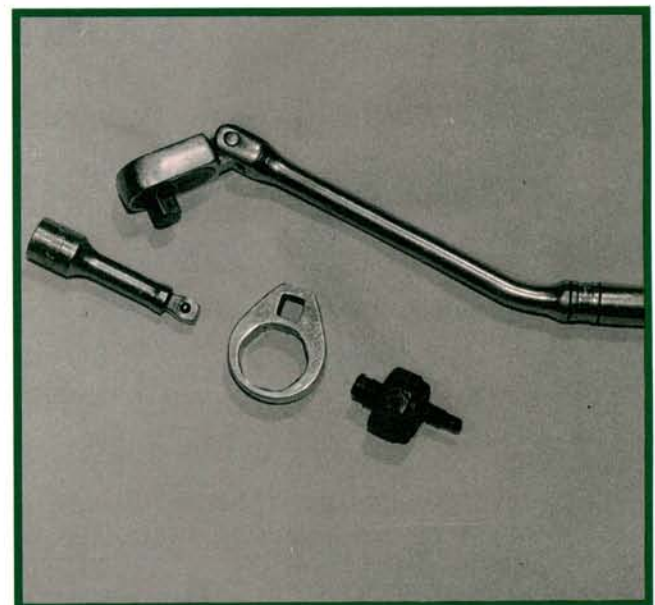
2 Without a ring-type socket, you'll need to remove the alternator, A/C compressor, mounting bracket, and left motor mount to remove the sending unit. Unlike a standard sending unit socket, a ring-type socket won't get trapped as the sending unit is removed. A wobble extension and flex ratchet will turn the socket.

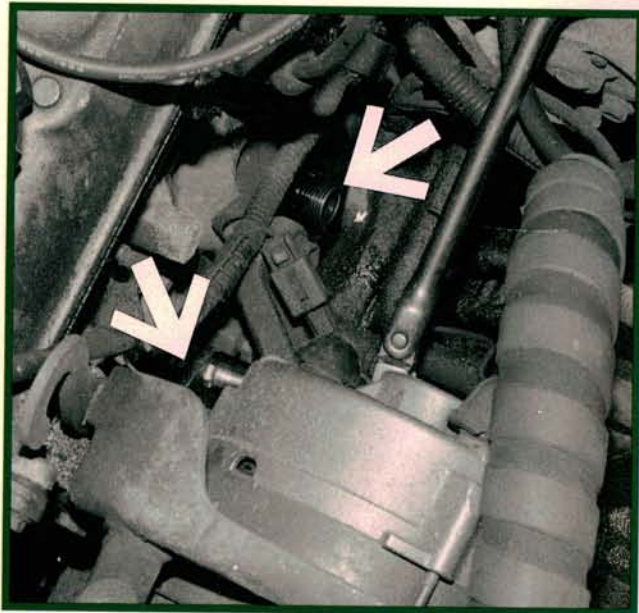
3 Removing the oil filter isn't absolutely necessary to get to the sending unit, but it sure makes things easier. Clearance is limited and we still had to grind a small amount of material off the heel of our sending unit socket before it would clear the engine's coolant drain plug.

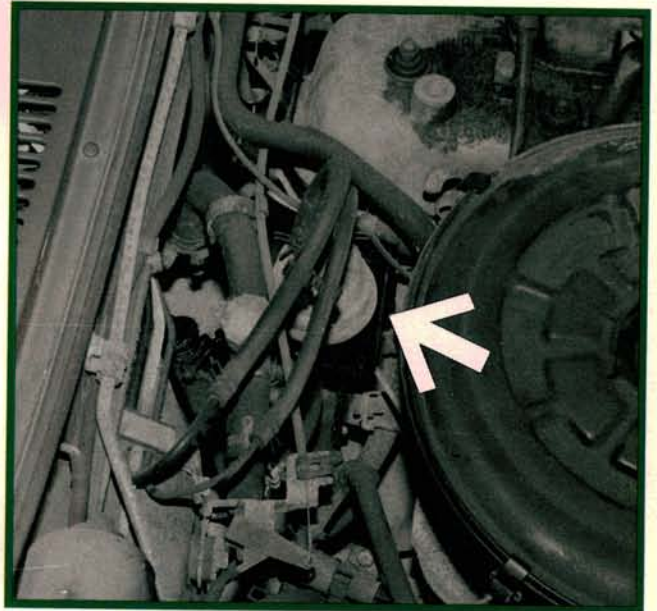
4 An oil leak from the fuel pump is not uncommon on these models. In extreme cases, the firewall may be soaked with oil. Be sure to check for damage to the heater hoses and the vacuum lines around the charcoal canister. These hoses and lines do not tolerate oil baths very well.

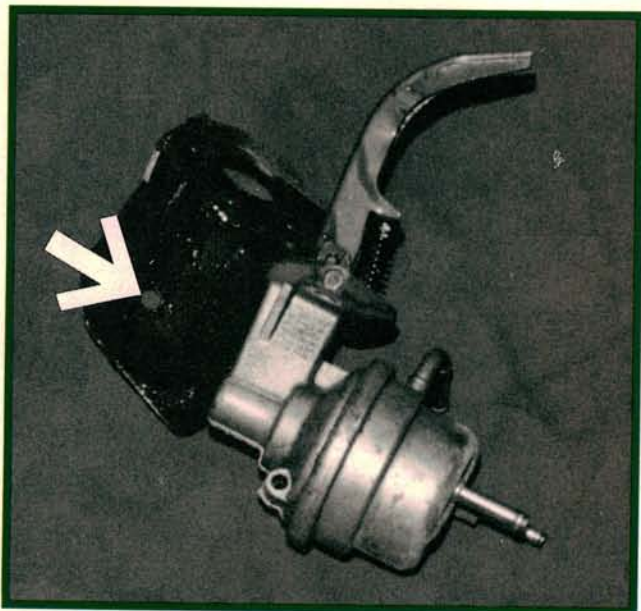
5 This photo shows the basin/insulator that Toyota uses to contain minor oil leaks at the fuel pump. The small drain hole in the basin does a good job of lubricating the heater hose that's routed directly below. A fuel pump leak can easily be misdiagnosed as a head gasket or valve cover leak.

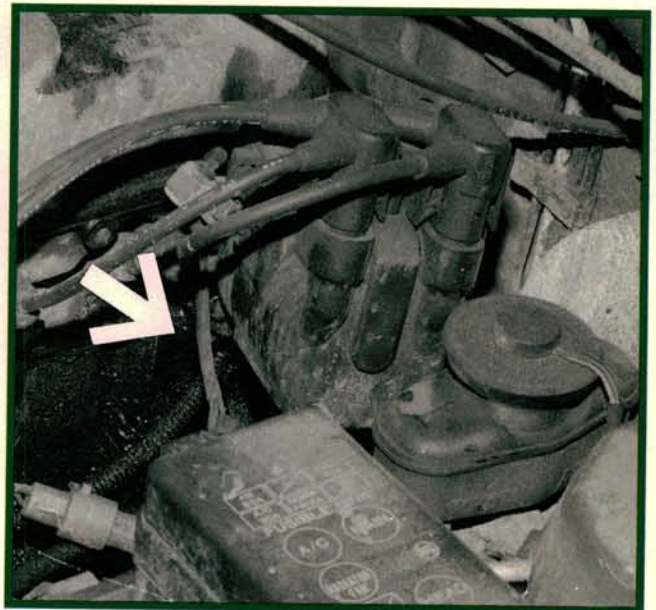
6 If the left rear side of the engine is covered with oil, the cause is probably a leaking o-ring seal at the base of the distributor. A single bolt secures the distributor and maintains the timing adjustment. Set the engine to TDC on number one, then mark the distributor rotor position before removal.

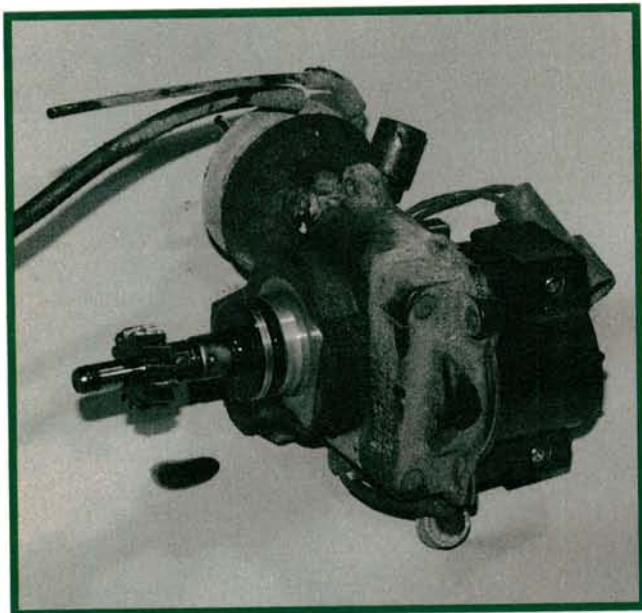
7 The distributor that is installed on 49 state models has three vacuum hoses. Before removing the distributor, unplug the hoses in the staggered manner shown to make reinstallation easier. Avoid scratching the distributor body by using a dull pick to remove the o-ring. Check the vacuum diaphragm for leaks.

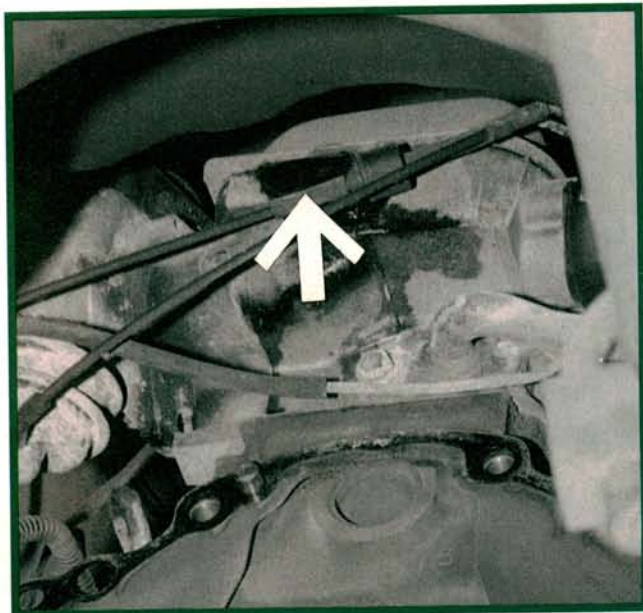
8 Don't forget to check the camshaft half moon seal at the back of the engine when you're looking for valve cover leaks. Since it's hard to see the seal (much less photograph it), use your finger to check for leaks. A clean finger that comes back wet with oil is your best diagnostic tool for this job.

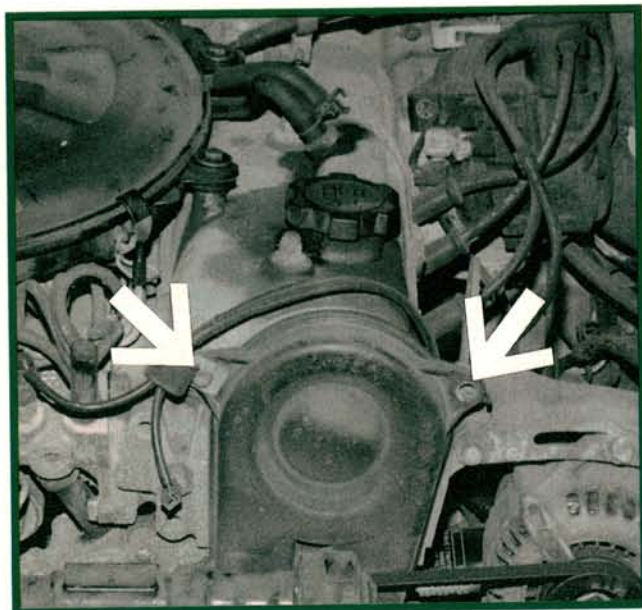
9 Simple stuff again. Two partially hidden bolts (arrows) secure the valve cover to the upper timing cover. You'll have an awfully hard time removing the valve cover if you forget to remove these bolts, along with the three acorn nuts at the top of the valve cover. Remove the air cleaner assembly first.

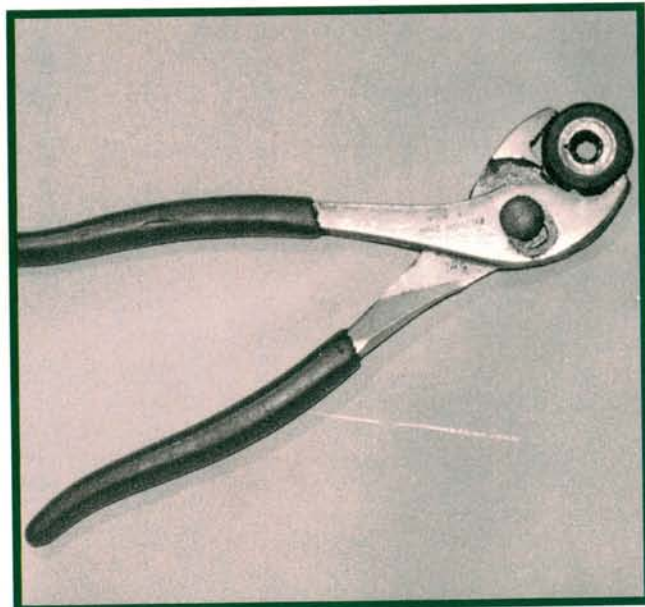
10 The valve cover grommets mold themselves to the mounting studs and harden, making it difficult to remove the valve cover. Unscrew the grommets with small adjustable pliers, then remove the valve cover. Replace the damaged grommets to prevent oil leaks from the top of the valve cover.

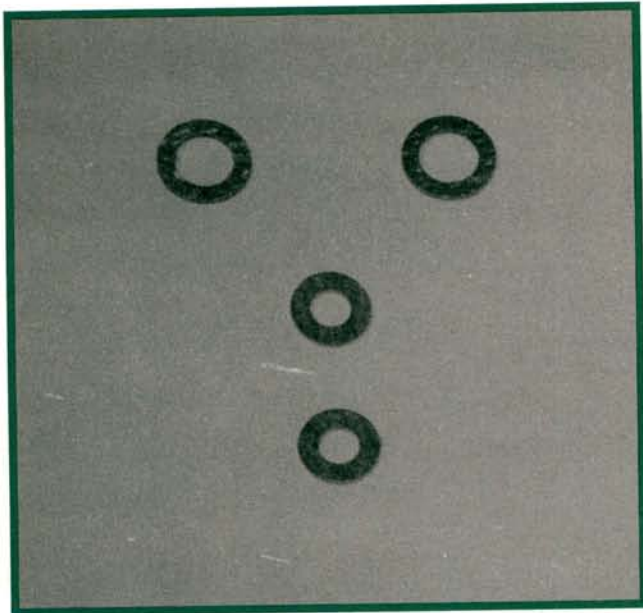
11 The treated paper drain plug gasket often sticks to the oil pan when the drain plug is removed. Fast lube jockeys have been known to mistakenly add a second gasket (if one is good, two must be better). The result is a slow but persistent leak. Overtightening won't stop the leak, but it will strip the oil pan threads.

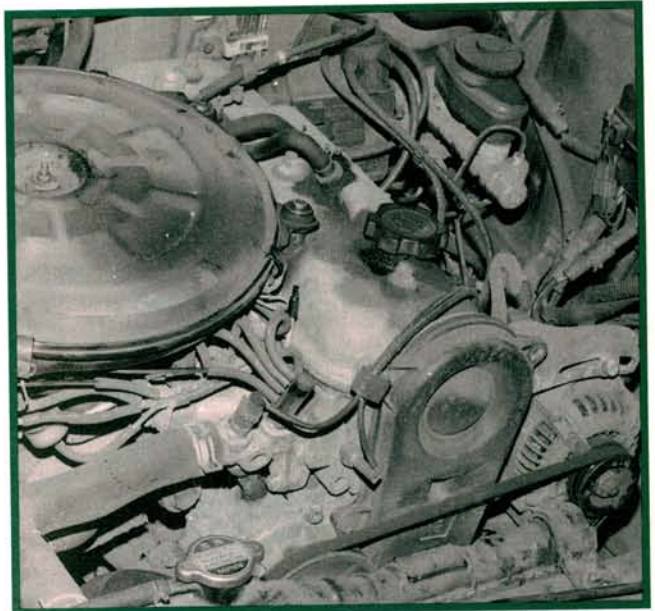
12 Tercel owners may complain of steam coming from under the hood following cold starts or a small puddle of coolant under the car after parking overnight. You may start to scratch your head if a cooling system pressure test reveals no visible leaks. Who's going crazy, you or the customer?

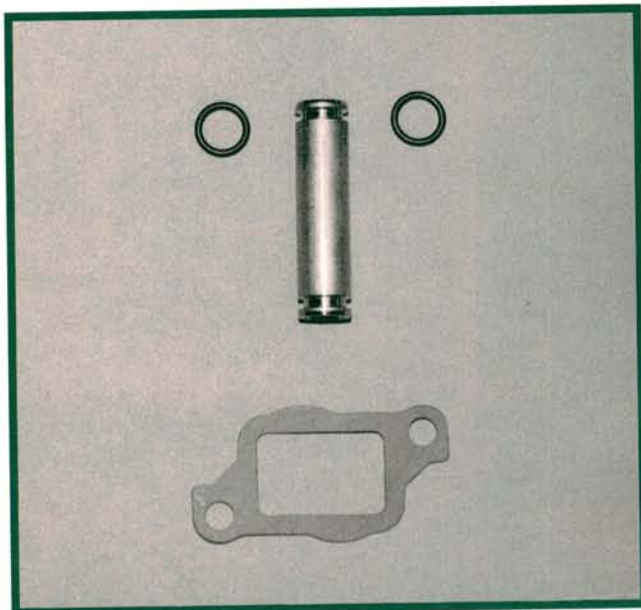
13 The water pump bypass tube o-rings are likely suspects. Worn o-rings allow coolant loss when the engine is cold, but expand enough to seal as engine temperature rises. A leak will leave a coolant stain at the base of the bypass tube. Remove the water outlet housing, then remove the bypass tube to replace the o-rings.

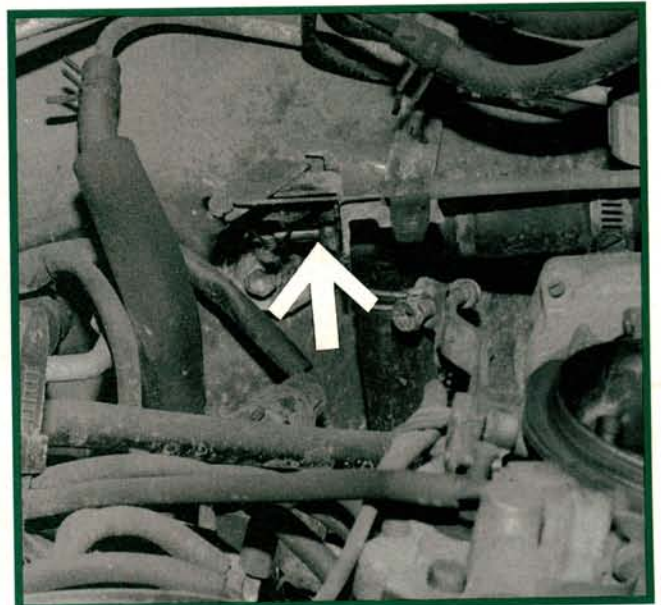
14 The valve seal at the base of the heater control valve is another site for easily overlooked coolant leaks. After replacing the leaking control valve, lubricate the new valve stem and cable pivot with a silicone grease to prevent a recurrence. Petroleum-based greases may damage the valve seal.

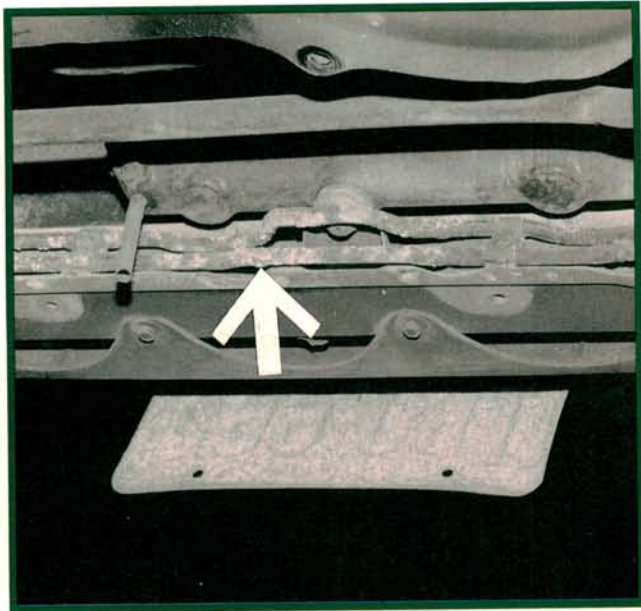
15 Before replacing what appears to be a leaking power steering pump, be sure to check the steel pressure and return lines that snake around the engine compartment and under the radiator (arrow). These lines frequently rust out. A misdiagnosis here could cost you a customer, or \$250 for the line set.

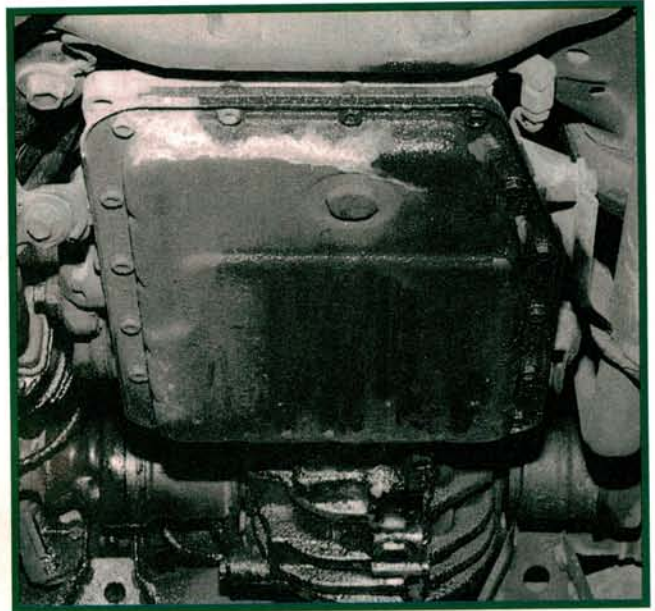
16 Keep your eyes peeled for ATF leaks before the transaxle gets damaged by operating while low on fluid. The price of a rebuilt transaxle will make your customer see red. If the fluid looks or smells burnt, replace it. There are no tricks to replacing the pan gasket. Clean or replace the strainer while you're in there.

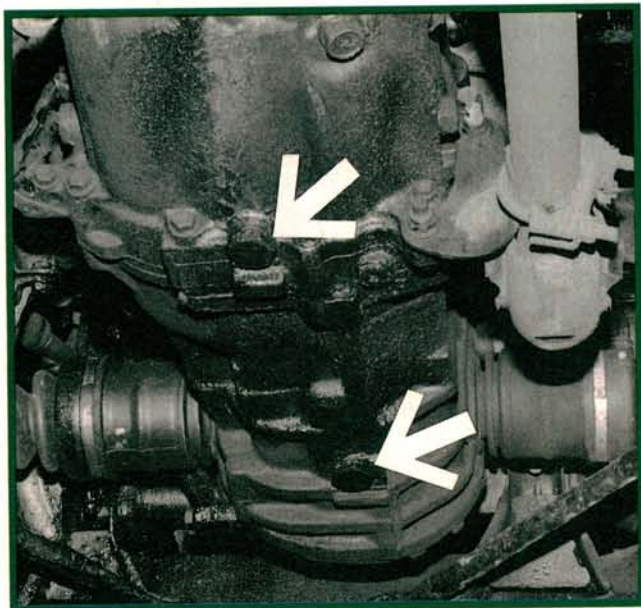
17 Check the manual transaxle, as well as the differential fluid levels. Two sets of drain and fill plugs are used on manual transaxle models. Remove both drain plugs to drain the trans and differential. Replace the drain plugs, then add lube through one fill hole until it comes out the other. Reinstall both fill plugs.

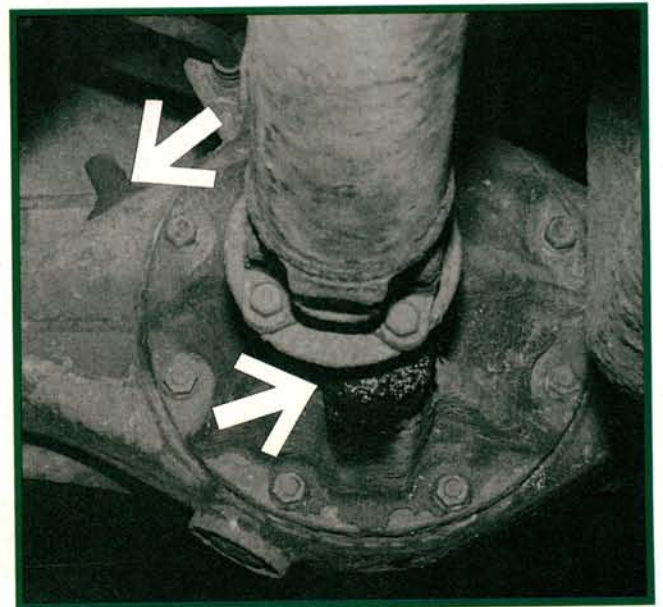
18 Four wheel drive rear axle seals, and differential pinion shaft seals (right arrow), will leak if pressure builds up in the rear end. Take a minute to check the breather vent (left arrow) for free operation whenever servicing a four wheel drive Tercel. Opening a clogged vent will cause a whooshing noise as pressure is relieved.

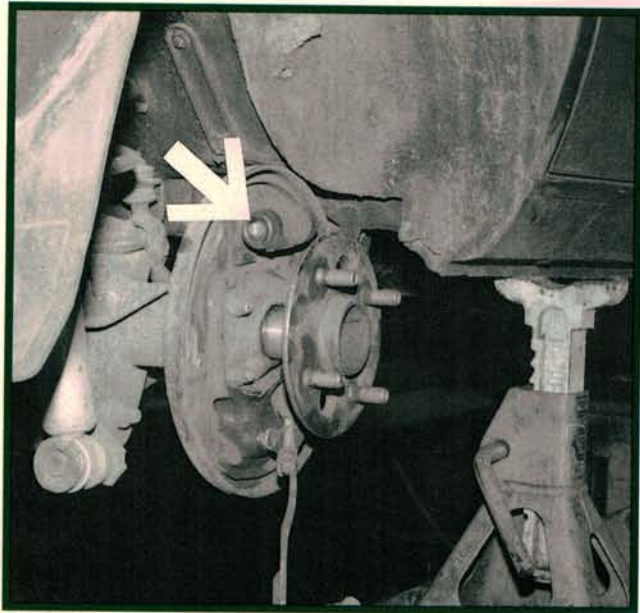
19 Low fluid in the master cylinder reservoir usually means the brake pads are worn, but don't overlook the possibility of a fluid leak. Rear wheel cylinders are likely culprits. Frozen parking brake cables may generate enough heat to damage new cylinders. Check for proper cable operation before quoting a price on the job.

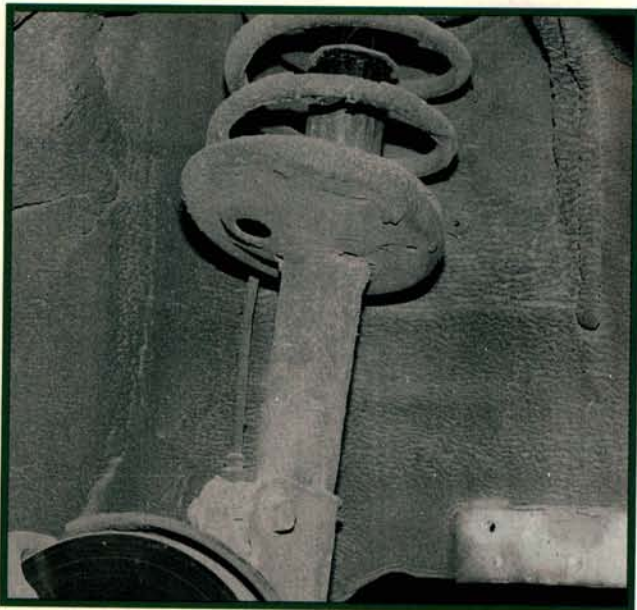
20 Check the shocks and struts for leaks. Replacing OE front struts may require cutting the brake line bracket or separating the brake line. Some replacement struts have removeable brackets, so a second strut replacement may be easier than the first. Check the strut bearing assembly for wear, too.

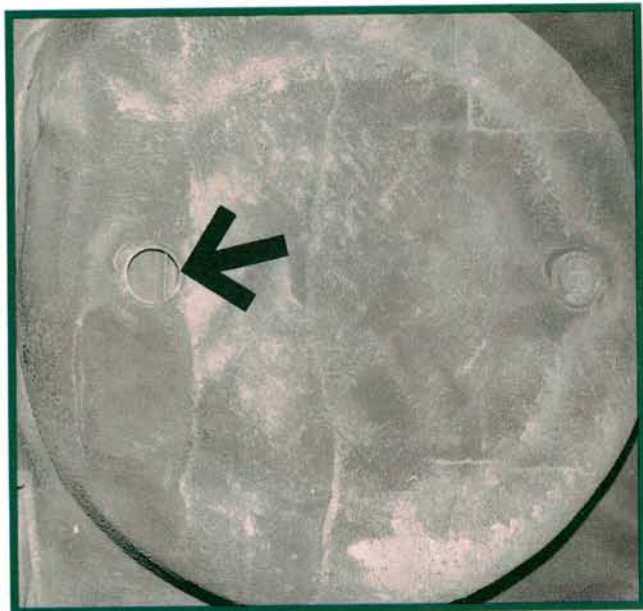
21 A flat spare tire can turn a nuisance into a nightmare. Always check the inflation as part of a pre-trip inspection. We've also discovered a number of lakes in the trunk (complete with algae) due to water leaks around the taillights. Remove the body drain plug (arrow), then break out the disinfectant to prevent mildew.

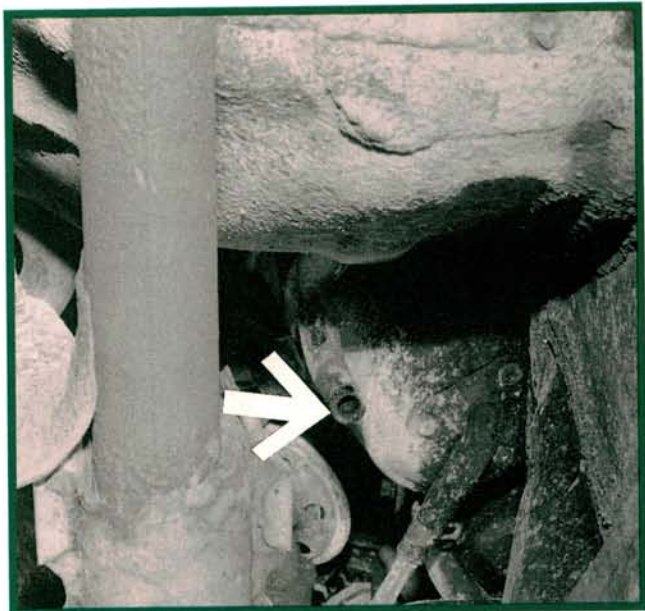
22 One "leak" you should be happy to see is the cold clear condensed water from the A/C drain hose. But remember that a clogged drain hose is a possible cause of wet carpeting if it's not accompanied by the smell of anti-freeze. Another possible cause of wet carpeting is a loose or missing body drain plug.

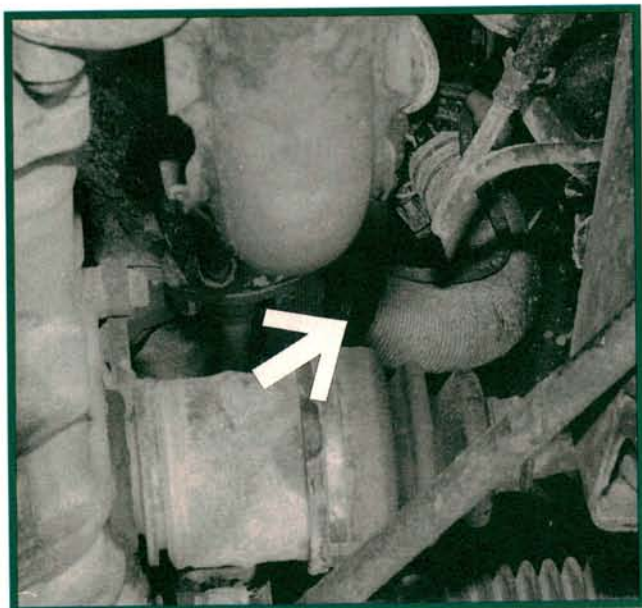
23 This broken carburetor preheat hose (arrow) may not leave a mess on the driveway, but the carburetor icing it can cause is no picnic. Carburetor icing may cause a loss of power and stalling while driving at moderate to high speeds in cooler weather. The ice will melt by the time the wrecker brings you the car.

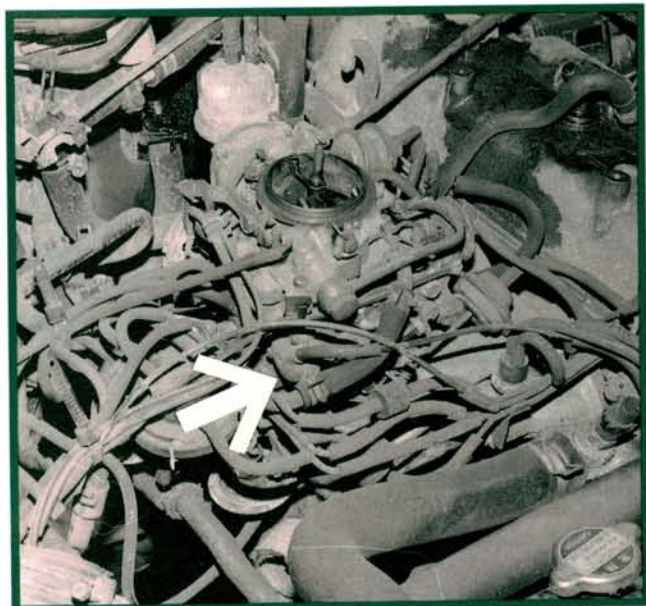
24 A ruptured auxiliary accelerator pump diaphragm may cause a noticeable bog on acceleration or spark plug fouling during cold starts. Break out your vacuum pump, then check for leaks. Many technicians replace the AAP diaphragm at the first sign of fuel in the vacuum supply line.
