Quantum Mechanics

— By Karl Seyfert

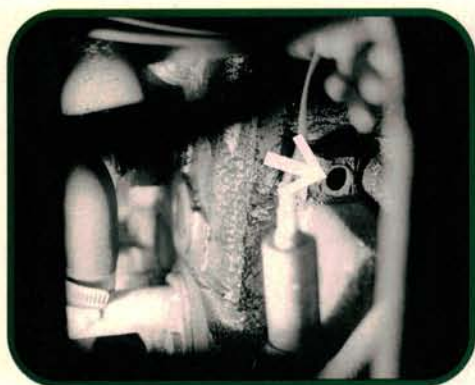
Broken exhaust manifold studs and leaking exhaust manifold gaskets are common on five cylinder engines. Expansion and contraction of the cast iron exhaust manifold may cause stud breakage at the number 1 and 5 exhaust ports. We saw this broken number 5 stud through an opening in the wheel well.

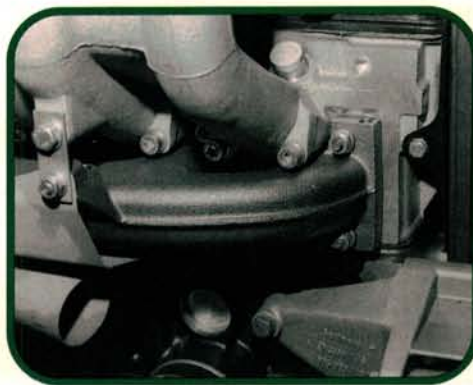
2

Specially tempered studs are available to replace broken exhaust studs. Always check the manifold mounting surfaces for flatness when replacing broken studs. The manifold can be machined and need not be replaced if it becomes slightly warped. Replace the self-locking manifold nuts, too.

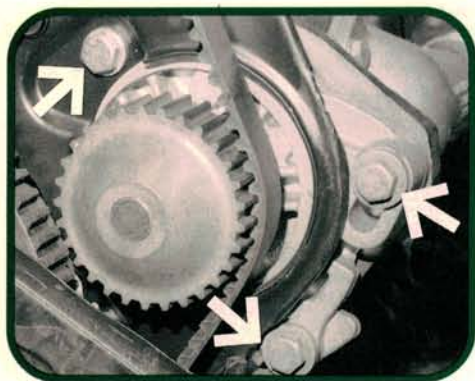
3

On five cylinder engines, timing belt tension is adjusted by pivoting the water pump. Whether you're installing a new belt or adjusting the tension on an old belt, always replace the water pump o-ring before moving the water pump. Used o-rings often will leak after the water pump has been moved.

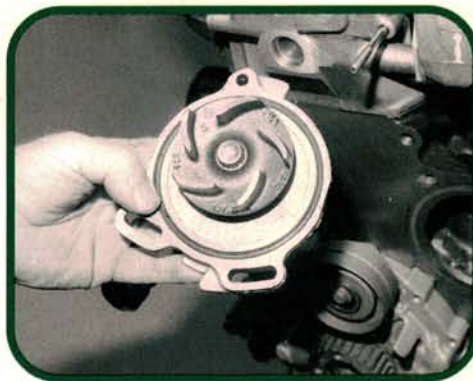
The sealing groove on some remanufactured water pumps has been resurfaced and enlarged. These pumps can be identified by the number 5 stamped on the fastening flange area. The 4 mm o-ring will not seal when used with these pumps. An oversized 5 mm o-ring (part number 069 121 043) must be installed.

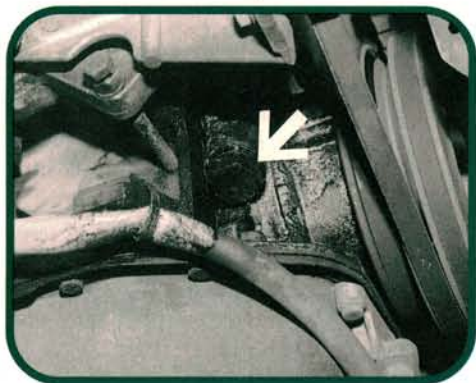
5

This engine is leaking from somewhere, but it's anybody's guess where the oil is coming from. Remove the timing belt cover for a better look. Likely candidates are the crankshaft seal, camshaft seal, or oil pump pressure relief valve (arrow). A leak like this will quickly ruin a timing belt.

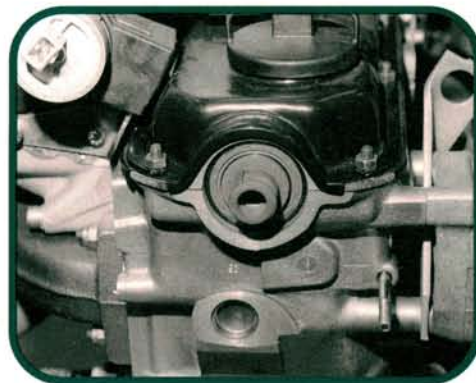
6

The cam and crankshaft both take the same size seal. The camshaft seal can be replaced without removing the valve cover or bearing cap, if you have the VW/Audi special tool or are handy with a hook-style seal puller. If not, remove the valve cover and front cam bearing cap.

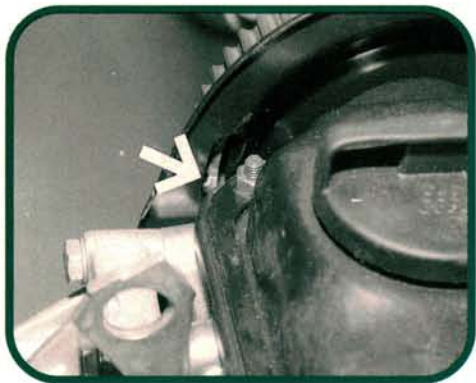
7

Cam timing marks are on the back side of the cam sprocket on four and five cylinder models. Line up the mark with the top edge of the cylinder head. An access window in the belt shield on five cylinders allows a glimpse of the timing mark with the timing belt shield installed.

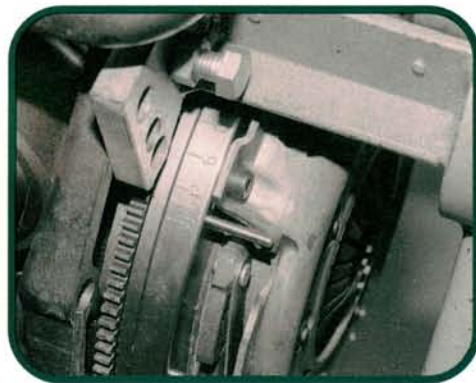
8

The crankshaft timing marks are on the flywheel. This engine is on a stand, so we can't show you the timing window in the top of the transaxle bell housing. Normally, you would line up the zero mark on the flywheel with the notch in the timing window before installing the timing belt.

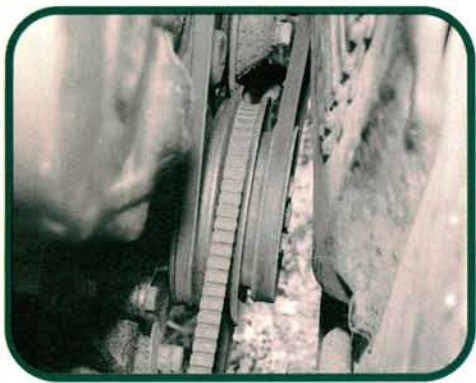
9

The large crankshaft pulley on four cylinder models puts a lot of strain on the end of the crankshaft. The constant pounding from the compressor may loosen the crankshaft bolt on engines equipped with A/C. If the pulley gets loose enough to wobble, it can quickly destroy the crankshaft snout.

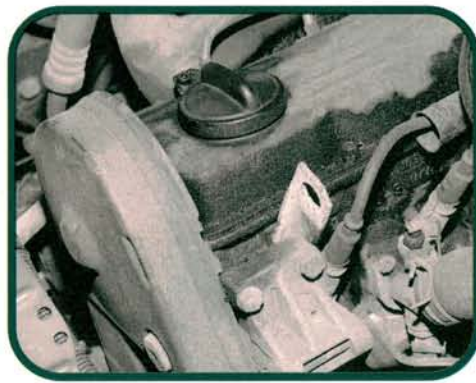
10

Valve cover gasket materials have been changed to combat oil leaks. The results have been only partially successful. Valve cover leaks are still common, and usually develop as the gasket hardens and compresses. A dab of RTV at the corners when a new gasket is installed will postpone the inevitable.

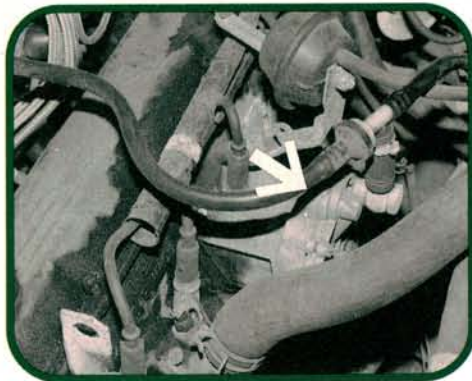
11

Five cylinder engines need a little extra help from a gear-driven auxiliary vacuum pump to produce enough vacuum for the brake booster and vacuum-operated engine controls. If the braking system loses power assist, the most likely cause is a broken vacuum pump diaphragm.

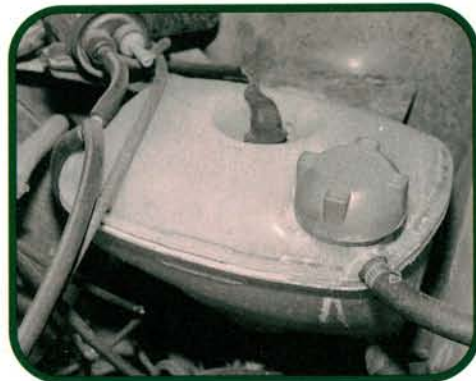
12

The cooling system pressure cap is mounted in the overflow bottle, not the radiator. Cracked and leaking overflow bottles are a common occurrence on Quantum, as well as other Volkswagen models. The bottle usually leaks when pressure expands the bottle. Break out your pressure tester to find the crack.

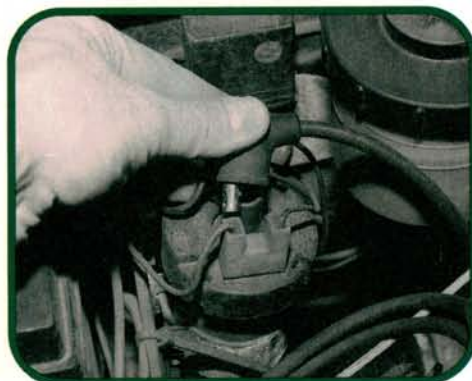
13

The ignition wire connectors have been changed on later five cylinder engines. Pull the smaller connectors straight out of the cap tower to prevent damage to the cap. Loosening and peeling back the ignition cable boot will make removal easier. These components are not interchangeable with earlier designs.

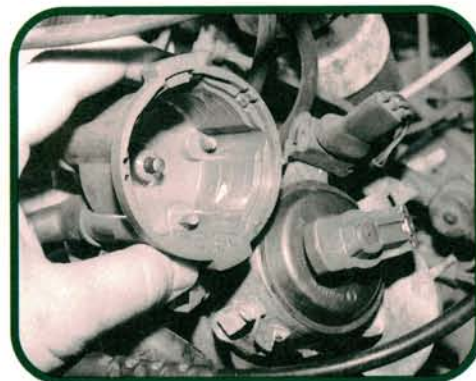
14

Inline resistors are used at the spark plug for radio noise suppression. This increases the secondary resistance to high levels. Any additional resistance at the cap, rotor, or spark plugs may be more than the coil can overcome. Rough running or intermittent misfires may result if the spark takes a detour.

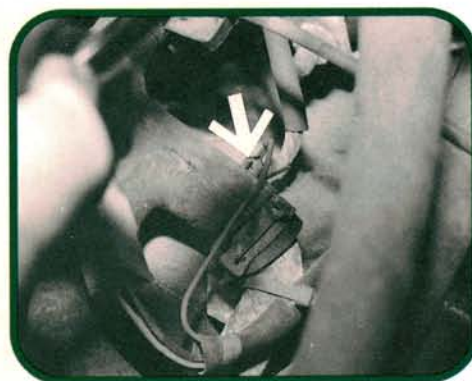
15

Corrosion at the main battery ground cable on the transaxle can cause starting problems. Remove the ground cable from the battery, then from its mounting point on the transaxle. Clean the eyelet and mating surface, then coat the area with lithium grease. Reinstall the cable and torque to specifications.

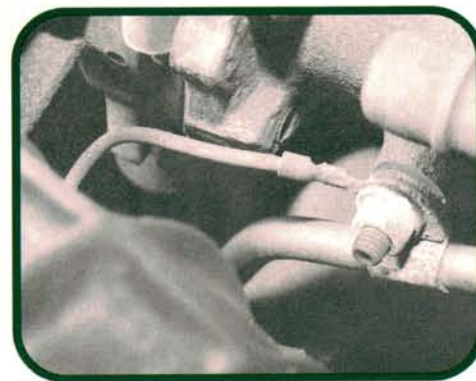
16

Several important fuel system ground wires are attached to this nearly hidden bolt on the side of the intake manifold. Loose, corroded, or broken wires here can give you some odd driveability problems. Uneven idle speeds may be caused by a poor ground to the idle stabilizer valve.

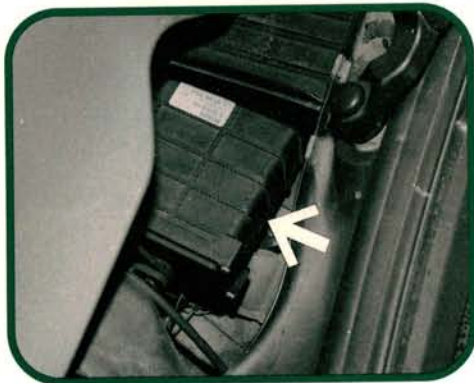
17

Grease on the ECU terminals may affect the oxygen sensor signal and cause a lean condition on five cylinders. Unplug the sensor, then check circuit bias voltage (ignition on). If it's more than 0.55 volts at the sensor's harness connector, disconnect the ECU harness and clean the terminals with rubbing alcohol.

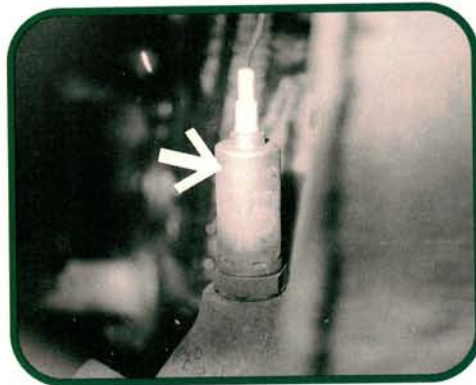
18

Writing about the oxygen sensor is much easier than actually seeing it. Volkswagen recommends sensor replacement at specified intervals. A light on the dash alerts the owner. Reset the mileage counter (mounted on the speed cable near the ECU) then remove the oxygen sensor through the wheel well.

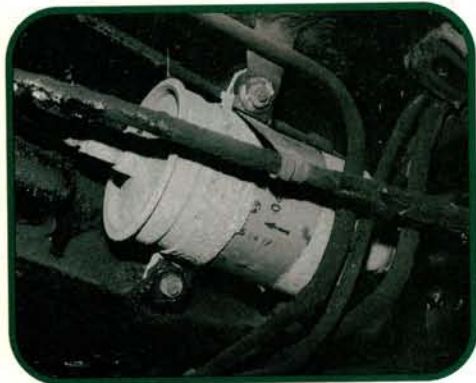
19

Starting or hesitation problems may occur after replacing the fuel filter. Many replacement filters have a recess on the inlet boss which may allow the original banjo bolt to bottom, restricting fuel flow. The correct bolt length to be used with the recessed filter is 25 mm (P/N N 021 0741).

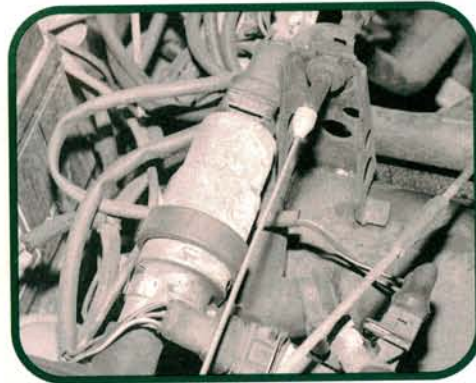
20

An idle stabilizer valve is used on five cylinder engines equipped with the KE fuel system. Engine heat may damage the valve's connecting hoses, causing false air leaks. Early valves also caused idle speed problems. A green or yellow dot on the valve indicates that it is the later, improved design.

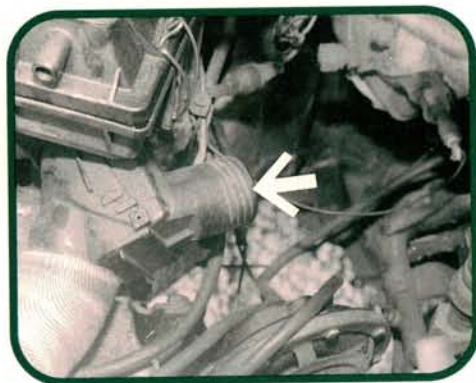
21

The condition and operation of the intake air preheat hose and thermostatic control door is very important on both K and KE fuel systems. If the hose is disconnected or broken, or if the door is stuck in the unheated outside air position, the air flow sensor will ice up during cold and damp weather.

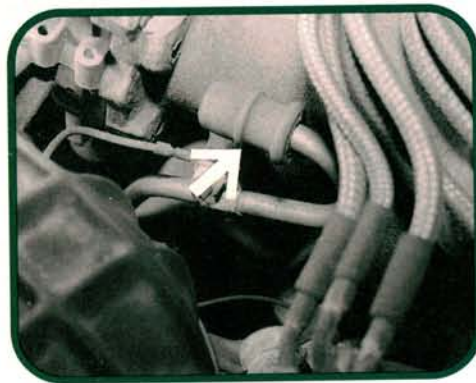
22

Volkswagen emission levels should be measured before the catalytic converter. A special test port connected to the exhaust manifold is provided for this purpose. When hooking up your emissions analyzer, be sure to use the recommended hose type. The wrong hose may melt and damage your analyzer.

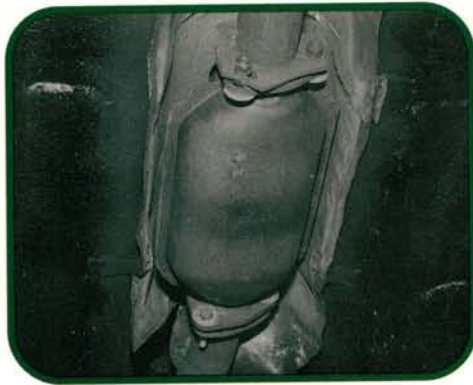
23

Loose catalytic converter ceramic inserts may cause exhaust rattles. Make sure the rattle isn't a loose heat shield or mounting flange, then remove the converter for a visual inspection. If the converter looks good, tap both flanges on a wood block from a distance of eight inches to check for rattles.

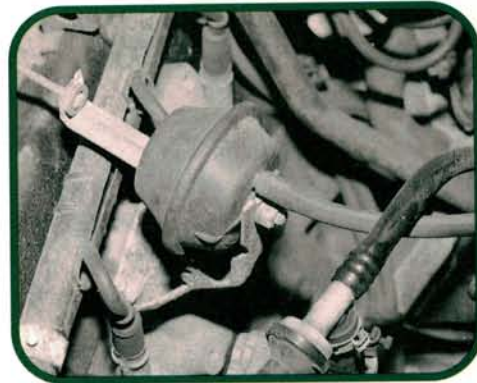
24

Cracked or leaking cruise control vacuum hoses may cause engine vacuum leaks and/or erratic cruise control operation. Volkswagen came out with an improved vacuum hose (P/N N 018 046 3) that should be used to replace any cruise control vacuum hose that has been damaged by heat.

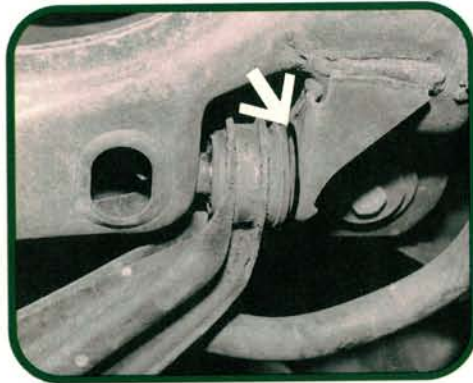
25

Front control arm bushing wear is a problem that is more commonly seen on manual transmission models. Worn bushings will cause a clunk as the engine is accelerated or decelerated. Rub marks on the frame indicate that these bushings have allowed the control arms to move forward and backward.

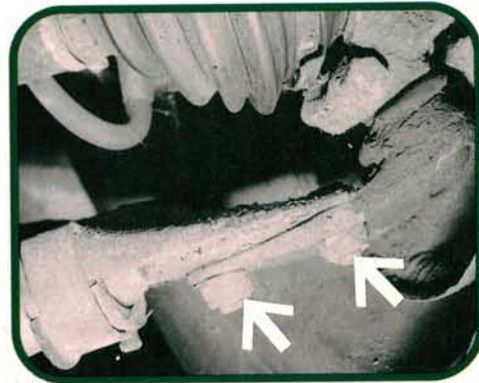
26

Unlike its Golf and Jetta brethren, the camber on the Quantum is adjusted by loosening the bolts, then moving the ball joint in or out on the lower control arm. If you don't have the special lever tool to slide the ball joint while the tire is resting on the ground, lift the wheel off the ground first.

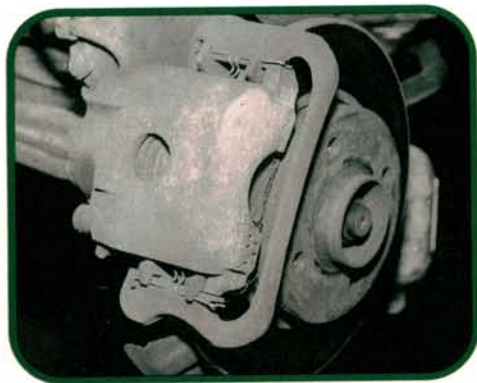
27

Front brakes are pretty standard-issue Volkswagen. Brake parts have come from several different suppliers over the years. The rotors are not "captive," and can be easily removed after removing the caliper and caliper mounting frame. These non-ventilated rotors don't take well to much resurfacing.

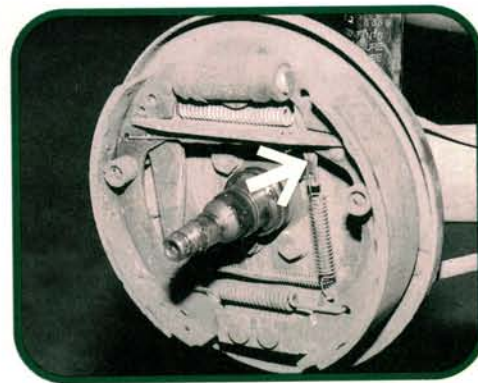
28

A ridge on the lip of the brake drum may make it difficult to slide the drum past the brake pads. A sliding wedge holds the rear brake self-adjustment. You should remove the wheel, then reach through an axle bolt hole to press this lever (arrow) and release the self-adjuster mechanism.
