Top to Bottom

What would you expect to find inside an engine that had 200,000 highway miles on it, with infrequent oil changes along the way? Plenty of sludge? Lots of worn out parts? We were dying to find out the answers ourselves. That's why we decided to overhaul an engine that fit this description. It just happened to be the engine in the boss's 1987 BMW 535 iS.

This will be a two-part article, with the first part dealing with upper engine repairs. There are several characteristic BMW "big six" engine wear areas that we'll point out along the way. We'll also explain one method of dismantling the cylinder head, including the camshaft, rocker arms, and rocker shafts.

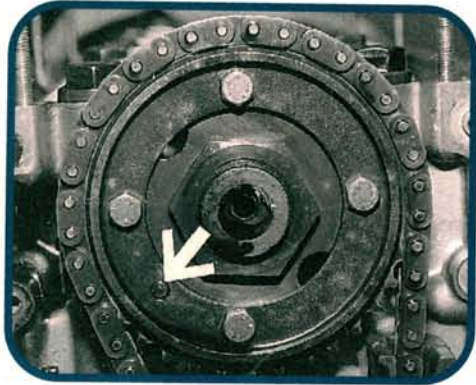
1

We'll skip most of the major engine disassembly formalities. Before removing the timing chain, rotate the crankshaft until the pointer on the front cover lines up with the "0" line on the damper. Cam sprocket bolts should parallel the upper head surface, with the pin at the lower left as shown.

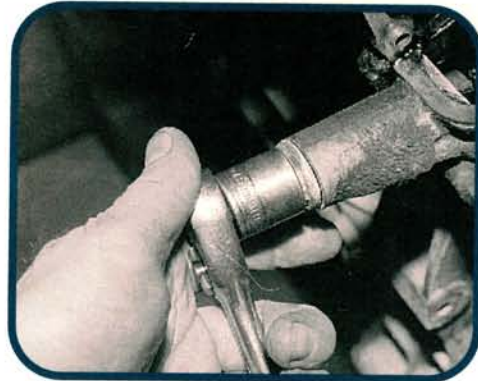
2

Carefully remove the timing chain tensioner cap. There's a large tensioner spring behind the cap, so don't get caught by surprise. Remove the cam sprocket bolts and cam sprocket. If you're only partially disassembling the engine, the chain can be placed out of the way inside the front cover.

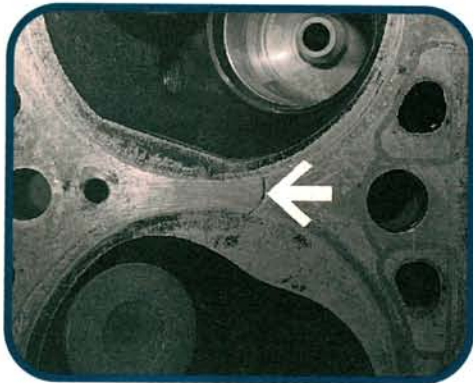
3

While inspecting the head, we discovered this carbon-filled OEM scratch between the number 1 and 2 cylinders. Only 0.3 mm (0.012 in.) is allowed for resurfacing. Rather than resurfacing the head to remove the scratch, we'll build up the damaged area first. A light cleanup cut will finish the job.

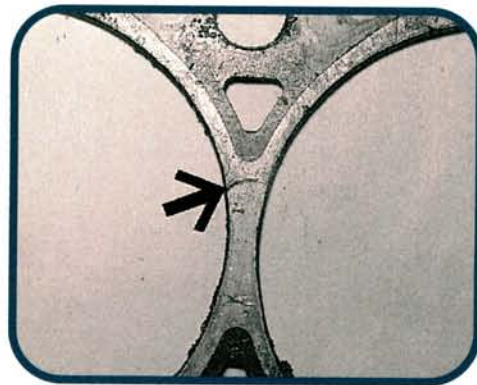
4

We included this photo of the head gasket to prove that we didn't gouge the head. The carbon mark is also visible on the gasket (arrow). They say dead men tell no tales, but a lot can be learned from a dead head gasket. Take a close look at the gasket before you scrape it off the head or block.

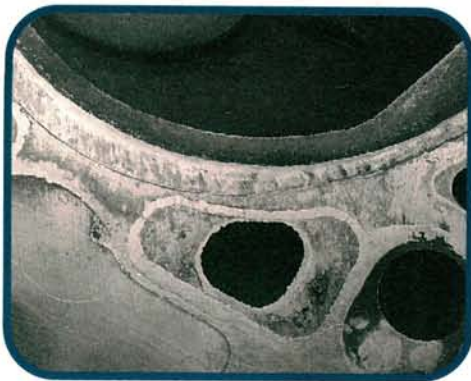
5

These corrosion marks near the combustion chambers indicate that the head gasket probably lost some of its original sealing ability over the life of the engine. The light surface cut should remove these marks from the head. Careful hand cleanup brought the block deck surface back to as-new condition.

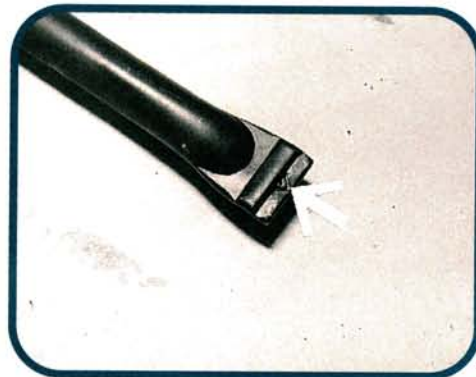
6

Camshaft oil sprayer bar banjo bolts have a nasty habit of loosening up, depriving the cam lobes and rocker arms of vital lubrication. During reassembly, position the mark at the end of the bar (arrow) facing the front of the engine and use new crush washers and thread locker on the rail bolts.

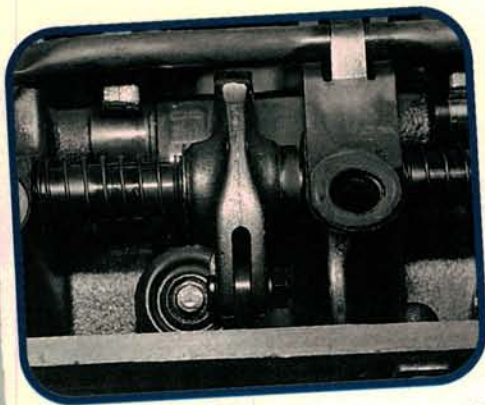
7

After loosening all of the rocker arm adjusters, two or three partially opened valves will prevent camshaft removal. A special BMW fixture is available to depress the valves, or screwdrivers may be used to open the valves. We chose to remove the rocker shafts first, then the camshaft.

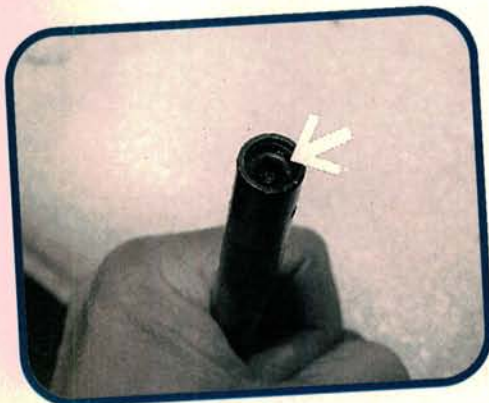
8

There are four rocker shafts, two per side. Each shaft is different, and can only be installed in one location in the head. Some shafts are tapped, with a hex head plug in one end (arrow). After removing the plug, a slide hammer adapter can be used to pull each rocker shaft out of the head.

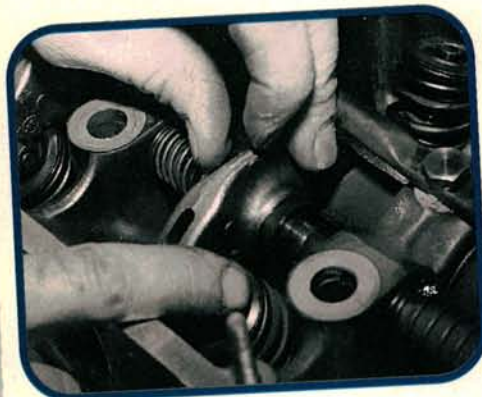
9

Turn the cam until most of the valves are closed. Push each rocker arm against its rocker shaft spring, then remove the rocker shaft spring clip with a pocket screwdriver. One side of the clip gets all the wear, due to contact with the thrust ring. Always replace these clips during an overhaul.

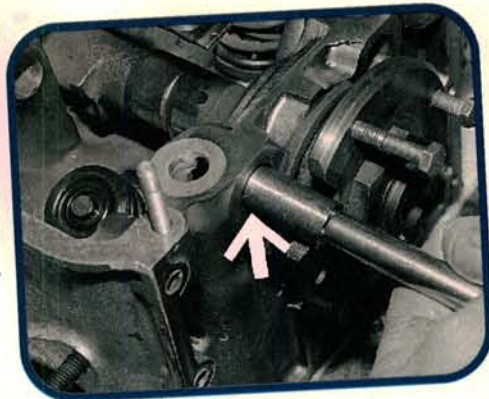
10

These rocker shafts aren't threaded, so we'll drive them out of the head instead. We used a modified socket and long socket extension to push out the rocker shafts. To avoid damaging the rocker shaft thrust rings, drive the rocker shafts from the end of the shaft facing the thrust rings.

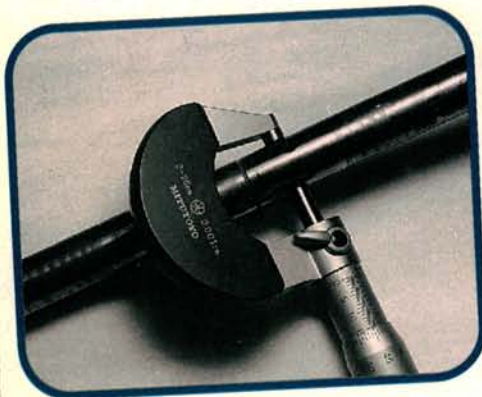
11

A very small amount of wear on the rocker shafts or rocker bushings can cause a noisy valve train. We measured the rocker shafts at several points with a micrometer, then slid a rocker arm over the shaft to check for radial play. Only 0.016-0.052 mm (0.0006-0.0020 in.) radial play is permitted.

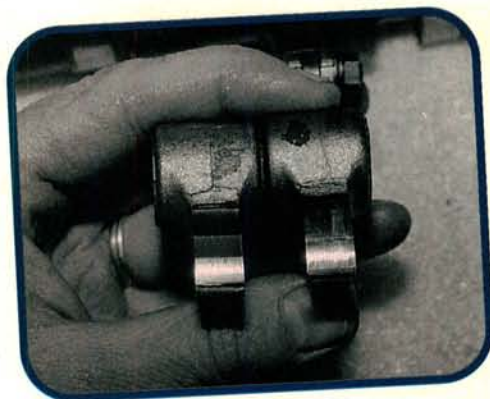
12

Given the extended oil change intervals we knew this engine had endured, we expected to find a set of rocker arms like the one on the left. It's actually a ringer from a different engine with a lot fewer miles. Poor quality follower slippers have been known to break off the aluminum rocker arm.

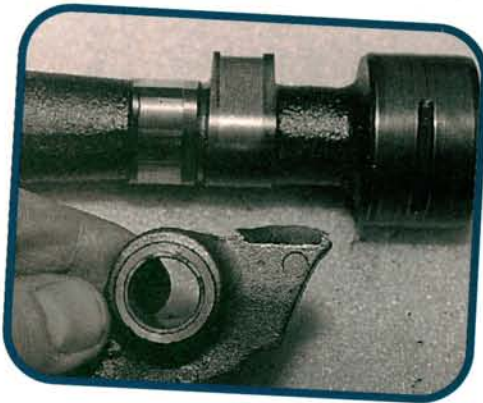
13

This heavily worn cam and lifter also came out of another BMW big six. Dirty oil, or a clogged or loose oiling rail above the cam can produce this much wear. Our cam was just beginning to show the stepped effect that is visible on this cam. We opted for a new cam, rocker arms, and rocker shafts.

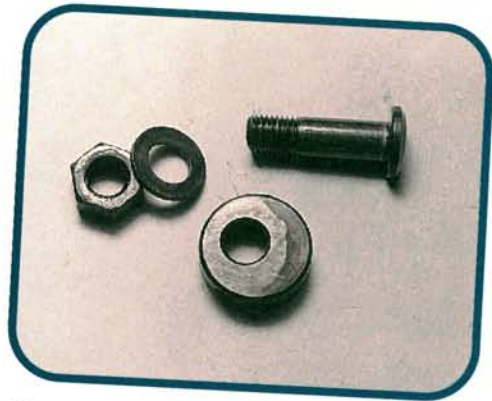
14

Disassemble the rockers and inspect the eccentric adjusting cams, bolts, and nuts for wear. Lock nut and bolt threads are often stretched by overtightening during valve adjustments (proper tightening torque is only 10 Nm). Worn adjuster eccentrics also prevent accurate valve adjustment.

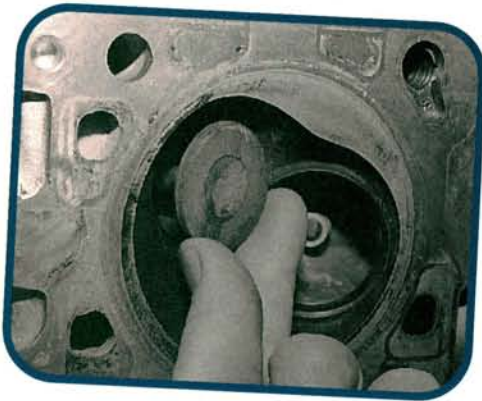
15

BMW engines of this vintage were notorious for intake valve deposit problems. This engine has a history of running problems that responded well to treatments with injector and valve cleaning solvents. We expected to find heavy deposits, but found the intake and exhaust valves surprisingly clean.

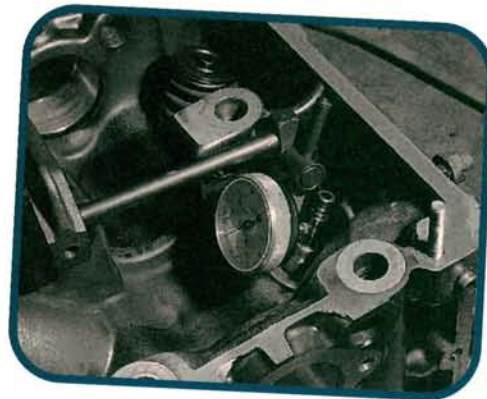
16

The engine had been using oil between changes. Worn valve guides and valve seals were a couple of likely causes. We inserted a new valve into the used guides, then measured play with a dial indicator. Maximum allowable play is 0.8 mm (0.031 in.). These guides flunked and will be replaced.

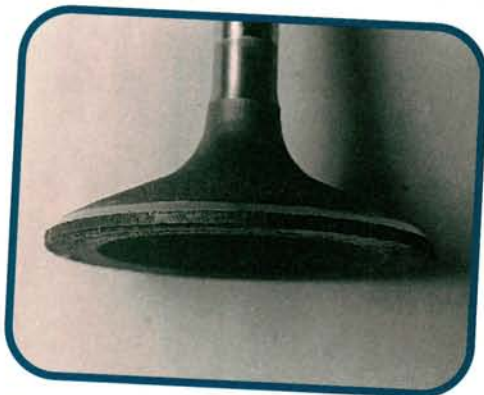
17

The valve tips were worn, although the sealing faces looked pretty good. Closer inspection revealed the extent of the stem wear (see the sidebar on micrometer usage for details). Measurement of the valve's overall length indicated that the valves had stretched slightly as well.

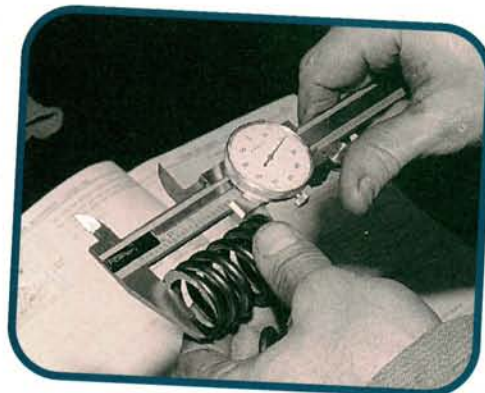
18

We planned to install new valve springs, but decided to measure the relaxed height, squareness, and compressed force of several springs to justify our decision. While each of the springs tested was within specifications, there's no telling how much life is left in a 200,000 mile valve spring.

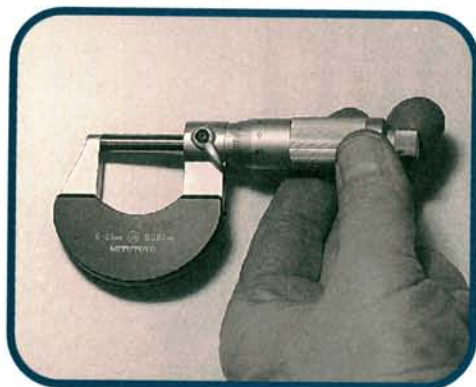
1

Accurate engine measurements require a properly adjusted micrometer. Turn the thimble until the spindle touches the anvil. Don't get carried away, it's not a C-clamp. The line next to the large 0 should meet the reference line. This mic's friction ratchet prevents overtightening.

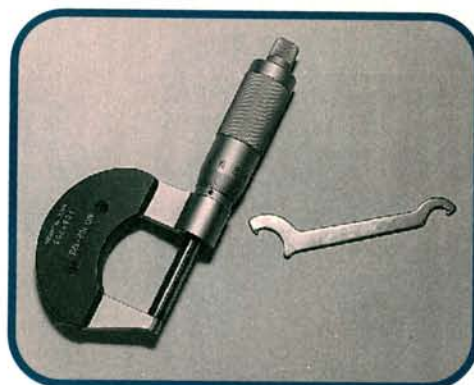
2

Most mics have a provision for adjustment if the mic has been overtightened and the 0 doesn't line up properly. This special spanner engages a hole in the mic sleeve for small adjustments. The sleeve fits tightly in the anvil. It may take several attempts before the 0 lines up perfectly.

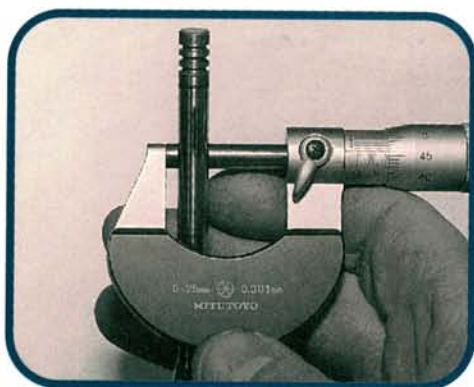
3

We measured a used valve in several spots along the valve stem. As you would expect, the stem thickness varied; with the smallest measurements in the valve guide area. The new valve stem diameter spec is 8 mm. The mic tells us this used stem is smaller. Let's find out exactly how much smaller.

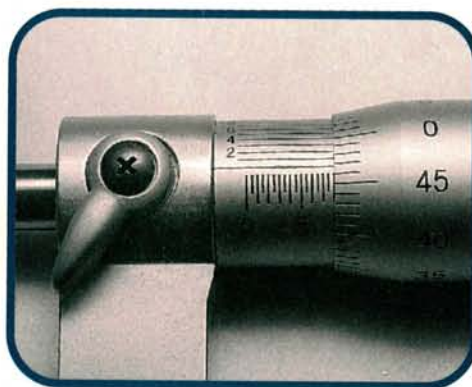
4

Each long vertical line below the reference line equals 1 mm on this 0-25 mm metric micrometer. Each short line equals 0.5 mm. Seven long 1 mm lines and one 0.5 mm line are showing. This tells us the valve is at least 7.5 mm thick, with a little extra left over that still needs to be measured.

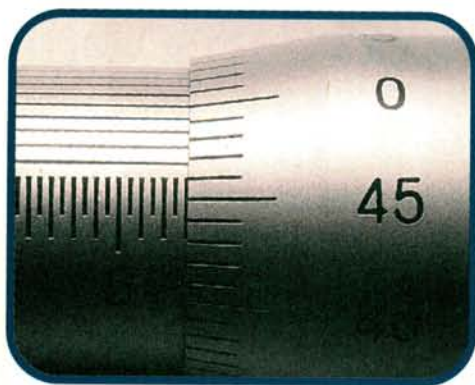
5

The thimble has 50 notches around its circumference. Each thimble notch adds 0.01 mm to our measurement. We started with 7.5 mm. We'll add 0.46 mm for the 46 thimble notches to bring the measurement to 7.96. Notice that the reference line is midway between the 46 and 47 notches.

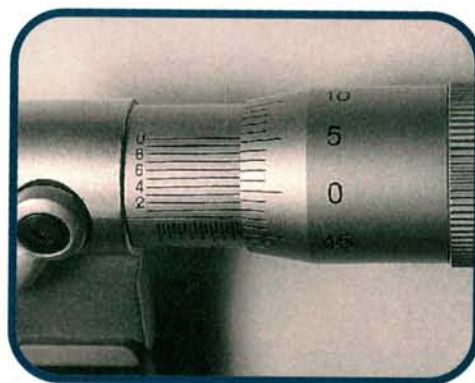
6

The 10 numbered lines above the reference line add the final thousandths of a millimeter to our measurement. Only one of the sleeve lines on the left will line up with one of the thimble notches on the right. In this case it's the 7 line, so we add 0.007 mm for a final measurement of 7.967 mm.
