# Rack 'Em Up

surprised when a certain 1985 Stanza of my acquaintance sprung a massive power steering leak after 45,000 miles of trouble-free service. If anything, I was probably more surprised that it had taken eight-and-a-half years to happen.

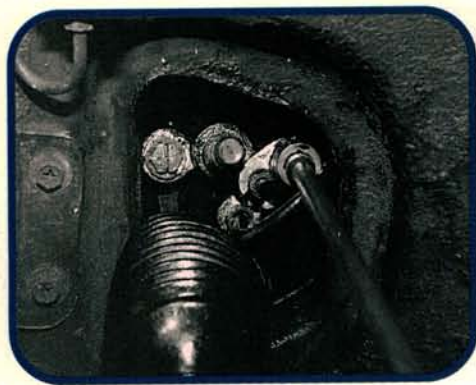
1

Loosen the power steering rack supply and return lines, as well as the steering column coupler through the tie rod opening in the left inner fender. Use a crow's foot and a long extension on the flare fittings. Turn the steering wheel from lock to lock several times to drain the old fluid.

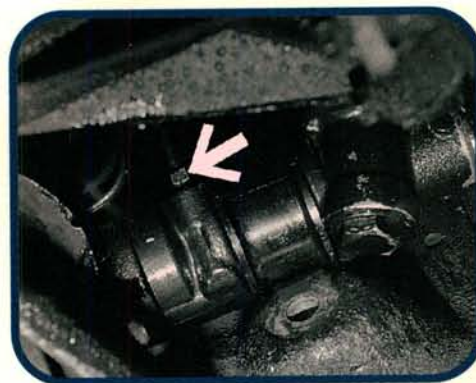
2

Now remove the smaller lines that feed power steering fluid from the pinion housing to either side of the rack piston. This may seem like an unnecessary step, but there's not enough room to remove the rack if the lines are not removed. Drain more old fluid from the rack by turning the steering wheel.

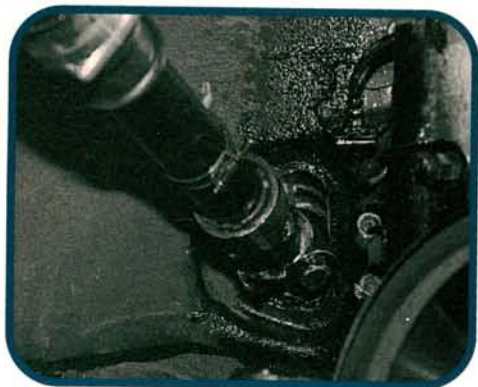
3

Disconnect both outer tie rod ends, then remove the rack mounting brackets. Push the rack through the right tie rod opening as far as it will go. The rack looks like it might fit through, but the pinion housing gets in the way (kind of like trying to drag a piano through a key hole).

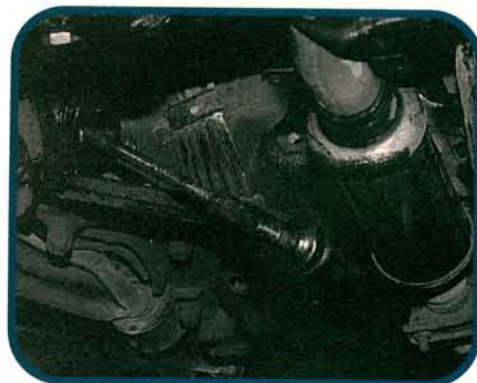
4

Now move to the underside of the car. To finish removing the rack, pull the left tie rod end down until it clears the exhaust, then angle the whole steering rack toward the ground. If the tie rod won't clear the exhaust, turn the pinion all the way to the left. It's tight, but it will fit.

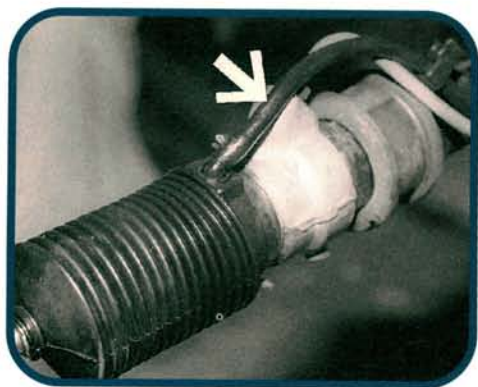
5

Both rack boots were filled with fluid. The extra pressure had also caused the left boot to tear. These air tubes interconnect the boots to equalize pressure, but they can also pass fluid back and forth when the rack leaks. This makes it difficult to determine which end the leak is coming from.

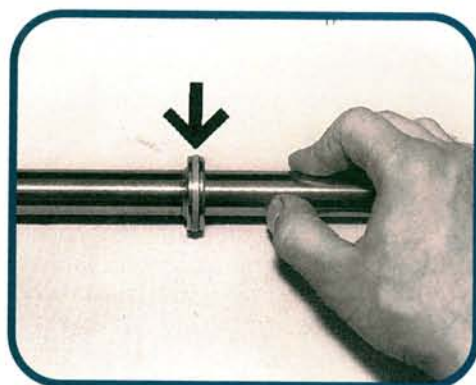
6

Even though we were replacing the rack with a rebuilt unit, we decided to take a peek inside. The smallest imperfection or roughness on the rack shaft on either side of the rack piston can result in a fluid leak. A rack that is rebuilt with a worn shaft won't stay dry for long, even with new seals.

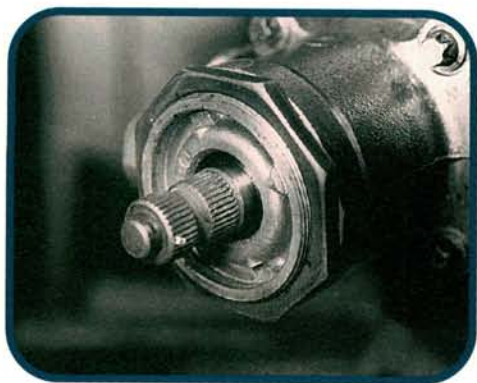
7

Another spot to check for leaks or damage is the pinion shaft and seals. The plastic pinion shaft cover may trap water, causing a pitted pinion shaft sealing area. Our pinion shaft wasn't pitted, but dirt had worn a groove into the shaft in the sealing area. Here again, new seals won't do the trick.

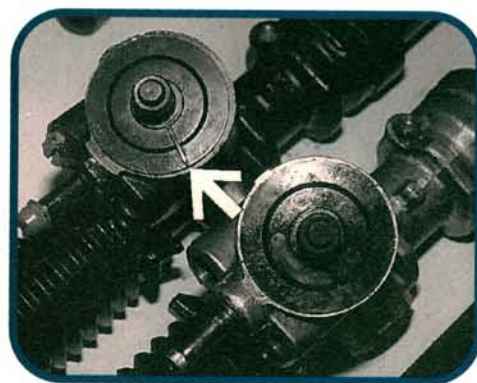
8

The notched plastic pinion shaft cover indexes the pinion shaft to the steering shaft coupler. The gap in the steering shaft coupler will point straight up when the steering wheel is in the straight ahead position. Find the center of the rack's travel, then install the splined cover pointing straight up.

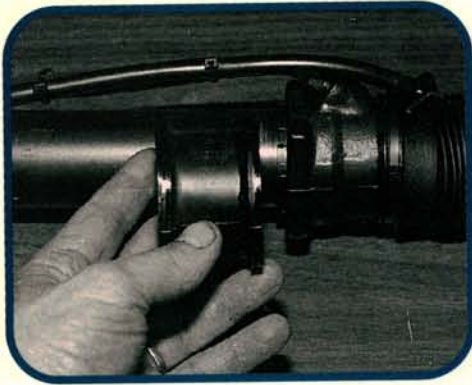
# 9

Someone forgot to install the right side rack mounting rubber on our rebuilt rack. The one piece rubber ring should be installed before the rack is assembled. Rather than disassemble both racks or cut the ring, we used large screwdrivers to stretch the ring over both cylinder end housings.

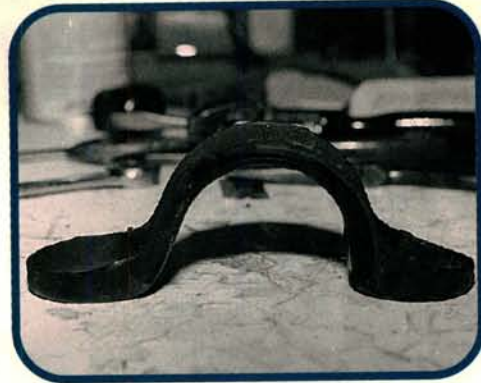
# 10

The left side mounting rubber wraps around the pinion housing. Both rack brackets have an eccentric shape. For the best fit, install the left and right rack mounts in their original locations. When correctly installed, the brackets should nearly touch the frame before the mounting bolts are installed.

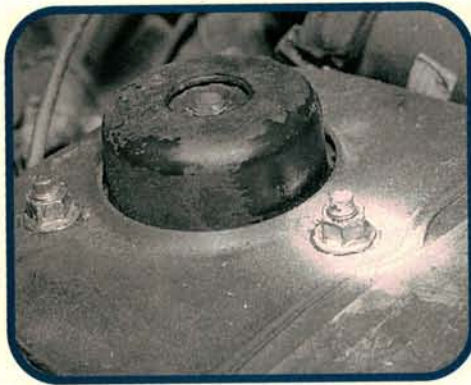
# 11

Before we removed the front struts, we marked the position of the upper strut mounting studs with paint. There's no camber or caster adjustment on the Stanza, but there's no way of knowing whether the upper mount is really concentric. Why introduce an extra variable if it's not necessary?

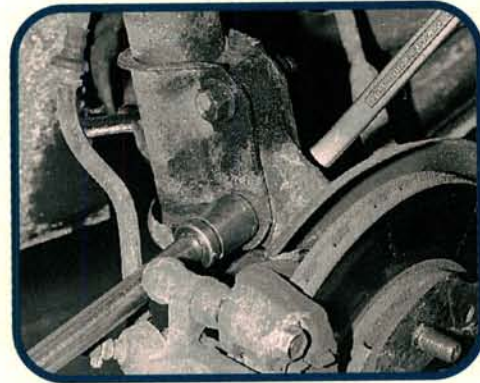
# 12

The lower strut mounting is attached to the steering knuckle. We decided there was no point in marking the bolt locations here. Unlike some cars, the holes in the knuckles are large enough for the bolts to pass; but not large enough to allow a measurable change in the camber angle.

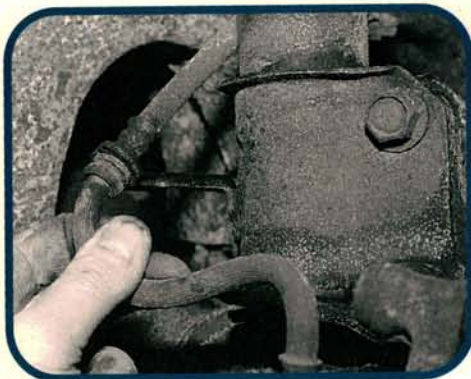
# 13

Someone at Nissan was thinking about us. The brake hose mounting bracket is slotted. Remove the spring clip, then slide the brake hose out of the way. Before removing the strut, make sure the caliper and brake hose are properly supported with mechanic's wire while the suspension is disassembled.

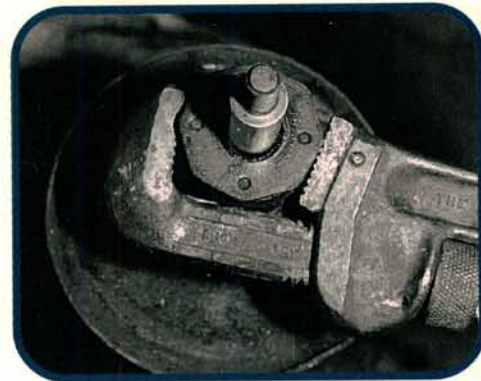
# 14

Secure the strut in a vice, then use a coil spring compressor to remove the coil spring (refer to the spring compressor sidebar beginning on page 14). We used a "dedicated" pipe wrench to remove the hex-headed gland packing nut, then removed the internal strut components and drained the fluid from the strut tube.

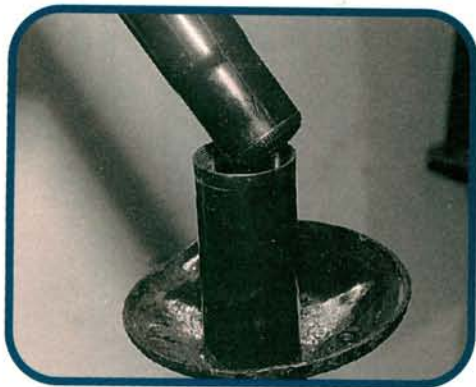
15

We took the empty strut tube over to the parts cleaner to remove all rust and dirt before installing the new cartridge. After drying the tube, we added 50 cc of fresh motor oil to cushion and cool the new strut cartridge. The new strut nut is slotted and should be torqued to 69-127 Nm (51-94 ft-lb).

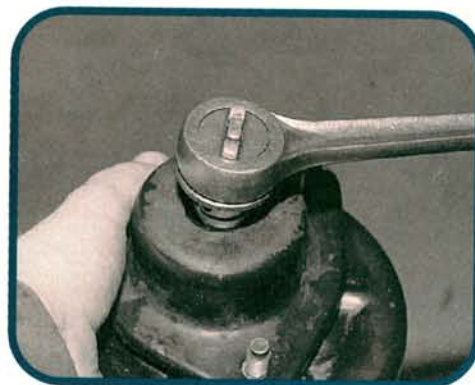
16

Check the condition of the strut bearing, strut insulator, and spring seat, then place the spring and spring compressor over the assembled strut tube. Tighten the new strut piston rod lock nut to 59-74 Nm (43-54 ft-lb). Position the spring on the spring seats, then slowly relieve the spring compressor.

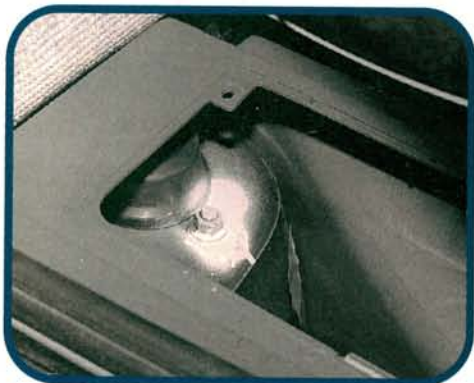
17

The rear strut upper mounting nuts can be reached through the rear speaker openings on this hatchback; they're inside the trunk on sedans. Once again, we marked the position of the strut insulators with paint. This helps line everything up when we're fishing the rebuilt strut into position.

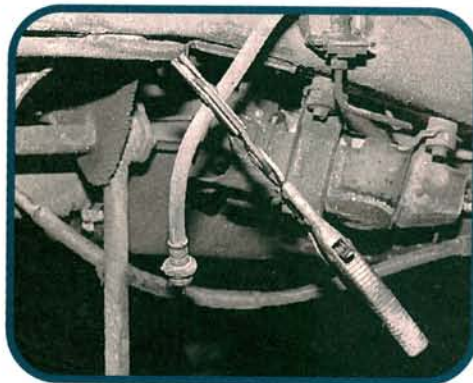
18

A different engineer must have designed the rear struts. The brake hose brackets aren't slotted. We disconnected the brake line at the strut bracket to avoid stretching the brake hose. These hose pliers prevent extra fluid loss and save time when bleeding the system.

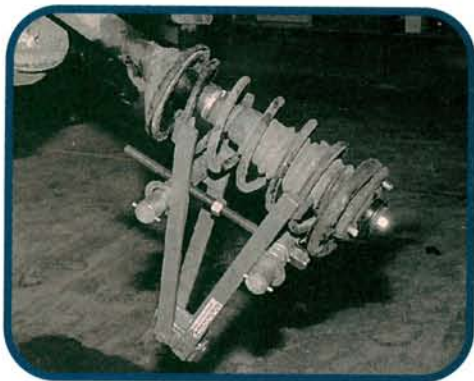
19

Rust had seized most of the bolts to the suspension bushings, preventing disassembly. On the right side, we disconnected the radius rod and parking brake cable, then swung the strut assembly and parallel links downward. With the strut parallel to the ground, there's enough room to use the spring compressor.

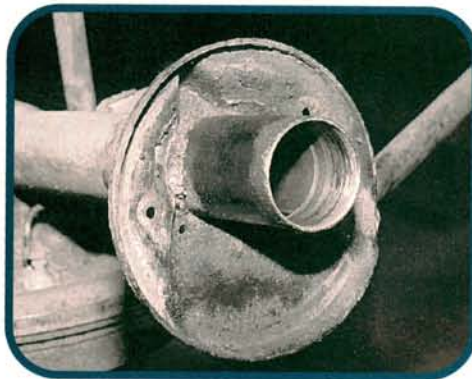
20

After removing the coil spring and strut internal parts, we cleaned the exterior of the strut and drained the rest of the fluid out of the strut tube. Temporarily tilt the strut upward to add the 50 cc of oil and the new strut cartridge, then reassemble the coil spring and upper strut insulator.

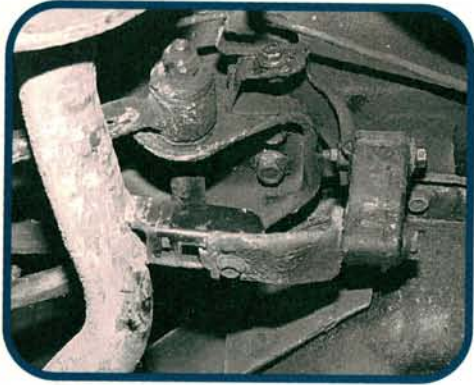
# 21

We had the same problem on the left side. However, the exhaust gets in the way and prevents the swing down technique we used on the right side. Disconnect the brake line, parking brake cable, exhaust and parking brake mounts, and parallel link bracket bolts, then remove the entire suspension as a unit.

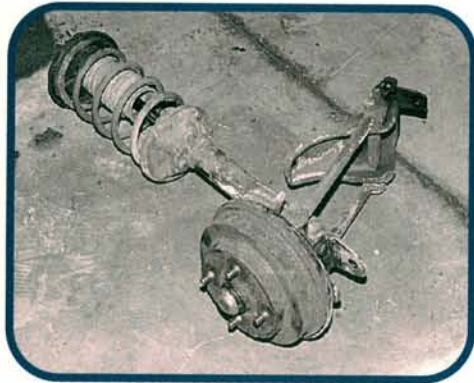
# 22

This may seem like a lot of work just to replace a strut cartridge. We decided that it was probably quicker in the long run, rather than wrestling with (and probably damaging) the seized bushings and bolts. Securely mount the whole mess in a vice before attempting to compress and remove the coil spring.

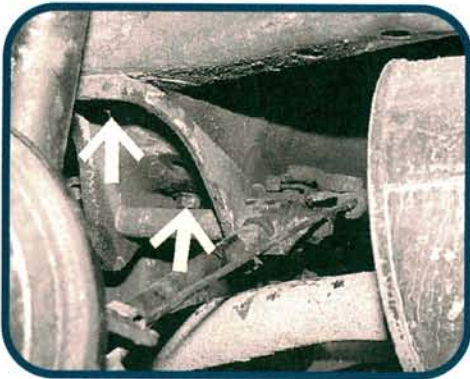
# 23

This early Stanza has no provision for rear wheel alignment adjustments. However, there is enough "slop" in the parallel link bracket holes to allow slight camber and toe changes. During reassembly, use the washer markings on the bracket to return it to its original location, then recheck the rear wheel alignment.
