The Joint or the

The Joint or the Shaft?

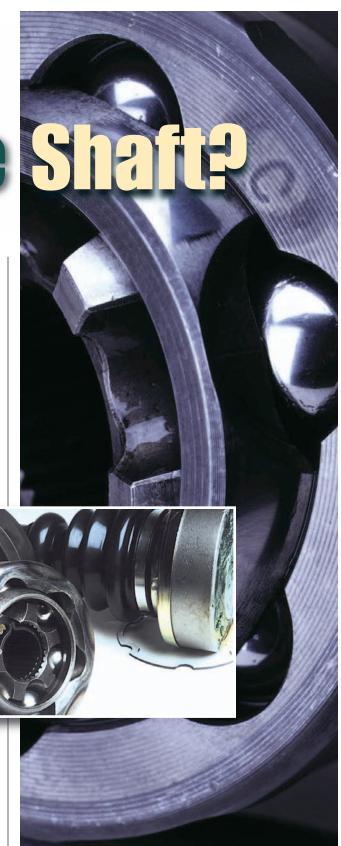
Both our Integra and Camry had the same problem, a split bellowsboot on the driver's side outer CV joint and just the beginnings of bearing wear. But we'd solve these identical problems in different ways.

replacing a boot alone, though, not with that kind of time on the car's clock, so we chose to replace one shaft entirely and replace one joint alone to compare the two jobs. There is, of course, the option of rebuilding the joint itself with the original races, but we passed on that one this time. Sometimes, of course, parts prices or availability decide the choices for you.

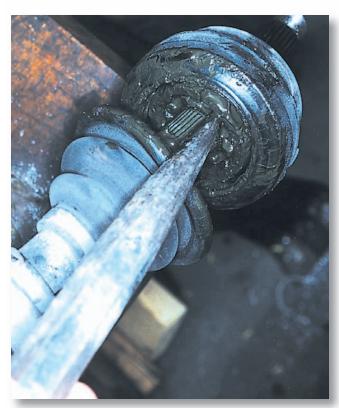
Since we were replacing the joint on the Integra, there was little reason to be particularly careful with the old internal races, tapping gently with a brass drift. Instead we just smacked it off quickly, being careful only of the splines on the shaft.

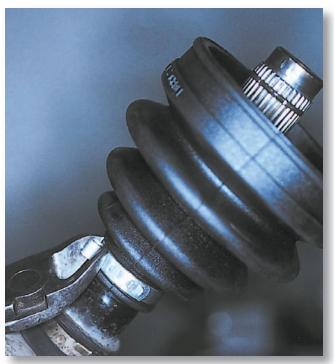
It wouldn't be a CV joint job without an envelope of special grease, squeezed, tamped and wiggled into all the passages of the balls and races. A new joint will be stiff when it's dry, $but\ once\ you\ lubricate\ it,\ the\ shafts\ should\ move\ smoothly.$

There are better tools for crimping the clamp than an anglesnip, but with some experience and care, it can do nearly as good a job. The thing to watch when clipping the bellows-boot closed is that there is no grease under the lip, or the clamp can slide off the boot in a tight turn.

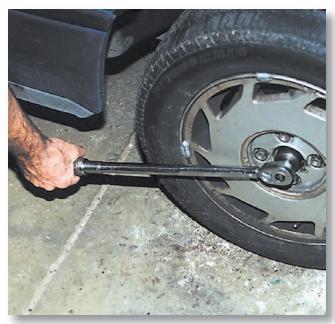
With the new shaft in the car and an assistant holding the wheel with the brake, tighten the axle nut to the shop manual's specifications. Don't guess and don't use an impact wrench for this job. Specifications vary considerably, and impact wrenches can destroy wheel bearings.

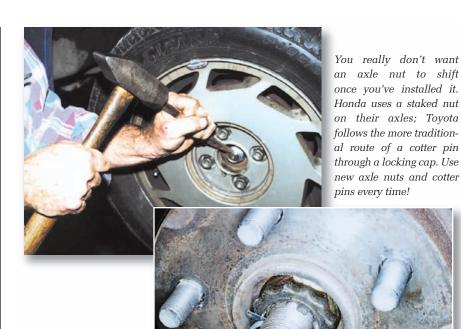
Jobs complete. The Toyota has a complete halfshaft; the Integra has a new outer joint. Different circumstances, including how busy the shop is and how available parts are, can point you toward one or the other way to complete this repair. While it's irritating to do, shopping around for parts availability can sometimes work to the benefit of both the shop and the customer, provided you find a way to keep your standards of quality at a high enough level. Presumably we could have found the prices reversed or lower if we'd just spent more time on the phone and less time under the cars.
