# Turn Up The Heat

## Summer 2000 A/C Report

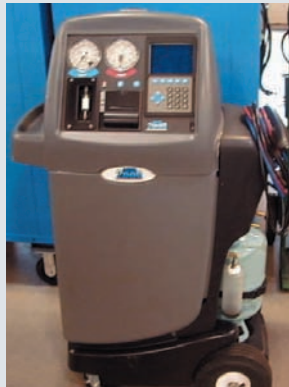
**Figure 7:** A clean machine is less likely to ingest dirt through the air intakes for its compressor (shown) and vacuum pump, and a clean machine performs better. So cover your A/C machine when it's not in use.

Want to get more use from your current A/C machine before you buy a new one? Then don't keep pressing the CONTINUE button (or bypass whatever tells you to change the filter), but maintain your machine. The simplest kind of all: Keep it clean and covered when you're not using it, so dirt doesn't accumulate and then get sucked in through the air intakes (Figure 7). Change your filters. Change the vacuum pump oil after each 10-15 hours of operation, so the pump can consistently pull a

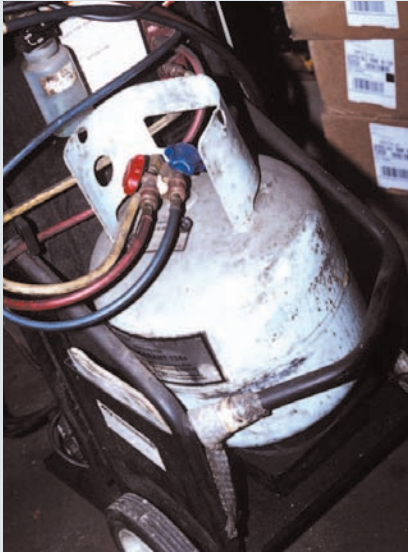
**Figure 9:** This tank was simply placed on the scale, but not in the retaining ring. The tank is tilted against the side and the scale cannot register accurately, so charging weight may be incorrect.

scale so your reading is accurate (Figures 8, 9), and call the equipment manufacturer to learn how to recalibrate it in your shop (often there is such a method, even if it isn't published in the operating manual).

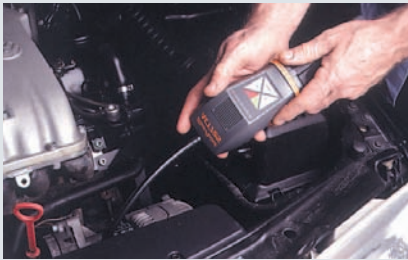
**Figure 10:** An R-12/R-134a-compatible conventional leak detector that meets the most recent leak detection standards is an acceptable substitute to find refrigerant leaks when trace dyes are not permitted by the manufacturer.

Toyota's U.S. tech people concede they would like to see a trace dye approved, but the hangups are in Japan, where the engineering work must be completed. And that hasn't happened yet. Until then, use an up-to-date conventional leak detector (**Figure 10**).

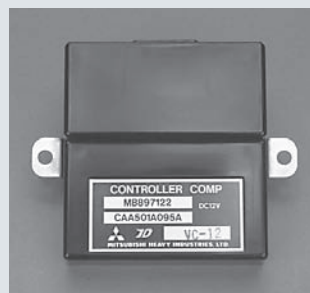
**Figure 12:** The belt lock controller is a separate electronic module as shown, or it may be part of the A/C module ("amplifier") on Japanese cars where the A/C compressor shares a drive belt with other accessories.

The BLC is an electronic module under the dash – **Figure 12** (or part of the A/C module – called the “amplifier”). It receives an A/C-on signal from the control head (or a pressure switch) and compares compressor rpm (sensor signal, **Figure 13**) with engine rpm. If it detects belt slip, the module should open the clutch circuit and trigger a blinking red light on the HVAC display (**Figures 14a and 14b**). Refer to the schematic in **Figure 15**. If the clutch doesn’t engage but the warning light also doesn’t flash, the engine idle doesn’t increase, etc., forget the BLC system: Your problem is elsewhere. But if the light flashes and the A/C clutch fails to engage or quickly disengages, you do know where to start.

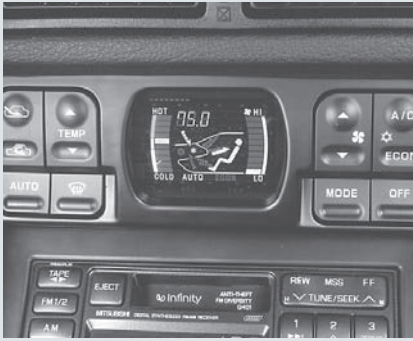
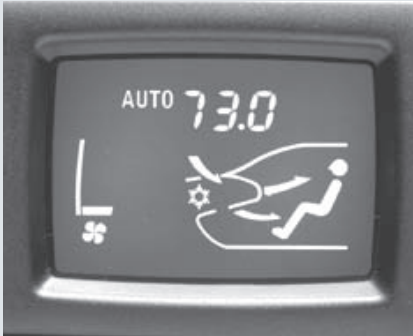
The warning light flashes when the belt-lock-controller circuit triggers. In this illustration above the light is in the car outline, and the outside air arrow points to it (14a). Warning light on the model below is a red snowflake (14b). On Mitsubishi Expo LRV, warning light may be at the underside of the dash, close to the steering column.

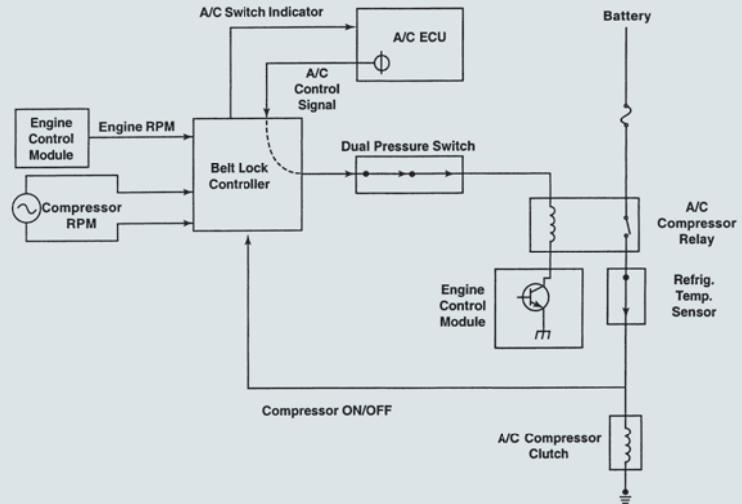
**Figure 15:** Representative circuit for a belt-lock-controller system. The BLC module gets an engine rpm signal from the engine control module, a compressor rpm signal from the compressor and two A/C-on signals, one from the A/C switch and another from the A/C module.

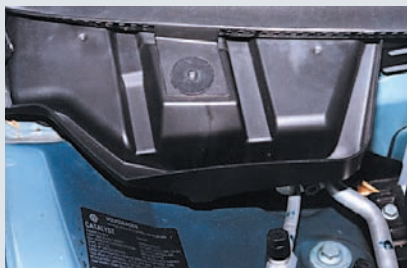
**Figure 17:** Plastic shield at the fresh air intake of a VW Passat. With an intake air screen above it (not shown) and this cover itself, you'd think the cabin air filter underneath was well isolated from anything but the finest airborne dust.

If the motorist complains about poor cooling, maybe the real problem is poor airflow because of accumulated debris. And on cars with no filter, that debris coats the moist evaporator face and provides an ideal breeding pen for malodorous fungus. Put your shop vacuum to work early and often (**Figures 17 and 18**). ■

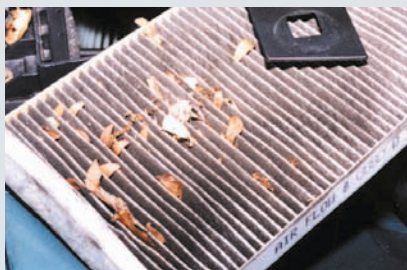
**Figure 18:** But when the plastic shield is removed and we pull out the filter, it shows a surprising amount of leaf debris after just a few thousand miles.
