# Coming Through *in the* Clutch

**A**fter an astonishing 184,000 miles, the original clutch on this one-owner 1987 BMW 325iS finally decided it had completed its tour of duty. The way it failed was curious, though. Instead of the typical symptoms of gradually slipping and losing engagement, the owner said the car developed a decided ‘crunch’ in the clutch pedal, followed by a loss of about 50 percent of pedal resistance. But even this change produced no clutch slippage, even during the additional 500 miles of driving before he finally brought the car in for a clutch replacement.

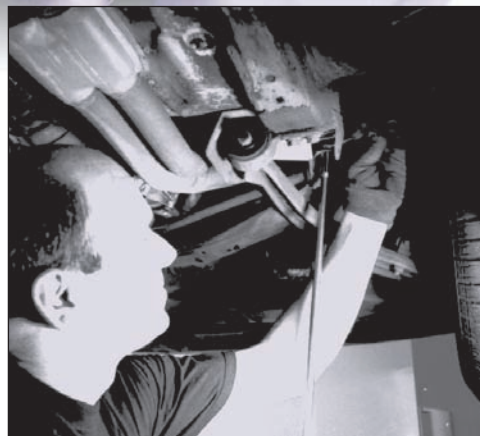
**Photo 1**

Working from front to back, loosen the swaybar subframe bushings to pivot it out of the way, then remove the lower bellhousing cover plate and bolts. Use a T-10 female Torx socket to remove these bolts.

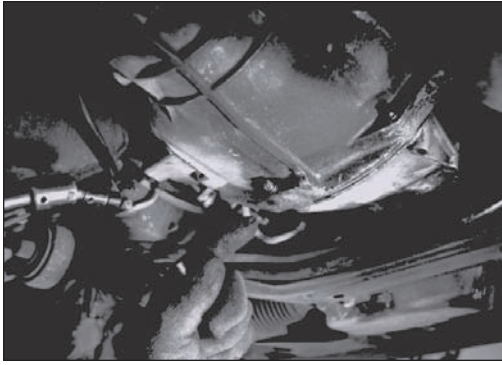
**Photo 2**

You can easily remove the bellhousing bolts with an air ratchet, a long extension, metric sockets and T-12 and T-14 female Torx sockets.

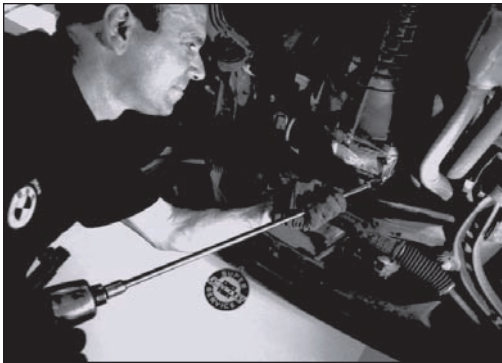
**Photo 3**

The starter motor bolts thread in from rear to front. While the lower bolt is reasonably accessible, the nut on the other side of the upper bolt is certainly not. To remove this upper bolt we used an impact gun, a long extension and a wobble socket until friction caught the nut just enough for the bolt to come out (more on this later).

Following the installation of the new pilot bearing, it’s time for reassembly, which, as they say, is ‘the reverse of disassembly’ — except for that one problem. Remember the upper starter motor bolt? Well now’s the time to deal with that, before the transmission is back in place. The problem is holding the nut in place on the forward side of the starter motor, since it is virtually impossible to touch after the transmission has been reinstalled.

Technicians have come up with some very innovative ways to solve this problem. The lead technician on this job used Super Glue to stick the nut in place. He did this while the transmission was still out by cleaning the transmission case, applying Super Glue to one side of the nut, holding it in place by hand and screwing the bolt into the nut while pulling rearward on the bolt until the glue set. Turning the bolt during the drying process helps assure that the bolt does not become glued to the nut. This procedure also assures that the nut will be properly aligned when the bolt is re-inserted — ever so gently so as not to dislodge the glued-in-place nut.

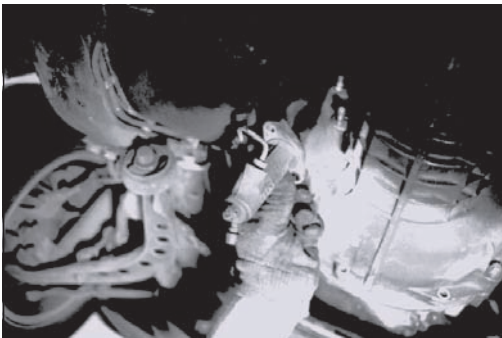
**Photo 4**

The clutch slave cylinder comes off after you remove the two mounting bolts. It is not necessary to remove the hose or otherwise open the clutch hydraulic circuit. As with any clutch replacement with a hydraulic clutch, it's a good idea to flush the system with fresh fluid just as insurance once you finish all the other work.

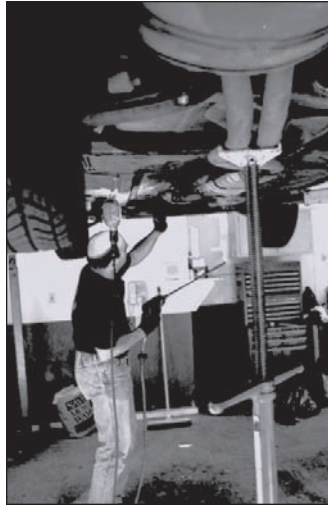
**Photo 5**

Some manuals call for removal of the entire exhaust system from the car. However, to save some time and effort it is possible to leave the front exhaust pipes connected to the manifolds and lower the rest of the system, supporting it at the rear.

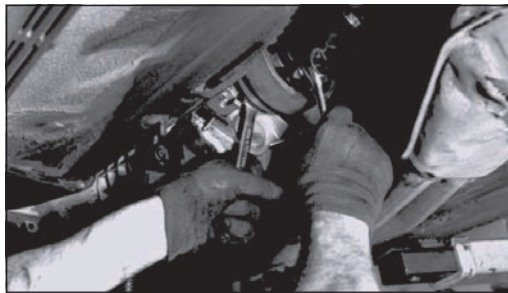
**Photo 6**

Once again, contrary to some manuals, you don't have to remove the driveshaft from the car completely. Remove the bolts holding the Hardy joint (a kind of harmonic balancer for the two-piece driveshaft) to the transmission output shaft flange (pay close attention to how it comes apart: There are several ways to reassemble it, but only one is correct!) It's a good idea to paint- or chalk-mark the components for proper reassembly alignment. Remove the bolts holding the center-support bearing to the floorpan. Then move the driveshaft off to the side to allow transmission removal.

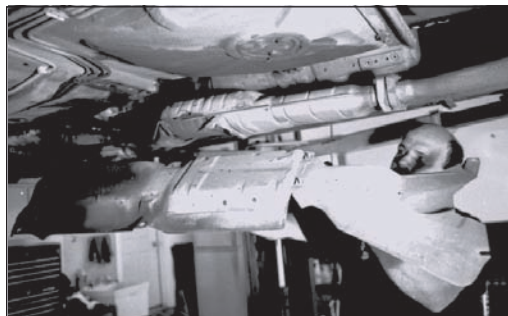
**Photo 7**

Remove the large underbody heatshield after unthreading its attaching bolts. With a little finesse, you can sneak it out between the underbody and the now-lowered exhaust.

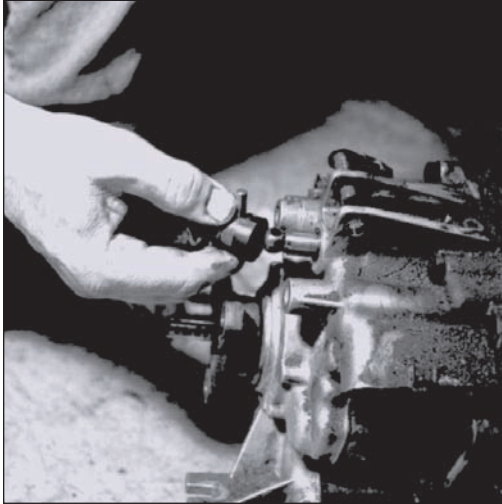
**Photo 8**

Disconnect the shifter from its shaft by removing the retaining bolt, clevis pin and clip. That's pretty easy. The forward shifter mount is an entirely different, and sadder story, however.

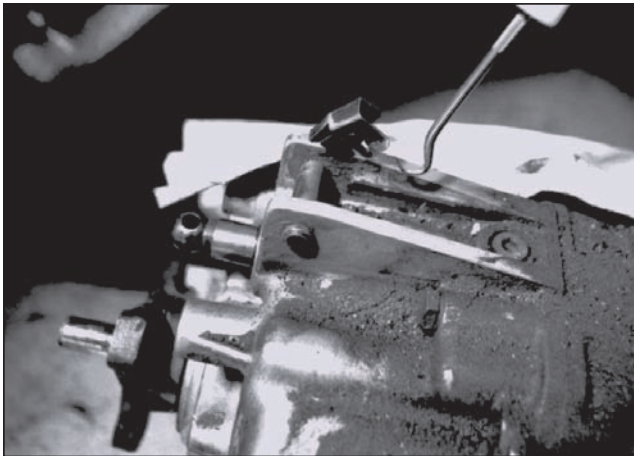
**Photo 9**

The forward shifter mount is attached to the top of the transmission by a clevis pin held in place by a flat U-shaped spring clip with a retaining tang. It is impossible to see this clip from any angle under the car, and very difficult even to touch! As shown in this photo taken after the transmission was out of the car, the trick is to use a cotter-pin puller or other hooked tool to catch under the edge of the clip, pulling upward and outward to dislodge the tang and remove the clip. This is surely the trickiest part of this entire clutch replacement job.

Although the forward shifter mount spring clip can’t be reinstalled while the transmission is removed, its reinstallation does not require any special tools or heroics. You’ll still be working blind, but the clip returns to its proper place much more willingly than it vacated it.

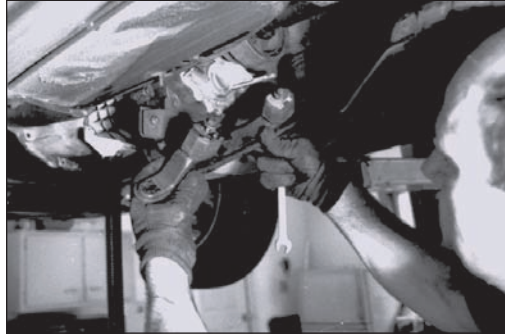
**Photo 10**

After supporting the transmission extension housing with an axle jack, remove the transmission cross-member from the car. Then with the driveshaft, exhaust system and other bits and pieces held out of the way, lift the transmission back and out, and you can unbolt and remove the clutch pressure plate.

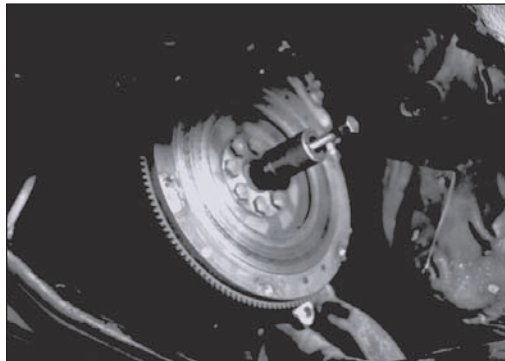
**Photo 11**

Examine the flywheel to determine whether you'll have to resurface or replace it. In our case, the owner had been gentle on the clutch (as we could have guessed from the 184,000 miles on the odometer), so the flywheel only needed to be scuffed with emery cloth and cleaned with brake parts cleaner. To replace the pilot bearing, you'll need a special puller like the one shown here.

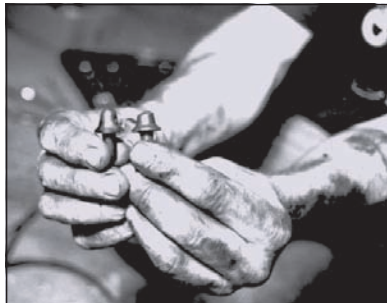
**Photo 12**

Carefully inspect the clutch release fork, especially at the bearing contact points and where the slave cylinder pushrod contacts it; replace it if necessary. Also examine the fork pivot and replace that if needed, using a hammer and drift. Note the worn pivot on the right compared with the new one on the left.

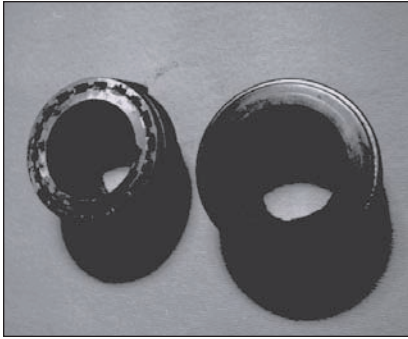
**Photo 13**

While replacement of the throw-out bearing is routine, it is interesting to note the wear pattern on the bearing we just removed. Because of the unusually high number of clutch applications over the course of those 184,000 miles, the clutch diaphragm fingers actually wore notches into the bearing contact surface. The result was a kind of ‘spline-effect’ in which the diaphragm fingers ‘indexed’ into these notches each time the driver pushed the clutch pedal.

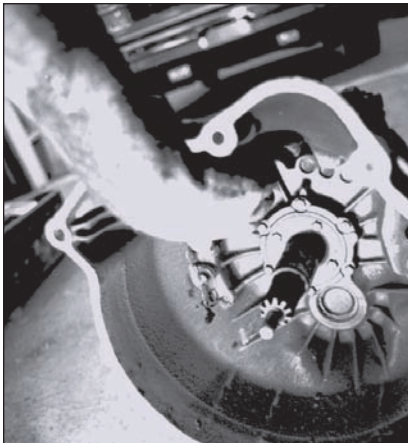
**Photo 14**

Having the transmission out of the car affords the chance to easily and inexpensively replace the front and rear transmission seals as well as the tiny shifter shaft seal and to change the trans lube. Especially on high-mileage cars, it’s a prudent idea to install new shifter bushings to eliminate freeplay and rattles in the gearshift linkage.

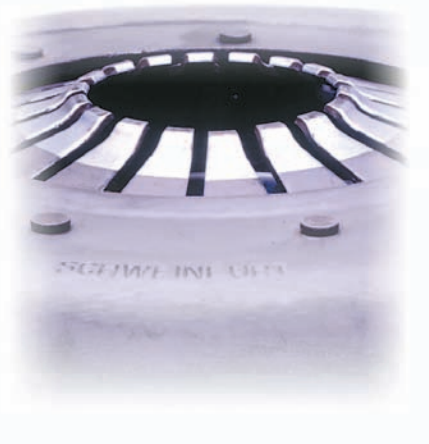
If you look closely, the crack in the pressure plate spring that triggered this clutch job is clearly visible. This was the source of the odd pedal pressure change we felt at the beginning. For the want of a nail....

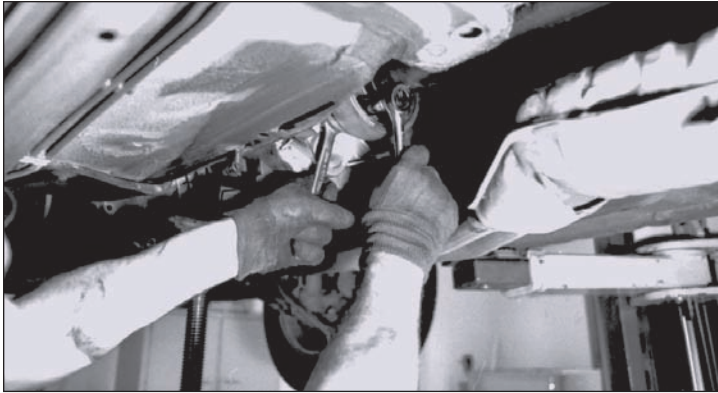
**Photo 15**

When reinstalling the driveshaft, it's very important to reassemble the Hardy joint properly. The large metal cup goes between the driveshaft and the rear transmission flange, with the cupped (concave) end pointing rearward. Also, it is possible to install the joint in the wrong 'clock' position, which will result in substantial vibration. Before disassembly we marked small arrows pointing in the direction the bolts should point in their respective holes. These marks assured proper reassembly.

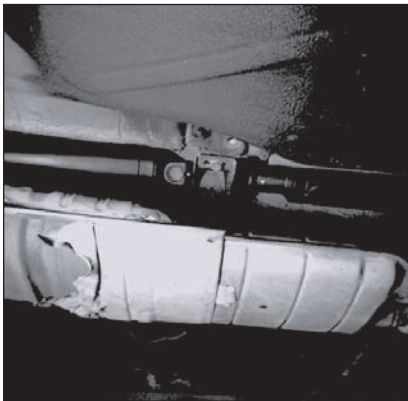
**Photo 16**

If you had occasion to separate the two halves of the driveshaft for any reason, match up the white alignment marks on each of the two pieces again to avoid vibrations. Judging by the condition of the lower exhaust heat shield, the owner has done some 'agricultural touring' a time or two.

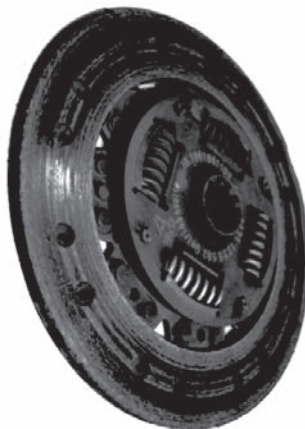
**Photo 18**

The original clutch disc was in much better shape than the plate. It might have lasted for a quarter million miles if the pressure plate had held up its end of the bargain.
