Off the Hook

Engine Transplants for Fun and Profit

Transplant Inspection

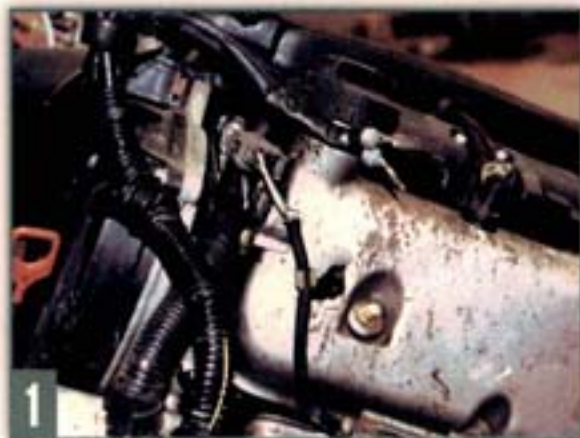
The first and most obvious problem with this donor engine was the hole bashed in the left valve cover (**Photo 1**). A closer look at the wiring harness on the engine showed part of it crushed, so I had to open the harness and inspect for cut wires, crushed connectors, etc. Two male terminals without a connector to tie them together needed repair. If the rest of the harness is okay, just stealing the matching connector off the departed engine will be all you need to restore an OE connection.

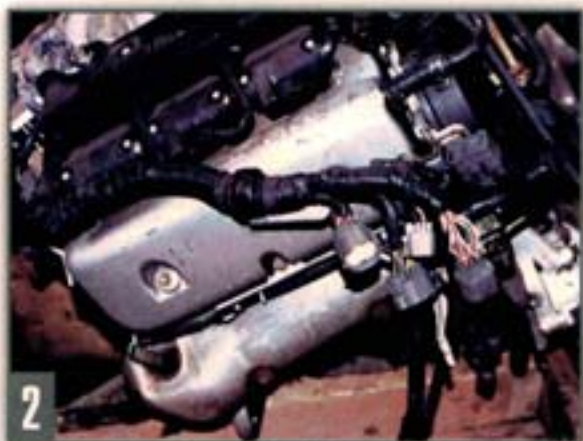
More inspection reveals visually good O2 sensors. The rest of the wire harness seems to match what's on the car. The crank pulley doesn't have a big chunk out of it or a belt-pinching dent. Other than the hole in the driver's side valve cover noted in the previous photo, this seems to be a suitable replacement.

Look at every inch of the wire harness if one comes with the used donor engine. **Photo 2** shows the four connectors at the right rear of the engine. Make sure all connectors on the donor engine and in the engine compartment match, pin-for-pin, before you start the transplant. Make sure there are the same number and type of connectors on both harnesses: the old and the replacement. You don't want to swap or modify a wire harness once you have committed the donor to the engine compartment. Check it now to save yourself a headache later. Most engine transplant jobs are close economic calls for the car owner, so identify every problem you can up front. You can bill more easily for extra work if you spot it early, before you finalize the estimate. Your customer will start with a much more realistic picture of the expenses he's about to incur.

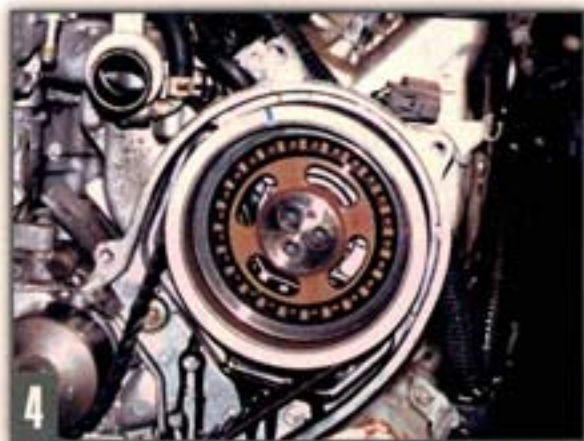
Position the crankshaft at #1 TDC before starting on your water pump replacement. The single white mark on the crank pulley lines up with the pointer on the lower cover. The marks on the cam gears line up with their corresponding marks on the rear cam gear covers. Take the three bolts out of the left-side cam sprocket before you remove the old timing belt. (**Photo 4**).

Always take the bolts out of the cam sprocket before removing the timing belt when replacing the water pump. You need the belt on to keep the pulley from turning, even when using an impact wrench to remove the bolts. The black slime from the sensors is normal, so don't sweat it, but the green crust below the lower left water pump bolt isn't. There's not much sense sending an engine out the door unless it's capable of going another 90,000 miles. Convince the owner to replace the water pump and timing belt.

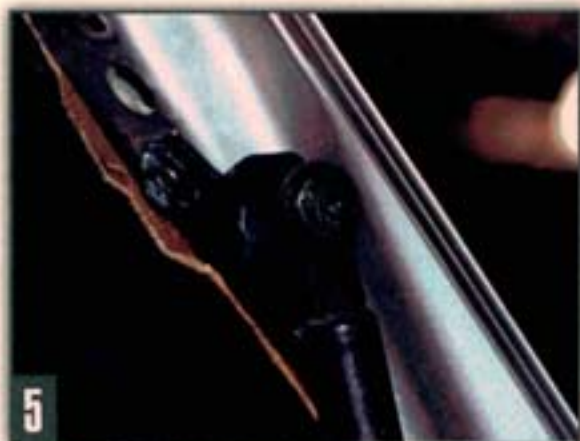
5
All we need is a little more space, right? Removing the bolts from the hood struts and repositioning them will give you a lot more room for that cherry-picker arm.

- Remove the bolts holding the hood struts to the hood, then open the hood a little farther and reattach the hood struts using the upper strut holes to locate the lower mount holes in the hood. **(Photo 5)** This is a one-man operation that will give you just a little more clearance for your cherry picker. Leaving the hood attached to the vehicle also keeps it out of harm's way during the engine swap.

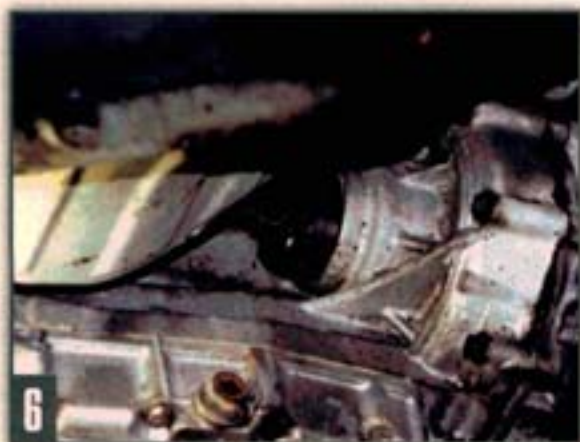
6
The extension shaft that couples the trans output to the diff must slide to the rear. There is an 8 mm hole threaded into the extension shaft just for this purpose. Remove the cover (it looks like an axle nut cover) by popping it off with a screwdriver. Then use your 1/2-inch breaker bar to unscrew this plug. With the plug out, you can see the extension shaft and its threaded hole. You really don't need the OE special tool, but your Acura dealer can get it for you if you run into a stubborn one.

- Drain the differential, engine oil pan and radiator. Remove the oil filter so the oil in it can't leak out the holes the connecting rods made.
- **Photo 6** details removal of the extension shaft. The extension shaft links the transmission final drive to the differential pinion gear. Since the diff stays on the engine until the whole combination is out of the car, we need to slide the extension shaft out of mesh with the pinion gear. Acura makes a special tool for this, but an 8 mm bolt with a nut threaded onto it and a large enough washer to span the output collar can pull the extension shaft out of the coupler (towards the rear of the car). Install the nut several threads onto the bolt, then the large washer, then thread this into the 8 mm hole in the center of the extension shaft. Now tighten the nut down against the washer to pull the extension shaft out of the pinion.

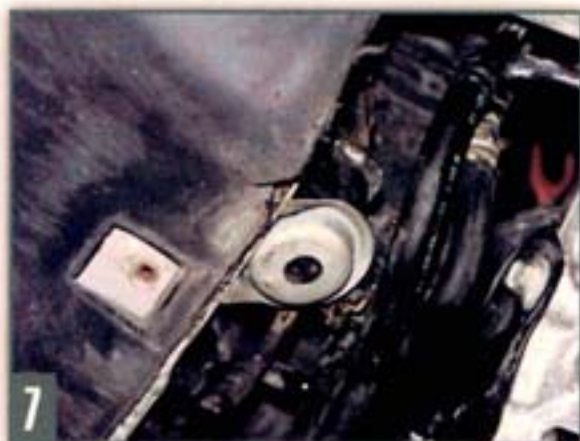
Remove the long ATF cooler hose from the radiator at the steel line, not at the radiator. Remove the short hose at the radiator. Take the long hose, loop it back to the radiator where the short hose came from, and loop the short hose back to the line on the frame. This keeps ATF drips to a minimum, and the job stays a little neater. We're changing an engine here, not a PCV valve. Anything to keep the floor mess to a minimum...

- Remove the radiator, fans and upper and lower hoses in one piece.
- **Photo 7** shows where the transmission oil cooler lines run from the pipes to the radiator. Disconnect the long cooler hose at the pipe and the short one at the radiator, then loop the short hose back to the pipe the long hose came from and then loop the long hose back to the radiator fitting you just opened. This keeps transmission oil much more contained. If you were to send a radiator out for repair, doing this and also looping the lower radiator hose from the lower engine fitting to the upper engine fitting, along with tying wires out of harm's way, could allow you to drive rather than push the vehicle out of the shop while you wait for the radiator to be repaired, albeit only a very short distance sans coolant.

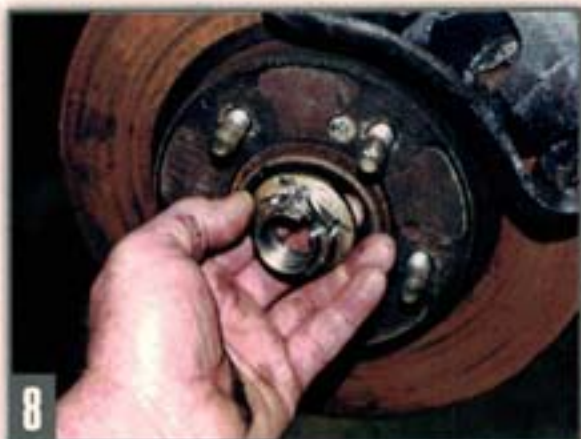
Neither axle nut would come off with my 1/2-inch impact, so I escalated to my 3/4-inch gun. Well, that didn't blow them off, either, so I swiped my neighbor's 1/2-inch air hose (the 3/8-inch hose at my workstation is usually more than adequate). With more air volume, the big gun nuked the right axle nut off without a struggle, but the left side still would not budge.

I knew there'd be a big surprise - there always is - but I didn't know what it would be. This was it: That driver's side axle nut would not come off! After escalating through my whole pneumatic tool arsenal without effect, I decided to cut the nut off. It actually went pretty fast. I used my angle cut-off tool with a carbide wheel, cutting as close to the axle as I could. Once I cut all the way to the hub, I used my impact hammer to walk the nut off. This worked much better than I envisioned. (If you're just starting out as a tech, and you can't picture these things working out for you, find another line of work. Really!)

Don't mess around here. Extended hammering with an airwrench can brinnell the wheel bearings. The only thing to do is cut the axle nut off. Use a 90 degree cut-off tool to cut a groove in the nut perpendicular to the hub as close to the threads of the axle as you can. (**Photo 8**, page 16).

The tips of a few of the axle threads were cut, but not enough to weaken the assembly. Cut through the nut until you just start to touch the hub flange. Once the nut is weakened by the cut, use a pointed airhammer bit against the groove in the nut to walk the nut off. Drive against the larger circumference of the nut, not the smaller, inner surface.

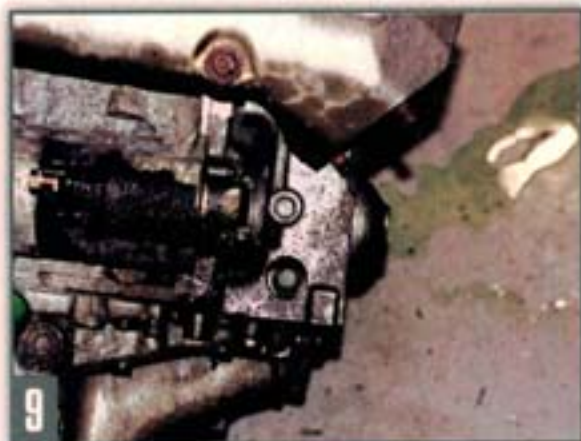
Remember I said this engine inhaled a thunderstorm last year? Some nearby water submerged the engine block at least up to and over the starter motor. Three or four dissimilar metals, road salt, lots of water and furry corrosion changed the snug fit between the starter and the back of the block casting into an interference fit. Even with the bolts out, that starter was going nowhere.

Getting the starter off the old engine was not what I expected either. That sucker was locked in there with Nature's Own thread-locker. I gently tapped on the starter on the 'silver' end, toward the block, then used a big prybar to rock it back, meanwhile spraying penetrating oil around the rusted corrosion until the starter finally worked free. Don't just whale away at the drive end. Of course, if you smash the starter to pieces, a new unit will go into the donor engine very nicely I'm sure.

I tapped the starter upward from the bottom, right above the green connector (Photo 9), and then I put a prybar between the starter and the block to wedge it back and forth. I kept up the tap-and-pry, with penetrating oil applied as needed until the starter came free. Don't try to drive it forward by beating on the back of the starter.

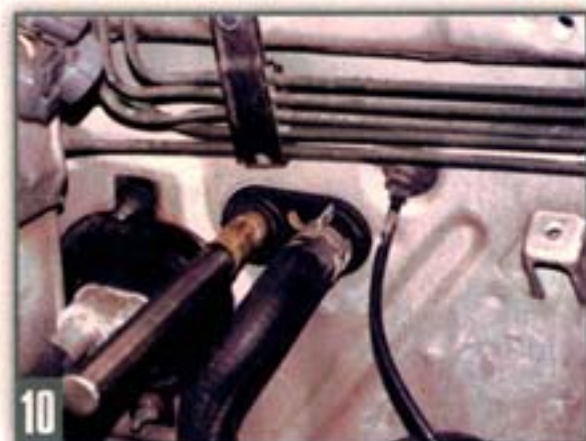
This is embarrassing but at least it's real-world. Crushing heater hosepipes isn't the smartest thing to do, and cleaning them up takes a little finesse. Gently walk a drift around the opening or you can even use a pliers to squeeze the pipe against the drift. Don't whack the drift into the heater core. Notice the vacant holes on the firewall to the right and above the heater core. Take everything out of the way.

Um..., I don't have any idea how that heater core pipe got itself crushed when the heater hose was removed (Photo 10). A few minutes with a punch, drift, socket or whatever you have work wonders to make it round again. Gently roll the punch in the pipe, working the brass back into shape. Don't just jam something in there and certainly don't hammer on it because the brass is delicate. If need be, use a pliers to squeeze the damaged pipe against the tool. When you reassemble something like this, install the hose clamp close to the flanged outer end of the pipe where it's the roundest.

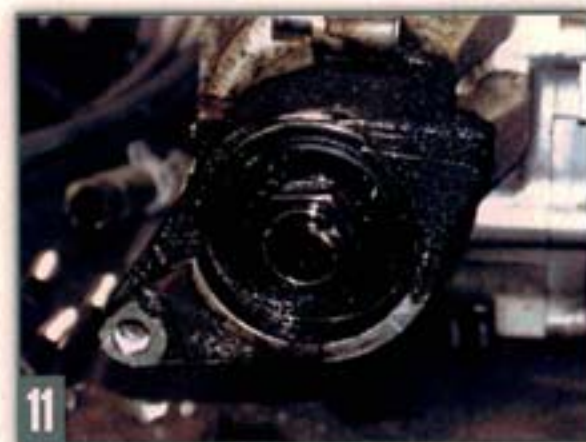
The pinion seal on this diff is a gooey mess. Changing it now takes just a little extra time. Be prepared to deal with unexpected, extra things like this along the way. When you quote estimates to your customer based on the 'been-there/done-that' perspective, rather than from a 'best-guess/rosey-scenario' approach, things can look very different. But the surprises will be minimal.

There was more than just engine oil under the front of the car. Diff fluid dribbled from the right end of the power steering rack, originating at the differential pinion seal (**Photo 11**). Changing diffs on these cars is a piece of cake, though. Take the three bolts off the flange on the driver's side of the oilpan, slide out the midshaft, then unbolt and remove the diff from the right side of the engine. Pop the old seal out; install the new one flush or just a tad into the recess, but no more than 1 mm below it. Replace the O-rings on the midshaft tube, and it should be leak-free.

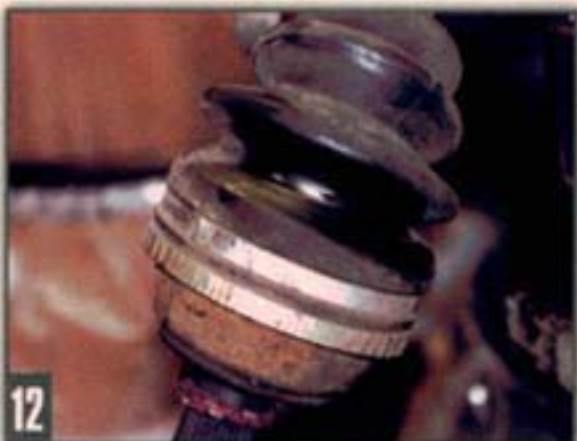
There is a seemingly harmless cut on this outboard CV boot, but it's by no means cosmetic. When a Legend boot does this, replace it. Not next summer, not next fall. Now.

Photo 12 shows a small cut on the right side outer CV boot. This is not a 'wait-and-see' cut — this boot should be replaced right now. You can save the customer some R&R money because you had to take the axles out already. I didn't spot this until I had the axle nuts free and lots of other things out of the way. Oh, well, you can't see everything at once.

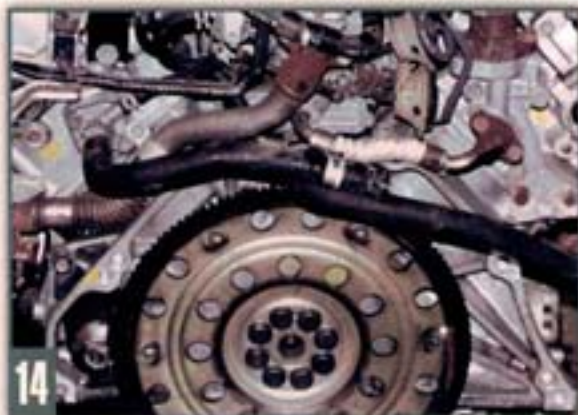
Take a very critical look at the back of the donor engine before you install it. After all, in a way, you're buying it, too - with your work that you may have to repeat if you miss something. Make sure nothing's bent or broken, and the pipes are all there and straight. EGR valves are particularly susceptible to damage during the transportation and inventory process. Don't overlook oil seals that might have begun to leak.

The rear of the donor engine appears ready to go (Photo 14). No leaks from the rear cam plugs; the piping is all there; nothing looks bent or broken; the heater hoses are all attached. You may wish to connect the driver's side rear heater hose after installing the engine. I think that may work better. It just came out easier this way.

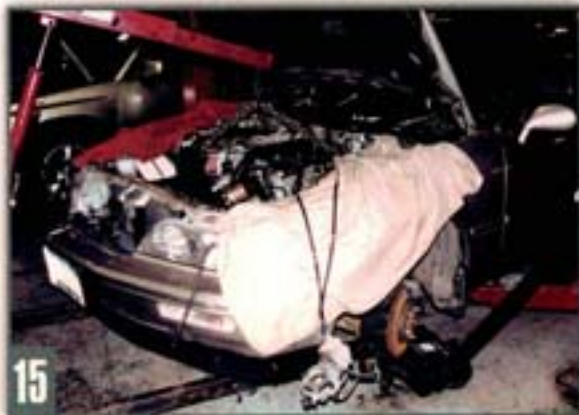
Place a jack under the trans pan to raise the front of the transmission to meet the engine as it's being lowered into place (Photo 15). This is where my 246 lb. chassis comes in handy. This engine needed some particularly delicate persuasion before it finally found home. Sometimes your best guess on the angle of the chain when you attach it to the engine is all you have to go on. At worst, you have to determine why things aren't lining up if you're having problems, then pull the engine back out and readjust your chain. That can be tough, especially after several attempts. I was getting

Raise the front of the transmission as you lower the engine into position. The throttle body and cables hanging over the driver's fender from the old engine looked much better than the ones on donor engine. If you're doing belts, a water pump, or anything like that, get the throttle body out of the way. It's very easy to remove.

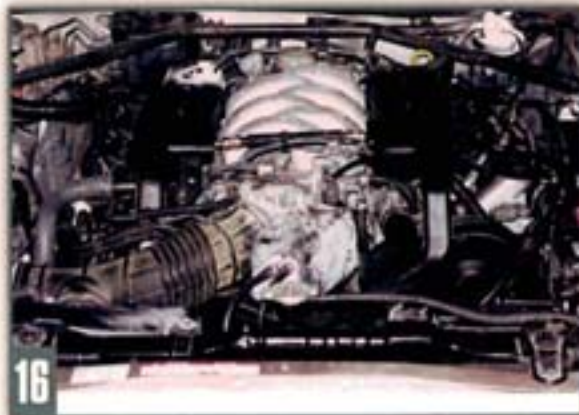
Somewhere after I got three bolts in the bell housing, I stopped what I was doing and cleaned the floor. I was so fed up sliding around in my own slime of gear oil, ATF and antifreeze that I could not continue. Take a last look around to make sure every nut, clamp, fastener and component is where it ought to be and tight. Make sure the fuel system is leak-free as well as the coolant and oil systems. This engine sounded pretty sweet after running at 2500 rpm for several seconds to quiet the lifters down. In spite of all my precautions, I wasn't completely surprised when I noticed the A/C compressor clutch bearing was howling away. Sometimes it's never over!

Everything is bolted on in Photo 16. The diff, cooling system, engine, power steering, trans, coolant overflow and washer jug are filled with their correct fluids. Fuel lines are tight and coated with leak-peek trace powder. Don't start that mill until you're sure it's ready to drive to California. In other words, don't just crank it up for a minute to see whether it runs. Make sure the exhaust, air filter - everything - is fully assembled and complete. ■
