...TO CORRECT SPARK TIMING!

A search of the service bulletins answered the question: There are three different positions you can bolt the ring gear to the flexplate. Two of them are wrong; one is right. Each of the wrong ones throws the crankshaft position signal 120 degrees out of place in opposite directions. Amazingly, the computer can make enough of a correction to the spark timing that the engine can still run. Service Bulletin 03/41, 15/35 spells this out with the warning, "When installing the ring gear and flexplates, care should be taken that the locating bores are aligned with one another. If, for example, the locating bores are offset by 120 degrees then the segments... on the ring gear will also be offset by 120 degrees with reference to the crankshaft. This will cause the crankshaft position sensor... to generate its signal at the wrong time and the electronic ignition control unit to compute the ignition timing incorrectly." OK, there's no easy way to correct this but to take the transmission back out, unbolt the flexplate, rebolt the ring gear in the right configuration and put everything back together.

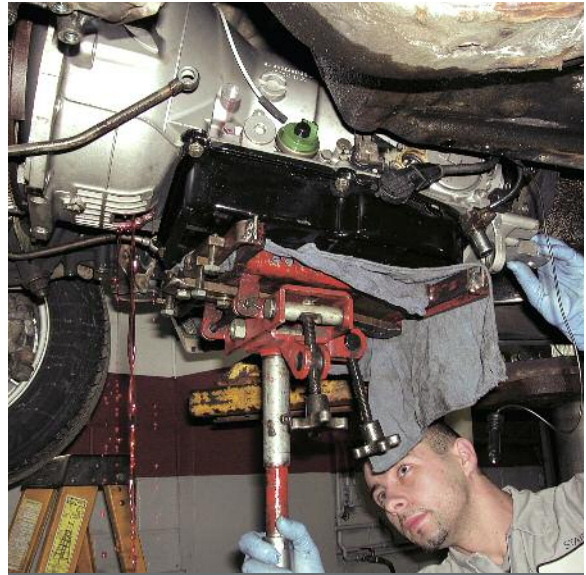
Drain the transmission both from the pan plug and (for most Mercedes-Benz vehicles) from a plug in the torque converter. Since this trans R&R was not chasing a trans problem but correcting a spark problem, the technician drained out only the minimum to keep the floor dry.

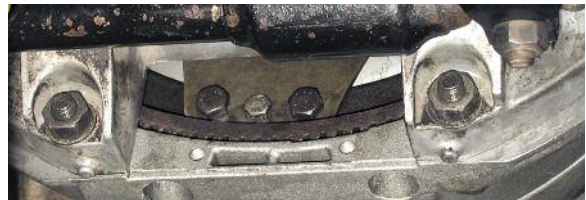
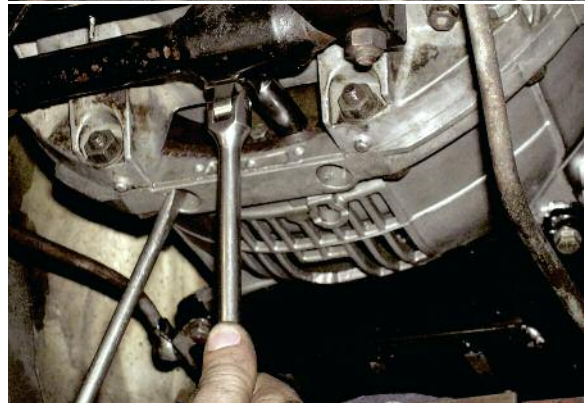
There are three sets of three hex heads as you rotate the flexplate. To unbolt the torque converter from the driveplate, loosen only the outer two bolts in each set. The inner bolts hold the ring gear to the flexplate. Be careful when rotating the flexplate to only turn in the normal direction of engine rotation, to protect the valve timing components of the engine.

Turning the ring gear clockwise from the front of the car, remove the two torque converter bolts from each of the three segments of the flexplate. Leave the center bolt for later; that holds the ring gear to the flexplate. Then being sure the engine will not pivot (a wooden wedge placed between the engine oil pan and the crossmember will work well), remove the exhaust system from the manifold to the tailpipe. If you can get this out as a unit, you can save some work, but you'll need an assistant. Remove the exhaust hangers as well; you'll need the clearance.

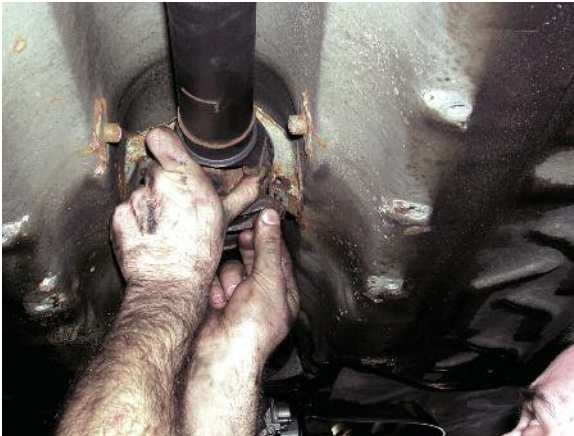
Match-mark the driveshaft and the transmission/differential flanges so you can insure the same balance as before. Make sure the center bearing is fully seated when you come to reinstall the driveshaft.

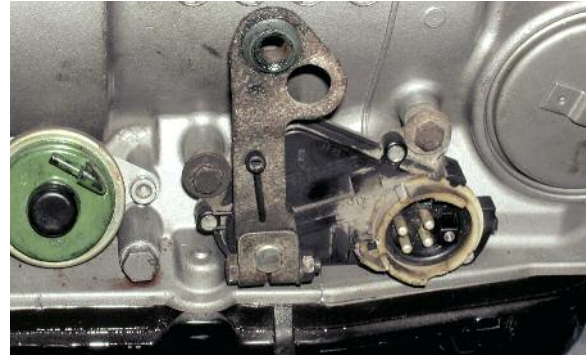
The neutral safety switch unplugs after it's unlocked. Plastic bushings at either end of the shift rod can be replaced to snug the feel of the shift lever.

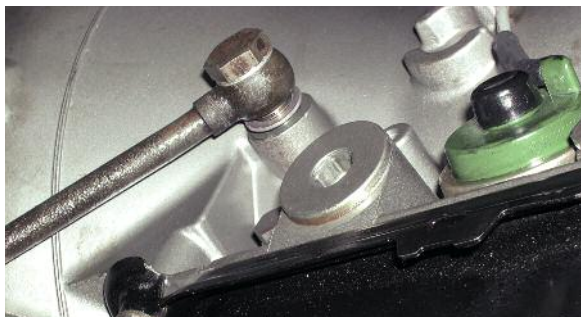
The transmission cooling system must work properly for satisfactory transmission life. Be sure to check that it is open from one end to the other and does not leak.

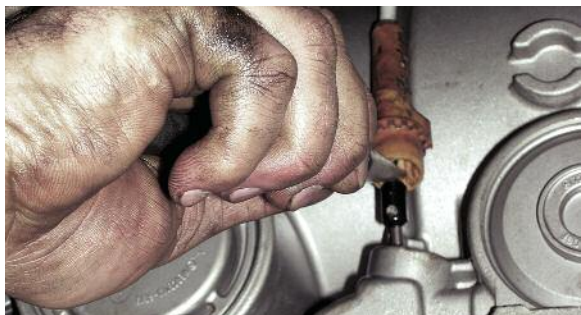
Don't forget to release the control pressure cable. This control often requires readjustment once the cable is released from the transmission and (at the other end) the throttle linkage.

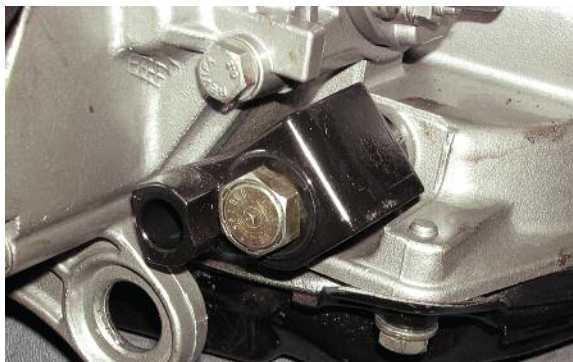
The electrical connector to the kickdown solenoid attaches at the right rear of the transmission. Disconnect it likewise and suspend the harness out of the way.

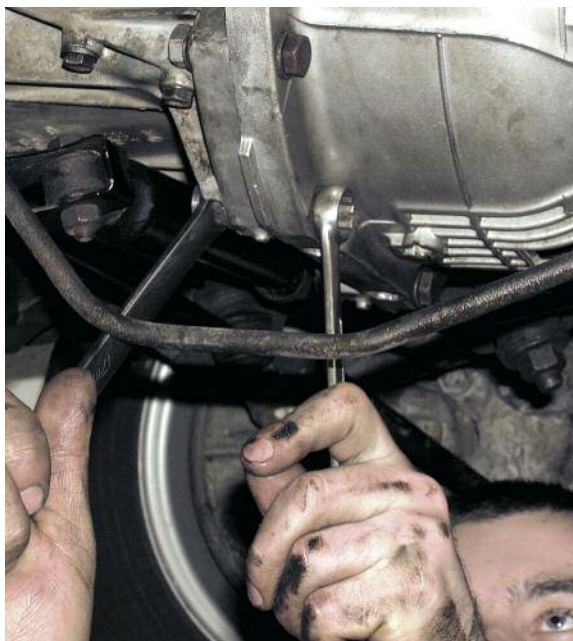
Remove the lower bellhousing bolts and nuts first. The transmission can probably hang from the upper ones, maybe not from the lower.

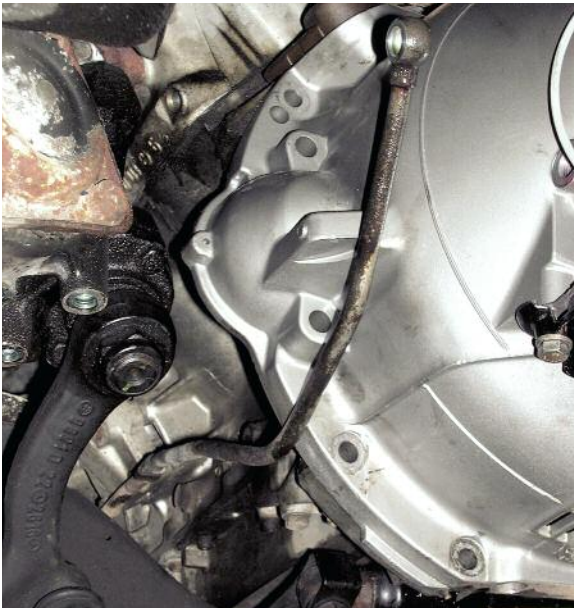
Next, unbolt the right and left side bellhousing bolts, with the transmission jack securely supporting the weight under the transmission pan.

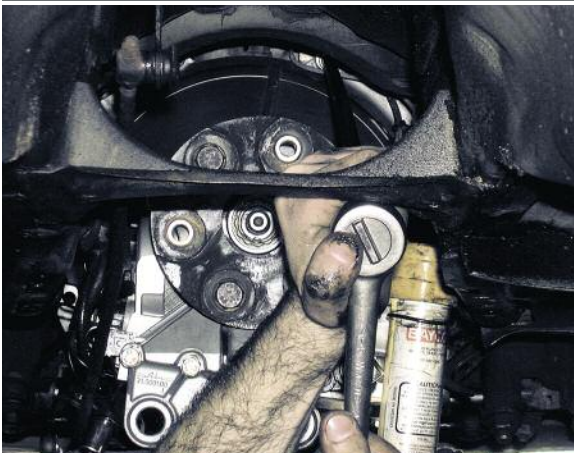
Finally, with the transmission on the jack, loosen the uppermost bellhousing bolts, checking for safety. When you're confident nothing will fall or slip, remove the last bolts.

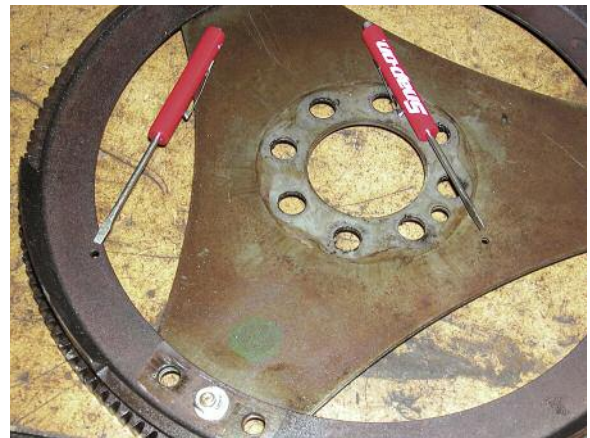
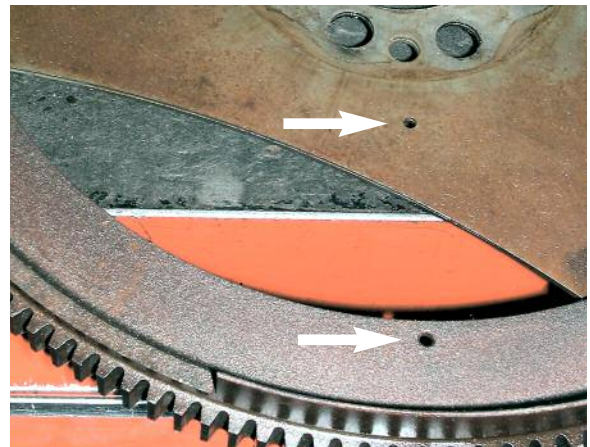
With the flexplate and ring gear on the bench, the misalignment is clear enough. You simply remove the bolts and nuts fixing them together, reposition them in the correct alignment and retorque the bolts. Would have been quick work before, eh?

Hardly seems like a big deal, but it certainly did to the ignition computer. With the ring gear in the wrong clock position (screwdriver tips), timing was off by 120 degrees. The computer could make some correction, enough to get the engine running, but not enough to produce normal power. With the position corrected, the computer would know which cylinder was where.

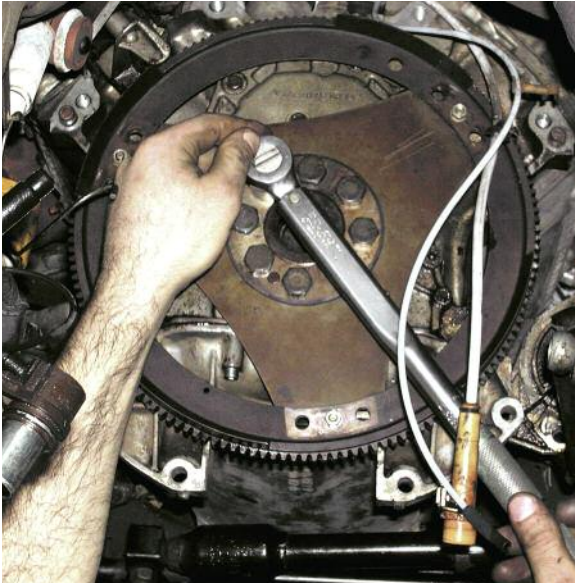
Torque each of the flexplate bolts (including those holding the ring gear!) in a starburst sequence, going around at least a second time to confirm that the stiffener plate and flexplate are bottomed against the crankshaft.

When putting things back together, there are a few heads-up points. Torque the flexplate and the ring gear attachment fasteners, with a torque wrench. While the specifications don't require it, many shops also use a threadlocker on each of these fasteners because of their importance in the drivetrain. If you don't torque them correctly, count taking this transmission out again, this time to replace the cracked flexplate. The same is true for the through-bolts to the torque converter.

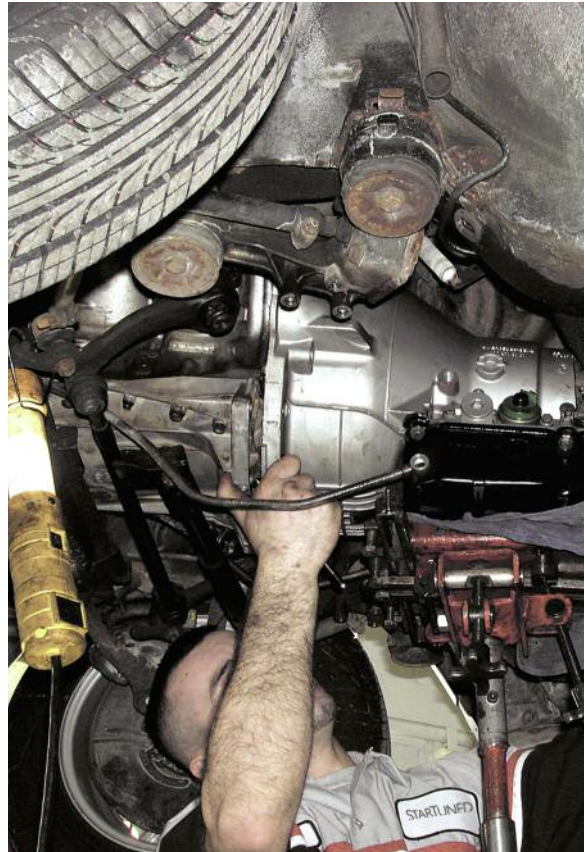
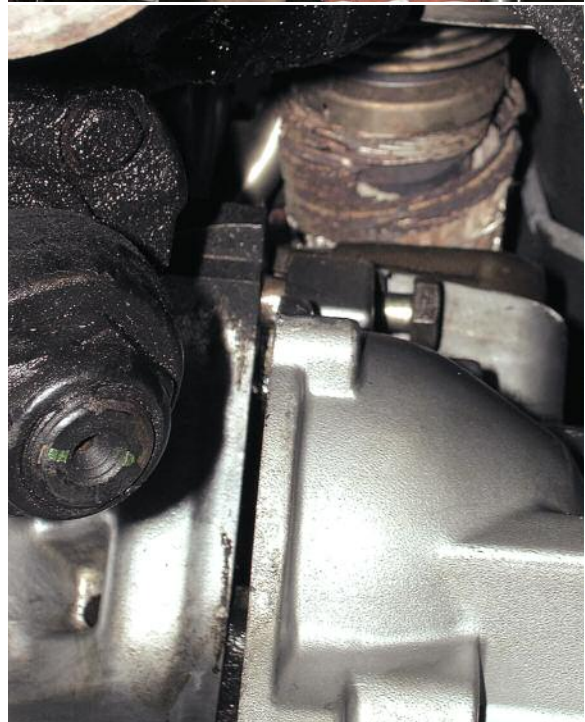
The fit between the engine, specifically the crankshaft centerline and the transmission input shaft centerline is very precise. Locator dowels on either side of the bellhousing insure accuracy of the lineup.

As you're lifting the transmission back into position against the engine, the tricky part comes with the locator dowels on either side of the bellhousing. These are quite the snug fit and must be correctly lined up before you can slide the transmission into place. If they are missing or removed, you'll probably find a cracked flexplate fairly soon. Of course, the torque converter must also be properly bottomed in the pump recess.
