We've all seen it: Rotors down to throw-away thickness at relatively low mileage. Why it happens, what you can do to mitigate it, how it's related to pedal pulsation, and why you should buy O.E. Also, a profoundly basic trend that flies in the face of traditional auto service practices

Brake Assist Can Stop in 45% Less Distance

Mercedes-Benz Brake Safety Landmarks

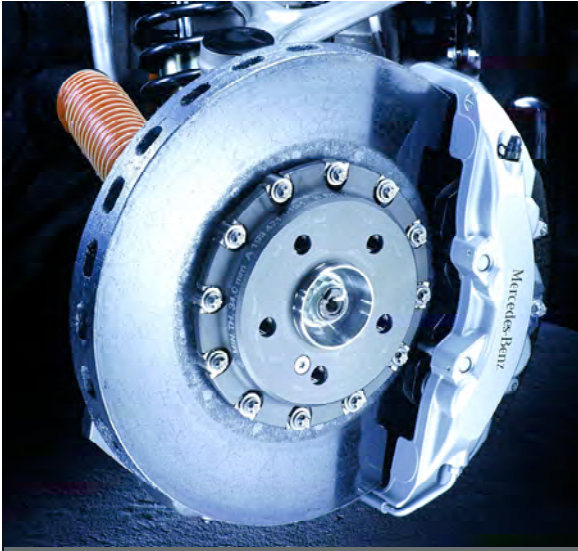
This is the kind of super high-performance brake you'll be seeing from Mercedes-Benz in the future. You won't be putting that futuristic rotor on your nasty old lathe, will you?

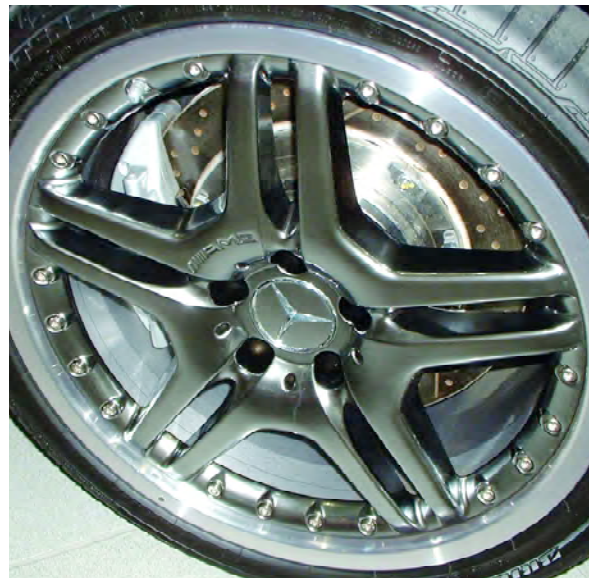
It would be foolish to use outmoded service procedures on something as highly-evolved as this AMG disc brake and wheel assembly. Your policy should be quality and careful craftsmanship above all other considerations.

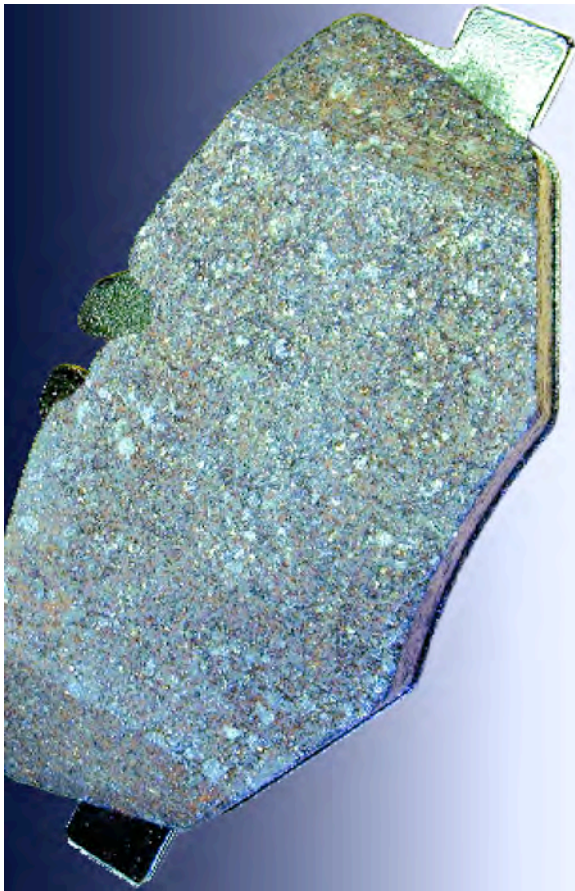
Friction materials have evolved to the point that they're far superior to early semi-mets. This M-B O.E. recipe is the ultimate combination of performance, noise reduction and good wear characteristics.

So, we got semi mets. Initially, these were steel wool, iron powder, and other metal particles molded together with a phenolic resin binder, which handled heat well, and in most cases gave quite long service. Early semi met recipes, however, had big problems with noise and tended to eat rotors. But today's formulas, especially those so painstakingly researched by Mercedes-Benz engineers, are vastly improved in every aspect. To achieve high-performance braking, the friction material and the metallurgy of the disc must be matched to the application. The trick is in balancing lining and rotor wear against stopping power and pedal feel, and compromises come at the expense of wear, which is just as it should be. Still, there's no denying that modern friction materials do take a toll of discs more severe than asbestos would.

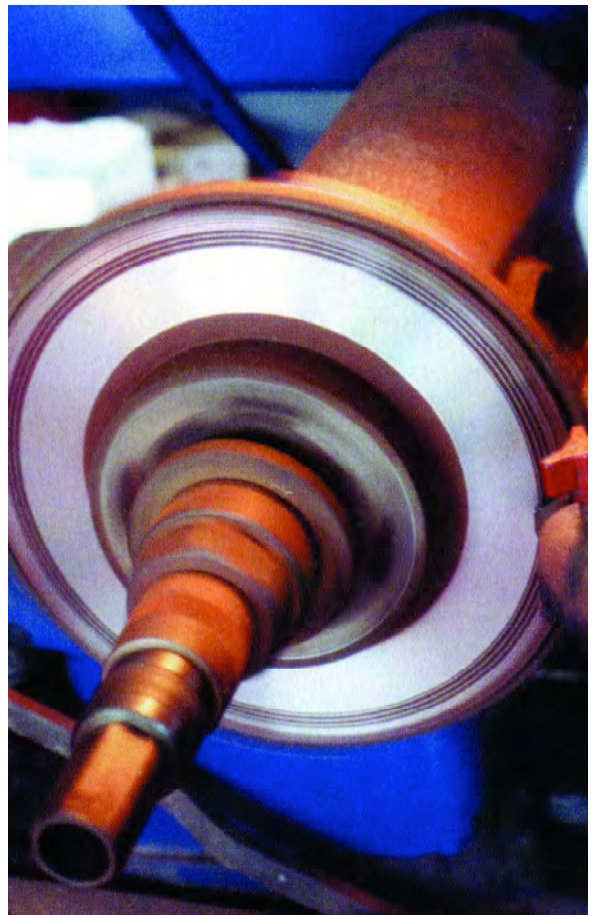
Not that many years ago, every shop in the galaxy turned rotors as S.O.P. at reline. Not anymore. As one M-B service manager says, "Our brake lathe went into the trash." Replacement is becoming the rule.

Guess what? None of that matters anymore – you can just put it all out of your mind to make room for something else. As one M-B service manager says, "Our brake lathe went into the trash." Yup, fewer and fewer professionals in the auto service business are machining discs. They've sworn it off in favor of buying new ones. Now that's a profound change considering that it wasn't that long ago when it was standard operating procedure to

automatically turn rotors on a lathe during a reline (providing they weren't down to their legal throw-away thickness). A successful Mercedes-Benz specialist puts it this way, "We've gotten rid of our brake lathe. The tolerances on late models are so close, any appreciable wear demands that the rotors be replaced." Also, new discs will be extra insurance against a recurrence of a pulsation complaint simply because they haven't been cut, so are thicker.

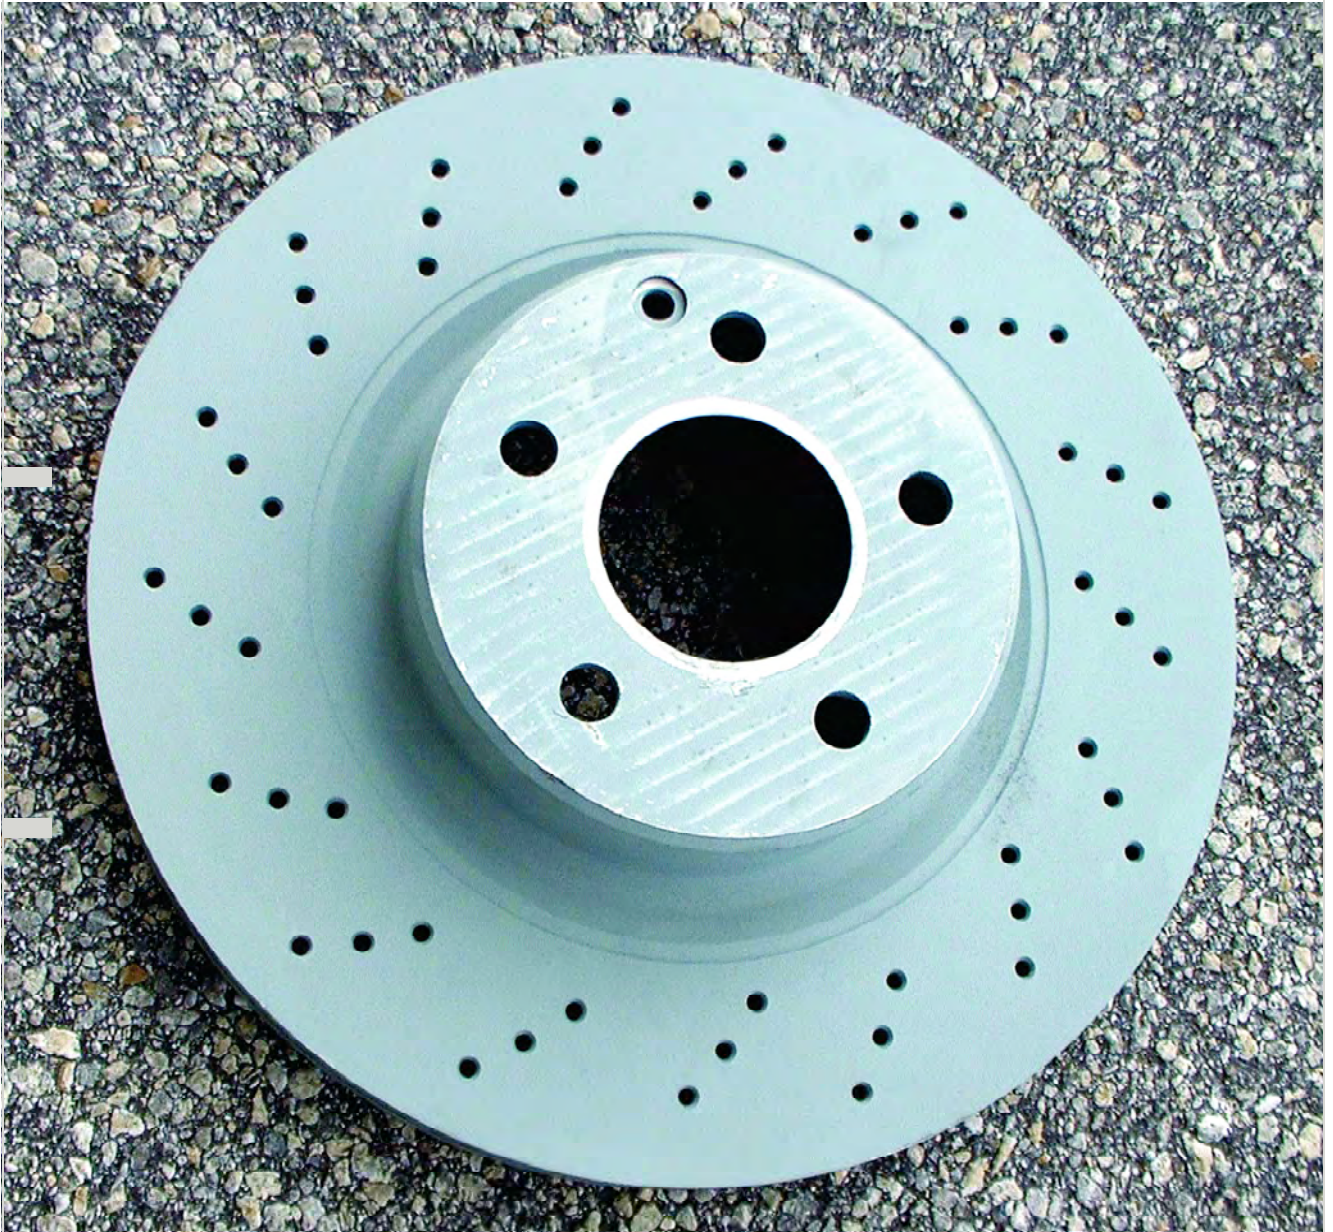
Nothing beats a genuine Mercedes-Benz O.E. rotor for avoiding comebacks and keeping your customers satisfied. By the way, don't bother removing that gray anti-corrosion coating.

- That gray anti-corrosion coating on new M-B O.E. rotors? You don't have to waste any time removing it. It'll disappear after just a few light stops during lining break-in, and leaves no harmful residue.
- Following the "no turn 'em" philosophy doesn't relieve you of the responsibility of repacking wheel bearings and replacing the grease seal when a rotor is reused.

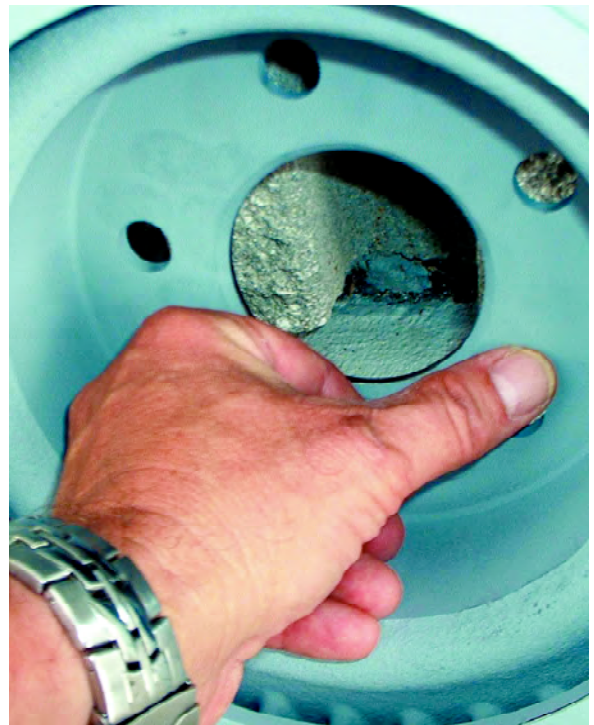
If you buy new O.E. discs, you won't have to worry about getting the mounting surface perfectly clean. The hub is a different story, however. Take your time removing all corrosion so that the rotor will run as true as possible.

rotor mounting. For example, corrosion on the hub or axle flange that keeps the disc from seating properly, hence introducing runout. In our shop, we use our "whizzer" with abrasive discs and various power wire brushes to get those flanges as clean as possible before mounting the rotor. If there was no pulsation problem and the disc is to be reused, we index a lug and the rotor "hat" with punch marks or paint so we can be sure to put it back in the same position.

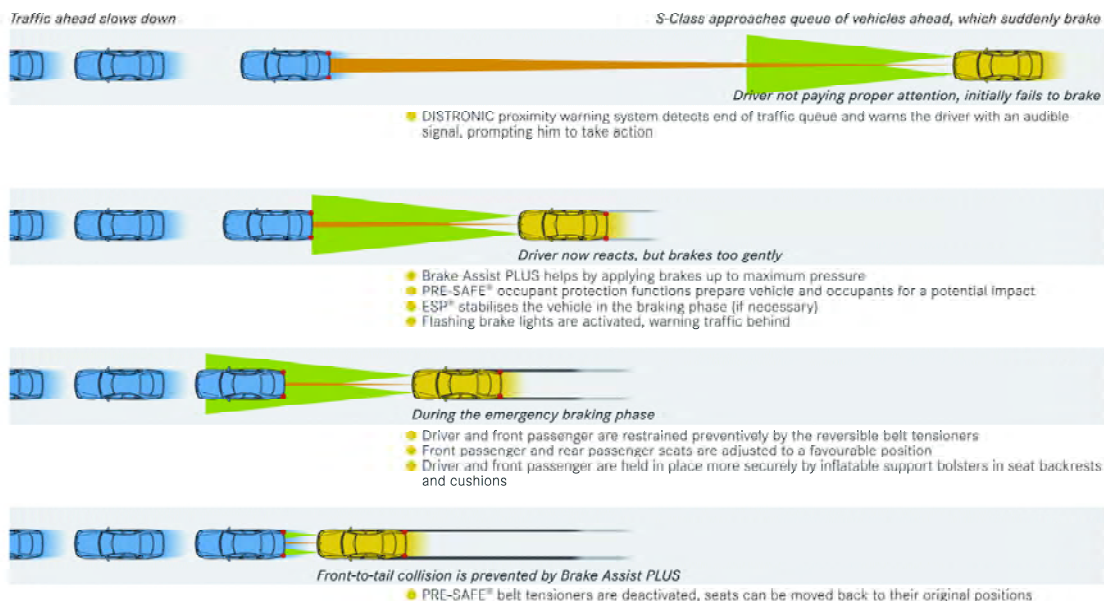
Mercedes-Benz was the first automaker to make standard an electronic brake-assist system that can recognize emergency braking and automatically apply full-power brake force for shorter stopping distances. Called Brake Assist, the system is activated only in emergency braking situations and doesn't affect normal brake operation. Brake Assist made its debut in model year 1998 on most Mercedes-Benz models.

In tests on driving simulators and on the track, Mercedes-Benz safety researchers discovered that even experienced drivers may not apply full braking force in emergency situations. Although the reasons for this are unclear, the solution is relatively simple: use technology to design a system which can recognize emergency braking (whenever the pedal is being depressed very quickly), then react with split-second electronic speed to apply full brake assist force automatically.

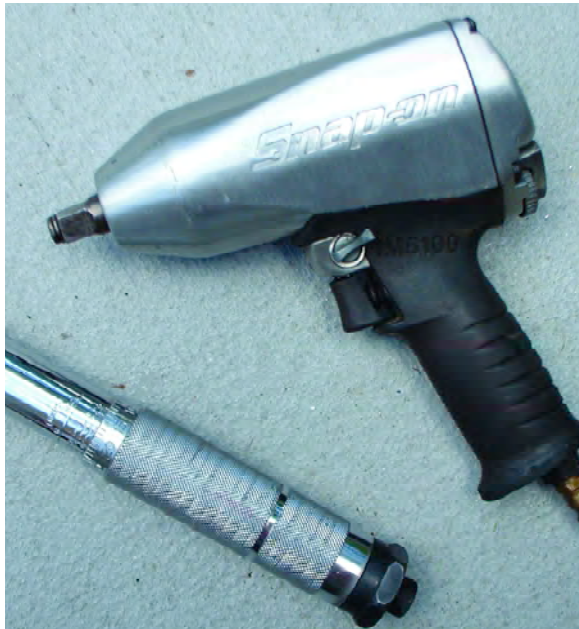
For lugs, nix on the 1/2-inch impact, and affirmative on the torque wrench.

This begins with what should be the simple matter of tightening the wheel lugs. This should always be done with a torque wrench, but we all know that just about everybody out there in the trenches of auto repair does it with a 1/2-inch-drive impact gun. Speed, you know. Shops that use a torque wrench typically have fewer comebacks for pedal pulsation (of course, they employ other careful procedures, too, which we'll mention later).

As one veteran brake expert explains it, "What happens is you tighten the first lug to 90 ft. lbs., and that cocks the wheel. Then, you may tighten the second to 90 also, but the wedge effect makes the other one actually closer to 130, which puts an uneven strain on the rotor. After a couple of months, or 1,500 to 4,000 miles, the iron relaxes to match the stress, and you've got a pulsation problem. You can avoid this by installing the wheel and tightening the lugs while the car's on the lift, lowering it, backing them each off half a turn, then torquing them."
