Addressing Oil Leaks

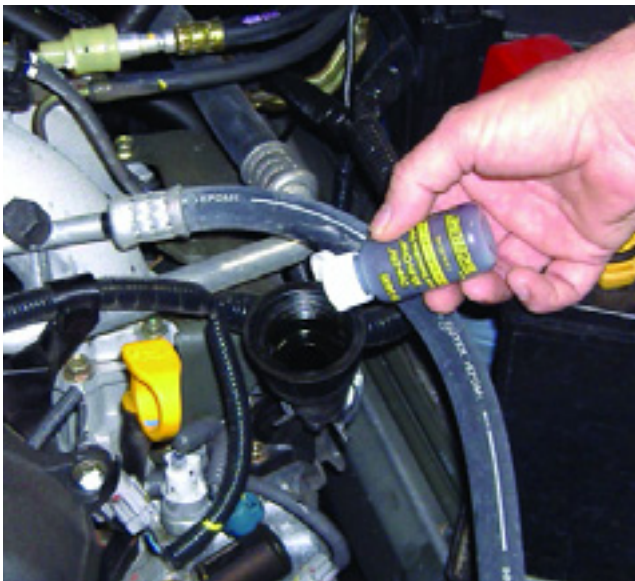
A crankcase dye and a good UV light will help you track down the most mysterious leaks.

Once the suspected area is clean, the next step may be nothing more than the simple matter of shining a lot of light on the area while running the engine and waiting to see what happens. More often than not, however, that won't be enough. UV lights, a.k.a. black lights, used in conjunction with a special chemical dye that is added to the engine's oil can be a godsend when trying to pinpoint the source of a troublesome leak. Typically, the dye is added to the oil and the customer is asked to drive

the car for a bit and then return to have the engine checked with the black light. Once the UV is shone on the engine, the leak becomes quite evident because it literally glows, and also leaves an obvious trail to follow back to the source.

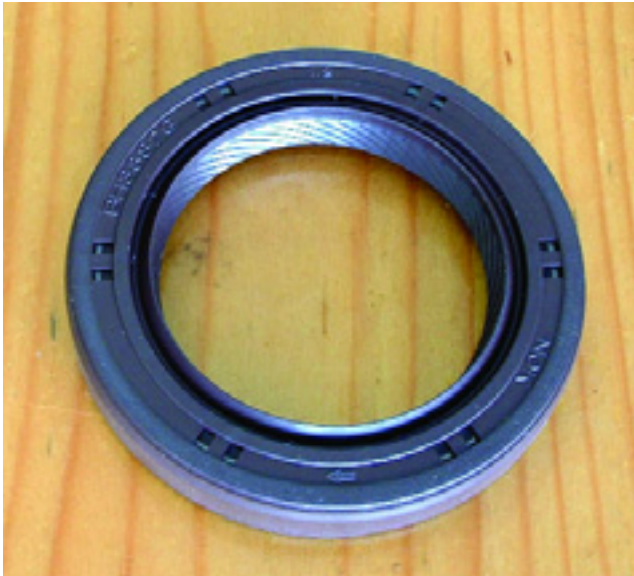
Whenever you're replacing either a crank or cam seal, be sure you use the new type, which will be brown.

Carefully inspect the crankshaft seal. In fact, when replacing the crankshaft seal make sure you use the new type (brown in color, PN 806733030). This will go a long way in preventing a reoccurrence of the problem down the road.

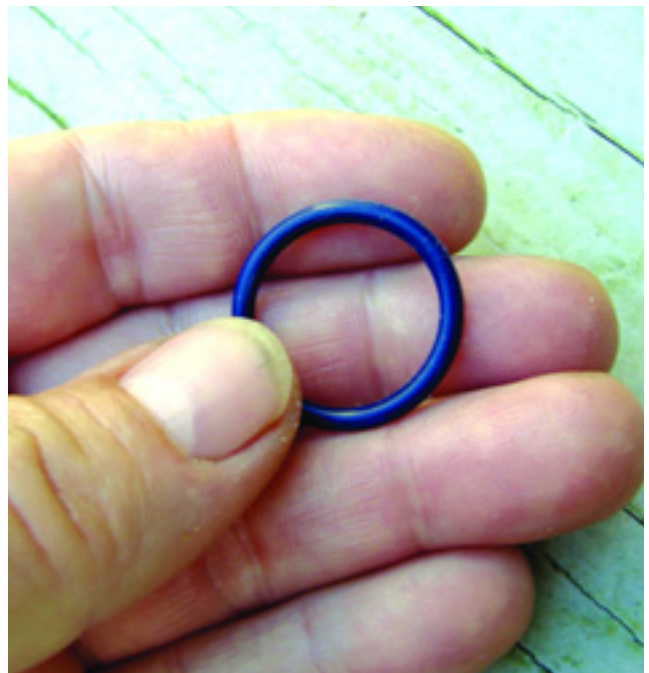
When those lifters start tapping, don't make the mistake of replacing the oil pump when a faulty O-ring could be what's letting air into the lubrication circuit.

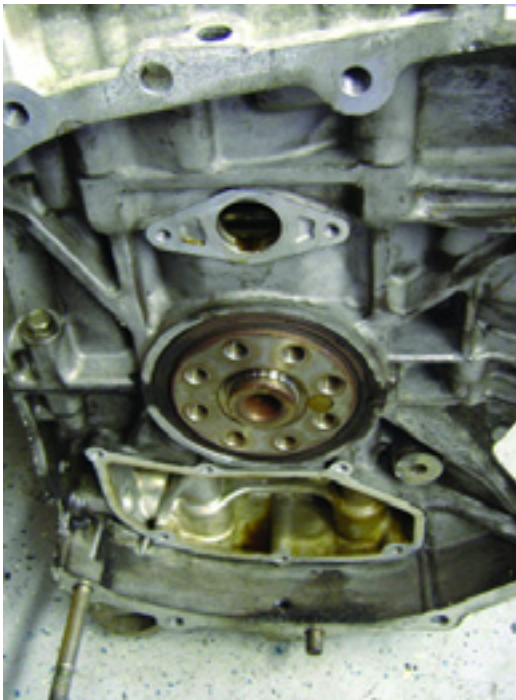
With rear crankshaft seals, direct inspection is difficult while the engine is in the car, so you've got to use some logical thinking.

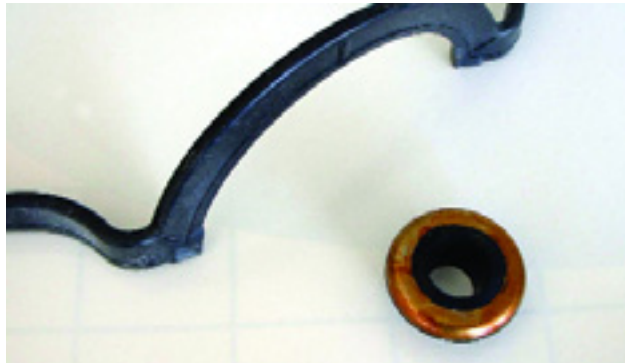
If a valve cover leak occurs, make sure you replace the little bolt seals too.

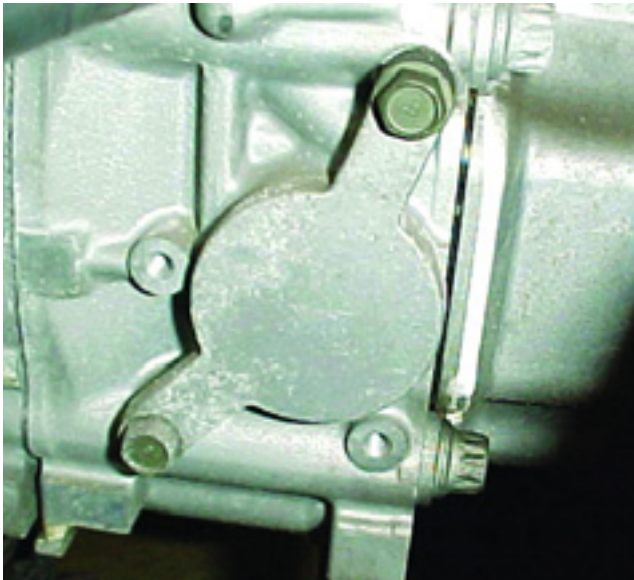
This cam support holder is sealed with an O-ring that is a potential leak point.

An important thing to remember when replacing camshaft oil seals is to also replace the o-ring on the back of the right side (passenger) cylinder head. This is a support holder for that camshaft and is sealed with an o-ring. It is only on the right side as the left side is of different design. Valve cover gasket leaks are easy to see since the area right underneath the bottom of it will be wet.

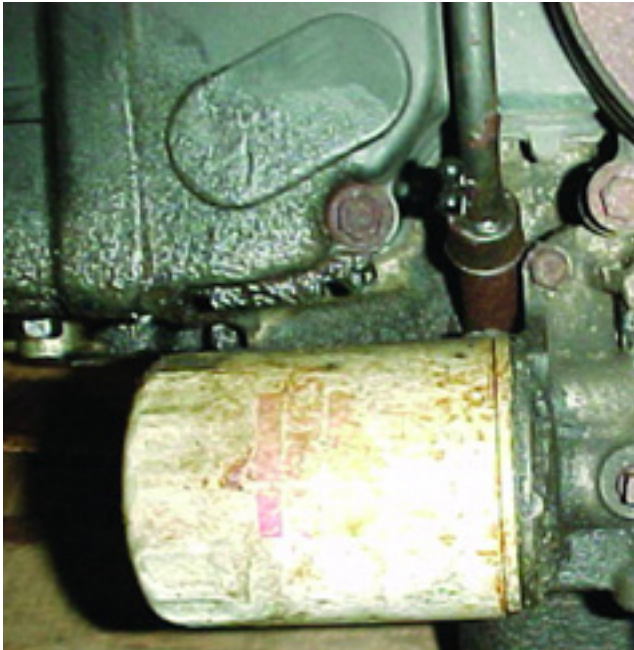
If while doing an LOE, you see a leak above the oil filter, suspect the oil pump O-ring.

Another potential leak that surfaces as the vehicle gets older is caused by the oil cooler O-ring. This is easily visible when performing an oil change because oil will be noticed above where the filter seats and oil cannot leak “up” in this area. This leak is caused by heat that hardens or “dry rots” the O-ring.

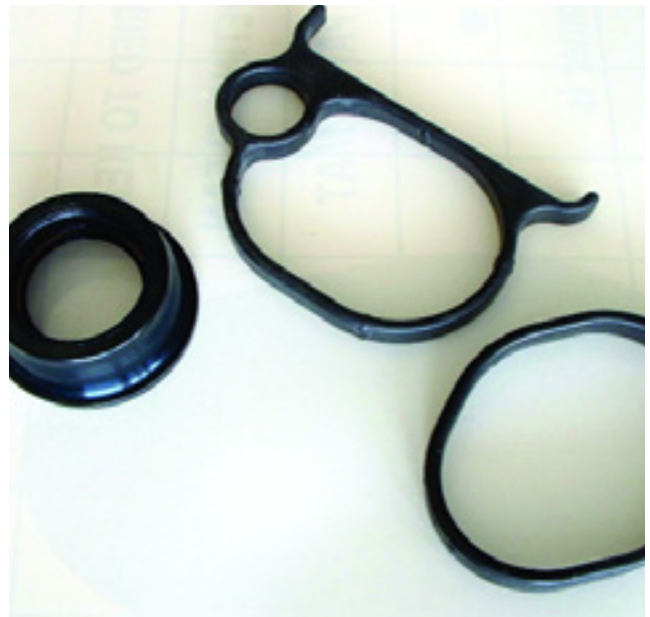
Various means have been used to seal the spark plug cavities in Subaru engines. We recommend replacing these whenever you're doing valve cover gaskets.

On occasion during spark plug servicing, the wire boot is found to be covered with oil. Unless you are knowledgeable of the product, you can be fooled and not realize that there is a seal inside the valve cover that protects the boot. Valve cover removal is necessary to replace these seals and even if not leaking they should be replaced whenever the valve cover is removed.
