Saving

The Heads

With BMW's service kit, you can clean, not replace M60/M62 heads.

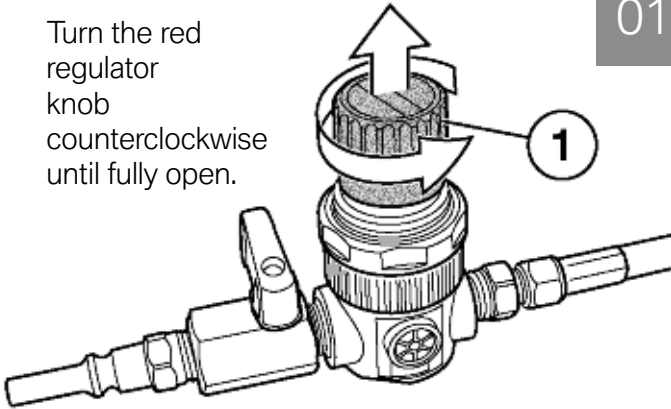
01

Turn the red regulator knob counterclockwise until fully open.

Open the red knob on the regulator, then insert the plug into the end of the tube and tighten until secure. Attach a pressure gauge or DISplus unit to the fitting on the tool. Connect shop air to the end of the tool.

Open the yellow flow control valve until the system reads 3.5 bar (50 psi). Then press down on the regulator knob to lock the reading. Shut off yellow flow control valve, disconnect the pressure transducer and remove the plug from the end of the pipe.

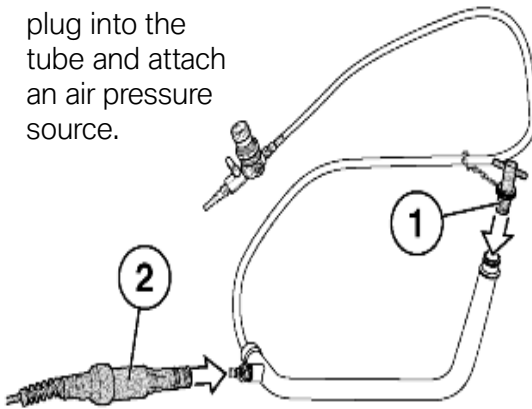
02

Then insert the plug into the tube and attach an air pressure source.

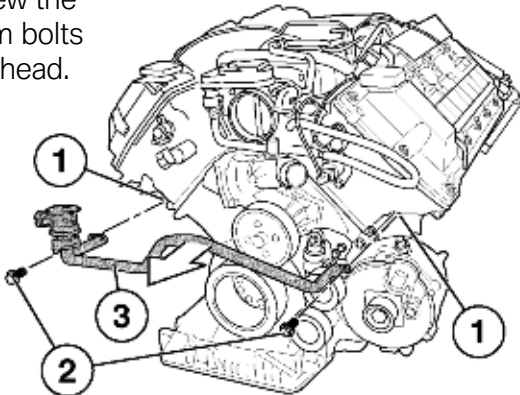
03

After removing the fan, unscrew the 10 mm bolts in the head.

Remove the fan assembly from the engine. Remove the two 10mm bolts (#2 in the next illustration) securing the delivery tube to the cylinder heads at the position shown. Move the tubing out of the way so you have access to the ports.

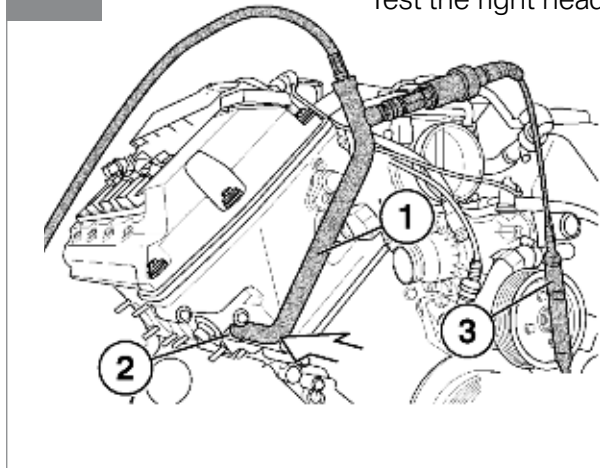
04

Test the right head first.

Insert the tool into the right cylinder head secondary air supply passage. Connect the pressure gauge or DISplus to the tool, connect shop air, and open the yellow flow control valve to allow the free flow of regulated air to pass through the head. Observe backpressure reading. If the backpressure is more than 1.10 bar (16 psi) the passage is blocked. Repeat the backpressure test for left head.

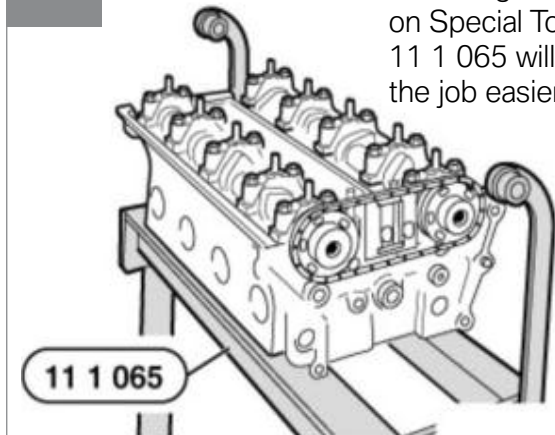
05

Mounting heads on Special Tool 11 1 065 will make the job easier.

Remove the heads according to BMW's standard procedure as described in Repair Instruction 11 12 505/506. Mount the heads on the fixture (Special Tool 11 1 065) and disassemble them. Use the special tools as required to remove the camshafts, bucket tappets, exhaust valve retainers, exhaust valve springs, and exhaust valve guide seals. Always position the removed parts so that you can reinstall each valve in its original cylinder, and all the other parts in their original locations.

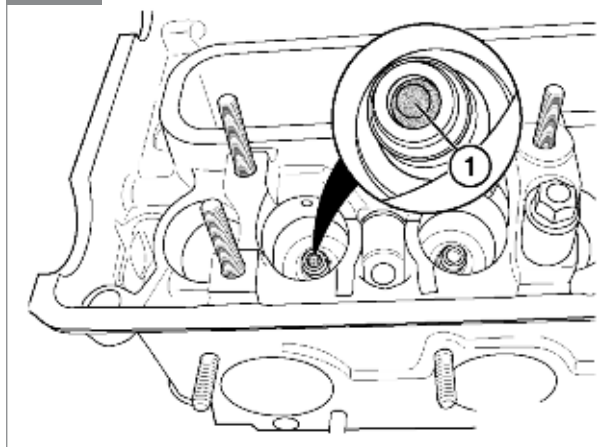
06

Make sure the valve stem is flush with the top of the guide.

Push on the valve stem until the edge of the stem is flush with the top of the valve guide. Secure a dial indicator to the side of the valve face and measure valve movement within the guide. Movement should be no more than 0.5 mm. If the movement is greater than 0.5 mm, the guides are worn and must be serviced.

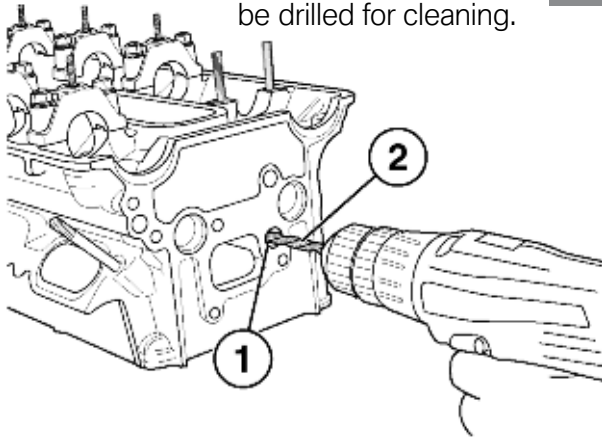
07

The core plug must be drilled for cleaning.

Using the drill bit supplied in the tool kit, drill a hole in the 10mm core plug for the main secondary air supply passage located in the rear of the head.

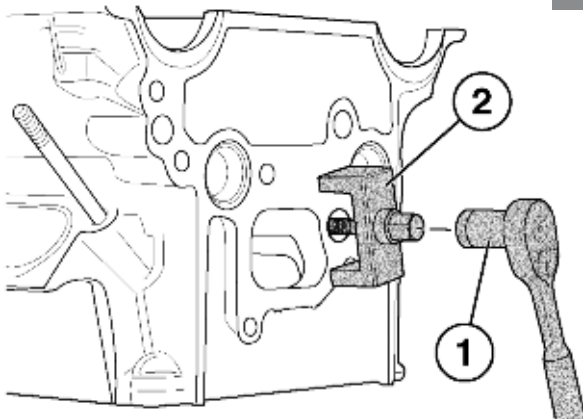
08

Pull the core plug.

Using the core plug remover from the tool kit and a 10 mm socket, thread the removal tool into the hole you just drilled. Continue to turn the screw clockwise until the plug is removed.

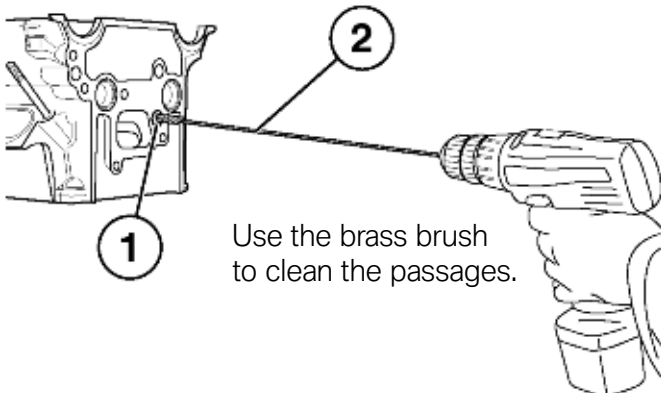
09

Use the brass brush to clean the passages.

Chuck the 10 mm brass brush from the kit into a drill and clean out the main secondary air delivery passage. Blow out the passage with an air nozzle and shop air and repeat. Repeat the brushing and blowing out with shop air until there is no more carbon in the passage.

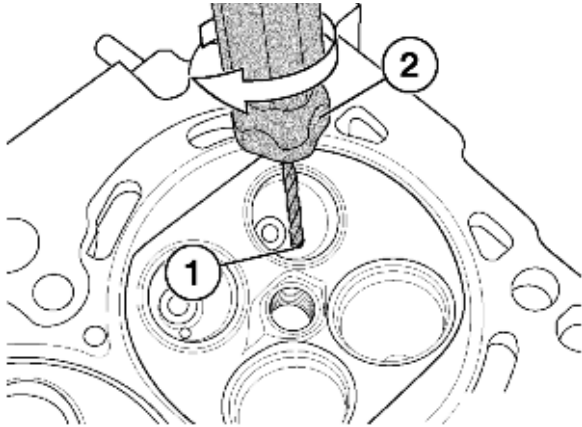
10

The secondary air passages must also be cleaned.

Locate the secondary air distribution ports (1) under the removed exhaust valve. Insert the reamer tool (2) from the special tool kit into the port. Slowly rotate the reamer clockwise until

no resistance is felt and the tool goes to the bottom of the passage. Repeat the reaming process for all eight ports in the cylinder head.

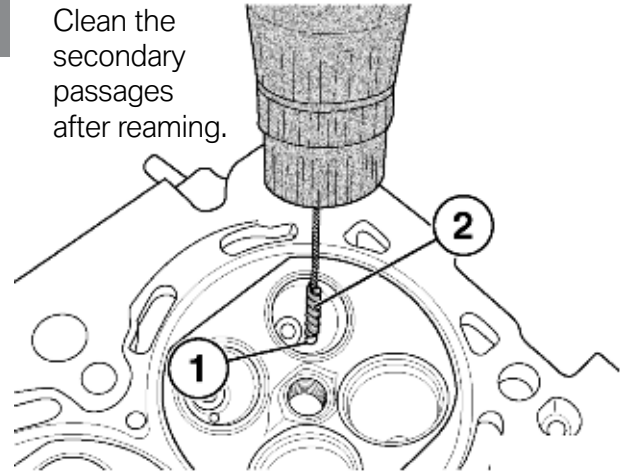
11

Clean the secondary passages after reaming.

After reaming each secondary air passage, clean the passage using the 4mm nylon brushes from the tool kit. Chuck the brush into a drill and clean each passage. Blow out the passage with air until all material is removed from the passage.

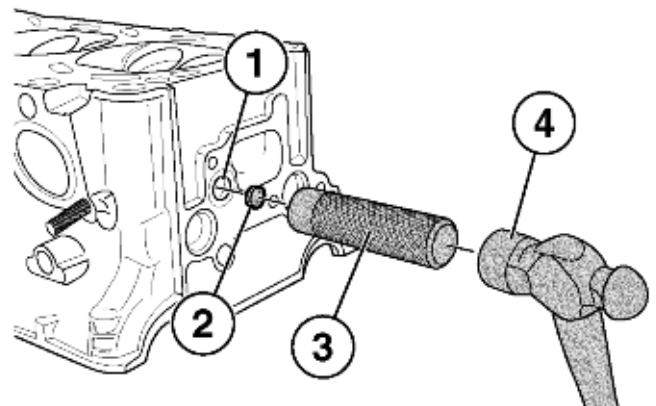
Reinstall the core plugs.

Using the core plug installer (3) from the tool kit and a suitable hammer, install the new core plugs into the secondary air distribution passages. Core plugs (PN 11 12 1 736 330) have to be ordered separately (Qty: 3 per vehicle).

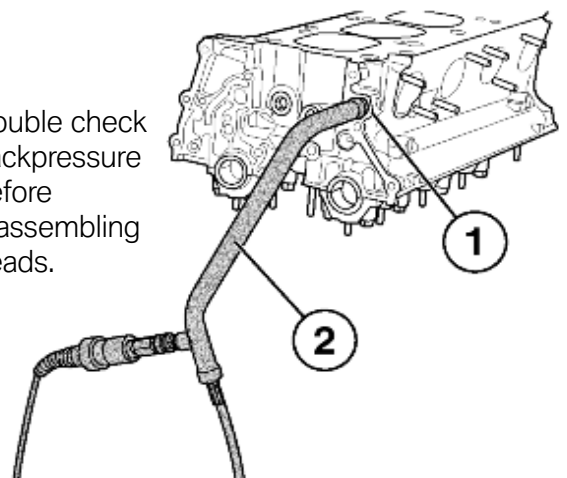
13

Double check backpressure before reassembling heads.

Before reassembling the heads, recheck the backpressure. You should get a reading of no more than 1 bar (14.5 psi). A steady flow of air should also come out of each of the eight secondary ports. If the reading is high, there is still blockage in the passages and you will have to repeat the cleaning process.
