# Premium Brake Service Should Include Correcting Runout

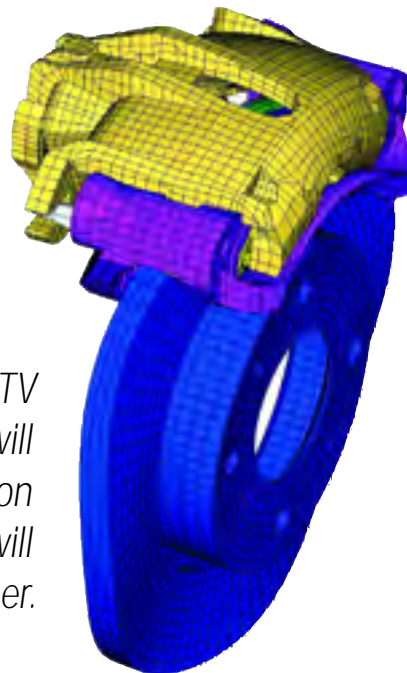
*A wavy rotor will develop DTV because certain spots will contact the pads on every revolution, which will make those areas thinner.*

The general public as well as many techs blame brake judder on “warped discs.” The truth isn’t quite so simple. At least in theory, a wavy or “perfectly” warped rotor would be the same thickness in all spots, and a floating caliper would simply follow it as it tracked from side to side. In practice, a warped disc, or a disc that doesn’t sit completely flat on the hub will contact the caliper at its high spots, but not the low spots. Constant rubbing leads to the creation of thick and thin spots on the disc. The caliper piston(s) follows these variations in and out, pushing fluid back against the pedal, creating the all-too familiar brake pedal pulsation, or judder. Hence DTV, or “disc thickness variation” is the actual cause of brake judder, not “warped” rotors.

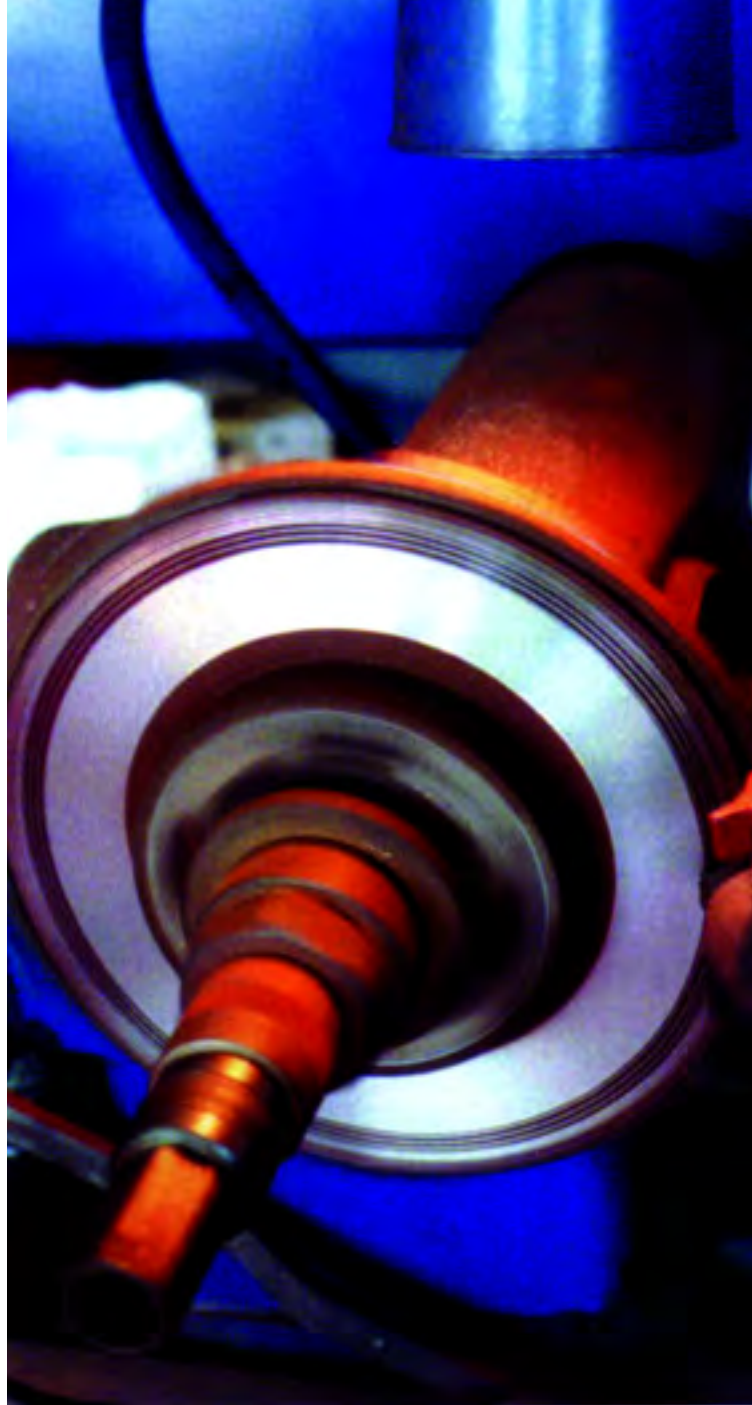
*If you are turning rotors to eliminate pedal pulsation, you must make sure you mount them on the lathe arbor perfectly.*

There are other potential sources of runout. A bent arbor on a brake lathe can machine rotors that are beautiful to look at, but become ugly when measured using a dial indicator. The same result can occur if the center hole, flange, and/or face of a rotor aren’t adequately cleaned of rust before it gets mounted on a lathe.

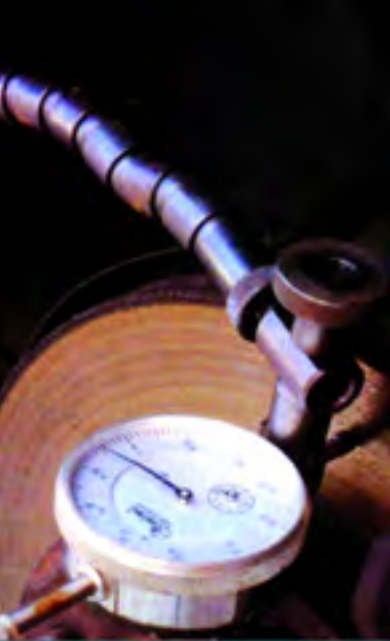
*It takes a little time to set up your dial indicator to read runout, but it's definitely worth it. Anything over .002 in. is too much.*

How do we properly measure runout? A dial indicator clamped to the steering knuckle is the right tool, but where on the face of the disc should we place the indicator's tip? One tapered shim vendor states 1/2 in. from the outside edge of the disc. Another authority says 5mm from the edge, and yet another says, "In the middle of the path the pad travels." The closer to the edge one measures, the greater the reading will be. Clearly, you don't want to measure runout on the rough, corroded ring beyond the contact area of the lining, but doing it somewhere along the outer third of the path the pad travels won't get you into any trouble.

Measuring rotor runout requires securing the rotor to the hub using a minimum of three lug nuts. You'll usually need spacers or washers. In theory, the lug nuts should be torqued the same as if the wheel itself were mounted. Since the car is no longer on the ground, snugging may be challenging, since applying the brakes during tightening could prevent the rotor from self-centering on the hub. Snugging them finger-tight, then jiggling the rotor may help you to center it before the final tightening.

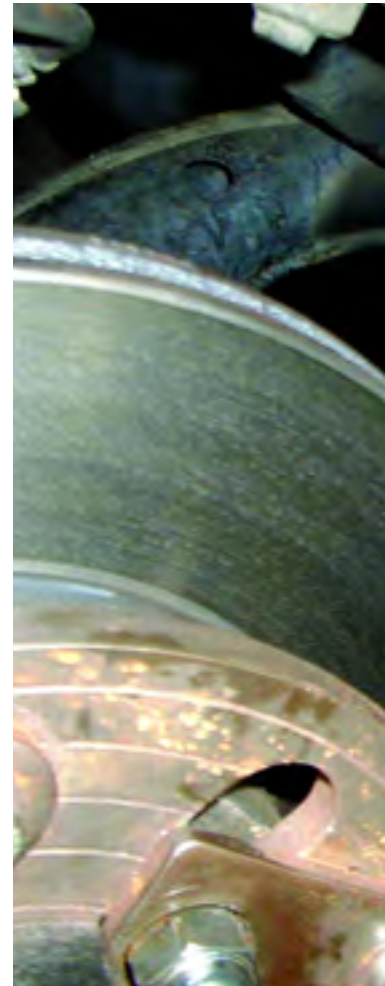
*Although an on-car brake lathe can eliminate runout and DTV, you still haven't addressed the mounting error. So, there's apt to be trouble at the next reline.*

The setup of most on-car lathes incorporates a step where existing runout is measured, and compensated for by the tech prior to cutting. The latest models from Pro-Cut International and others, use a microprocessor-based system to compensate for runout automatically. As a result, rotor indexing, shimming, hub cleaning, and all of these other steps are avoided, provided the rotor has enough "meat" left to allow resurfacing.

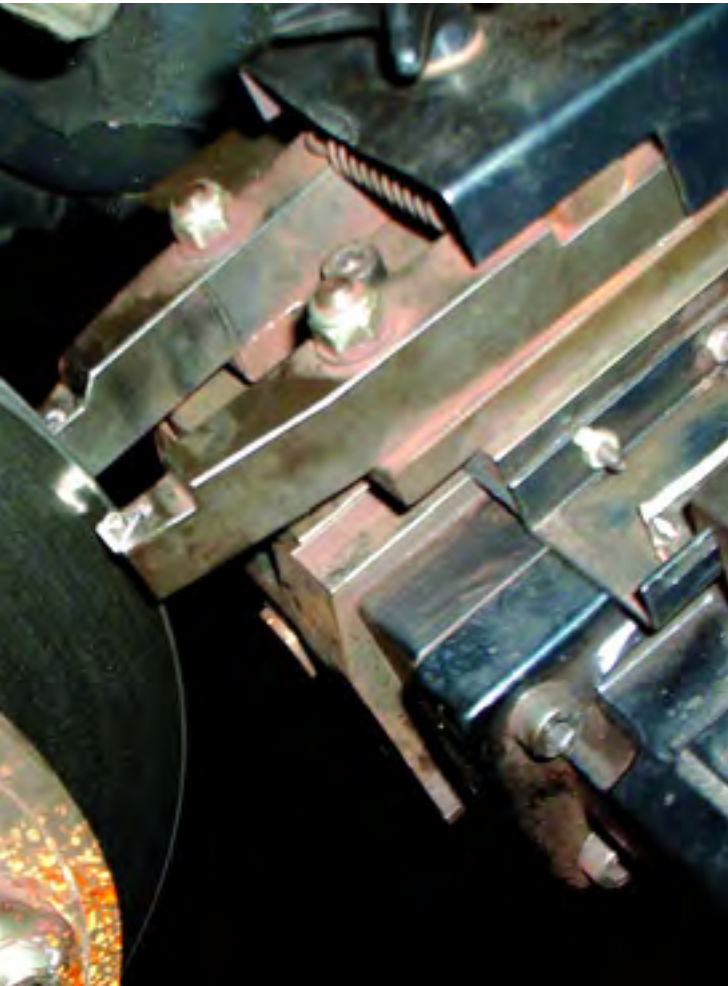
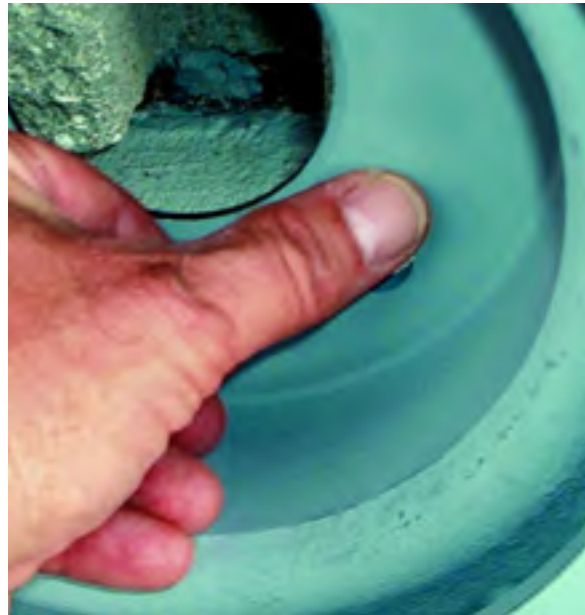
*The mounting surface inside the rotor “hat” must be perfectly clean, or runout will be inevitable.*

Rust on the face of the hub where the rotor mounts is probably the leading cause of runout. Iron combines with oxygen to form rust, which takes up sixteen times the space that iron itself does. Just like a tree root lifting a concrete sidewalk, rust in a pitted hub surface, or the back of the rotor “hat” can lift the rotor off the hub even with the lug nuts securely snugged down. This will, of course, cause runout.

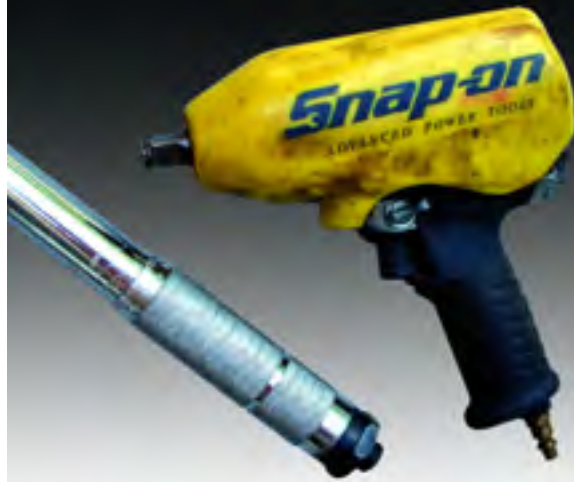
*Always use a torque wrench for final lug tightening. Never use a 1/2 in. drive impact gun at all. Spin them down with a 3/8 in. drive tool on a low setting.*

Most experts agree that in order to prevent lug nut-created runout, wheel installation procedures should be improved. They recommend adding an intermediate tightening step of torquing each nut to half of spec before cinching each down to its final torque setting, as always following the proper tightening pattern.

Using a lower-powered, 3/8 in.-drive impact gun, pneumatic or electric, to spin the nuts down lightly will allow you to add this step to wheel installation without slowing down the operation. Never use your 1/2 in.-drive impact for final tightening – grab that torque wrench!
