# **HOCUS FOCUS**

**The little Ford that couldn't**

by John Anello

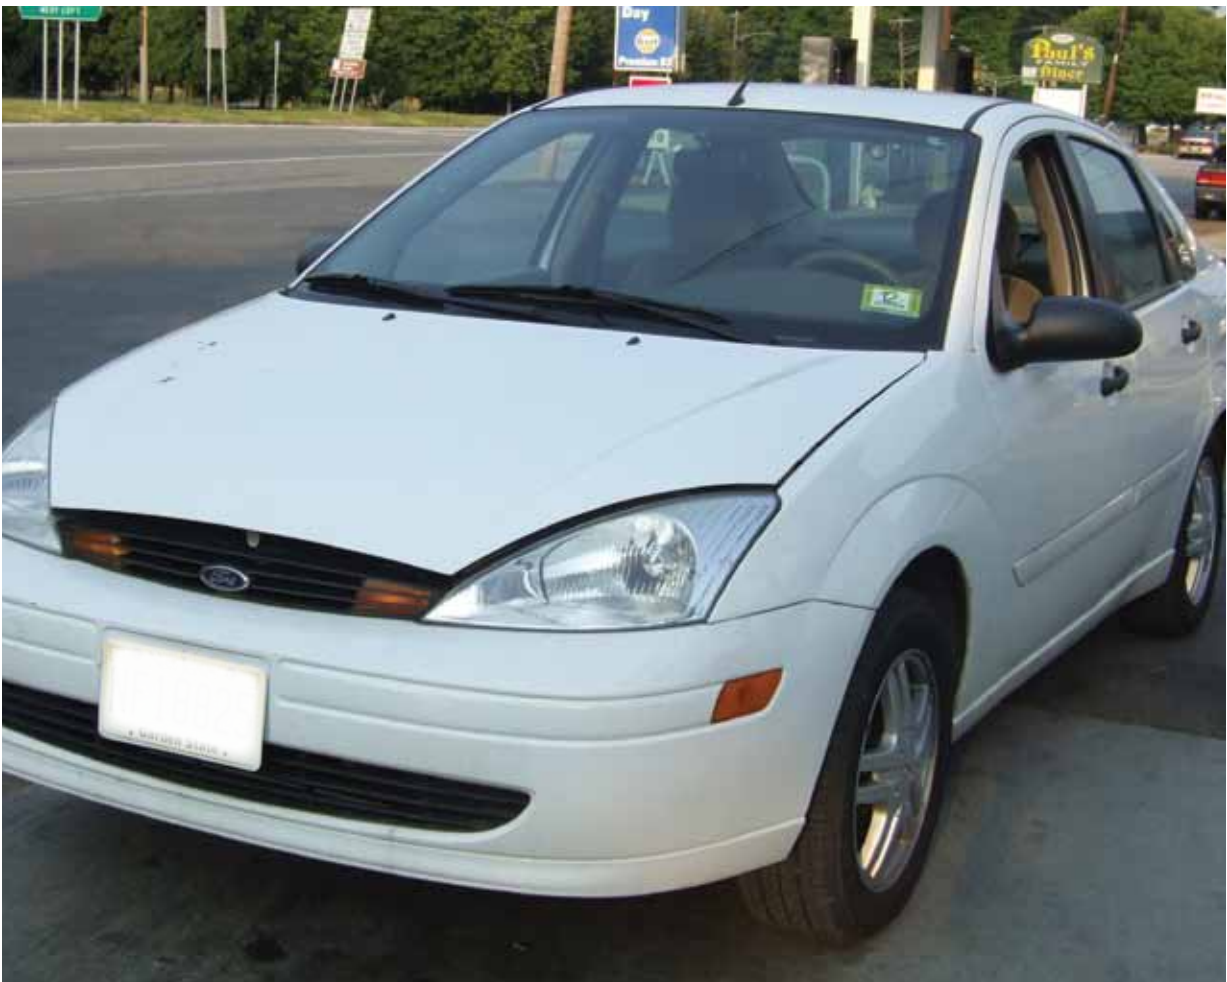
Figure 1

A shop called me in to investigate a 2002 Ford Focus with 2.0L that had poor power on a hard acceleration (**Figure 1**). The vehicle, which only had about 53,000 miles on it, idled fine with no misfires or codes stored in memory. It just didn't have the horsepower it should have had.

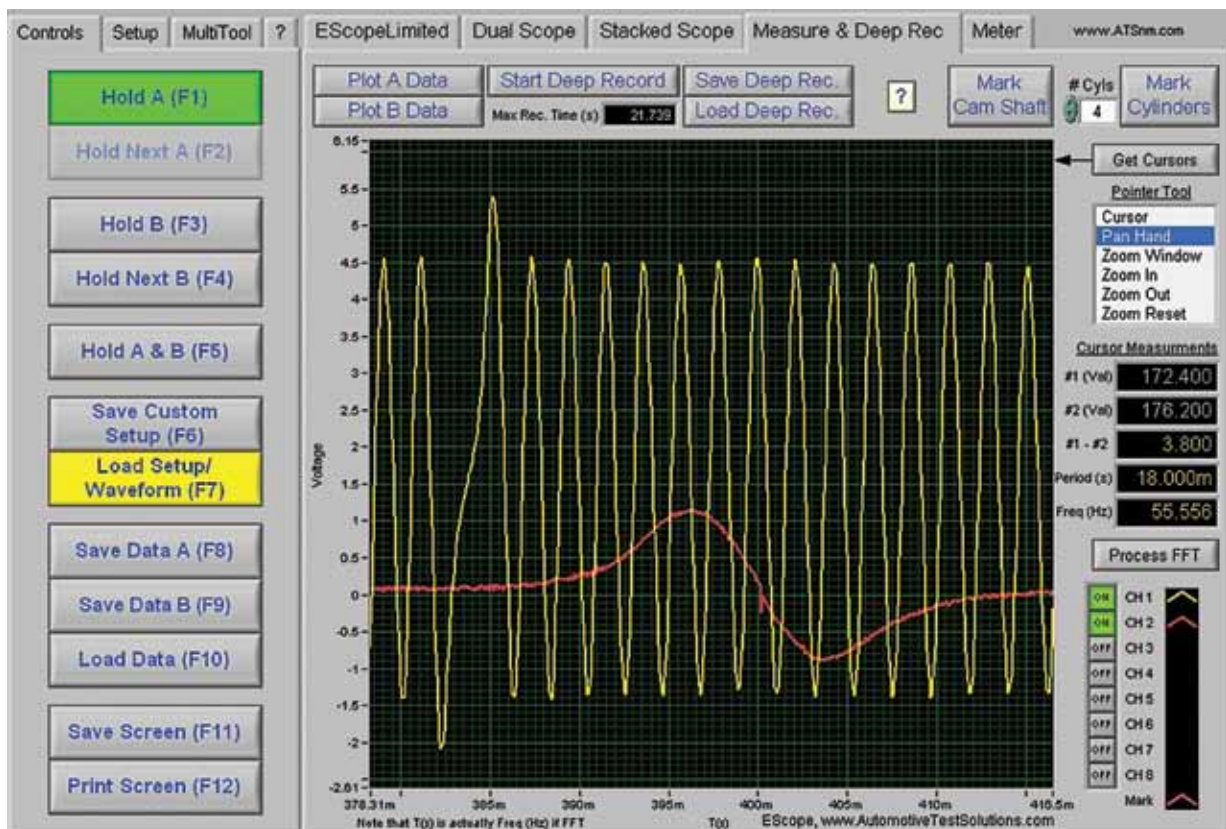
Figure 5

I next hooked up my scope and tagged the crank and cam sensors to perform a correlation check by viewing the signals in a superimposed format (Figure 5) to prove my suspicions. By pulling up a known-

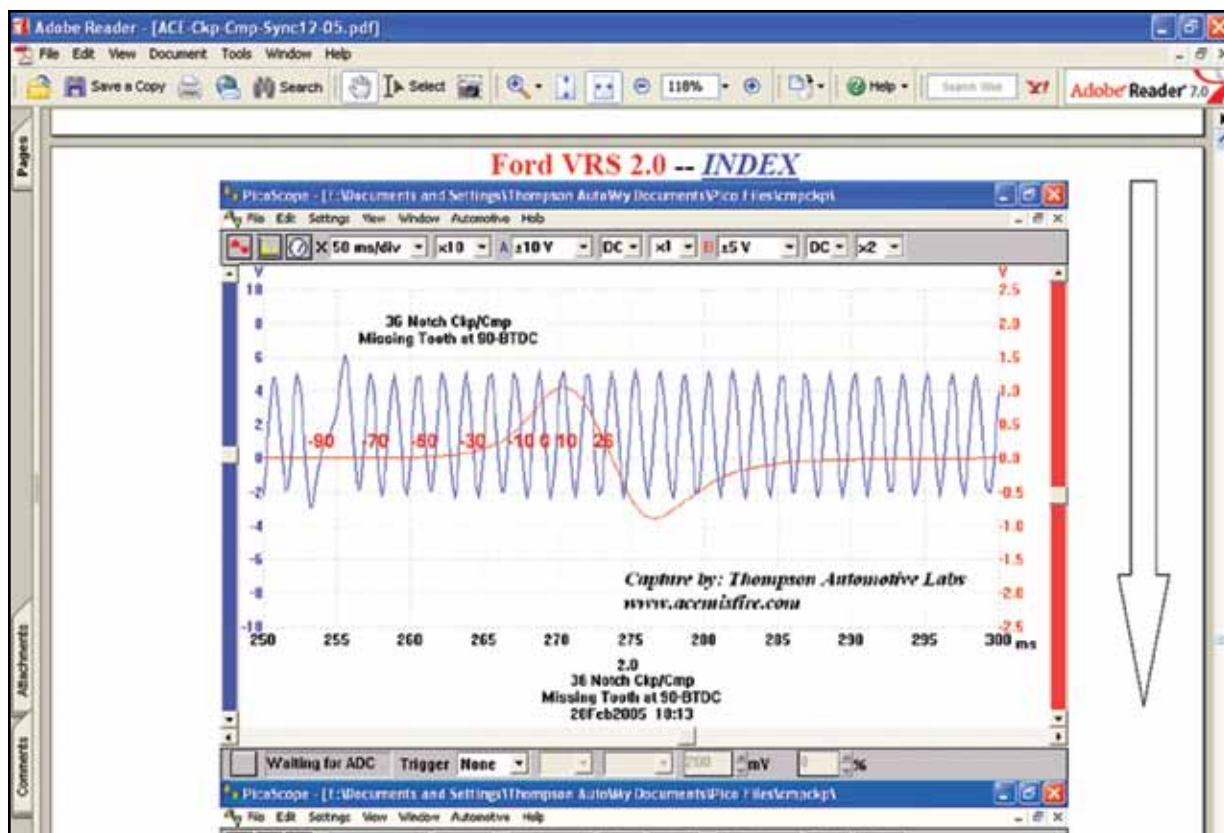
Figure 6

good pattern from my Ace Misfire database (**Figure 6**), I could see that the crank and cam correlation was off by about 60 degrees. This is a quick and easy check to validate mechanical timing issues with trigger points, but it alone still cannot prove out a jumped timing chain or belt. There have been too many situations where I have found loose trigger wheels that had lost their indexing, damaged flywheels, worn crank pulley keyways, or even sheared cam gear pins. The only true way for me to quickly prove out a valve train problem would be to

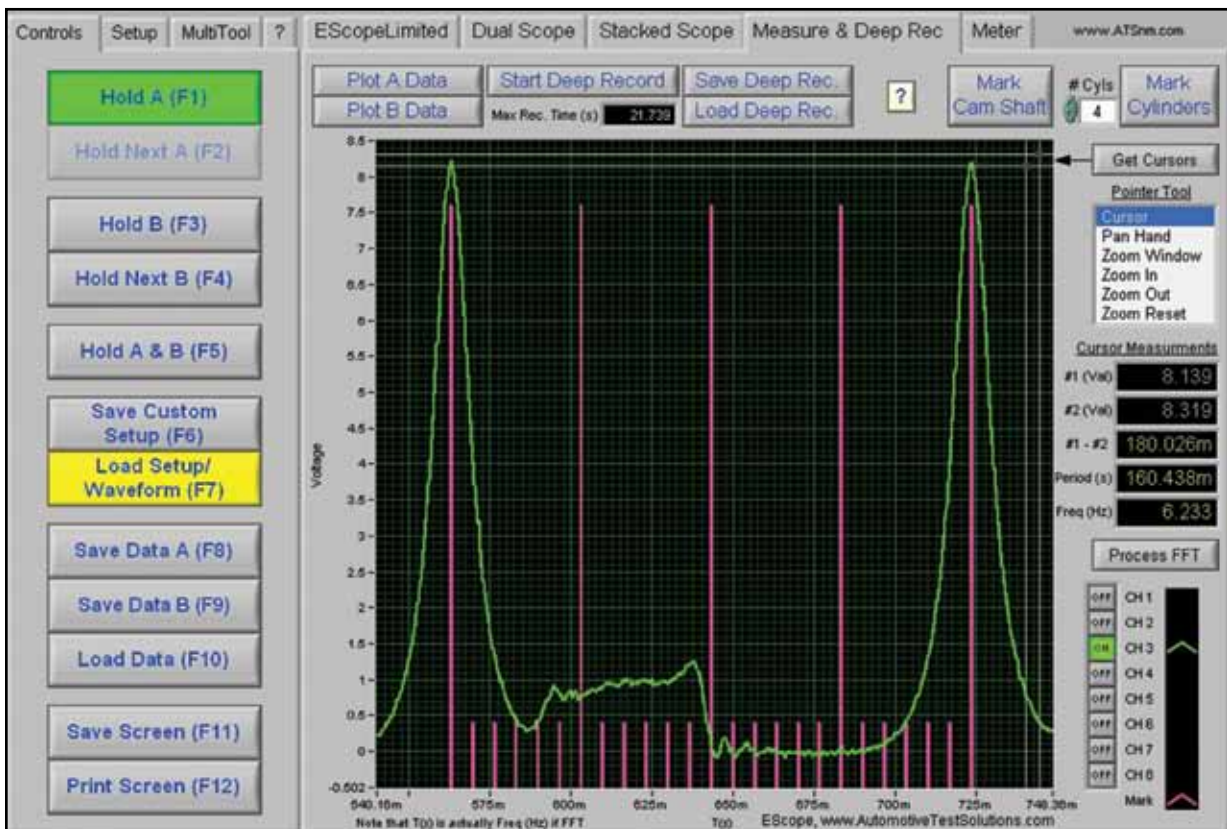
Figure 7

I removed the spark plug and placed a spark tester on the wire. I next screwed the pressure transducer and adapter assembly into the cylinder and started the engine to capture a waveform. I shut down the engine and zoomed in on the pressure pattern to view the peak-to-peak pressure rises indicating one combustion event of 720 degrees. I placed the cursors on the peak-to-peak compression rises and then hit the Cam Timing

button within the EScope program (Figure 7). The program automatically placed five large purple cursors creating four divisions of 180 degree of crankshaft rotation and five smaller purple cursors creating six subdivisions of 30 degrees on the screen. You could now see that the exhaust valve was opening at about 75 degrees before BDC of the power stroke (note that the lowest fall after the compression rise is where the exhaust valve begins to open). Having seen many waveforms showing exhaust valve openings between 30-45 degrees before BDC of the power

stroke, this engine's valve timing was definitely off by 30 degrees or better. It was now safe to instruct the garage to pull apart the front timing cover, which involved supporting the engine with a jack, removing an upper engine support and removing an upper metal timing housing cover -- all that just to expose the timing belt.

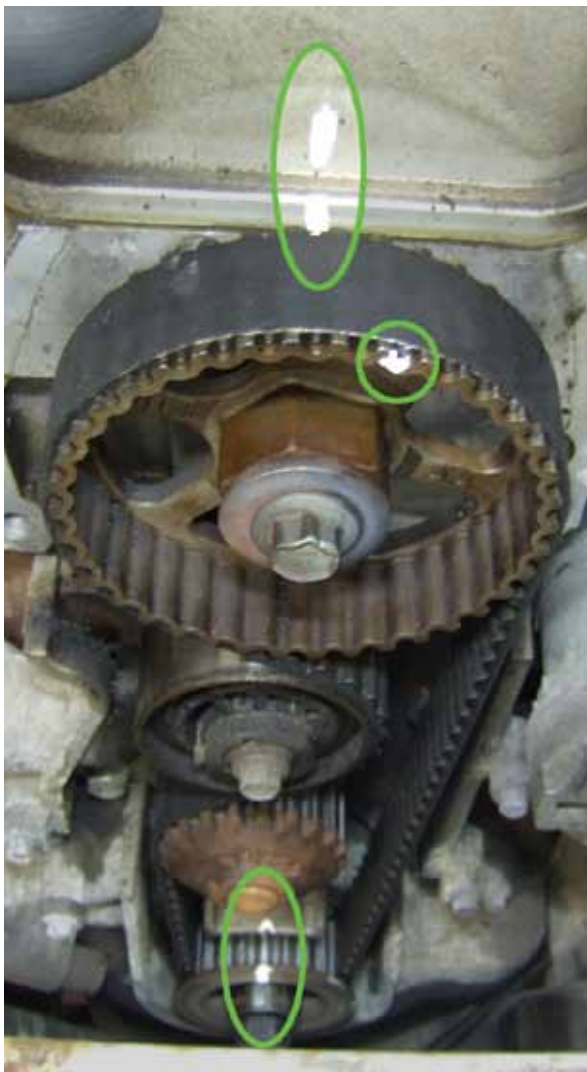
Figure 8

Once the timing belt cover was removed, I marked the sprockets with White Out (Figure 8). The cam gear was off by about two teeth. Also, the belt had some slop indicating that

the self-adjuster was not doing its job of compensating for belt stretch. The fix here was to sell the customer a timing belt and a new belt tensioner. I also recommended replacing the water pump that ran off the belt as a preventative maintenance measure. Prior to being a mobile technician for the last 15 years, I worked in an engine rebuilding shop for five years and as a dealer technician for another 10 years, and I have seen so many guys in the field skimp on so many types of jobs to try to save a customer money by not replacing a component that may
