# Electric Slide

*An Escape Hybrid no-start sends our man John on a research binge*

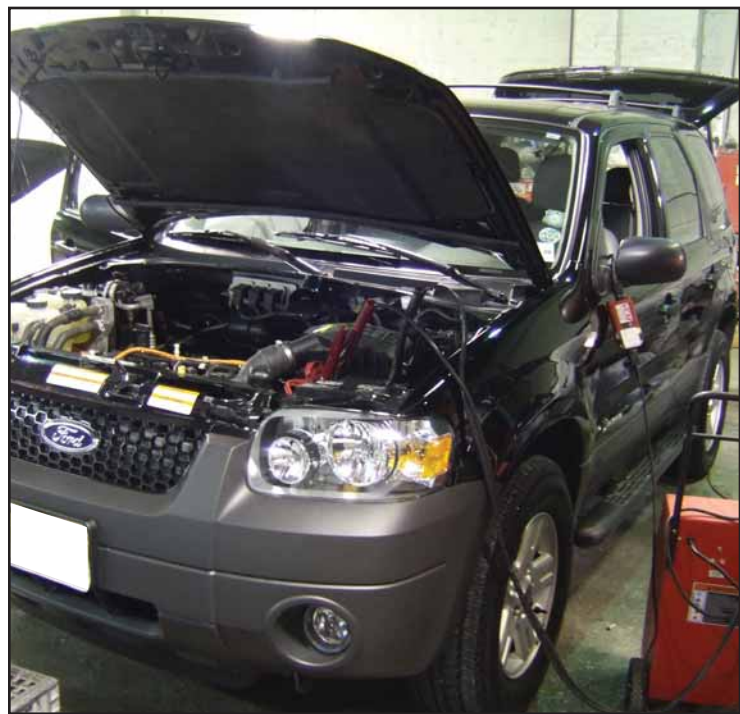
I received a call from a body shop for a complaint of a no-start on a 2006 Ford Escape 2.3 Hybrid (Figure #1). The vehicle was involved in an accident and had damage to the front and the transmission housing. The shop had no choice but to replace the entire transaxle assembly to correct a problem with a damaged transmission case. They claimed that the engine ran before they installed the transaxle, but now the vehicle would not start. The shop was well aware of how to disable this hybrid vehicle by pulling the high voltage

Figure 1: A no-start on a 2006 Ford Escape 2.3 Hybrid.

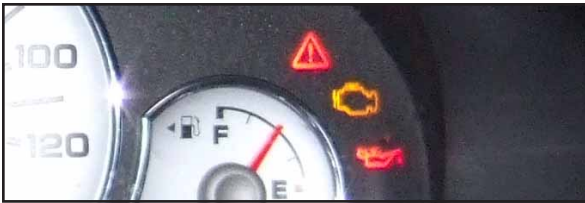
Figure 2: An attempt to start the Escape and it would not do anything. The “Red Triangle of Death” was lit up on the dash indicating a serious hybrid problem.

When I arrived at the shop, I attempted to start the Escape and it would not do anything. I noticed that the “Red Triangle of Death” was lit up on the dash indicating a serious hybrid problem (Figure #2). This vehicle also uses a yellow wrench to alert the driver to

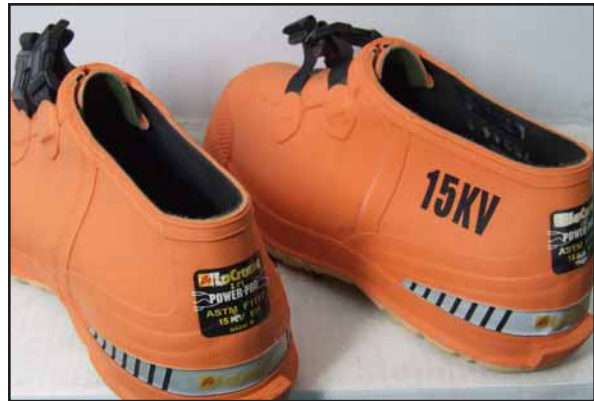
Figure 3: A set of insulated boots rated at 15 KV's

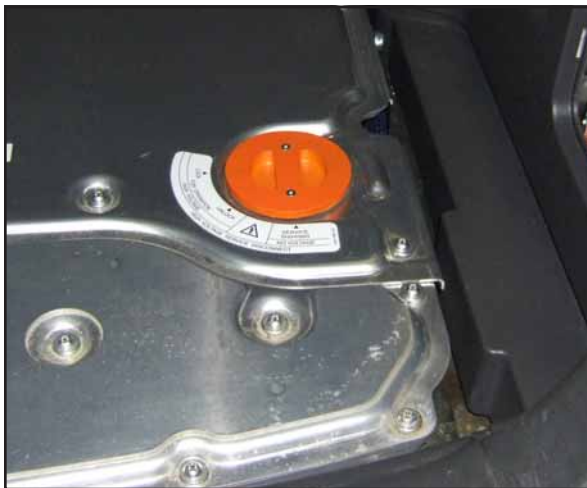
Figure 4: I walked over to the rear of the vehicle to check the battery disable plug located in the rear compartment

I tried to use a common-sense approach to interpret the code descriptions without having to dig into an information system for help. The battery disable and high voltage inter-lock circuit faults directed my attention to safety devices used on this Escape. I walked over to the rear of the vehicle to check the battery disable plug located in the rear compartment (**Figure #4**). A closer view shows that there are three possible positions the plug can be installed in (**Figure #5**-Lock, Unlock or Service Shipping). The body shop had properly reinstalled the service plug back in its original Lock position. I find quite a few of these plugs in the field that are not latched properly and cause the hybrid vehicle to be temporarily disabled. I even went a step further and removed the plug and used my special CAT5 hybrid-rated Fluke 1587 meter to test the fuse within the safety plug (**Figure #6**), and that was okay as well.

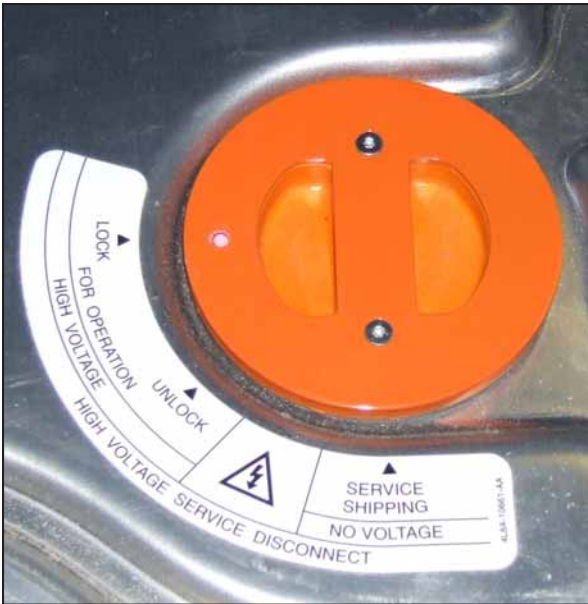
Figure 5: A closer view shows that there are three possible positions the plug can be installed in (Lock, Unlock or Service Shipping)

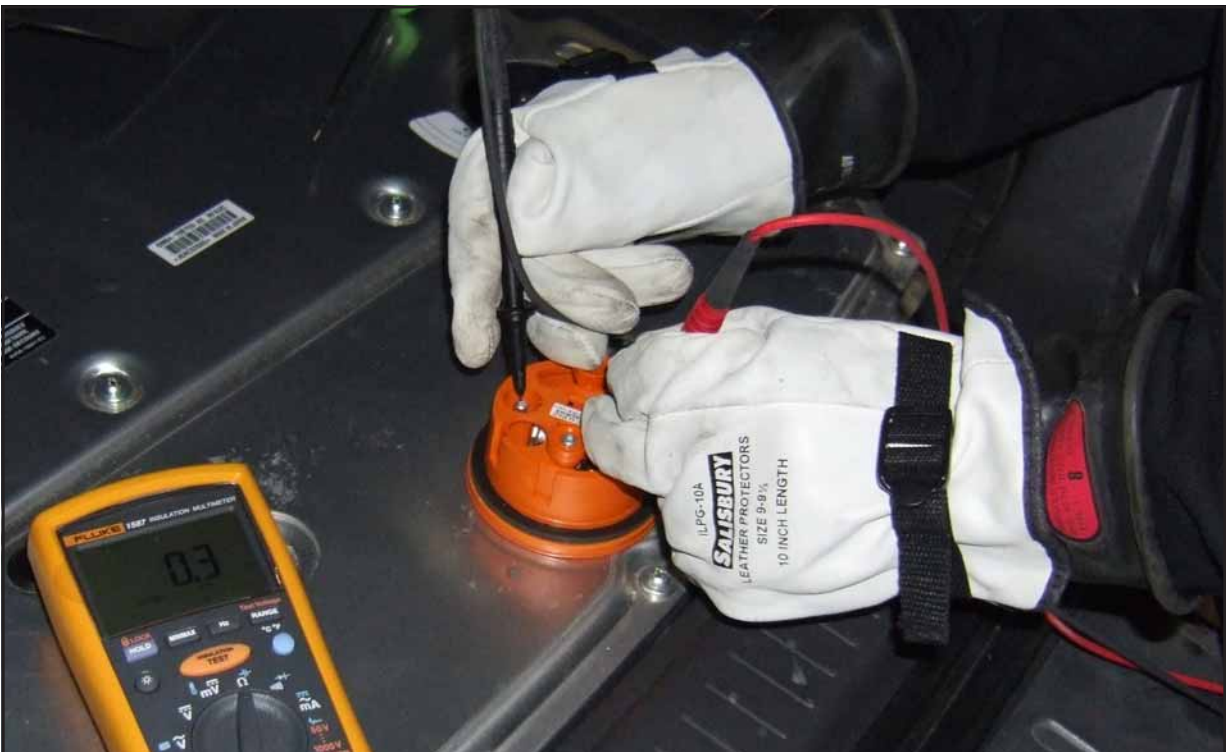
Figure 6: I removed the plug and used my special CAT5 Hybrid-rated Fluke 1587 meter to test the fuse within the safety plug.

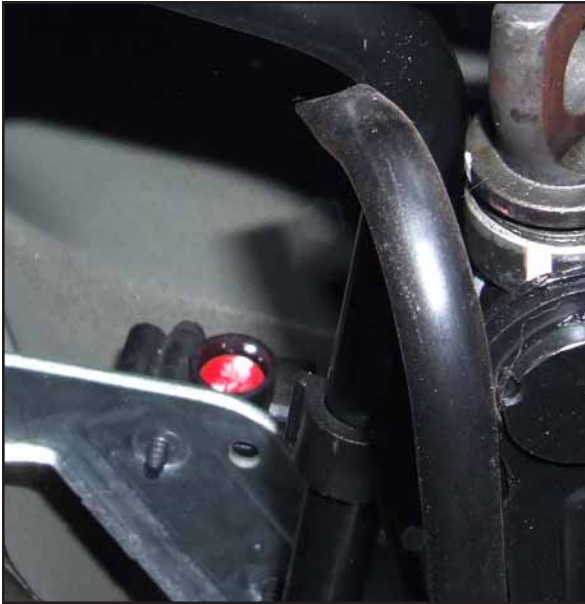
Also located in the rear compartment in the right rear quarter panel is a hybrid inertia switch (**Figure #7**), and in the right front kick panel there's a fuel inertia switch. Most manufactures use just a high-voltage service plug, but ford uses an inertia switch to quickly disable the hybrid system during a collision. The rear inertia switch got triggered from the impact.

Figure 7: Also located in the rear compartment in the right rear quarter panel is a hybrid inertia switch.

After I reset the hybrid inertia switch, I cleared all codes and attempted to start the vehicle again. Still nothing, and when I checked for codes again

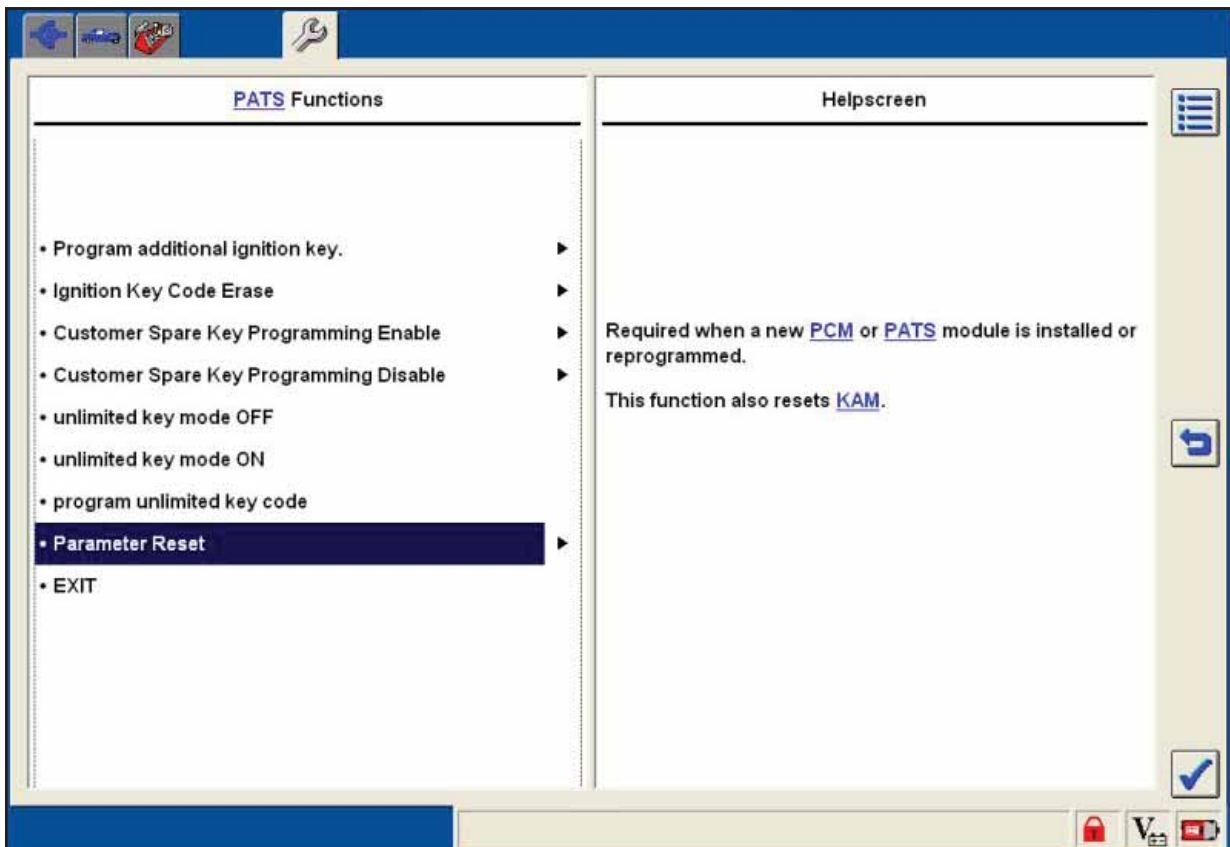
Figure 11: PATS function main screen

The TCM latched a code P1260 in memory because it did not belong in this vehicle, thus causing the PCM to go into an anti-theft mode. The PCM was in control of the PATS (Passive Anti-Theft System). It didn't put the theft light on, but it did put the vehicle into a failsafe disable mode. There was no As Built data for the TCM on the Ford website for this particular vehicle, but there was a procedure to line up both the PCM and TCM if either controller was replaced. This was done by going to the PATS function main screen (**Figure #11**) and selecting Parameter Reset. This procedure lines up both modules like a welcome-home party so that they can be paired together. After this procedure was done, I erased all codes in memory and turned off the ignition. When I attempted to start the vehicle, it started up with no lights and everything was back to normal.
