2Peas in a Pod

by John Anello

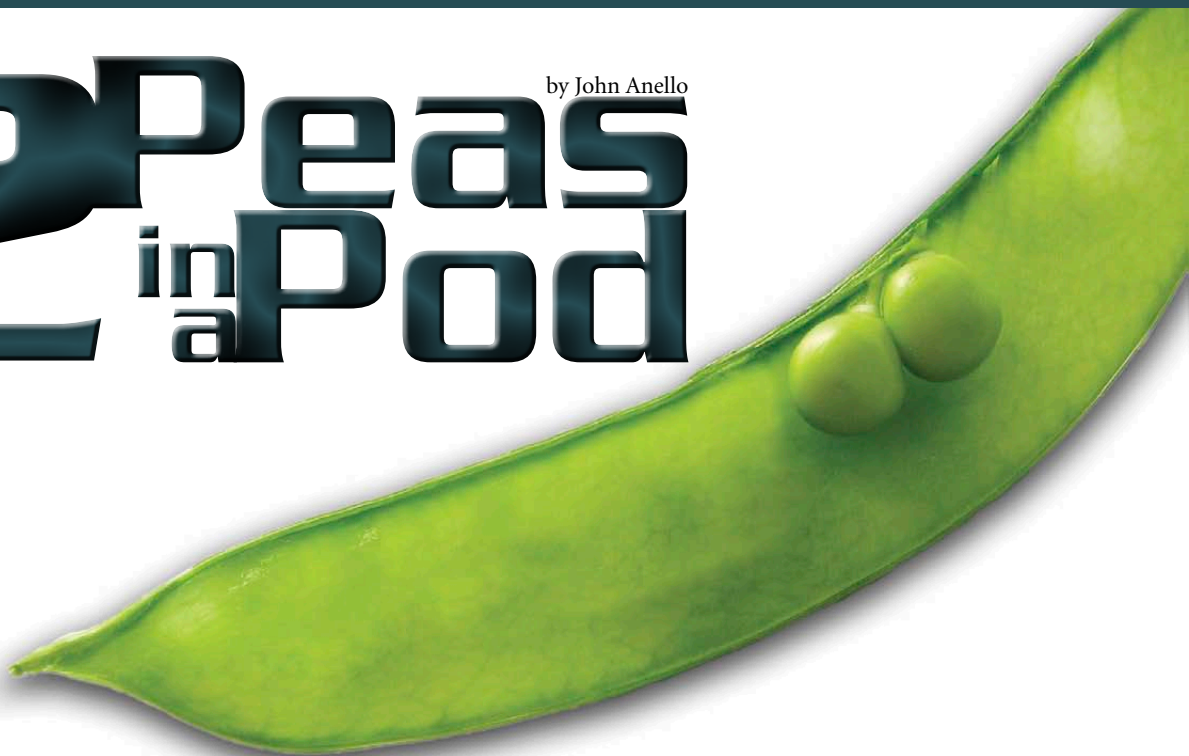
A shop called me in concerning a no-start complaint on a 2001 Chevy pickup with a 4.3L Vortec engine (Figure 1). It had 232,000 miles on it, and had sat for eight months in a back yard until the owner decided to revive it and put it back on the road. The only history the owner provided was that the vehicle ran badly, and that he didn't have the money at the time to fix it.

Figure 1: 2001 Chevrolet pickup with a no-start 4.3L Vortec engine.

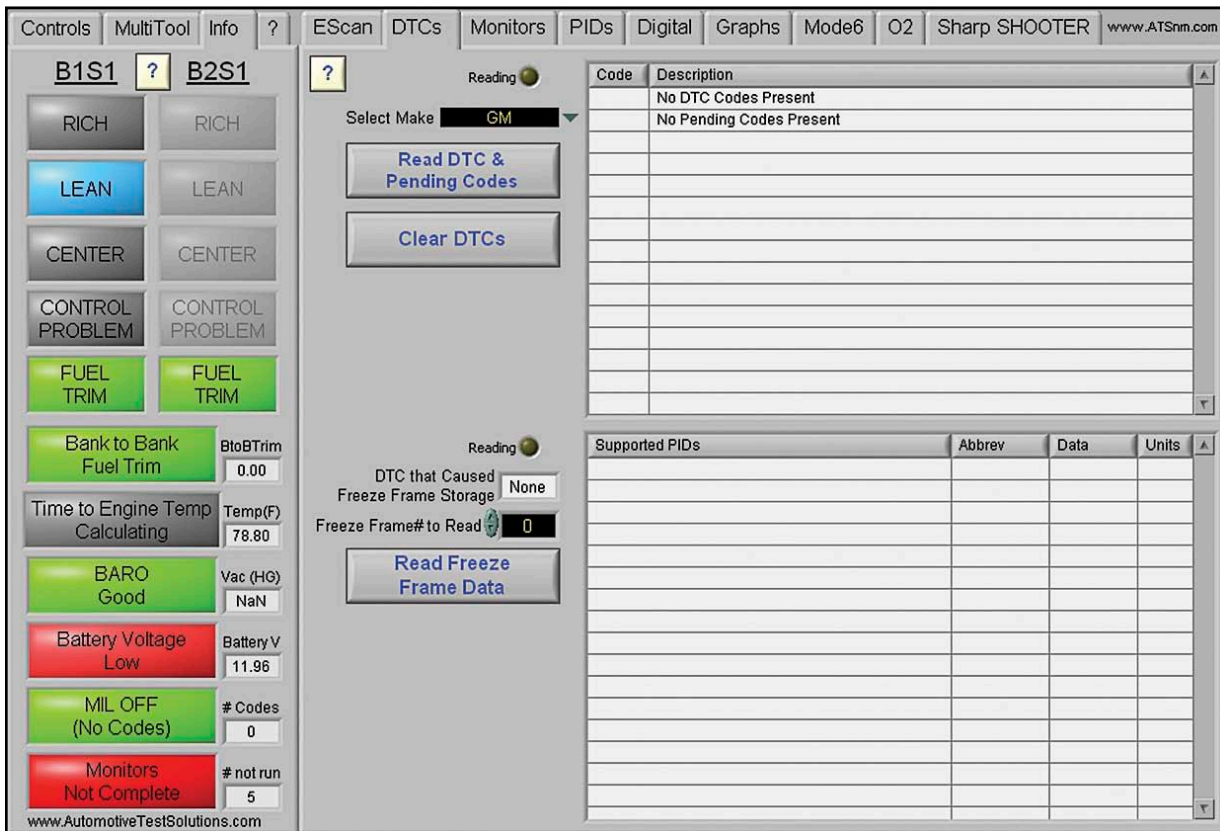
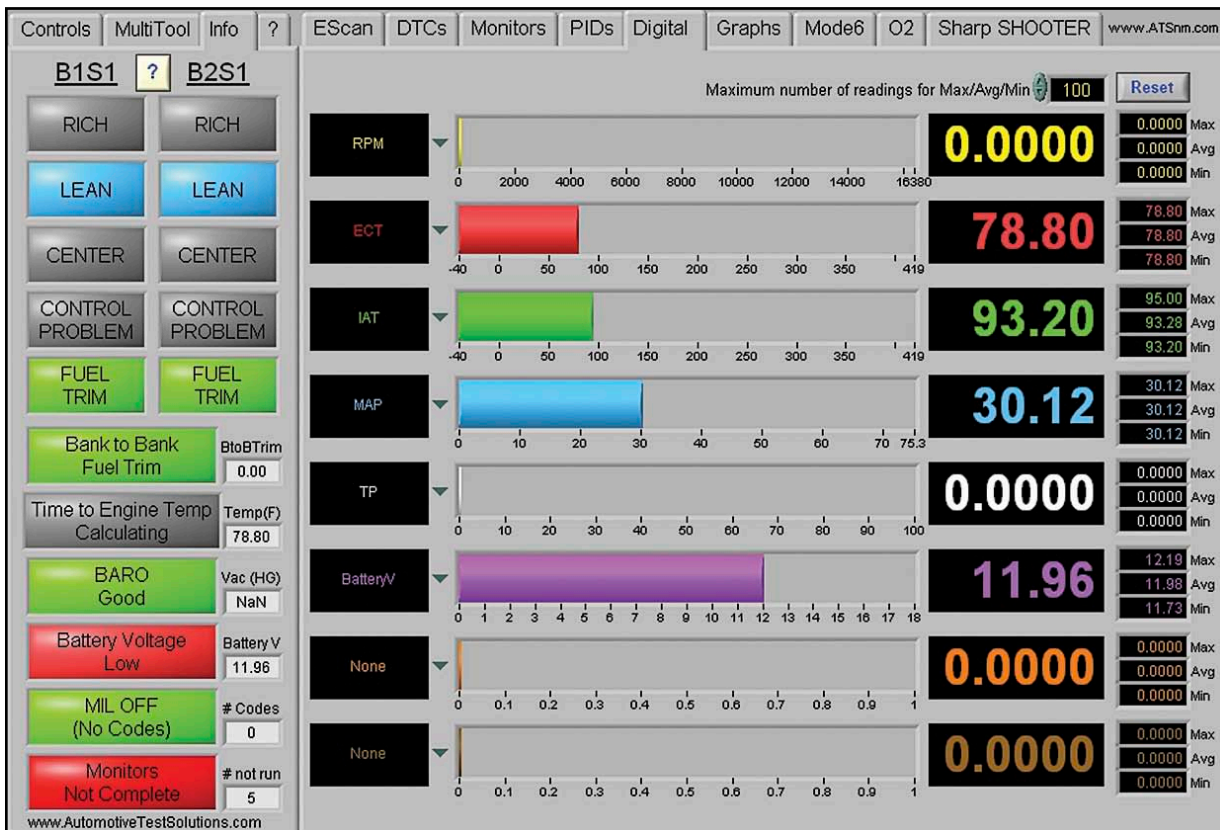
Figure 2 (Above) & Figure 3 (Below): A simple scan to make sure all the PCM's vital signs were in order.

When I arrived, I talked to the shop owner to get a little history on the vehicle and a description of what tests had been performed. I decided to do a simple scan (Figures 2&3) to make sure all the PCM's vital signs were in order. There were no codes in the system, and the data PIDs seemed to all be within range. Looking for codes and reading raw data such as coolant temp, air temp, TPS, or MAP can save a lot of time when dealing with an over-fueling engine, but sometimes you need to take a step back and look at the big picture. If the engine cranks and floods with raw fuel, it may not be due to a rich condition. It may be a lack of combustion created by valve timing, ignition timing, clogged exhaust, or even weak spark. The quickest way for me to validate most of these possibilities was simply to place a pressure transducer in any cylinder and use an inductive clamp to tag the

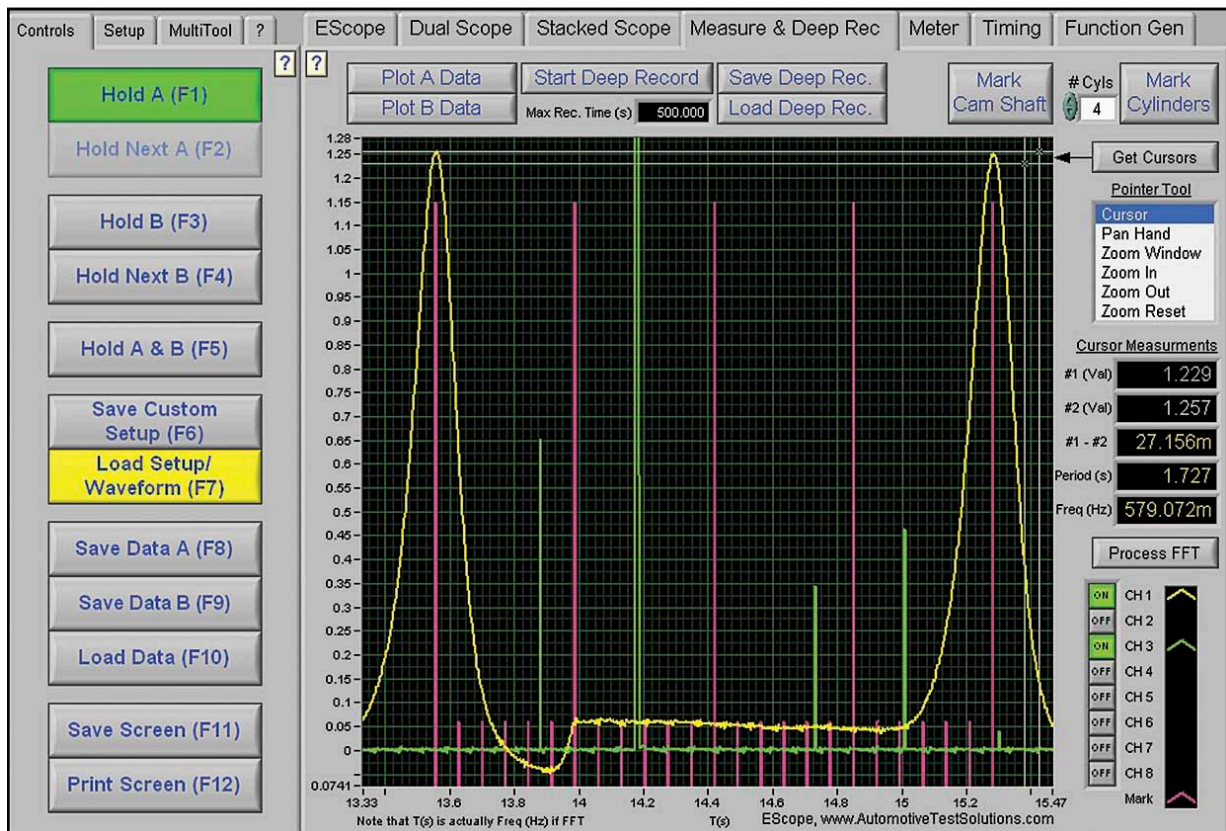
I chose to capture the events in cylinder #1 (Figure 4) using my scope program coupled with my pressure transducer and inductive probe. You first need to be aware that each large purple cursor represents 180 degree increments, and the smaller cursors represent 30 degree increments. The peak rise is the compression stroke, and the peak-to-peak rise is one full cylinder event of 720 degrees of crankshaft rotation. The small upward slope after the peak compression fall is the point at which the exhaust valve begins to open. I usually find this to be about 30-45 degrees before BDC of the power stroke while cranking the engine. The waveform capture (Figure 4) shows the exhaust valve opening at about 30 before BDC of the power stroke, which proved that the timing chain on this high-mileage engine had not jumped, and that the crank-to-cam gear correlation was correct. If you look at the green square waveform

Figure 4: The events captured in cylinder #1 using my scope program coupled with my pressure transducer and inductive probe.

pattern created by the inductive clamp, you can determine the time the spark occurred in the cylinder. There are other smaller green spikes, but these are usually caused by electrical noise the probe can pick up from other cylinders firing. The first rise in the square wave is the point where spark has occurred. By looking at the pattern, you can see that the spark was very late by firing about 255 degrees after TDC of the compression stroke. This engine was not out in valve timing, but had a serious spark timing issue.

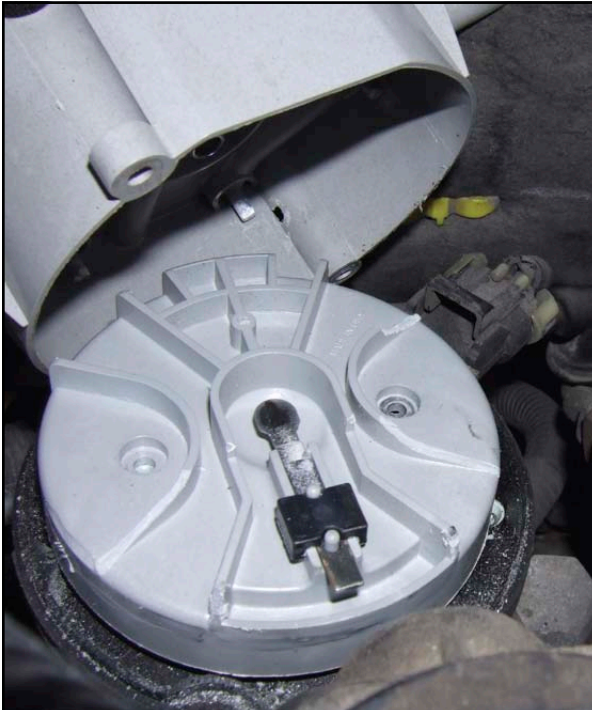
Figure 5: The distributor rotor was no longer secured to the distributor shaft because both screws were missing.

Spark timing malfunctions can be caused by a crank sensor or cam sensor correlation problem from out-of-synch trigger wheels, or possibly an incorrectly indexed distributor. The engine did run poorly before it was stored and finally cut out, so maybe the distributor gear was wiped. I set the crankshaft at TDC compression for #1 cylinder, and removed the distributor cap to check for proper rotor indexing, but was taken aback by what I saw. The distributor rotor was no longer secured to the distributor shaft because both screws were missing (**Figure 5**). The amazing thing was that it still spun when the engine cranked over, thus providing a good repetitive spark at the plug, but at the wrong time. Any technician checking the spark could have easily been fooled into thinking the spark was okay, but without the proper equipment it would be impossible to know just when the spark was actually occurring in the cylinder. Further inspection revealed the two missing screws to be lying under the rotor tucked away like two peas in a pod (**Figure 6**). It was as if they longed to be together in the face of doom when they both decided to jump ship together.

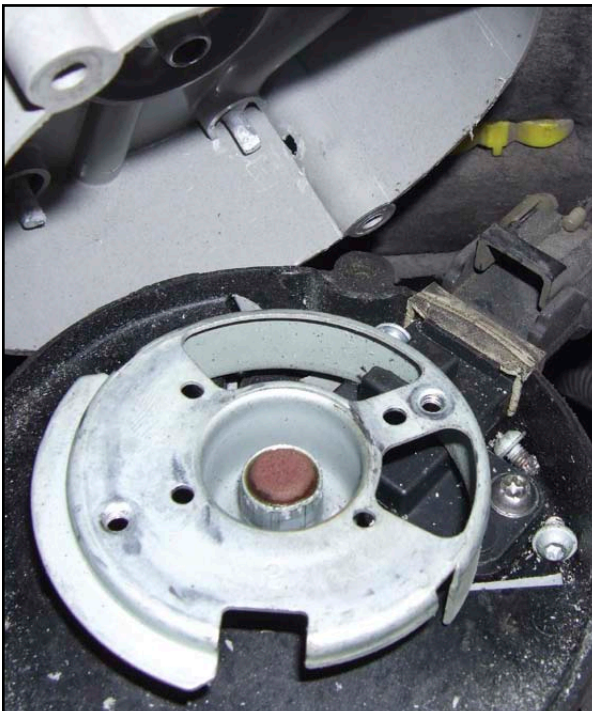
Figure 6: The two missing screws were lying under the rotor tucked away like two peas in a pod.
