# How “U” Doin’? Diagnostics

by John Anello,  
“The Auto Tech on Wheels”

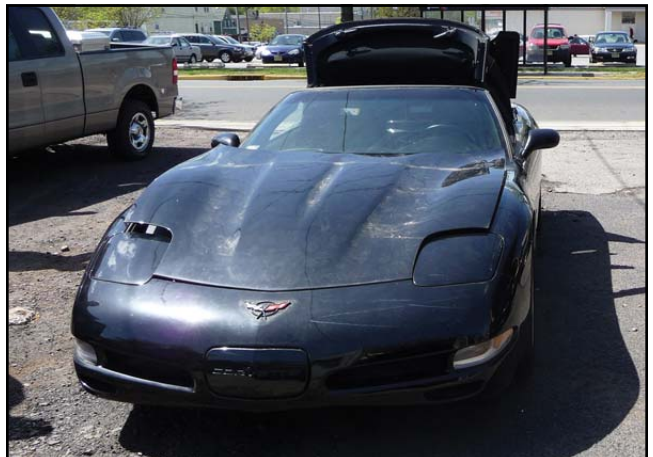
I was called to a shop on a 2004 Chevy Corvette with a no-start condition (Figure 1). There was no communication with the PCM and the security light was on. This prevented the engine from cranking. The tech had already checked all PCM powers and grounds, but was reluctant to condemn the engine control module because of the costs involved if he was wrong. There was a good chance that this would turn out to be a costly marriage, and there’d be no turning back. Divorcing an un-needed part is always a bad scene. So, at this point the garage opted to call me in for a second opinion.

Figure 1: 2004 Chevy Corvette with a no-start condition.

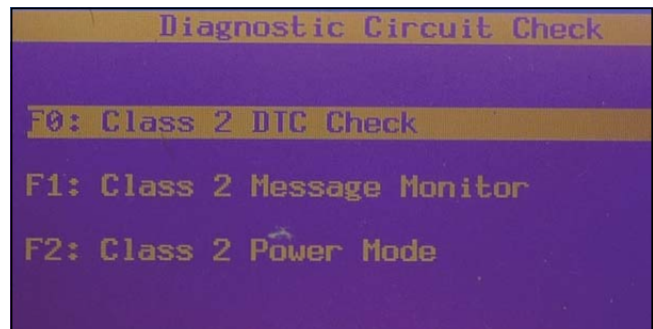
Figure 2: Class 2 DTC Check feature allows the scan tool to interrogate each controller for a health check and code status.

like doing a role call that pings all modules on board to see who responds and who is alive on the network. Simply navigating to the Class 2 DTC Check feature (Figure 2) allows the scan tool to interrogate each controller for a health check and code status. When I initiated this function, I received the message "No Communication with Vehicle" (Figure 3). This Corvette did not just have a PCM communication failure but also a network issue causing all controllers to be unresponsive. This is why it so important to use your scan tool to interrogate all possible modules that it supports because you just don't know how wide your problem is.

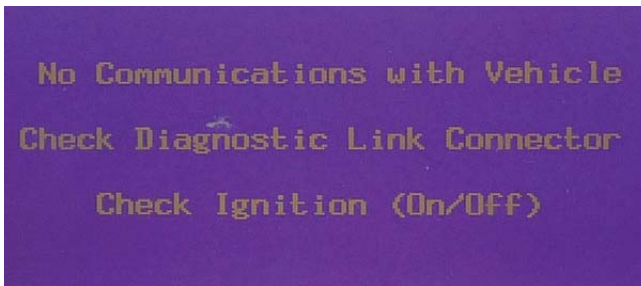
Figure 3: After initiating this function we received the "No Communication with Vehicle" message.

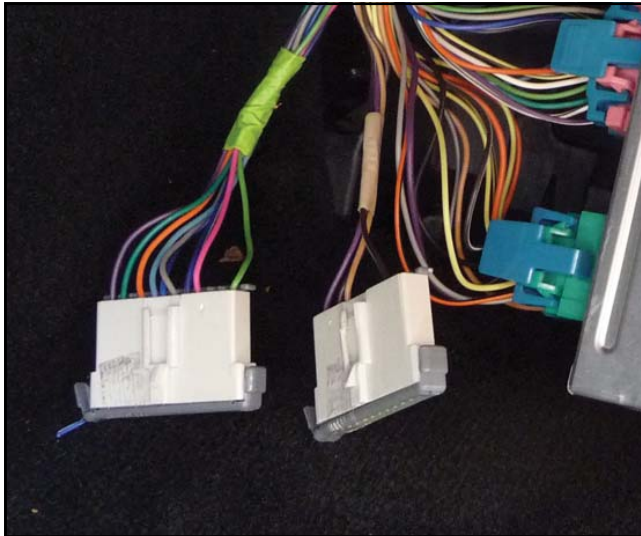
Figure 4: Two star network connectors conveniently located next to the PCM.

Some manufactures will place network lines into one accessible area for simplified testing, while others may fragment different groups of network connectors throughout the vehicle. This Corvette had two star network connectors conveniently located under the right side dash next to the PCM (Figure 4). I was lucky that day to have in my possession the Kent Moore Tool #J42236-A. I purchased it a while before to hook into both of the

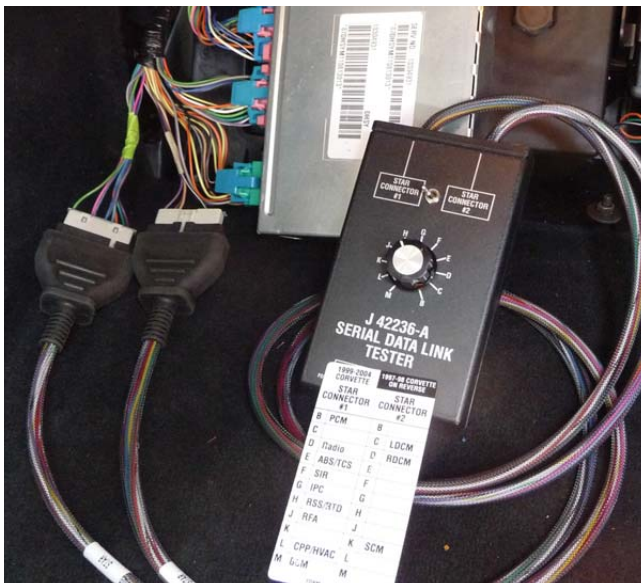
Figure 5: Removed the star connector combs from the connectors and installed the Kent Moore tool.

network connectors. This isolates the PCM from all the controllers on board and directly links PCMit to the data link connector to program the PCM in isolation mode. This prevents any controller network noise from affecting PCM programming. This tool has the ability to isolate each controller to the data link connector one at a time by the use of two selection knobs, allowing me to go into each controller separately to see which one had an issue.

I removed the star connector combs from the star connectors and installed the Kent Moore tool (Figure 5). I printed out a computer data line diagram from Mitchell-On-Demand and started checking off controllers that did respond as I moved the tool selector knobs

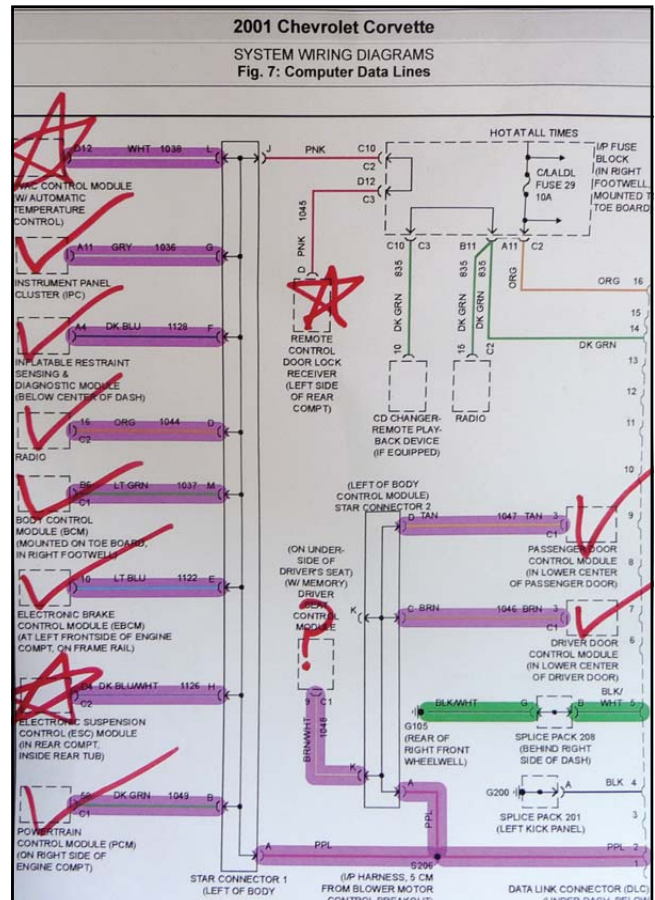
Figure 6: A print out of the computer data line diagram from Mitchell-On-Demand and checked off controllers that responded as I moved the tool selector knobs.

(Figure 6). All responded except for the Electronic Suspension Controller module, Remote Control Door Lock module, and the Driver Seat Control module. The fact that all the other controllers worked independently proved to me that one of these three unresponsive units was at fault. It was like rolling the dice at this point -- I had to decide which one of these three was the culprit. I removed the tool and placed the star connector combs back in place. I cut the wire to the ESC module and I still had no communication with the scan tool. I next cut the RCDL line (Figure 7), and, lo and behold, I got communication back with all the modules on board (Figure 8). The security light went out, so next I cranked the car and the engine started. Okay, I got the car running, but what about the RCDL issue?

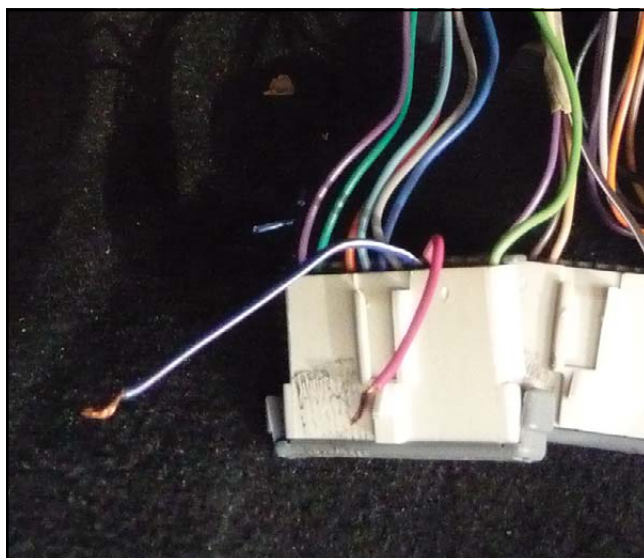
Figure 7: Still no communication with the scan tool. I next cut the RCDL line.

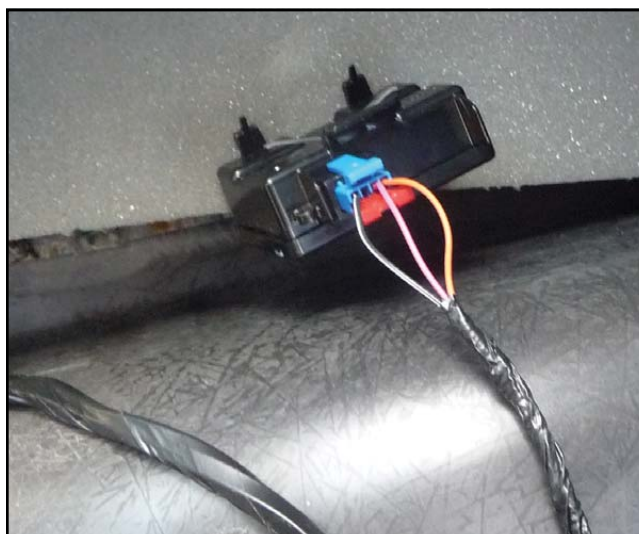
Figure 9: Locating the RCDL module in the left rear compartment, I checked the wiring before condemning it.

I located the RCDL module in the left rear compartment (Figure 9) and checked the wiring to it before condemning it. It's not uncommon for a bad module to back feed power or ground into the network causing communication failures. There were three wires at the RCDL module consisting of power, ground, and a signal line. When I checked the ground, it was elevated at 12 volts. This to me seemed like an open ground, and the 12 volts was probably back-feeding from the module 12-volt feed line. I decided to back probe the wire with a ground. When I did, I saw an arc. This was not a bad ground, but rather a 12-volt feed shorted to the ground line within the module, or externally to the ground feed line from another source. I immediately unplugged the RCDL module, but the 12 volt short remained on the ground feed line.

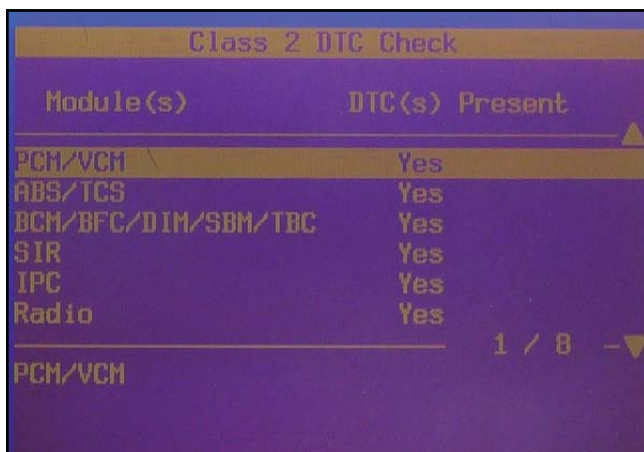
Figure 8: Communication is reestablished with all the modules on board.

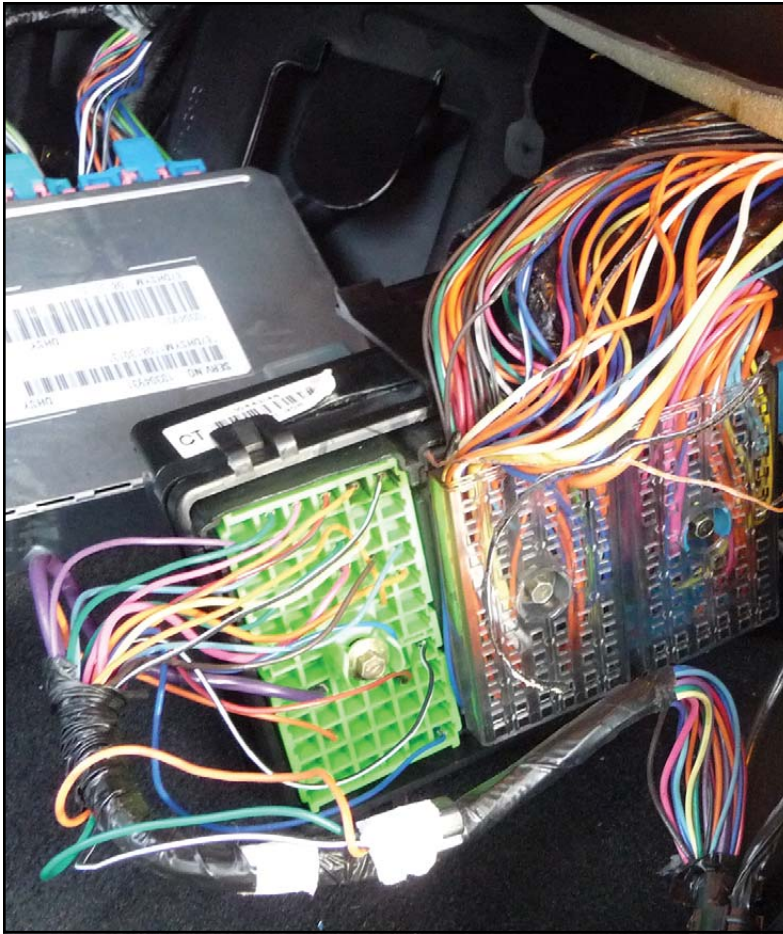
Figure 11: A closer inspection here showed a 12-volt feed line next to the RCDL ground.

I followed the ground wire back through the vehicle and it led me to a junction block in the right kick panel (Figure 10). A closer inspection here showed a 12-volt feed line next to the RCDL ground (Figure 11). This line bridged itself to the ground feed and burned the ground all the way back to a firewall splice where it was stopped by a heavier gauge wire that led through the firewall out to the the frame rail in the right-side engine compartment (Figure 12). The splice gave in, but the heavy-gauge wire leading back to the frame well held its ground (no pun intended).
