Bushings, Ball Joints & Bearings Oh My!

An important part of any well-engineered vehicle is its handling. A taut suspension provides precise control and safer driving. But when the components involved wear out, the suspension can't perform as designed.

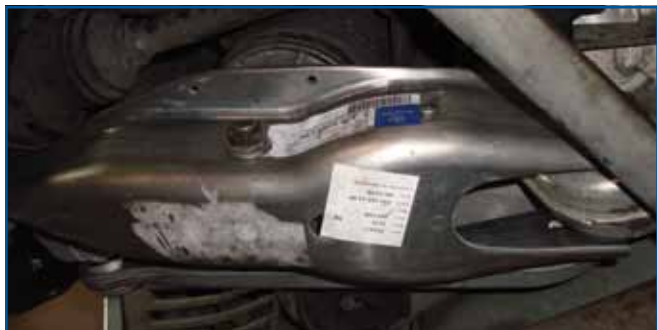
Here, a rear lower control arm needed to be replaced. Using OEM parts supplied by our Mercedes-Benz parts dealer, the fit of the component was the same as the original, so there was no extra labor wasted in trying to get an aftermarket part to fit.

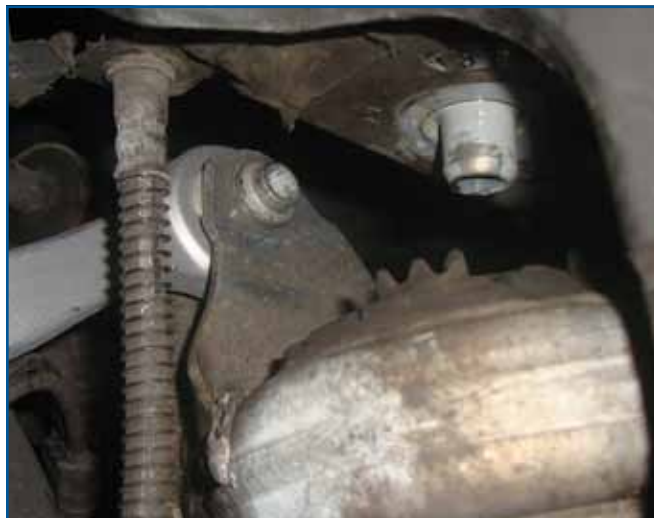
On most chassis, if the forward upper link of the rear suspension needs to be replaced the sub-frame will have to be dropped to remove the bolt. Here, the technician has reversed the direction of the bolt to make future service easier. If the vehicle has a hydraulic suspension it needs to be depressurized with the SDS before beginning the repair.

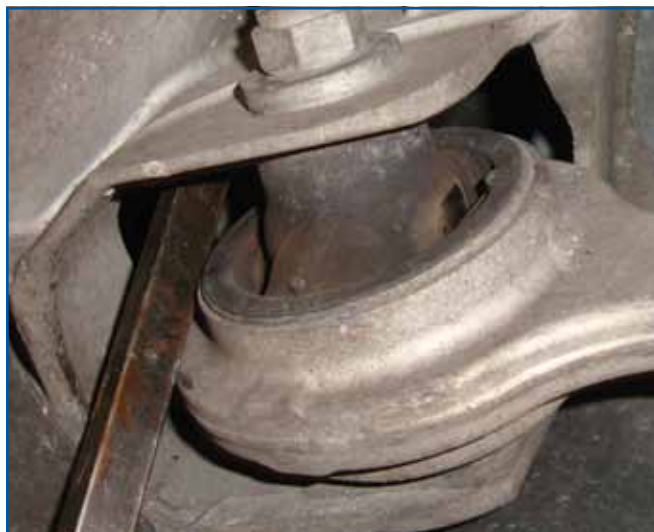
Mercedes-Benz does not recommend the traditional practice of prying between the chassis and the arm to check bushings as it's too easy to damage them, especially if they are of the hydro-bushing type. Instead, do a thorough visual exam using a good light. Look for deep cracks and leaking fluid. Note that the new ones will probably have to be installed in a specific position. Check www.startekinfo.com for the proper procedure.

—Bushings can soften and crack over time, so inspect the rubber insert carefully using a good light. Typically, a bushing has an outer housing attached to the arm, an inner mount secured to the chassis and a rubber webbing in between to absorb vibrations. If the rubber has cracked, it will allow the arm to vibrate with road irregularities. This can be felt in the steering wheel and the chassis. If oils from the other systems under the hood leak onto the bushings, they can soften them and allow excessive steering deflection. This changes handling characteristics, especially under heavy loading. In many instances, bushings can be replaced separately, but you should also check the joint at the other end of the arm as it may need to be replaced as well.

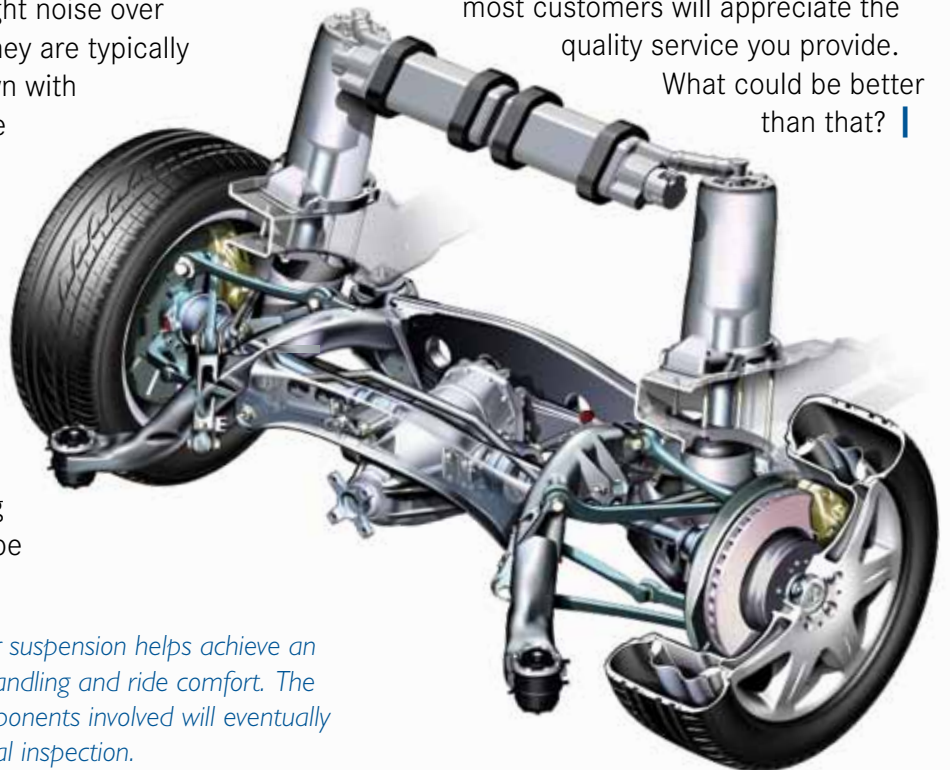
Right: Mercedes-Benz's multi-link rear suspension helps achieve an unparalleled combination of sporty handling and ride comfort. The many bushings, joints, and other components involved will eventually require that you do a very professional inspection.
