# Diagnostic Blitz

*How can applying the brakes cause an engine to go lean? No, it's not the booster.*

by John Anello,  
"The Auto Tech on Wheels"

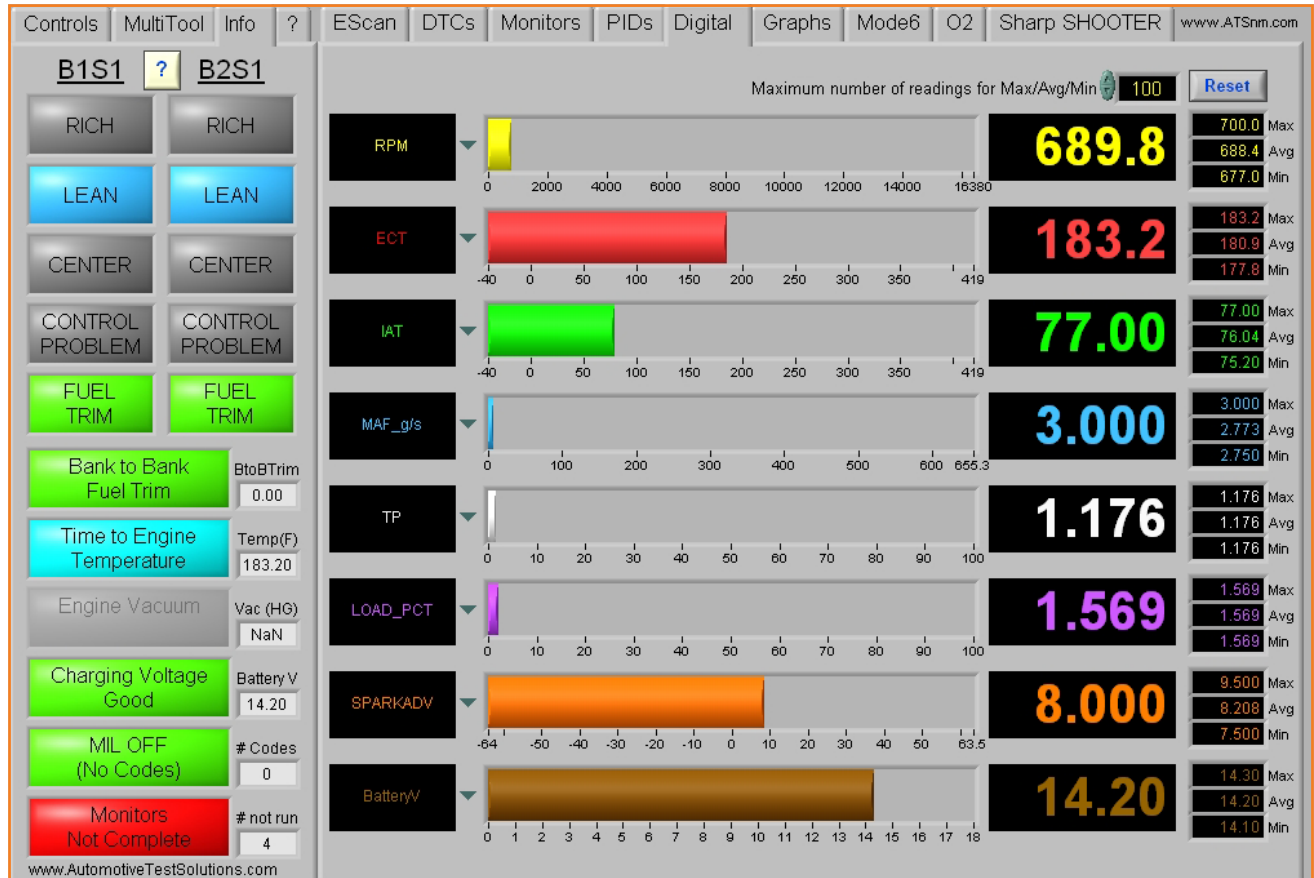
Figure 2: EASE scan tool to view some basic parameters.

I hooked up my EASE scan tool to view some basic parameters such as rpm, coolant and air temp, mass air flow and throttle position (Figure 2), and everything seemed to be within range with my foot off the brake pedal. When I placed my foot on the brake pedal, I didn't see any drastic changes in any of the parameters to point me in a sensible diagnostic direction. The shop mentioned to me that the fuel trims were changing when the brake pedal was being applied, so I decided to warm up the engine to take a look at it myself. I placed the long-term and short-term fuel trims in a graphing mode using one screen on the Escan, then placed both upper O2 sensors in a graphing mode on another screen. I watched the O2 sensors and fuel trims with the engine idling and all seemed okay (Figure 3). When I stepped on the brake pedal, however, both O2 sensors went lean and the short-term fuel trim maximized to positive 25% without the PCM achieving any fuel control at all (Figure 4). This could be seen by viewing the flat line in both O2 signals that stayed near zero. As soon as I took my foot off the brake pedal, both O2

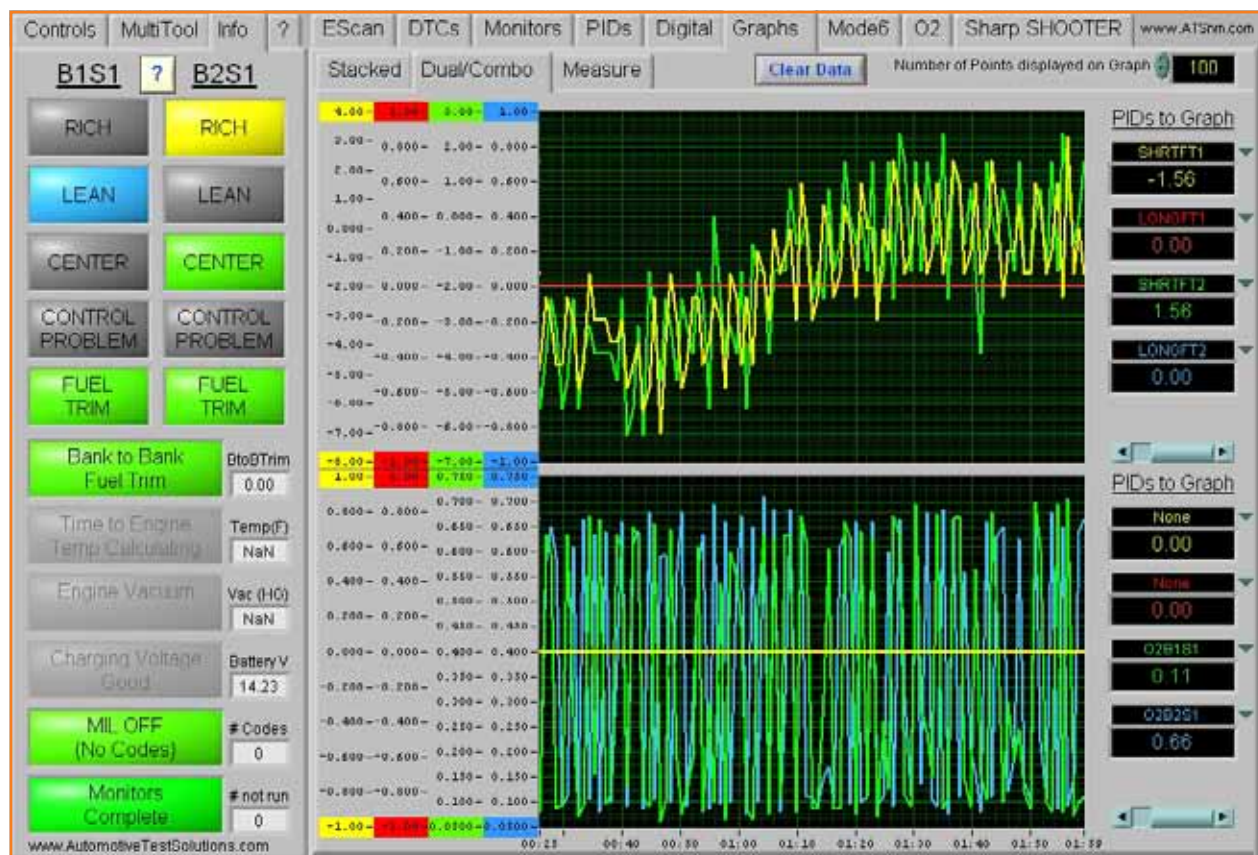
Figure 3 (Above): O2 sensors and fuel trims with the engine idling and all seem okay.  
 Figure 4 (Below): Stepping on the brake pedal, both O2 sensors went lean & the short-term fuel trim maximized to positive 25% without the PCM achieving any fuel control.

sensors hung at close to 800 mV due to the added fuel needed to overcome the prior lean problem. The PCM immediately went into fuel control by decreasing the fuel trim to about negative 10% to achieve O2 switching.

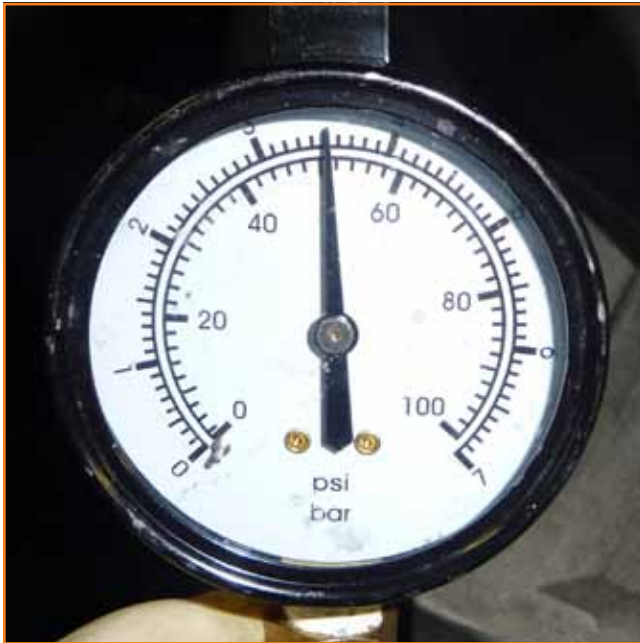
*Figure 5: At idle, with foot off the brake pedal, pressure was within specifications at about 50psi.*

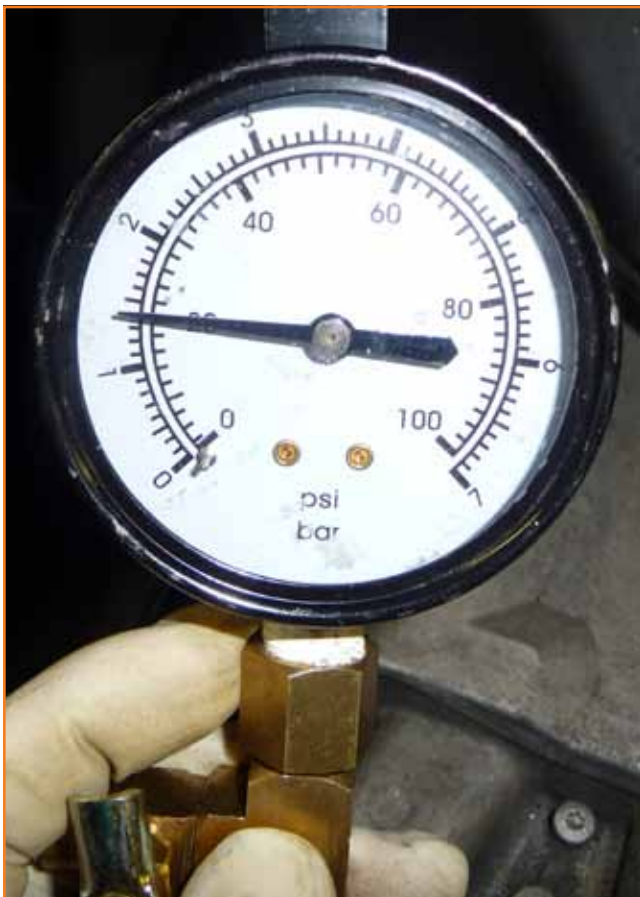
*Figure 6: Applying the brake pedal, pressure dropped to about 20psi.*

shared ground or power feed with the fuel pump that was being overloaded. I was now on a diagnostic blitz mission because I had found the cause of the seemingly mysterious problem, but I needed to isolate the specific location of the defect. It was all about fuel pump wiring.

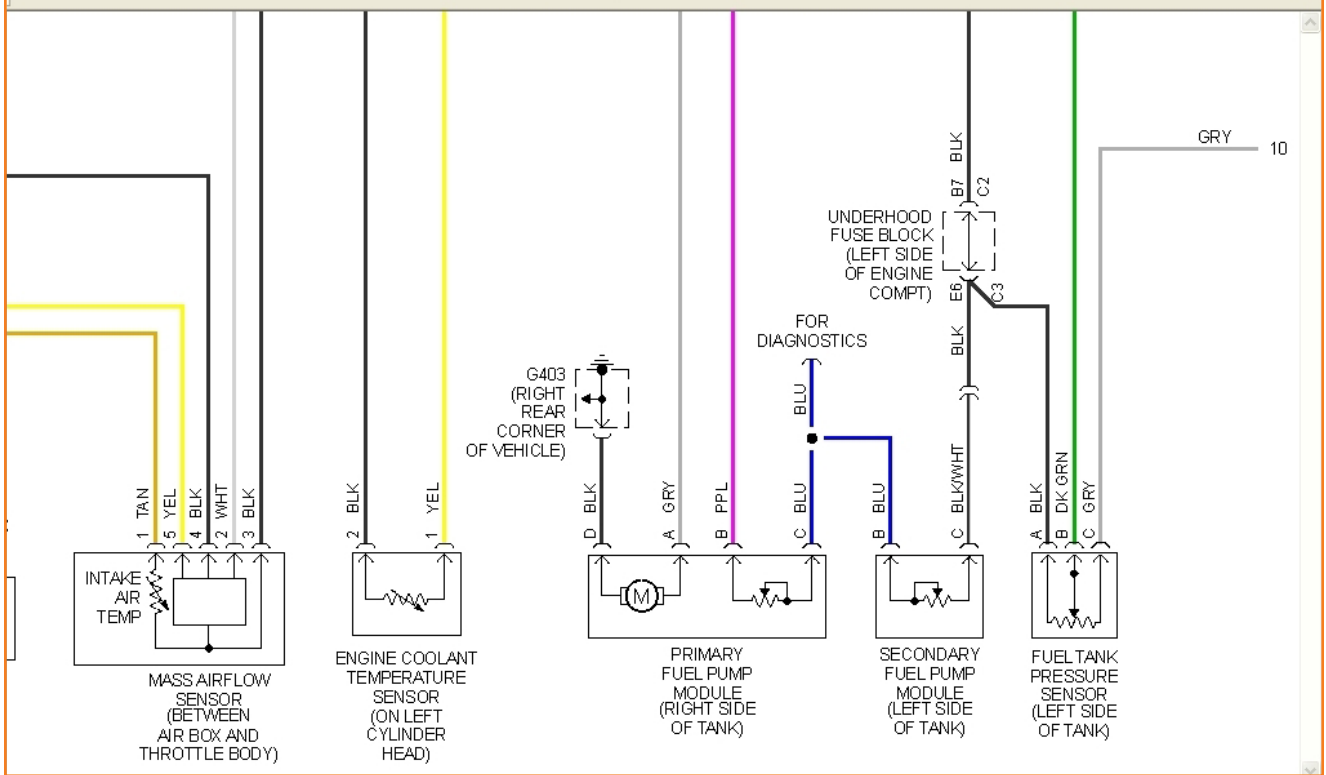
Fig. 21: 3.0L VIN R, Engine Performance Circuit (2 of 3)

Figure 7: Mitchell Repair Information system diagram of fuel pump circuit.

I went directly to the fuel pump feed wires under the vehicle and I had the tech apply the brake pedal while checking the power and ground feeds to the pump. I discovered a weak ground for the fuel pump. I followed the ground wire, but it seemed to travel back into the car. I didn't want to waste a lot of time just looking around and hoping and poking -- I needed to know exactly where the pump ground resided. This is where an information system that will show you what grounds are shared and where to locate them in the vehicle comes in handy. So, I went to my Mitchell Repair Information system to pull up a diagram of the fuel pump circuit. It labeled a pump ground #G403 located at the "right rear corner of the vehicle" (Figure 7). I also pulled a diagram of the brake lights (Figure 8) and discovered that there was a common ground "splice pack" #G403 located in the "right rear of storage compartment." I appreciated this more precise location description because "right rear corner" did not specify inside or outside of the vehicle. Then again, it was only a label on a diagram and not a ground location feature, which I would have used next within the program.

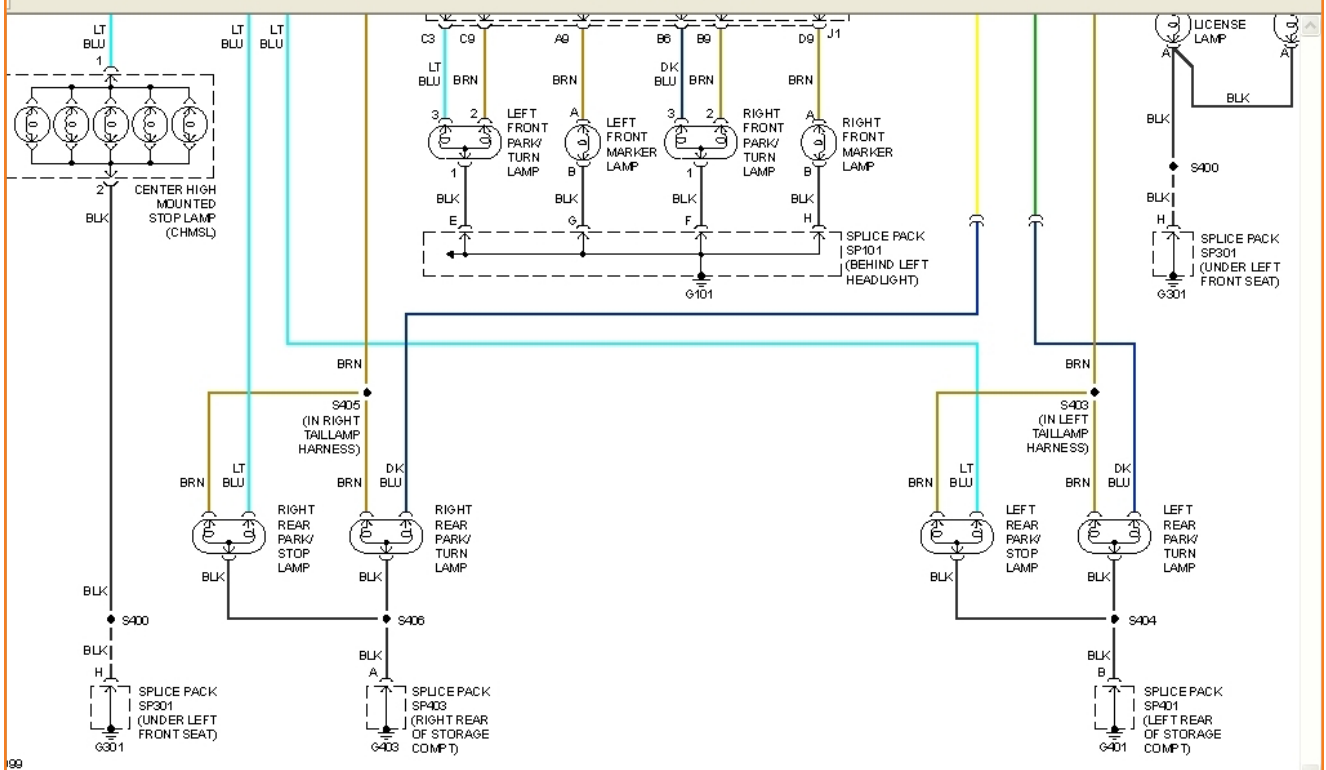
Fig. 24: Exterior Lamps Circuit

Figure 8: The diagram of the brake light circuit gives good descriptions of ground locations.

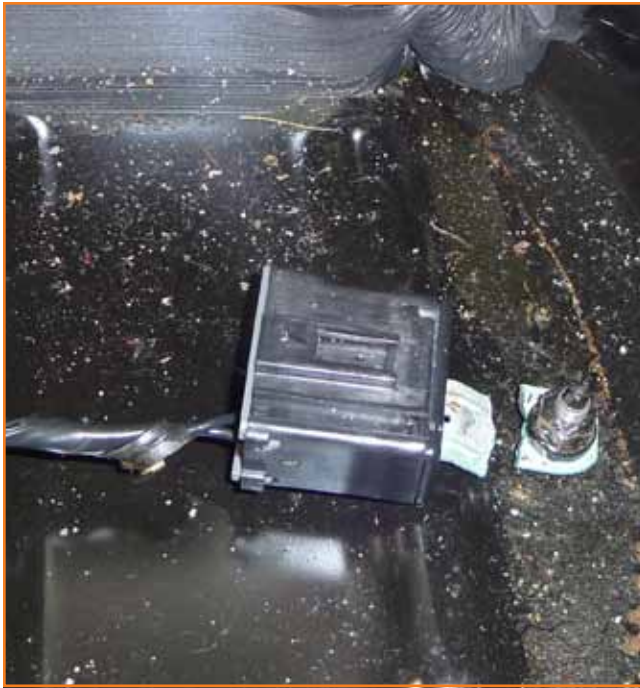
Figure 9: Broken ground found in the right rear cargo compartment.

I opened the hatch and pulled back the rug at the right rear and found a broken ground strap (Figure 9). There was no direct fuel pump ground feed to the body of the vehicle, but rather a ground that was supposed to back-feed through this broken strap into the harness. Looking at a similar ground in the left rear cargo compartment gives you an idea what a good connection should look like (Figure 10). What was amazing to me was how the fuel pump motor back-fed through that connection to achieve enough of a ground to run at all. If any shared circuit on that connection suddenly needed a ground when the brakes were applied, there was just not enough to go around. This was why the fuel pump slowed down and put out less fuel pressure whenever the brake lights were energized.

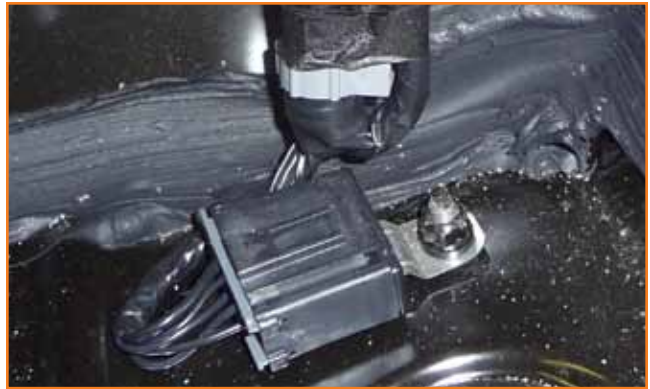
Figure 10: This is what the ground should look like.
