Diagnosing Power Seats

Though very durable and dependable, after long use Mercedes-Benz power seats can develop problems. Here's how to approach them.

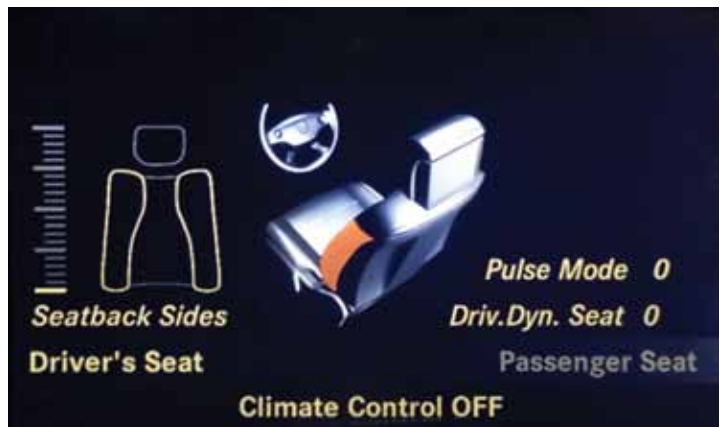
The Dynamic Seat function uses steering sensor input to instantly inflate the side cushions in tight turns to keep your body more stable.
