Beating Around the Bushings:

Suspension & Steering Joints

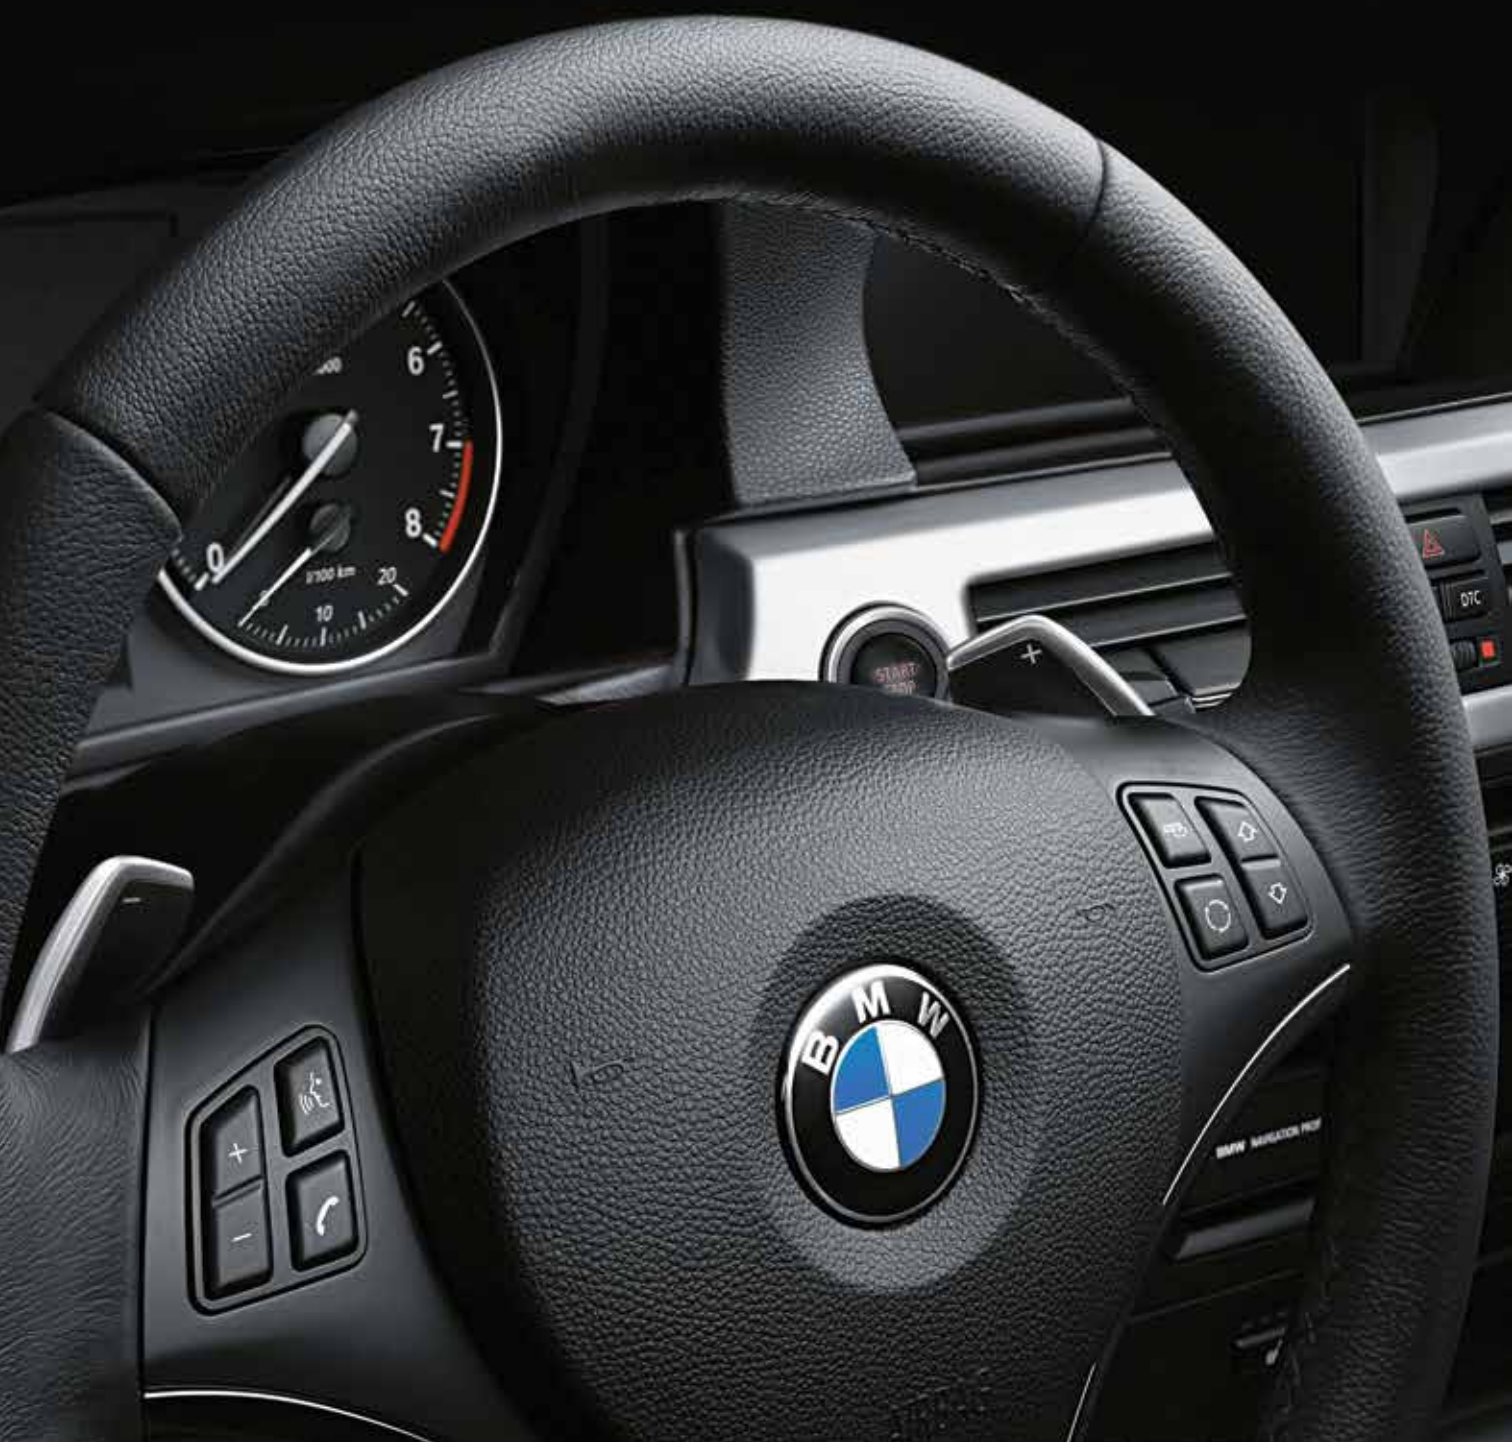
Left: In BMW's Electric Power Steering (EPS) system, a torque sensor measures the force the driver applies to the steering wheel, and adjusts the vehicle's steering characteristics. BMW calls the system "low maintenance" – translation: You can replace rubber boots and adjust alignment, but everything else is factory-sealed.

Another example is the Electronic Power Steering (EPS) system. You can replace the rubber boots and adjust alignment. Everything else is sealed at the factory, and therefore other components are not serviced separately.

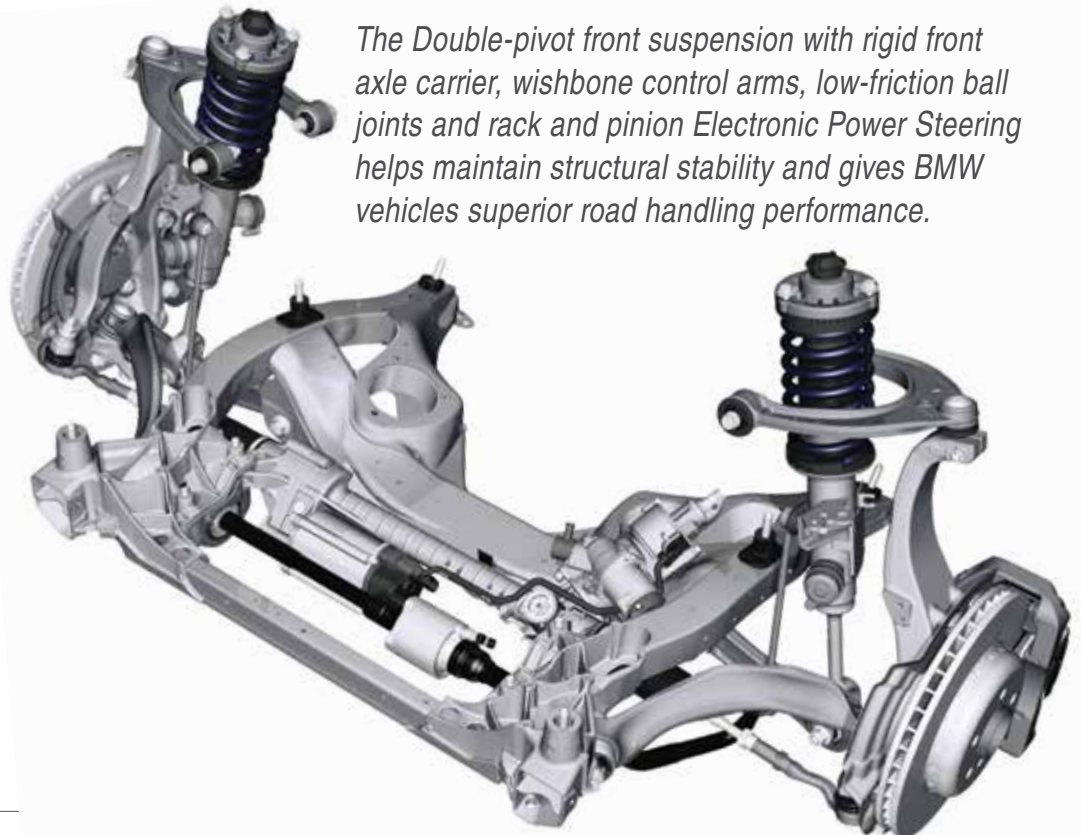
The Double-pivot front suspension with rigid front axle carrier, wishbone control arms, low-friction ball joints and rack and pinion Electronic Power Steering helps maintain structural stability and gives BMW vehicles superior road handling performance.

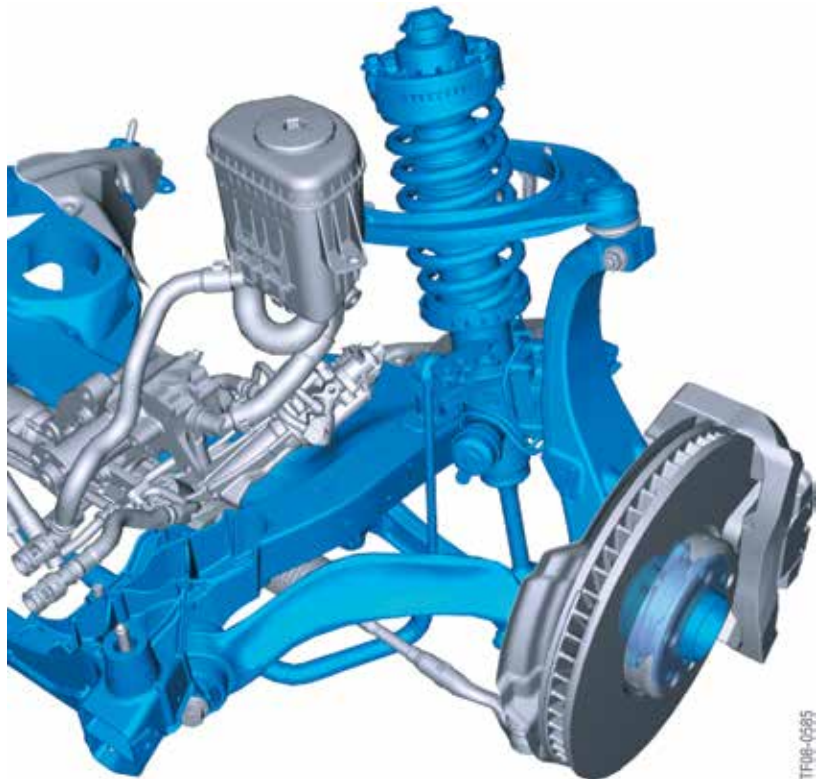
The upper control arm reduces camber changes during jounce and rebound events. The arrangement of the front suspension includes bushings at multiple swivel points. This helps reduce friction, which allows the damper to respond extremely quickly to road surface irregularities.

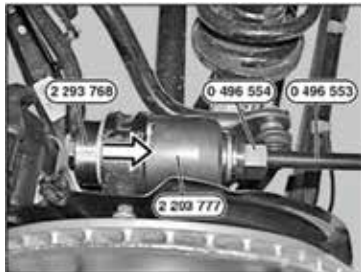
The Rubber Bushing Remover is used along with Sleeve 2 293 777, Spindle 0 496 553 and Nut 0 496 554 to remove the Upper Wishbone

Bushing. For complete instructions for this tool, refer to ISTA Repair Manual section 33 32 029. The same tool is also used to remove the bottom trailing arm bushing (see ISTA Manual section 33 32 031 for details).

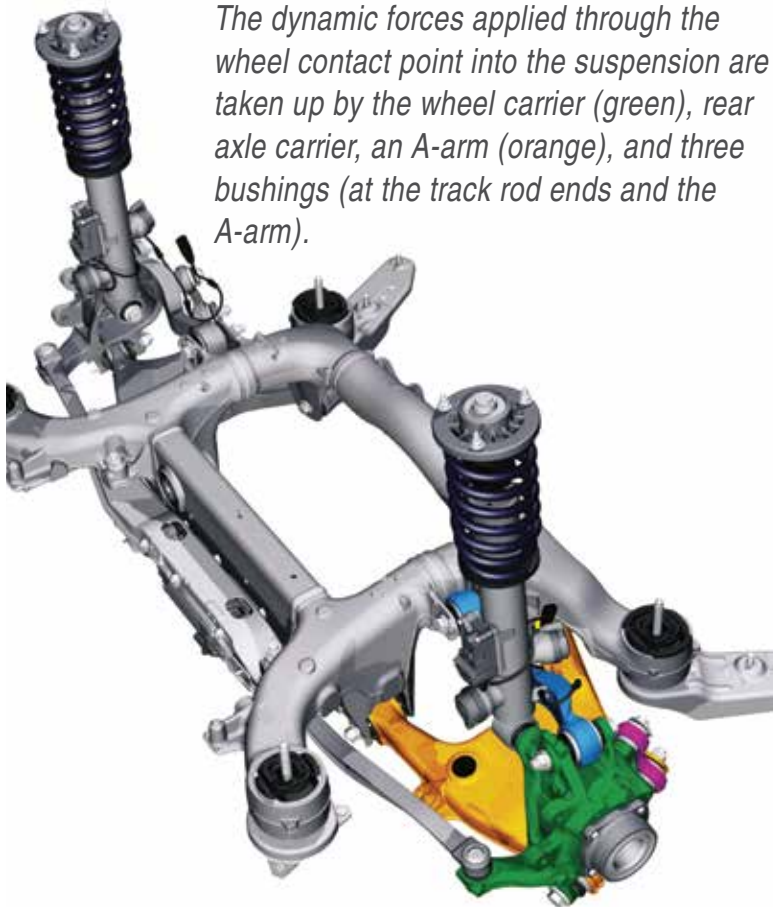
The dynamic forces applied through the wheel contact point into the suspension are taken up by the wheel carrier (green), rear axle carrier, an A-arm (orange), and three bushings (at the track rod ends and the A-arm).
