Climate Control Vents: Fair or Ill Wind?

Mercedes-Benz
has gone far
beyond cables and
vacuum to control
HVAC accurately.

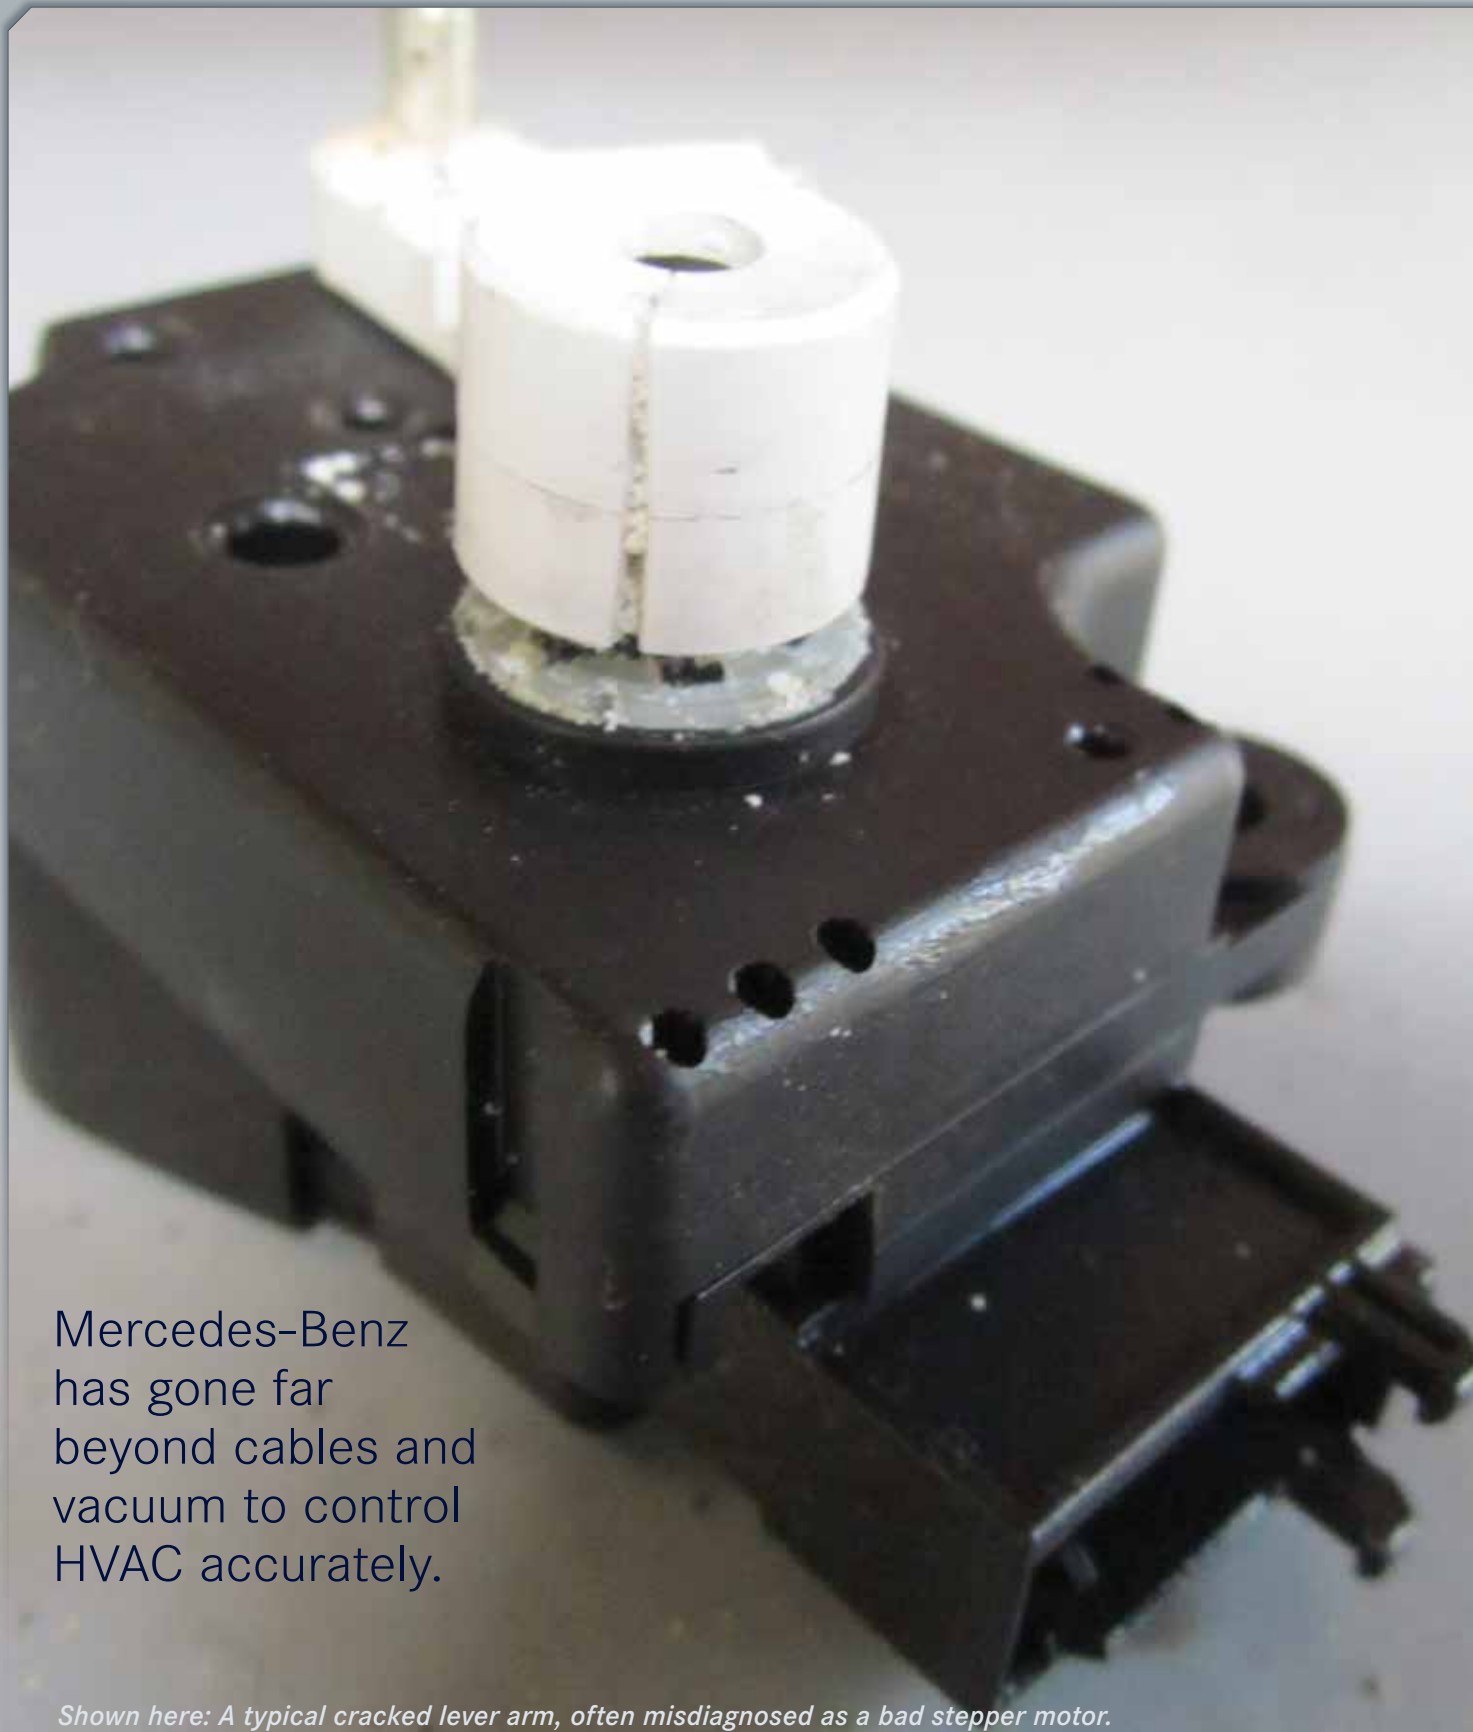
Shown here: A typical cracked lever arm, often misdiagnosed as a bad stepper motor.

perpetual motion, a clicking noise, or just no vent action at all. Time and time again stepper motors are condemned for the problem when, in fact, they work perfectly. The most likely culprit in these situations is a broken or cracked actuator linkage. These linkages are plastic and subject to wear. They are, in some cases, easily replaced with minimal disassembly. In other cases, it may require an involved dash tear-down with a significant cost. This makes accurate diagnosis of this (or any problem for that matter) with climate control by the Independent Service Provider a wise practice. Guesswork could cost both you and your customer financially, or add unneeded stress due to a bad diagnosis not based on facts. Other problems to look out for, as on many other systems on a vehicle, are if there are multiple failures or faults at the same time. The same basic diagnostic analysis is applicable, such as:

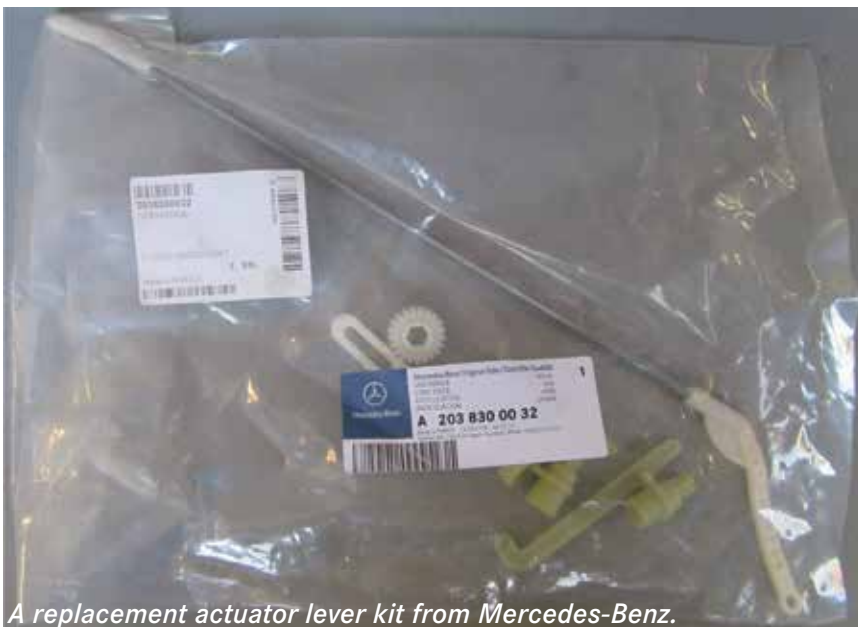
A replacement actuator lever kit from Mercedes-Benz.

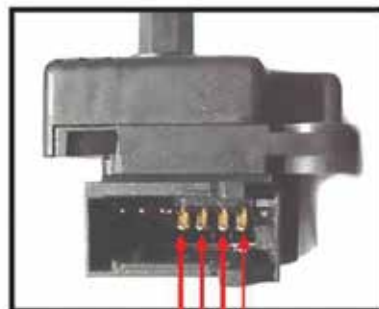
Flap Motor Coding

4 pins for coding

Plastic bridges built into the connector plug act as spreaders forcing shorting pins apart. Since there are 4 pins up to 16 coding variations are available.

Plastic bridges

A coding plug used to assign the positions of stepper motors as seen in W203 W463 HVAC literature.

The first stepper motor system found on vehicles such as the W203 C-Class and W 220 S-Class were Controller Area Network (CAN) based, meaning they operate on the interior CAN, and as such can be influenced by other faults in the network. All stepper motors are identical, so how does the controller know which is which? On the CAN system, all motors work off of a single ribbon cable originating from the climate control panel. Spliced onto the cable are colored connectors. Each connector (depending on color) has specially-placed dividers that open or allow closed control pins on the motor itself. This could be compared to the way you would place jump terminals on a computer hard drive, or flipping dipswitches on older remote controls. These first systems differ slightly with some using a three-wire cable to assign motors, and others a four-wire cable on more complex options that require additional motors.

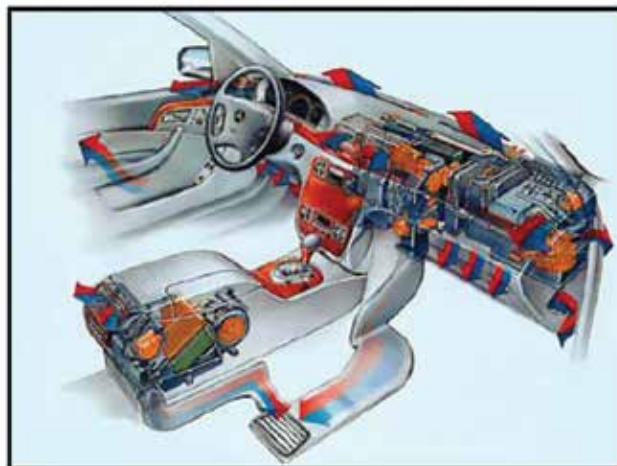
The dash vents of a typical late-model Mercedes-Benz are quite complex.

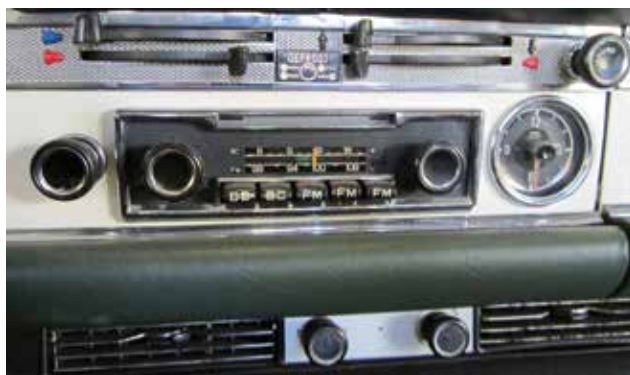
We've come a long way from the vent slides and under dash-mounted air conditioner of this 1968 280SL.

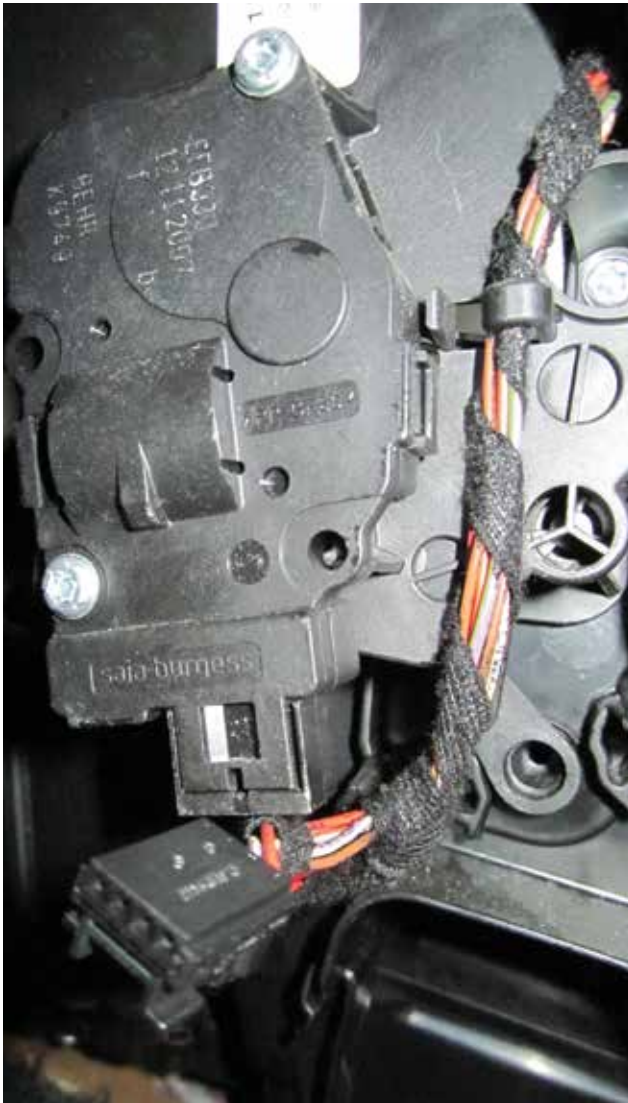
With this LIN system stepper motor, there are no color-coded plugs since these actuators are given a digital address.

The second system found on all later Mercedes-Benz models is Local Interconnect Network (LIN) based. LIN is a sub-network used to drive serial or multiple like components. The advantages of LIN are that it's cheaper to implement, reduces the burden on the interior CAN bus, and (because of its simple programming) can be expanded easily as future needs develop. LIN also eliminates the need for special connectors for motor identification. As with the CAN system, LIN-based motors are identical. The LIN system has the ability to assign a motor digitally to a specific location to perform a specific task. In essence, this is a form of version coding accomplished through a teach-in process.

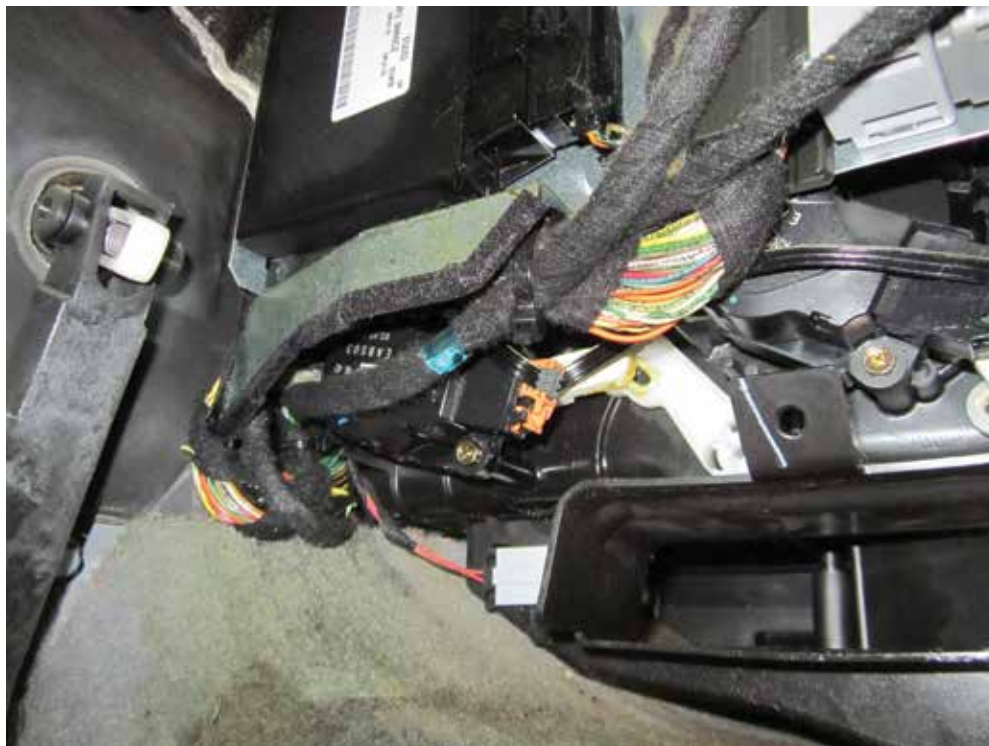
In this under-dash shot of a 2004 ML500 W163, if you look closely you can see where transmission fluid wicked all the way through the harness to the transmission controller above. The ATF then spilled out and contaminated the HVAC stepper motors directly underneath. The initial customer complaint was erratic vent operation.
