# Fresh Air Blower Performance

*Heating and cooling functions depend on proper operation of the HVAC system*

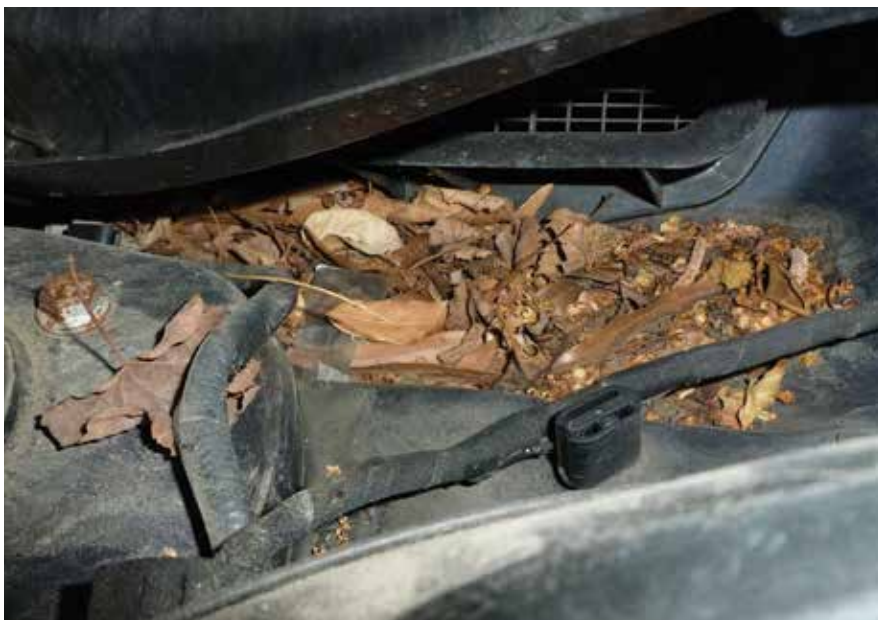
*Plant matter tends to accumulate in and around underhood drains. These drains must be periodically cleaned and cleared, just like sunroof drains.*

An issue often neglected by vehicle owners is cleaning out the cowl area of their vehicle. Many motorists are not aware that pollen, dirt, and plant matter may accumulate under the hood. This can eventually lead to a buildup of material that impedes fresh air blower performance. In extreme cases,

organic matter can clog the cowl drain, causing rain water to overflow into the fresh air intake. This can damage the blower motor and associated components, necessitating replacement.

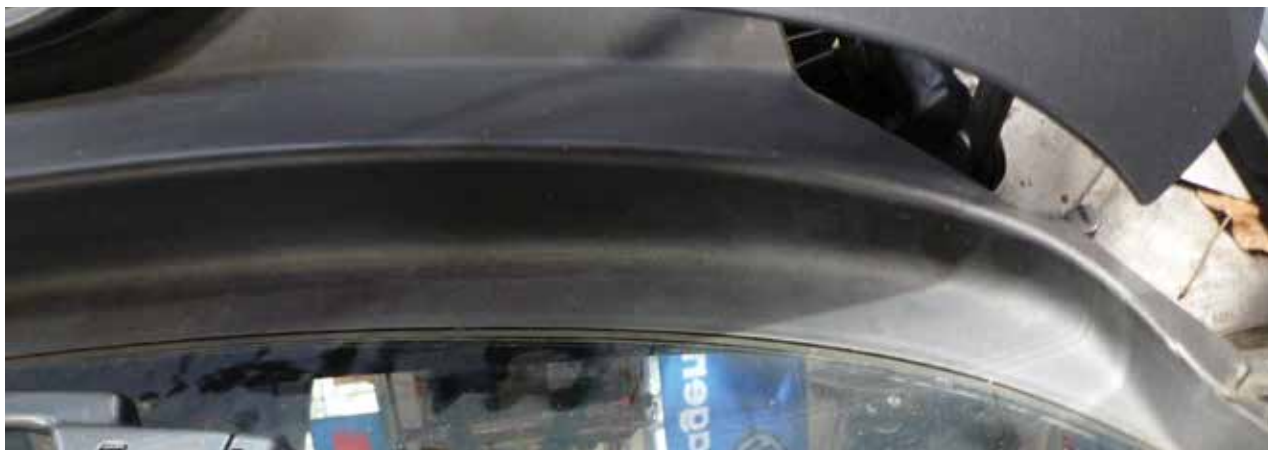
*The cowl seal is very important in keeping water out of the vehicle as well. These seals can become damaged or pop out of their guide track occasionally. If these seals are not fully seated, rain water can wash directly down the windshield into the air intake. Not good!*

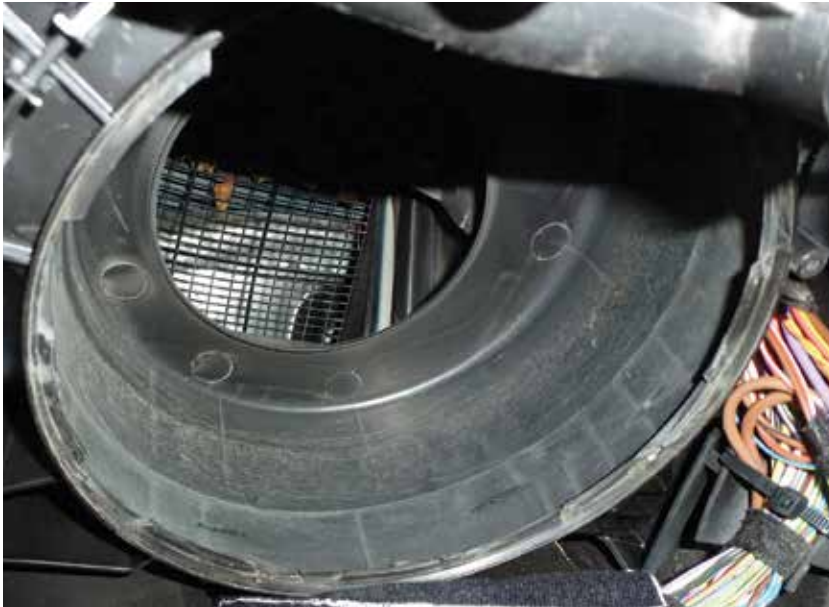
*As you can see, the inside of the blower casing is not protected. Any water or material that flows into the intake can fall directly into the blower motor.*

Water can quickly damage the electrical components as well as the bearing surface on which the motor rides, which can render the motor inoperable or increase noise from the blower motor. This water damage can appear as a green corrosion buildup on connectors and the motor windings. If you must replace the blower motor due to water ingress, it is wise to replace the blower resistor at the

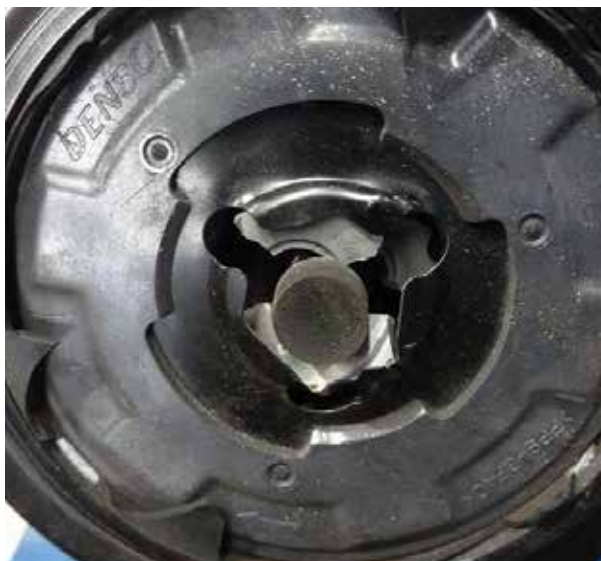
*After removing the dust cap, most pulley damage is apparent. This compressor was still spinning, although it was noisy.*

If the compressor exhibits strange noises or if customers complain of drive belt noise, it is wise to inspect the compressor pulley. Using a stethoscope is a good way to localize strange noises from accessories. Visual inspection is also possible but may be difficult without removing the dust cap on the front of the compressor. Often, when the pulley has separated, bits of material may remain on the bearing surface, creating loud noise as it spins.

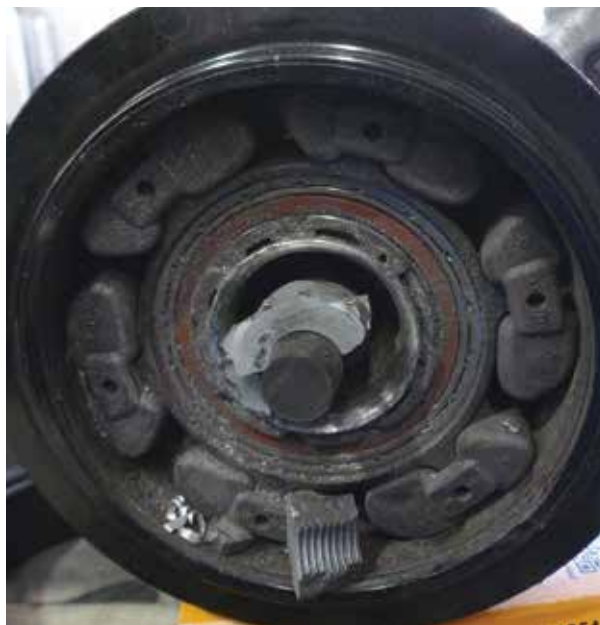
*Fully exposed you can see the damage to the compressor.*

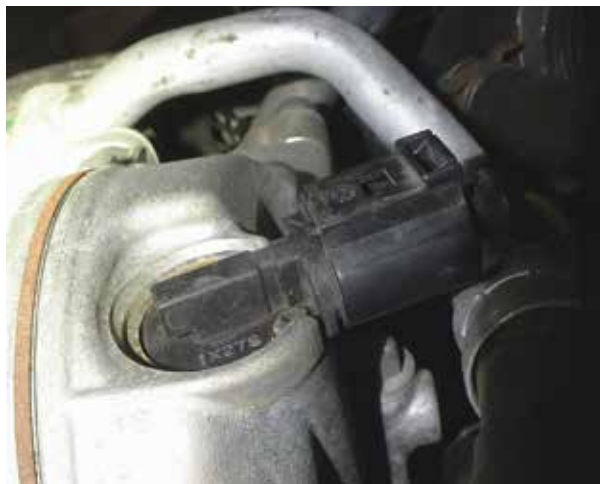
*The electrical connector for the regulator valve is accessible from the bottom of the vehicle. A standard two pin connector, it is easy to access for back probing.*

modulated) signal. It operates on a lower voltage (0–5 volts) than battery voltage. Do not test by power probing these units. Damage most likely will occur.

You can back probe the connector at the compressor and check for proper incoming signal voltage. Again, the most common failure point on these units is the valve itself in the compressor. The control valve is not serviceable and, if it is faulty, a new compressor assembly must be fitted.

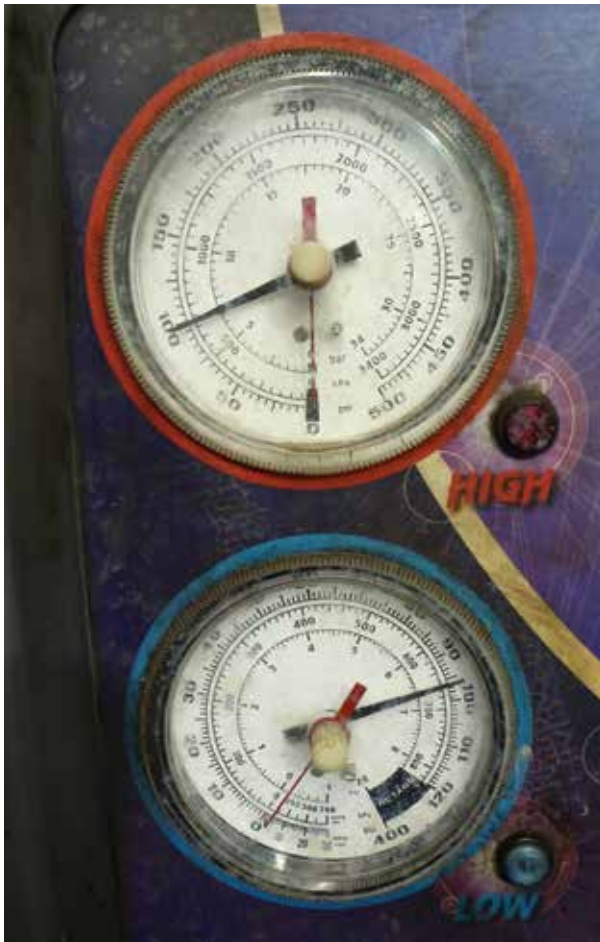
*When the compressor is not pushing refrigerant, the pressure on both high and low sides of the refrigerant system is relatively equal. This system is either not energized or not operating properly.*

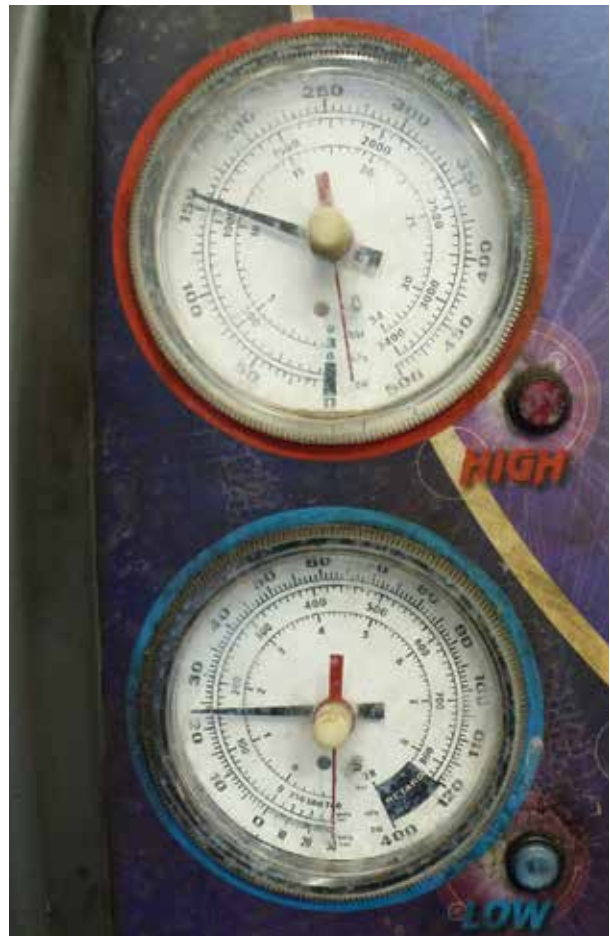
*Here you can see a clear pressure drop between the high and low side of the system. The A/C is properly operating with these pressures.*

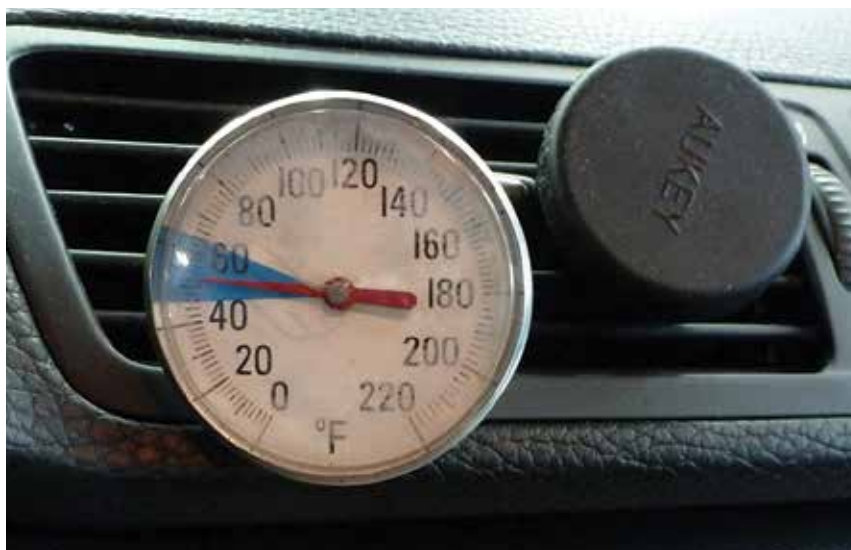
*With a proper working climate control system, vent temps can get quite low! This is very important for drivers in warmer climates and for lowering humidity levels.*
