# The "New" Beetle

...Sleek, sporty, and fun

*The VW Beetle is an accessible, fun car. The current generation pays homage to the original by keeping the unmistakable shape. But its similarities stop there.*

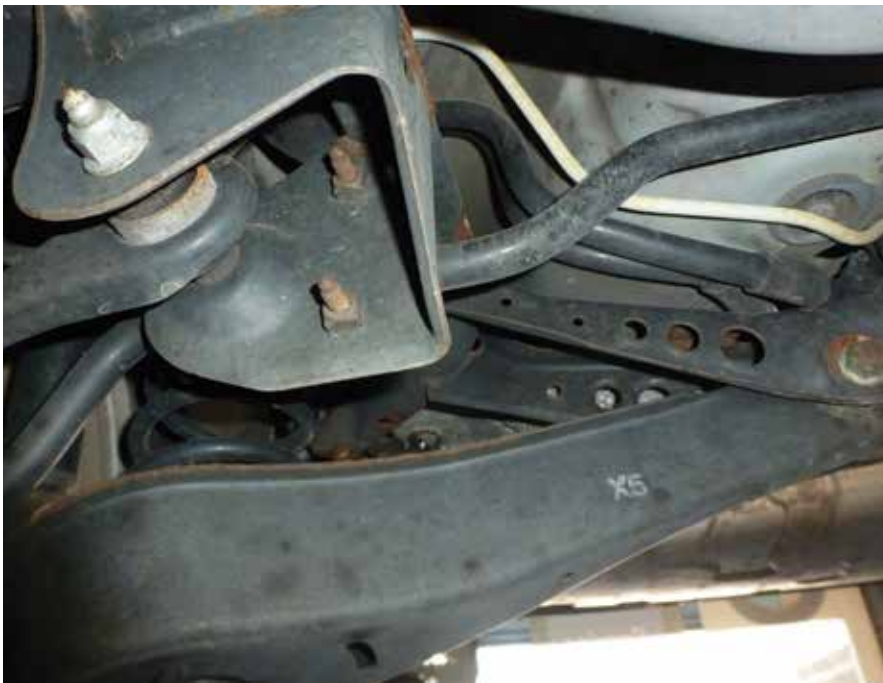
*Alignment adjustment points are readily accessible. It's wise to spray bolts with a penetrant to ease movement, particularly in rust-prone areas of the country.*

Buying a 2015 or newer turbo model Beetle will get buyers the same multi-link rear suspension design offered in a Jetta GLI. This definitely inspires confidence and sportiness in the handling department. It also allows for rear camber and toe adjustments if necessary. Minimal tools are required for adjustment. A 16mm and 18mm wrench will cover all rear-end adjustments.

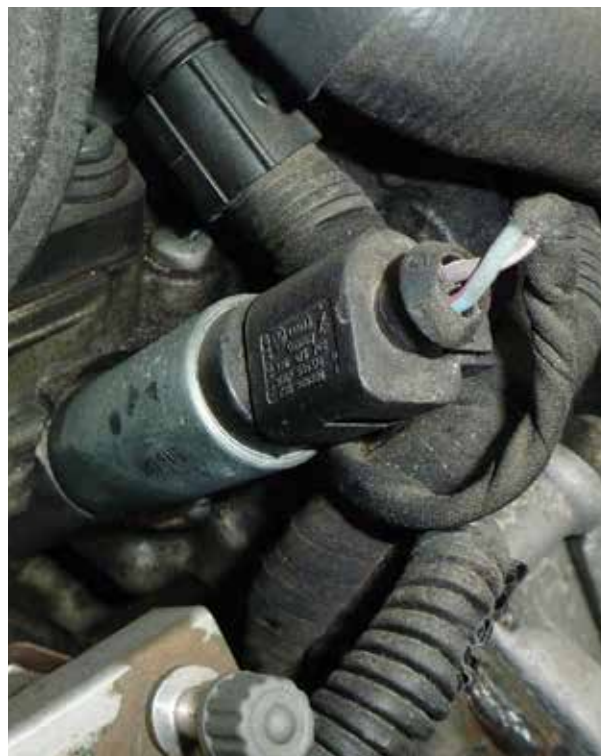
*The solenoid can be quickly tested for proper operation. The solenoid will also make a clicking sound when operating, which can be felt by hand.*

The most common failure on this setup is a stretched chain or worn chain guide components. Another common failure point in this system is the cam adjustment solenoid. This actuates the cam adjuster and may fail, causing cam timing faults that often do not pinpoint the faulty solenoid. It's important to actuate this solenoid as part of diagnosis to verify proper operation.
