TechConnect

V8 | N1 | Spring 2016

**Fresh Air Blower Performance
Driver Assistance Systems
2015 Golf Trunk Repair**

Your Source for Genuine Volkswagen Repair Information.

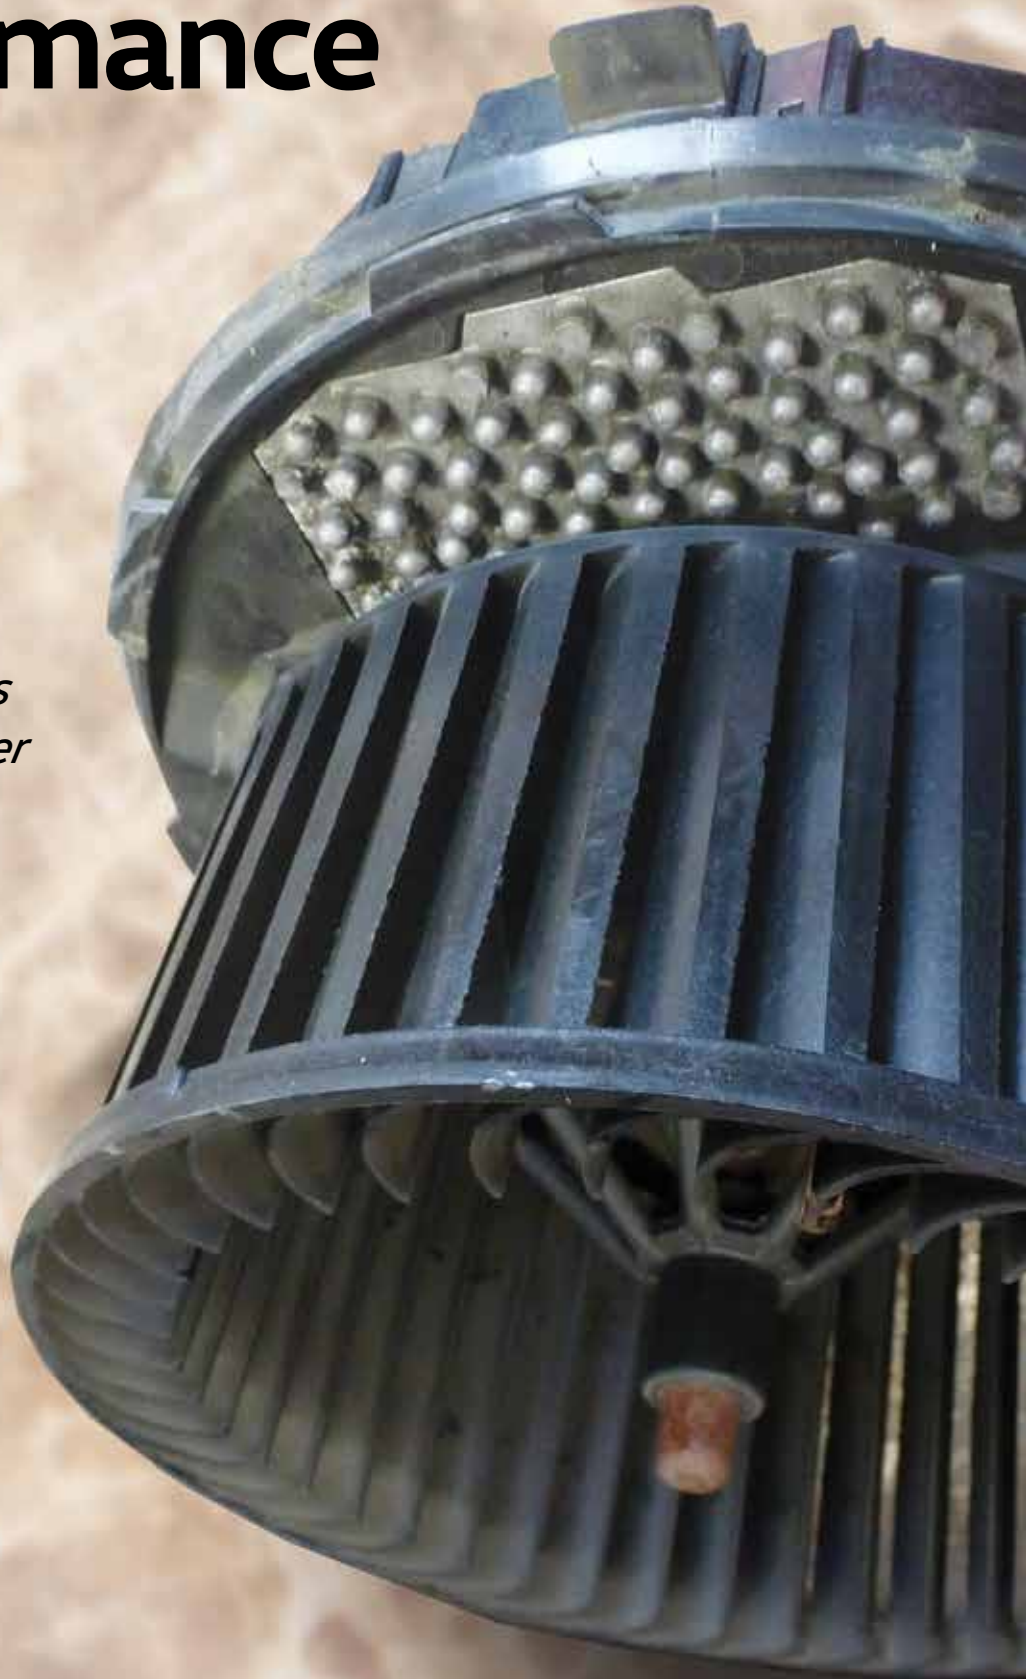
Fresh Air Blower Performance

Heating and cooling functions depend on proper operation of the HVAC system

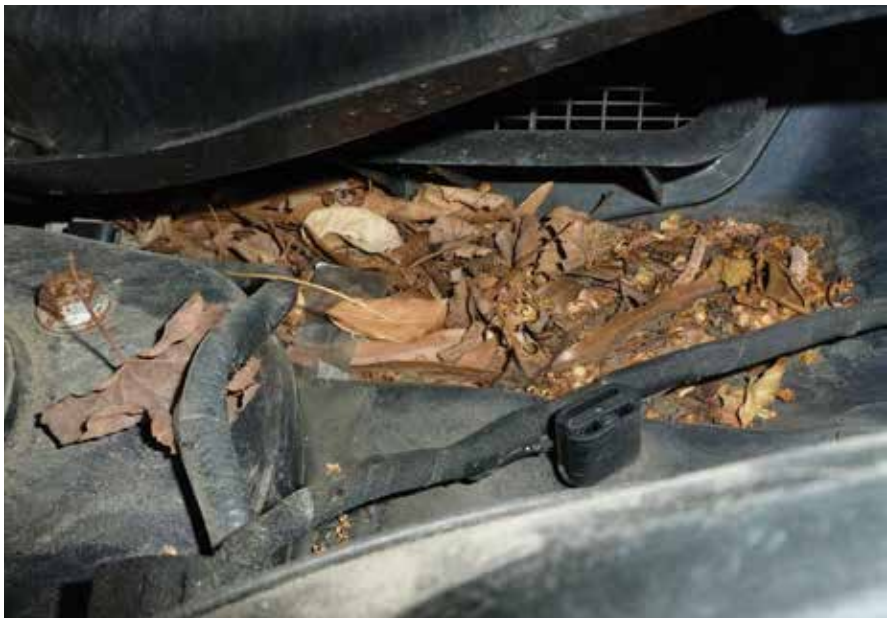
Plant matter tends to accumulate in and around underhood drains. These drains must be periodically cleaned and cleared, just like sunroof drains.

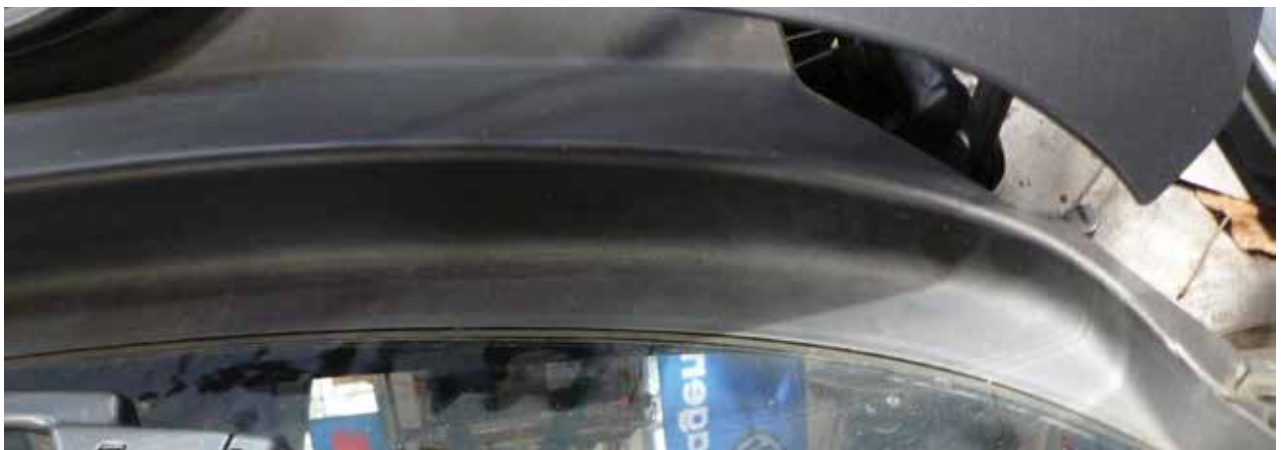
The cowl seal is very important in keeping water out of the vehicle as well. These seals can become damaged or pop out of their guide track occasionally. If these seals are not fully seated, rain water can wash directly down the windshield into the air intake. Not good!

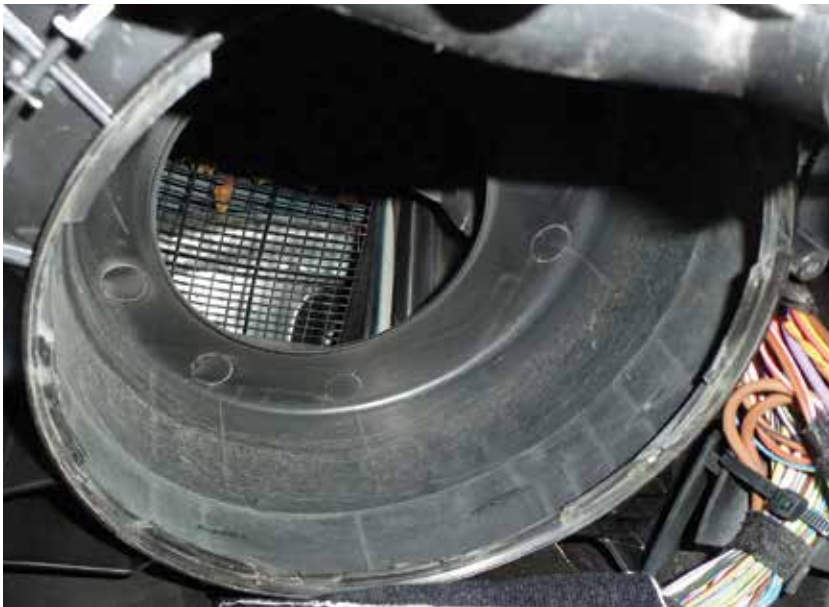
As you can see, the inside of the blower casing is not protected. Any water or material that flows into the intake can fall directly into the blower motor.

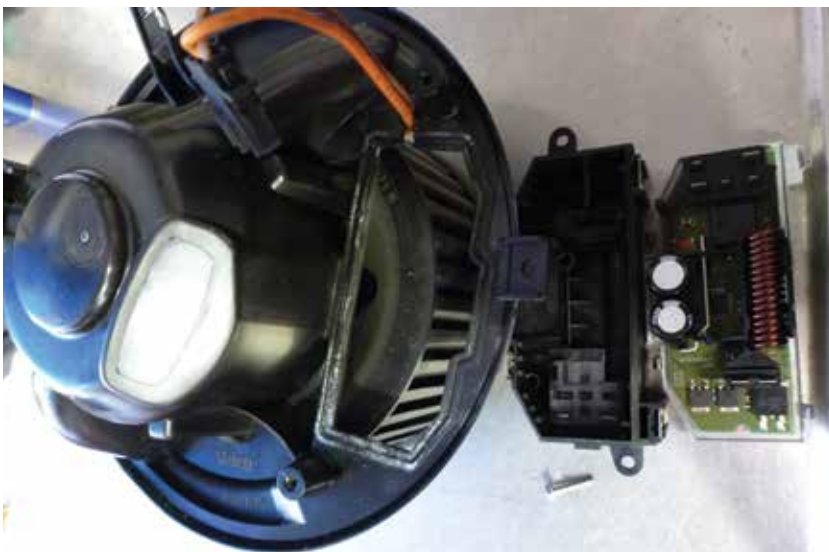
The blower motor resistor is not serviceable. If damaged, it must be replaced.

Replacing the resistor is normally a straightforward operation. After removal of the passenger side lower cover, the blower motor and resistor pack are visible and accessible for testing and replacement. Thanks to the work of VW design engineers, few tools and little time are needed to get to this piece of the HVAC system.

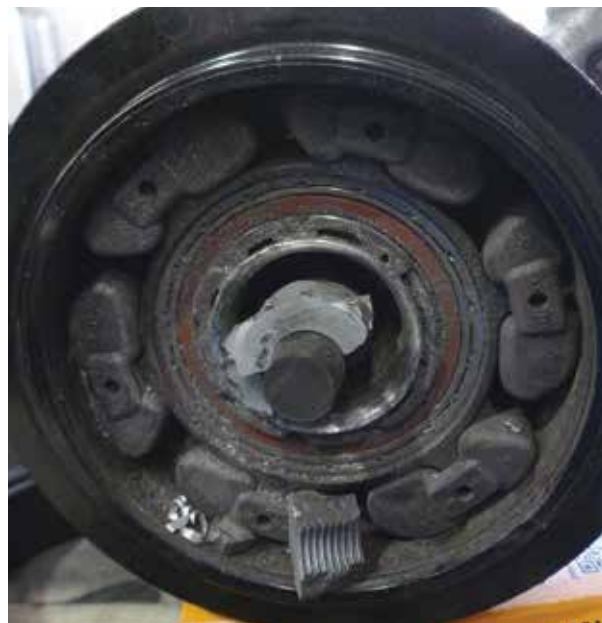
Fully exposed you can see the damage to the compressor.

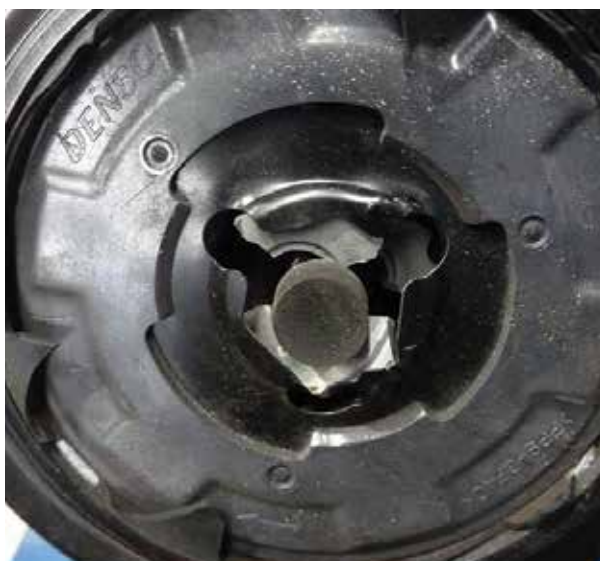
After removing the dust cap, most pulley damage is apparent. This compressor was still spinning, although it was noisy.

Instead of using a clutched pulley, VW compressors have a standard pulley with a built-in breakaway design. This is used to keep the compressor from completely locking up if becomes too hard to turn. Often, a low or empty refrigerant level can cause this. The refrigerant and oil normally act as lubricants, keeping the inside of the compressor spinning smoothly. Without them, overheating of the internals may occur, causing extreme drag.

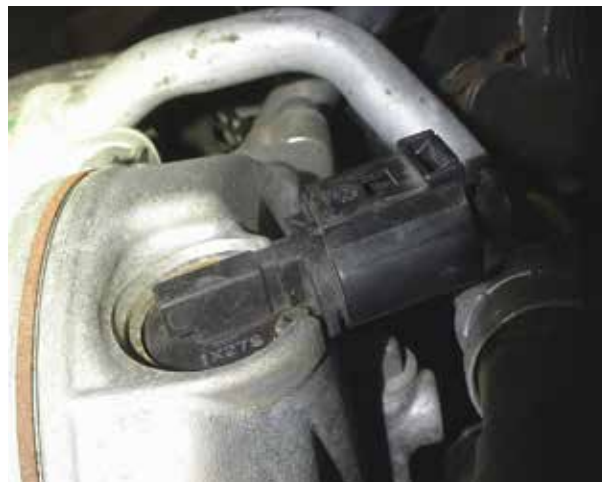
The electrical connector for the regulator valve is accessible from the bottom of the vehicle. A standard two pin connector, it is easy to access for back probing.

modulated) signal. It operates on a lower voltage (0–5 volts) than battery voltage. Do not test by power probing these units. Damage most likely will occur.

You can back probe the connector at the compressor and check for proper incoming signal voltage. Again, the most common failure point on these units is the valve itself in the compressor. The control valve is not serviceable and, if it is faulty, a new compressor assembly must be fitted.

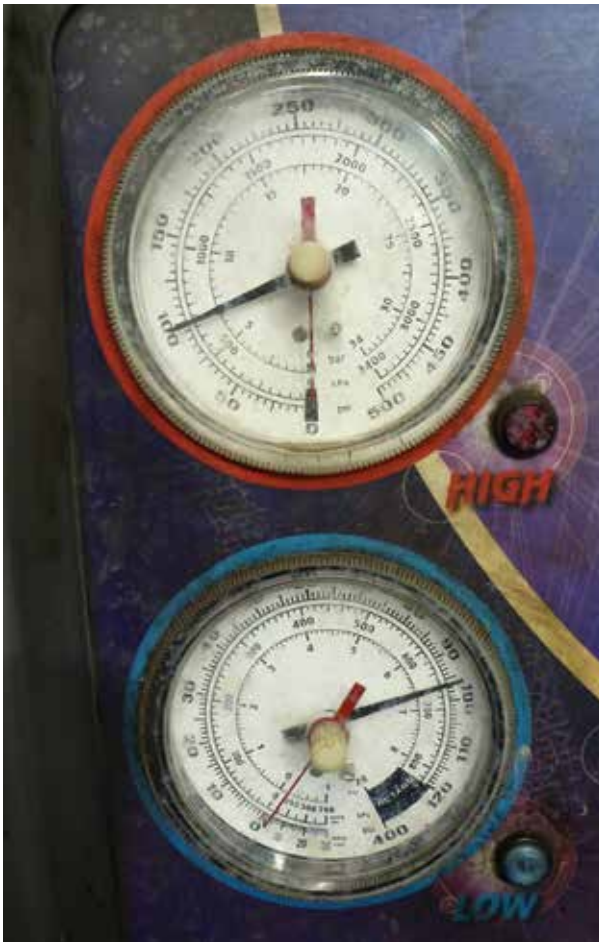
When the compressor is not pushing refrigerant, the pressure on both high and low sides of the refrigerant system is relatively equal. This system is either not energized or not operating properly.

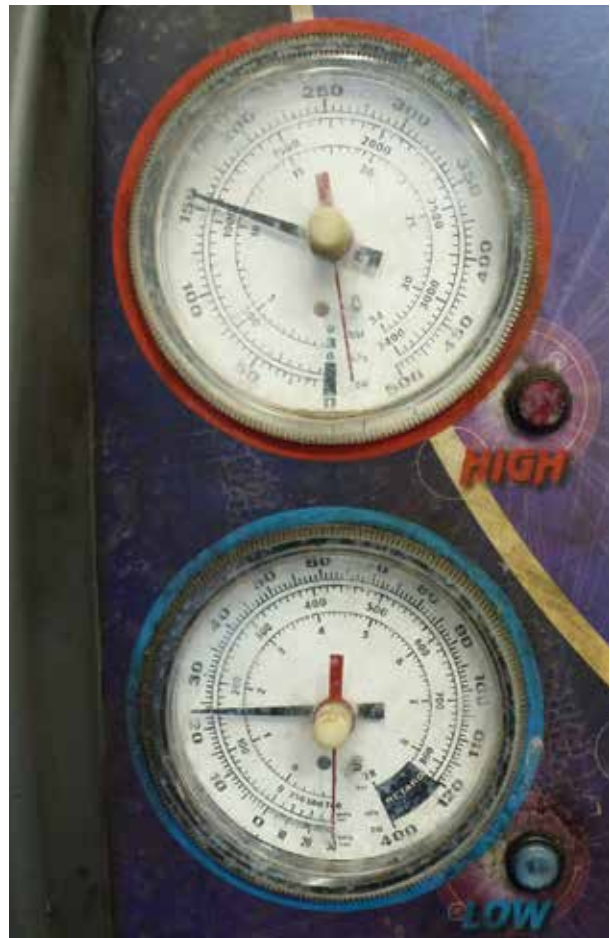
Here you can see a clear pressure drop between the high and low side of the system. The A/C is properly operating with these pressures.

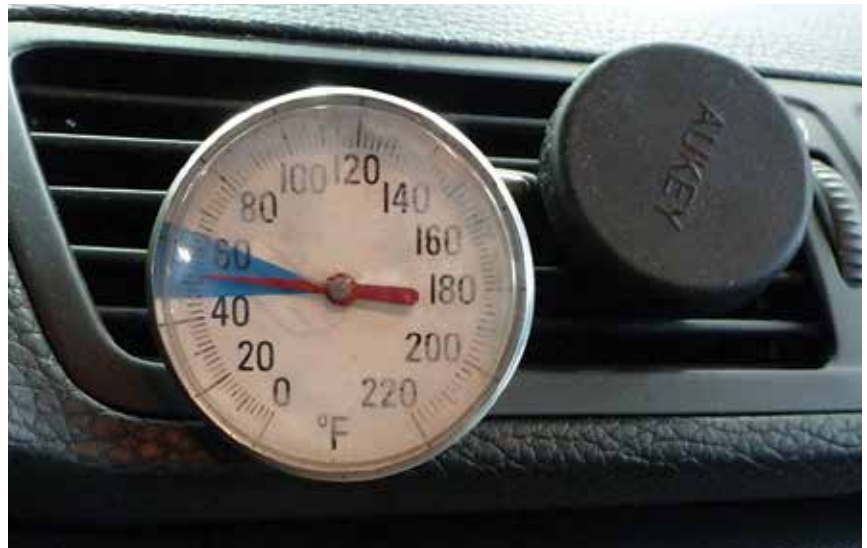
With a proper working climate control system, vent temps can get quite low! This is very important for drivers in warmer climates and for lowering humidity levels.

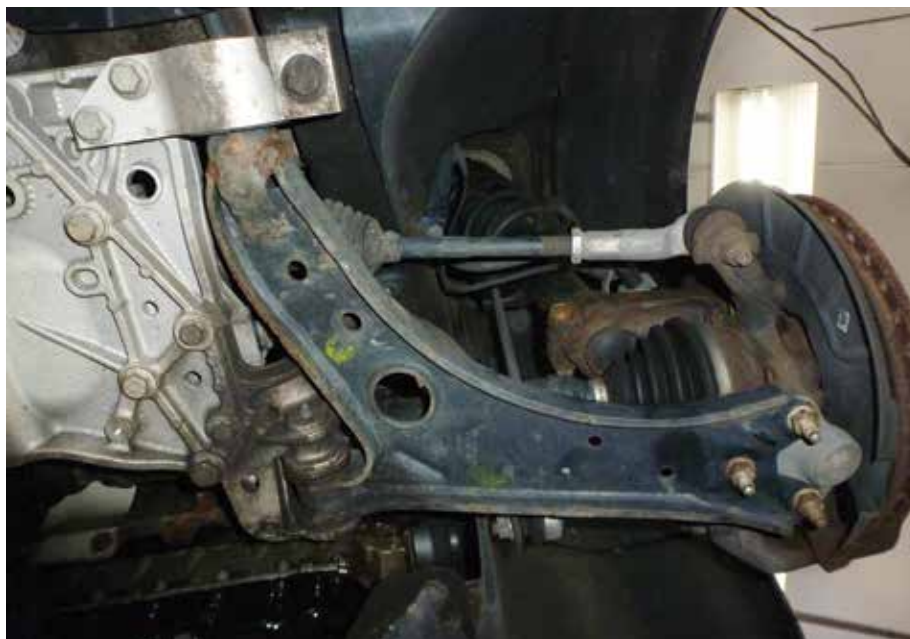
The one area in the front suspension that wears is the control arm bushings. These take significant abuse and absorb initial jarring from road surface irregularities. Worn bushings, however, are relatively easy to spot. Visible tears in the rubber and excessive movement in the control arm are indicators of a failed rear control arm bushing.

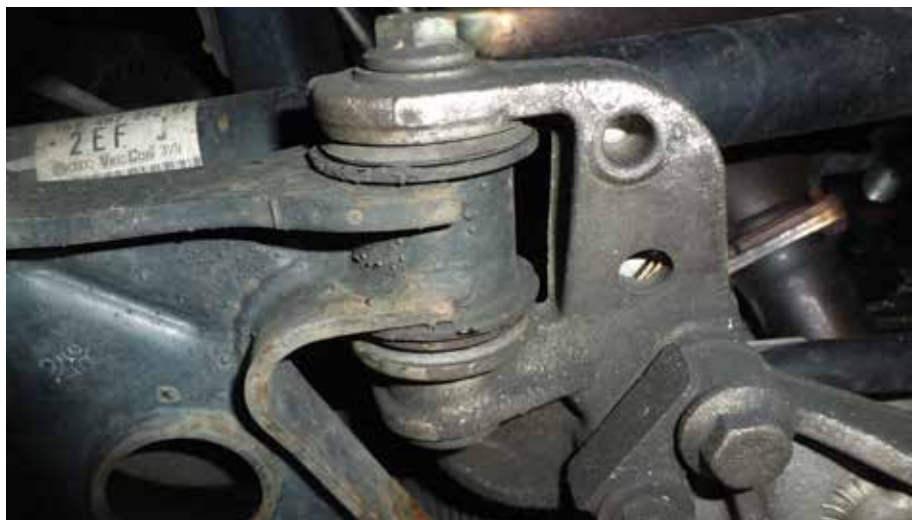
The front lower bushing helps to control and dampen vertical suspension movement.

The front lower bushings also get a lot of use. They provide a twisting dampening force as the vehicle moves up and down over varying road surfaces. Often, if these fail, they make a squeaking sound, very similar to a failed upper strut mount. Don't be fooled! The easiest way to test the front bushings for noise is to first remove the three nuts securing the control arm to the spindle. Once removed, it's easy to move the control arm up and down to listen for abnormal noise or movement.

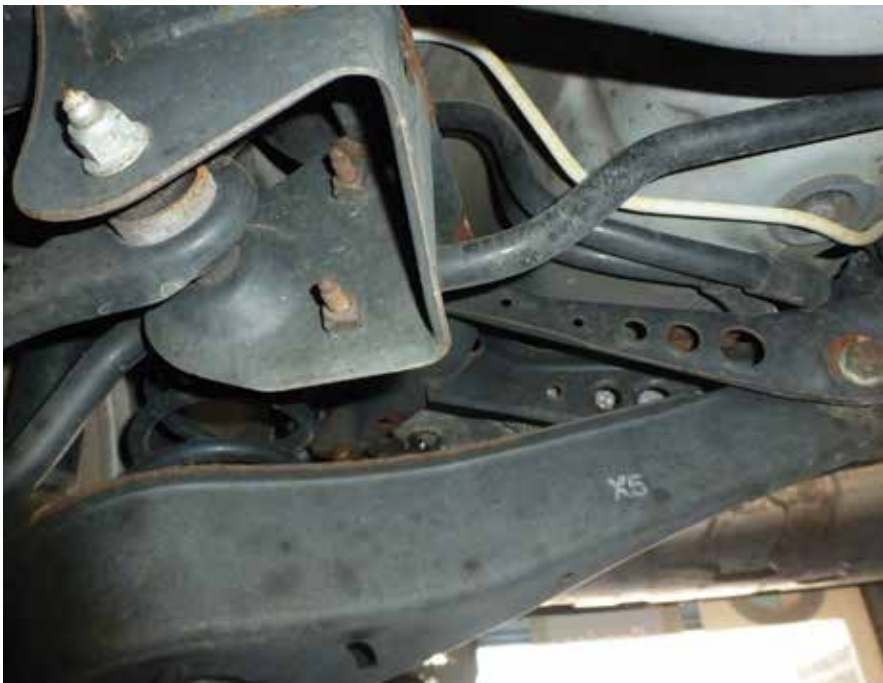
Alignment adjustment points are readily accessible. It's wise to spray bolts with a penetrant to ease movement, particularly in rust-prone areas of the country.

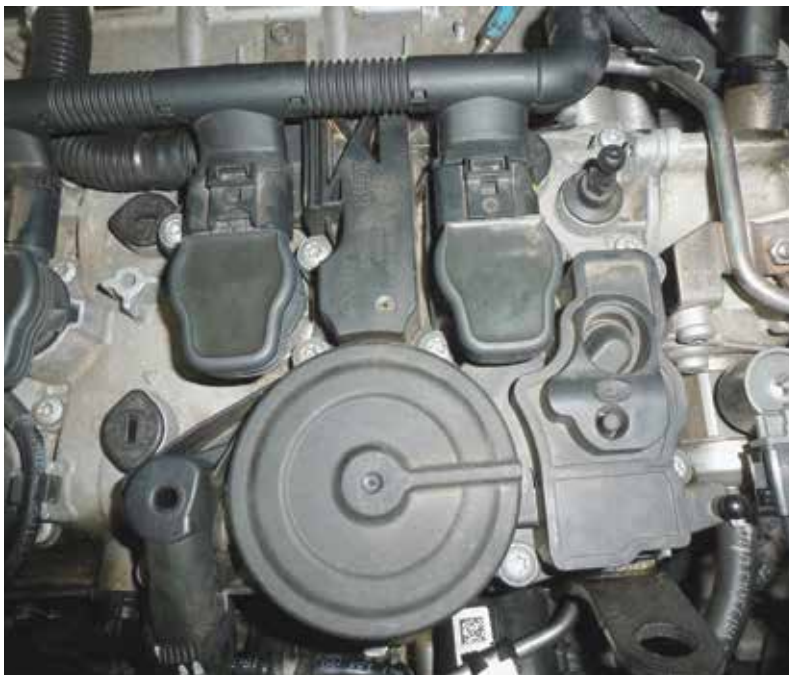
The PCV valve is located directly on top of the cylinder head on the 2.0T engine. It is very easy to replace in event of failure.

The easiest diagnostic technique to pinpoint a failed PCV valve is to remove the engine oil filler cap while the engine is running. When the PCV valve fails, the crankcase vacuum becomes so strong that the cap becomes almost impossible to remove. This test takes only seconds and is one of the easiest ways to pinpoint the failed breather. Often a moaning or hissing sound accompanies this action, as air is being pulled in from various seals.

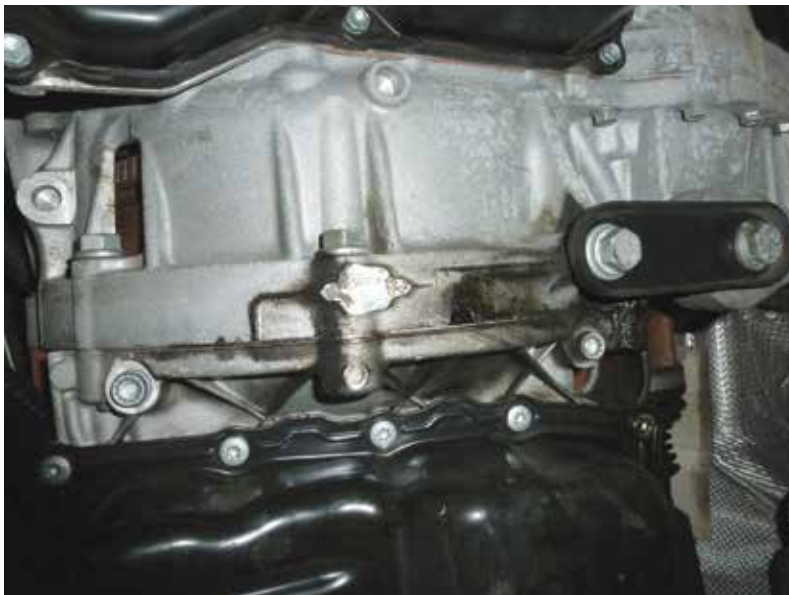
Here is an example of a rear main seal leak. In this case, the leakage has not yet reached the point to cause unmetered air loss. But if left unresolved, it can become a problem.

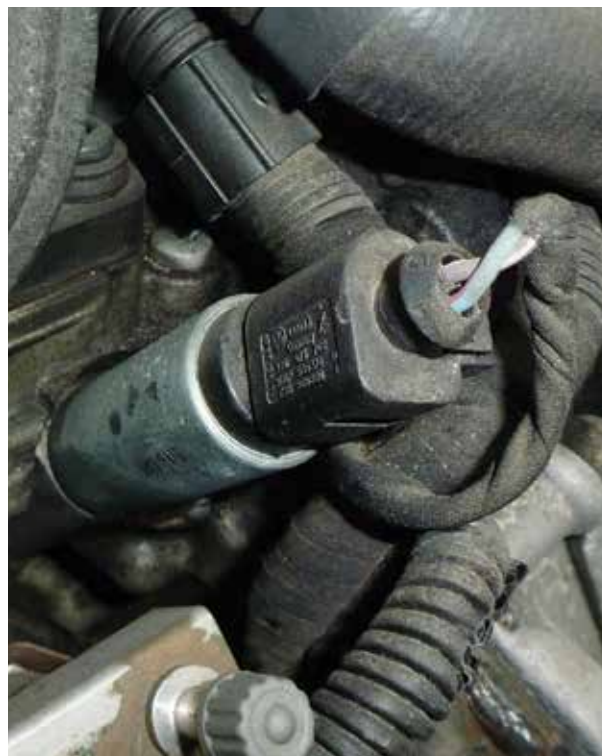
The solenoid can be quickly tested for proper operation. The solenoid will also make a clicking sound when operating, which can be felt by hand.

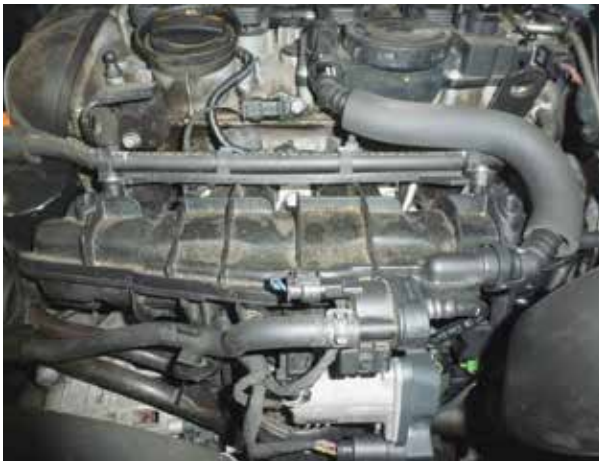
Overview of top of 2.0T engine.

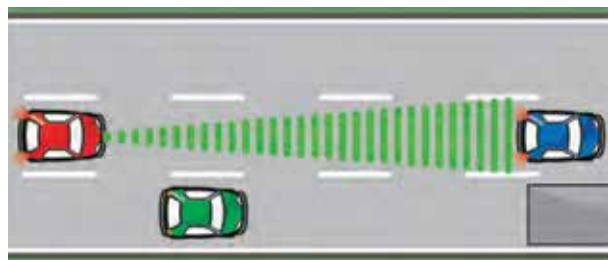
The ACC system identifies the vehicles in front.

Much like Adaptive Cruise Control, ACC with Follow to Stop can regulate the vehicle speed. In addition to speed and distance regulation, ACC with Follow to Stop can bring the vehicle to a complete stop in normal traffic flow. Pressing the accelerator pedal, or using the Resume function on the ACC control lever

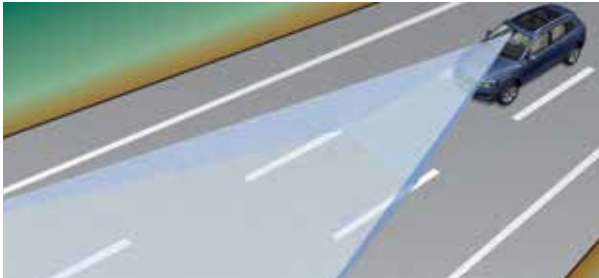
Touareg camera will monitor approximately 260 ft (80 m) ahead

The Lane Departure Warning system on the Touareg functions differently than on other Volkswagen models. The Touareg system will not provide active steering intervention. If lane departure is detected, the system can send a signal to vibrate the steering wheel to gain the driver's attention. There is also a visual indication in the multifunction display.

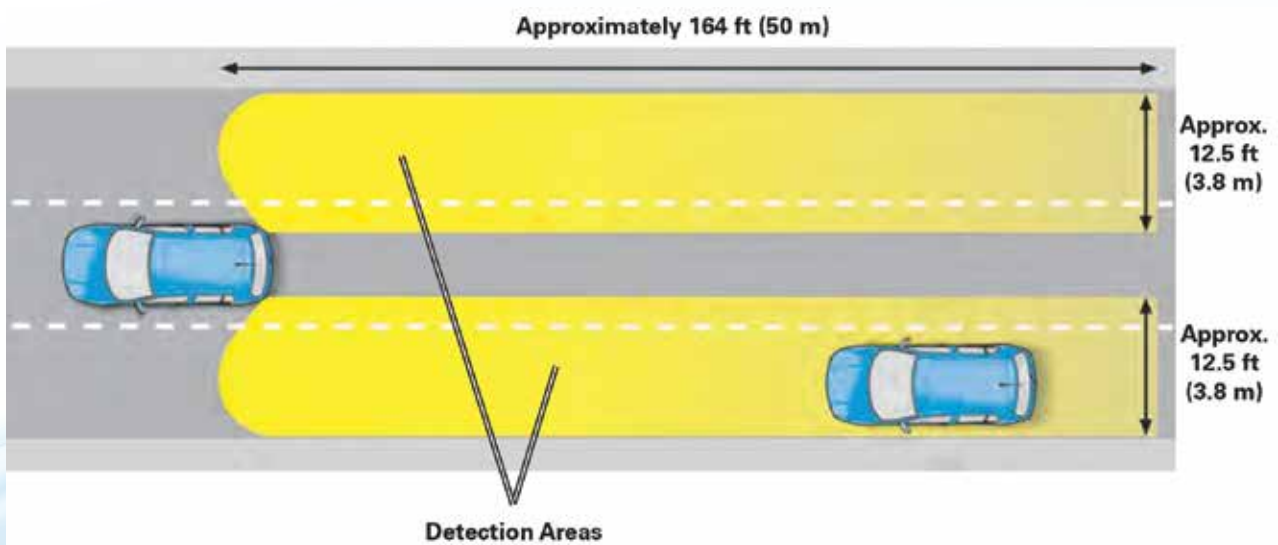
The illustration above shows the sensor monitoring area on a straight road. On winding roads, the Blind Spot Monitor operates up to a minimum curve radius of about 558 feet. If the curve radius is below the 558 feet limit, the system switches to a deactivated state since the radar beams being transmitted can no longer scan the full rear monitoring area.

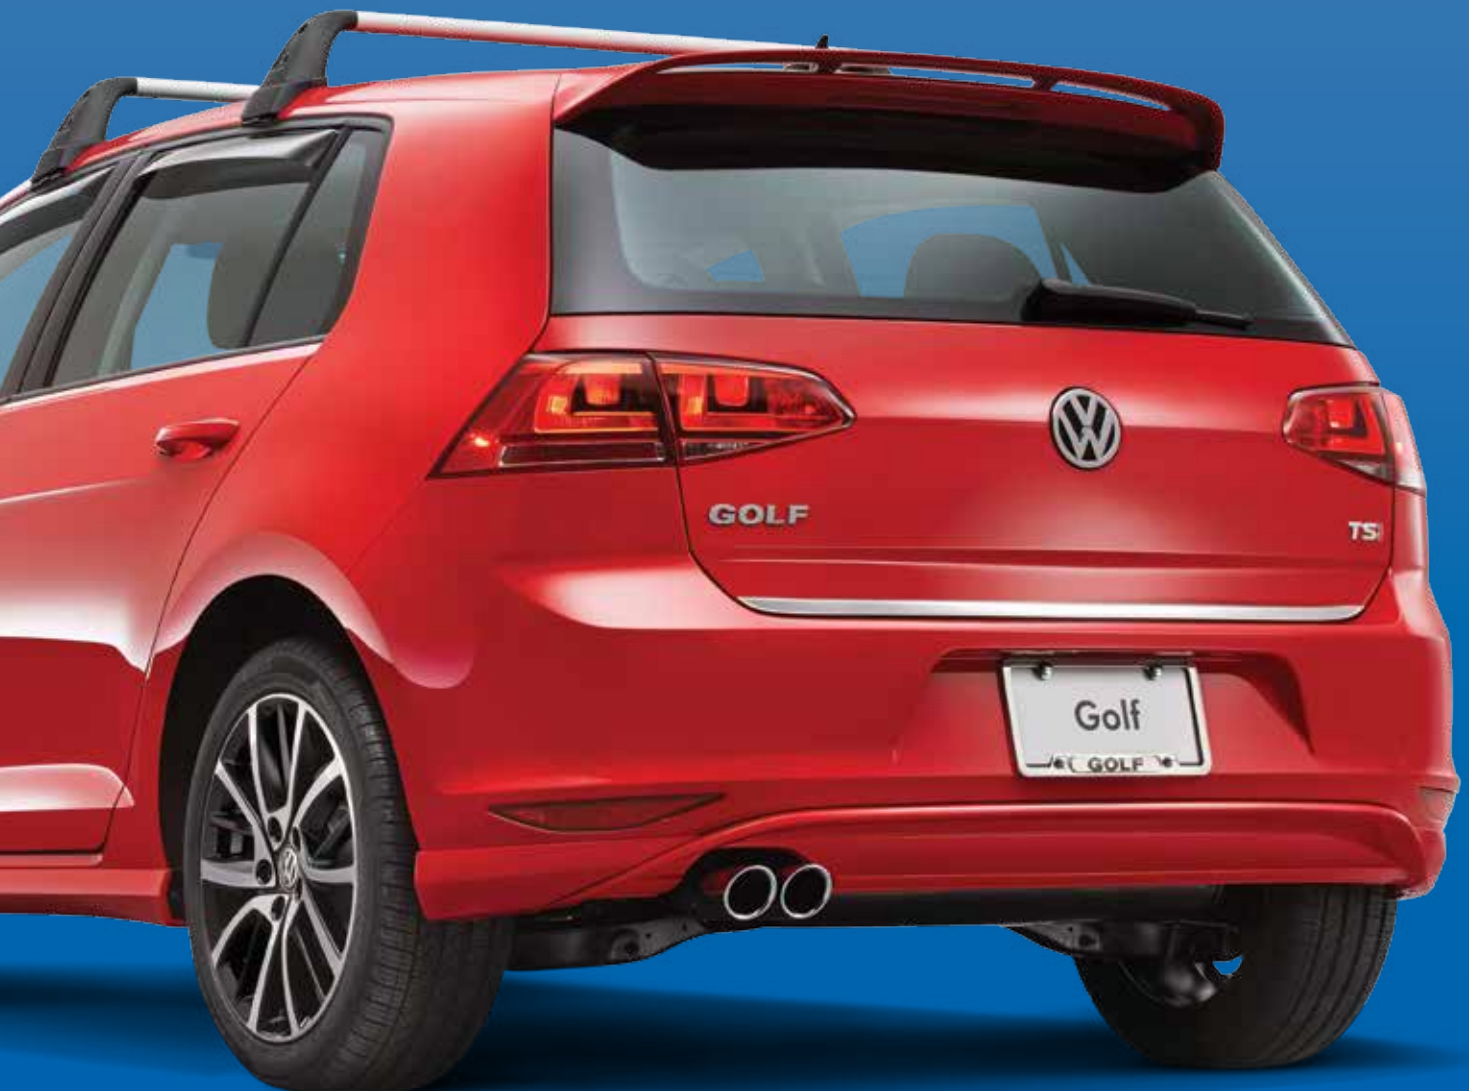
To help minimize potential weakening of adjacent panels, reinforcements, corrosion protection, and other critical body elements, Volkswagen recommends partial replacement of the Golf luggage compartment (trunk) floor pan if it has received collision damage. Here you'll find detailed examples of steps in the sectioning and replacement procedures for a 2015 Golf.

Volkswagen allows partial replacement of the trunk floor on the 2015 and newer Golf. There are specific OEM-required procedures to help restore the Golf trunk floor to pre-collision condition. It's not complicated.

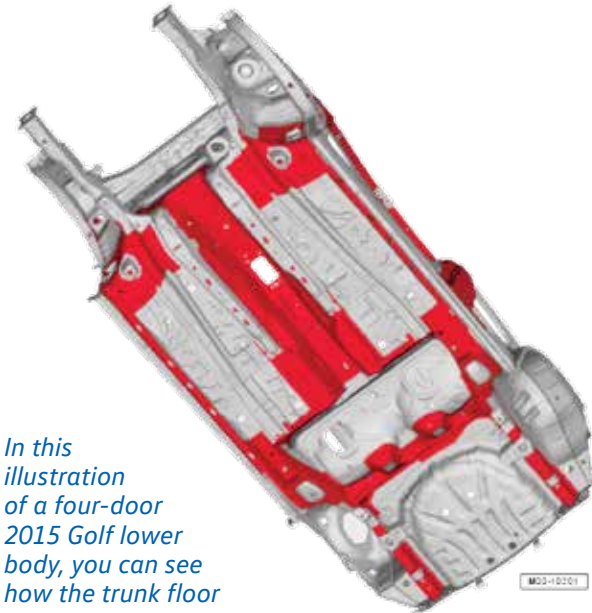
In this illustration of a four-door 2015 Golf lower body, you can see how the trunk floor pan (bottom of the illustration) attachment to the rear crossmember, frame rails, and rear cross panel (not shown) completes the enclosure and helps support the structural rigidity of the lower rear end.

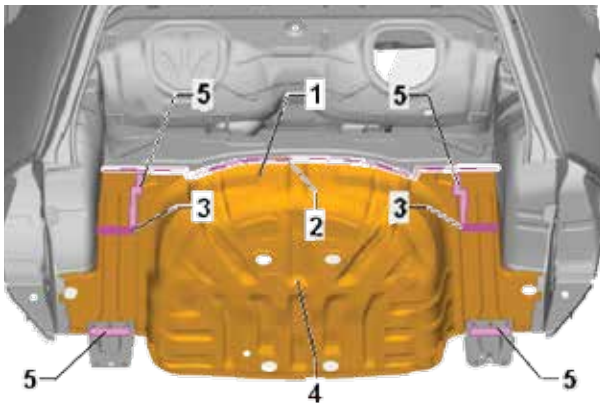
Right: Volkswagen allows a separating cut at the dashed pink line (2) across the front end of the spare tire well (1). On each side there is a cavity containing a molded structural foam insert at (3), which you must inspect and replace if necessary. There is bonding adhesive joining the trunk floor to the frame rail and to the end plate or bumper impact bar bracket at (5), which must be replaced during floor pan reassembly. The spare tire retaining bracket (not shown) is mounted at (4).]

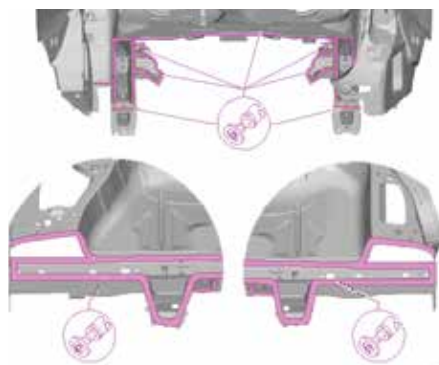
Transfer the separating cut to the new trunk floor pan, then cut and remove the shaded area. Drill or punch 7 mm diameter holes for the MIG/MAG plug weld seam. Sand welding surfaces down to bare metal, and lightly grind the areas which will not be welded. Weld the spare tire retaining bracket (1) to the trunk floor using a straight line spot weld seam on each side of the bracket.

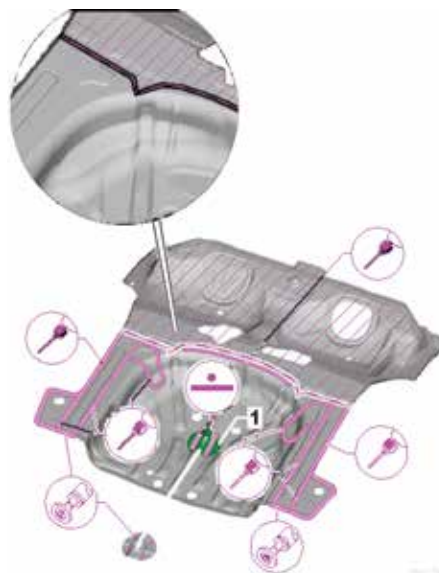
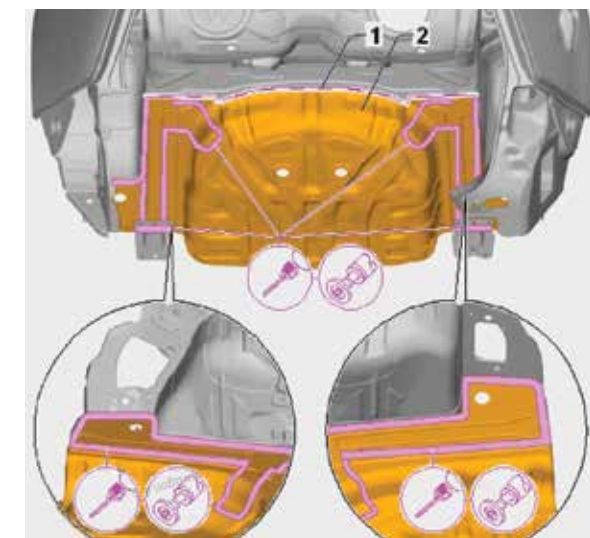
When making the separating cut (1) at the front of the spare tire well (2), be careful not to cut into the reinforcement below. Drill out any spot welds where the pan joined the frame rails, the reinforcement under the front of the spare tire well, and the sidewall support area for the tire well. Then remove the pan from the vehicle.

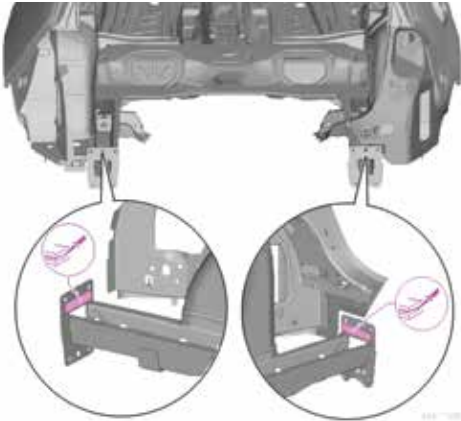
Apply two-part body adhesive (D 180 003 M2) to the side of the bumper bracket facing the rear seat. Fit the replacement floor pan with the vehicle secured to an alignment bracket set on a frame bench, or while it is standing on its wheels.

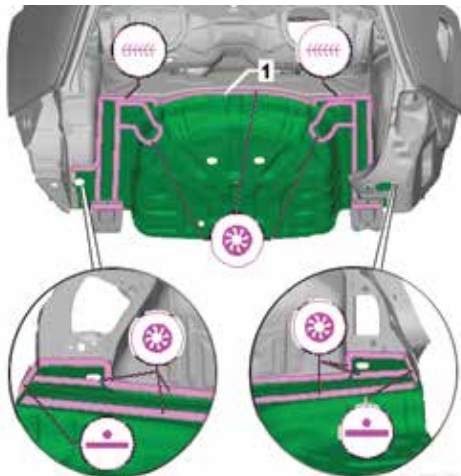
Weld the left and right side front (straight portion) of the floor pan front overlap using MIG/MAG continuous seam welds. Using a MIG/MAG plug weld seam, weld the curved front (1), the vertical reinforcements that drop down to support the spare tire well sides as they curve toward the front, and the sides above the frame rail. Weld the ends of each side using a straight-line spot weld seam.
