CRANKCASE BREATHERS ARE CRITICAL!

PCV WAS MANDATED IN THE U.S. 53 YEARS AGO(!), AND THE SYSTEMS HAVE NATURALLY EVOLVED. ON VOLVOS, ALWAYS CHECK THEM DURING ANY ENGINE SERVICE OR THE CONSEQUENCES MAY BE FAR-REACHING.

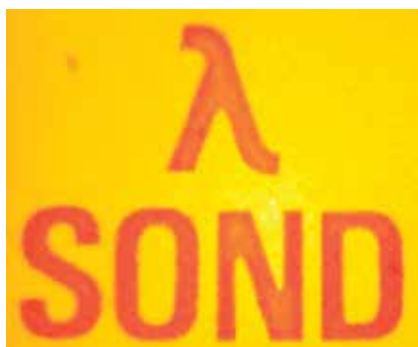
Ancient history: The Lambda Sond warning light on a 1981 Volvo 242 Turbo.

A long time ago in a galaxy not so far away (Sweden), Volvo engineers used a standard PCV system — a one-way vacuum valve and a hose or two to recycle engine blow-by (through 1975). It was a simpler time when men were men, cars were heavy, and gas cost less than a dollar a gallon. But in 1976, Volvo introduced the B21 engine, the 2.1L naturally-aspirated follow-up to the legendary B20 and B18. At that time, Volvo, like all auto makers, was trying to keep up with the latest U.S. and California emissions regulations. The year before, Volvo engineers in conjunction with Robert Bosch, came up with the first oxygen sensor-regulated fuel injection system (electronic K-Jetronic). Volvo called it Lambda Sond.

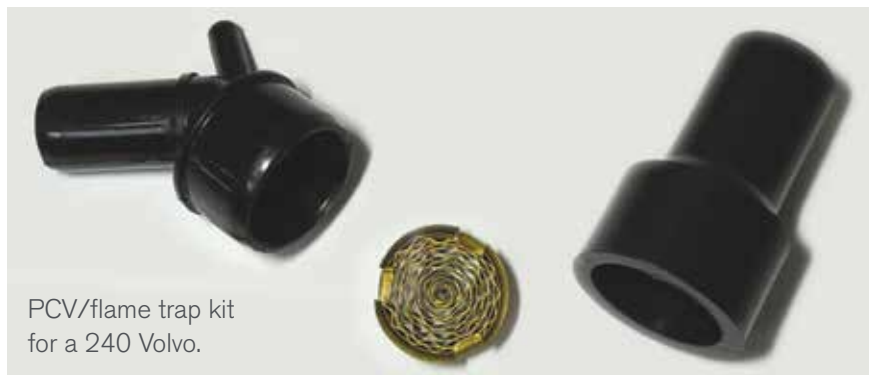
PCV/flame trap kit for a 240 Volvo.

On '76 through '79 models, the flame trap was right on top connected to the valve cover, which made it easy to check and change. In 1980, the flame trap holder was relocated under the intake manifold on top of the oil separator box, which made it much more difficult to check or service. If the shop did not specialize in Volvos, the technicians most likely did not even know it existed.

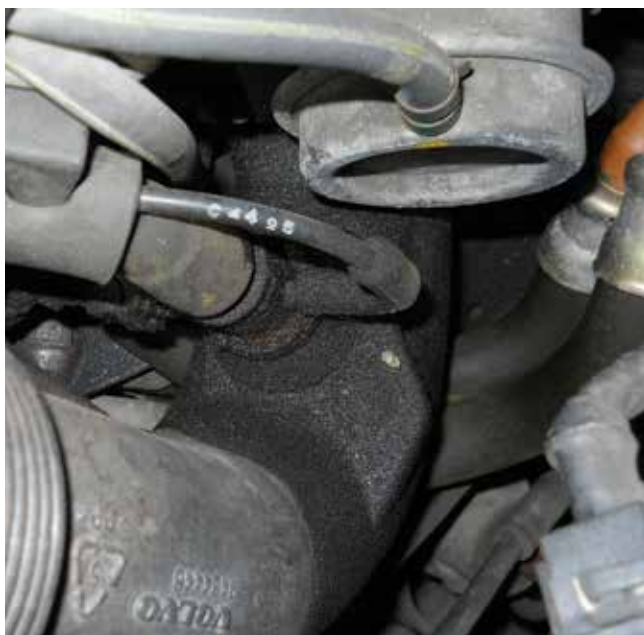
Here's the heater element for the PCV system on a 1997 850 Turbo. The electrical connector can fill with oil and cause a short.

In 1994, Volvo introduced the 850 series to the U.S. market. The new five-cylinder all-aluminum engine, which came in either N/A (Naturally Aspirated) or turbo versions, used a new type of PCV system. Non-turbo models still had a plastic flame-trap screen, but turbos added a heater element to the vacuum fitting in the air intake tube from the MAF (Mass Air Flow) sensor to the turbo inlet. This system worked well, but as the cars got older they were likely to develop some of the same clogging problems.

These days, we see clogged breather systems causing more far-reaching damage on the networked fly-by-wire cars, such as the PCV heater on the intake hose leaking oil into the connector and causing a short. This won't turn on the MIL (Malfunction Indicator Lamp) for the heater, but it will sometimes set a code for an oxygen sensor because they share a ground.

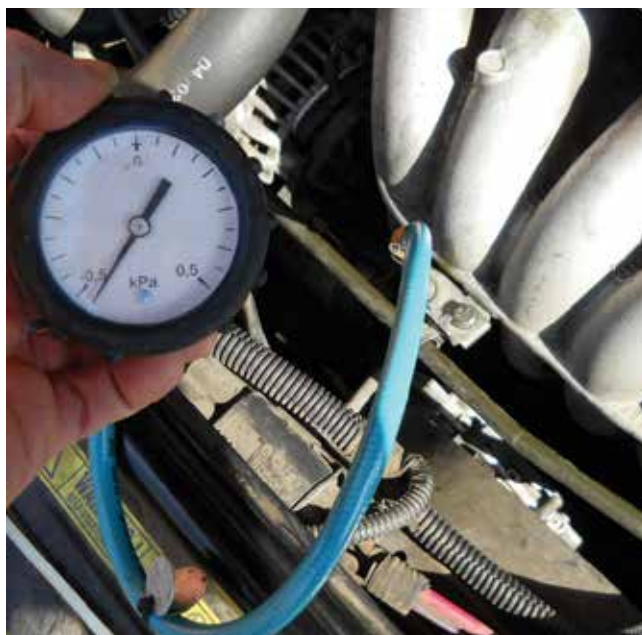
Here's the reading at idle on a 2003 Volvo V70 after the breather system was replaced. Before the repair, the car had a fuel trim code and showed positive pressure on the gauge.

So to test the PCV system have the car at operating temperature and idling, then remove the oil dipstick and insert the nipple of the test gauge into the tube. You should see negative pressure (vacuum), the amount of which depends on the model. After you've done this frequently, you'll know what normal looks like on different engines.

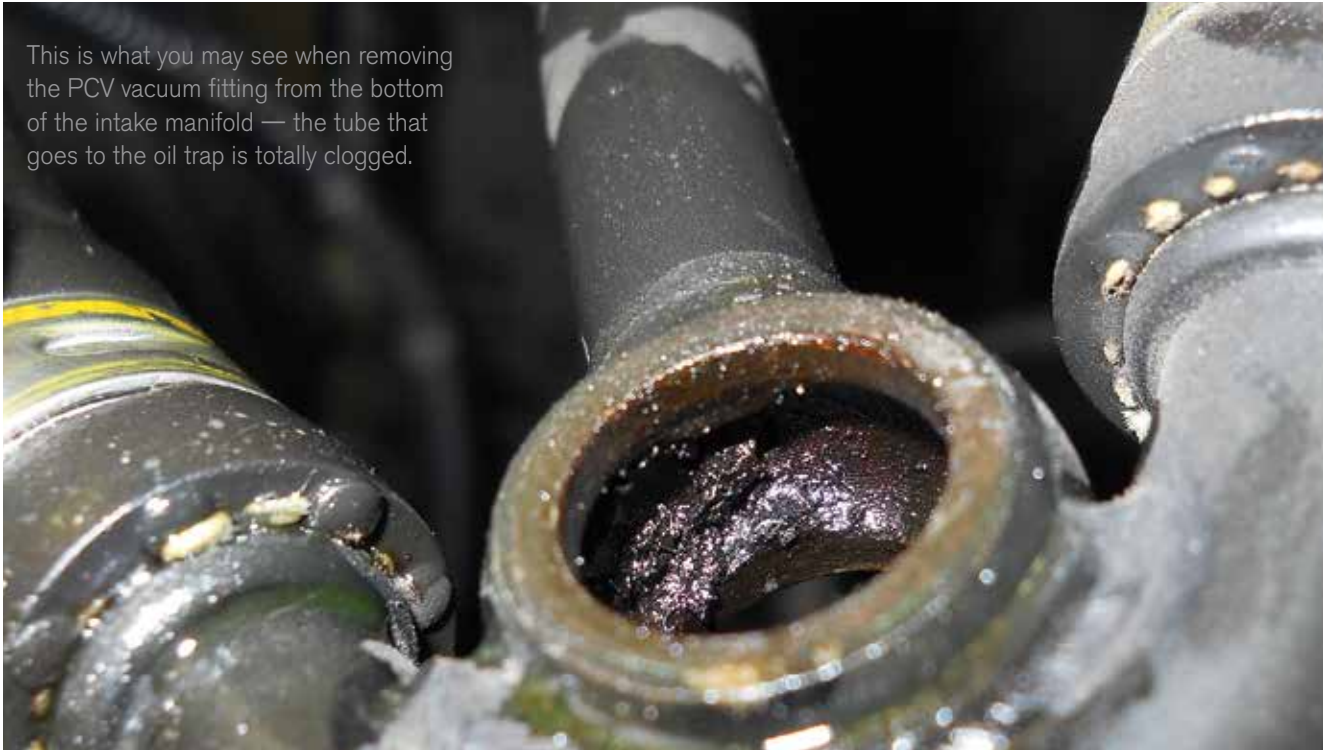
This is what you may see when removing the PCV vacuum fitting from the bottom of the intake manifold — the tube that goes to the oil trap is totally clogged.

One thing we can see on 1999 and up cars is carbon clogging of the orifice under the intake manifold

that supplies vacuum to the breather system. If you catch this in the early stages of the blockage, you can sometimes get away with just cleaning the orifice, but most of the cars we see have been clogged for so long that you will need to replace the whole breather system.

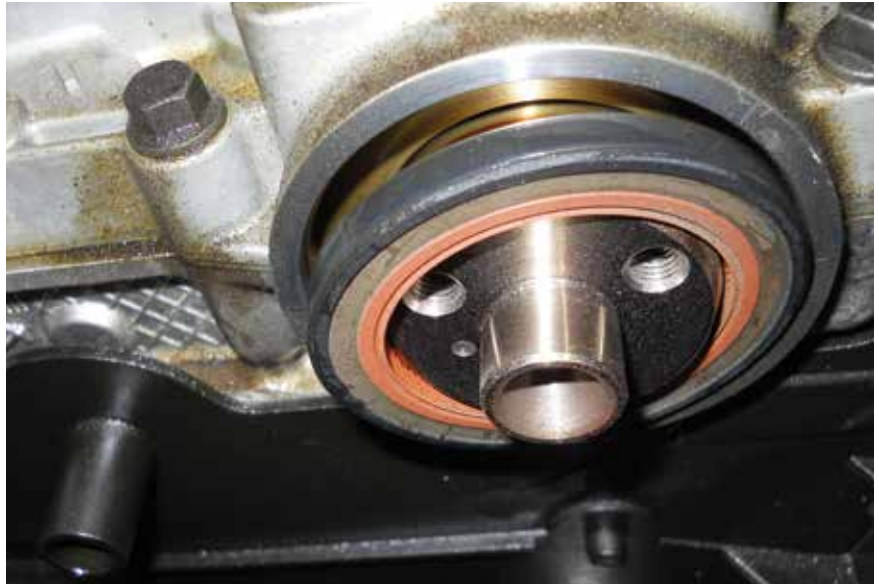
The breather on this Volvo was clogged, which caused a front camshaft seal to pop out. A massive oil leak was the result.

Once the PCV system stops working and the engine starts building up carbon, oil leaks are likely. Sometimes front camshaft seals are actually pushed out of place so that the timing belt becomes wet with oil. You know what happens if the belt jumps off or breaks — the valves would say "nice to meet ya" to the pistons.

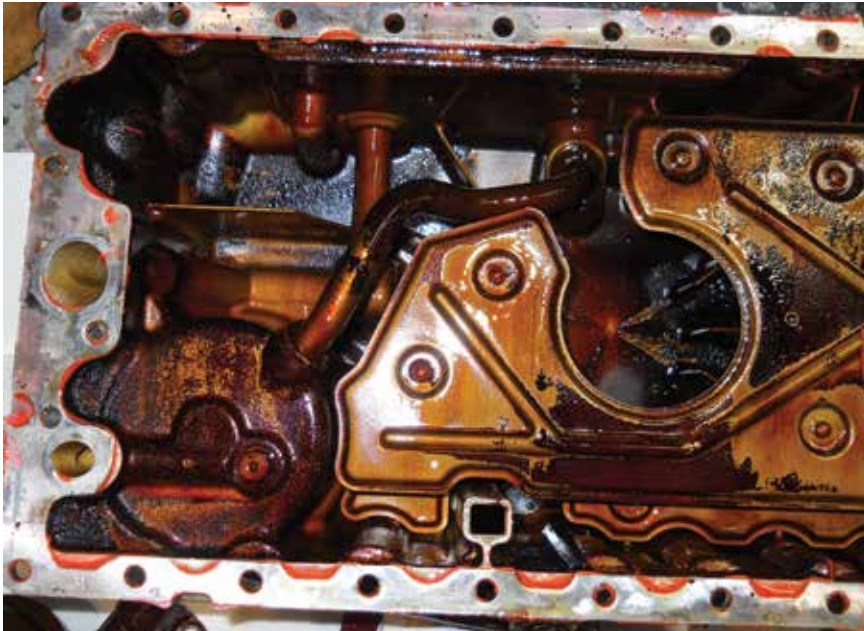
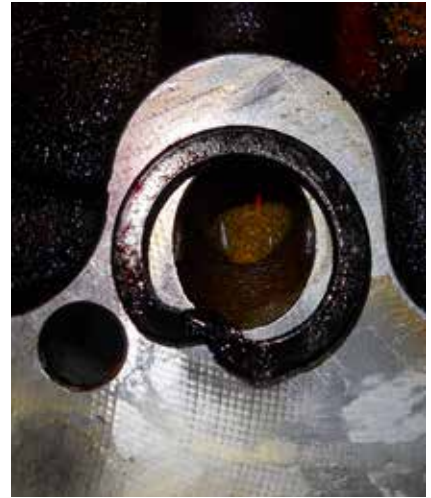
Always change all of the oil seals when you remove the pan.

Once the PCV system fails, the sludge and carbon can grow like a cancer. This car only had 120K on it, but there was a 1/4 inch of sludge in the oil pan that was clogging the oil pump pickup.

As suspected, the reading dropped to 10 psi at hot idle and rose to normal above 1,200 rpm. Cracked seals for the oil pickup tube can cause this condition, so the oil pan was removed. The amount of carbon and sludge was incredible. The passageway that connects to the oil separator was totally clogged and there was a quarter-inch of sludge and carbon in the bottom of the pan.

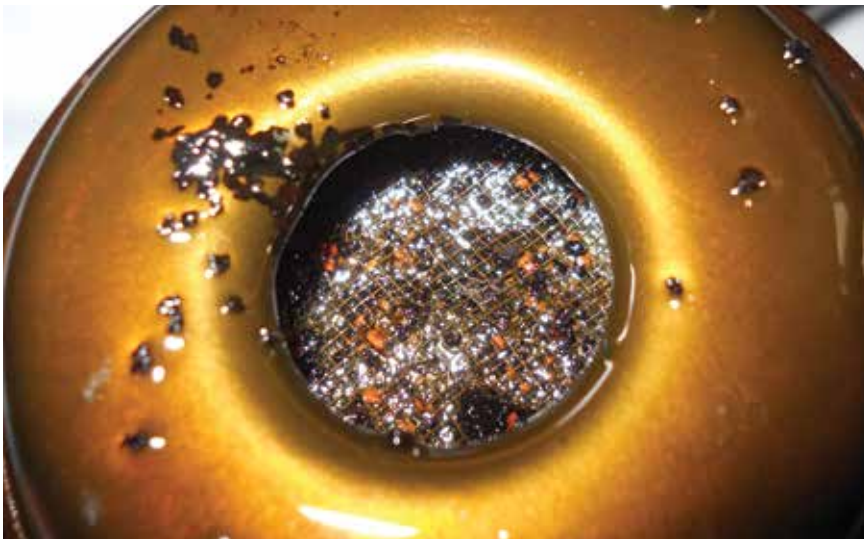
A clogged oil pickup screen caused low oil pressure at hot idle.

Removal of the pickup tube revealed the cause of the low oil pressure. The

pickup seals were bad, plus the pickup tube's screen was completely plugged.

A rod and main bearing cap were pulled to inspect for damage. The bearings looked good, and so were re-installed and torqued to spec. The recommended repair is the installation of a new breather system, an oil system cleanout, and new pickup seals, along with a new updated oil pickup (Part #9186116) that has a much larger screen so it won't clog as easily in the future.

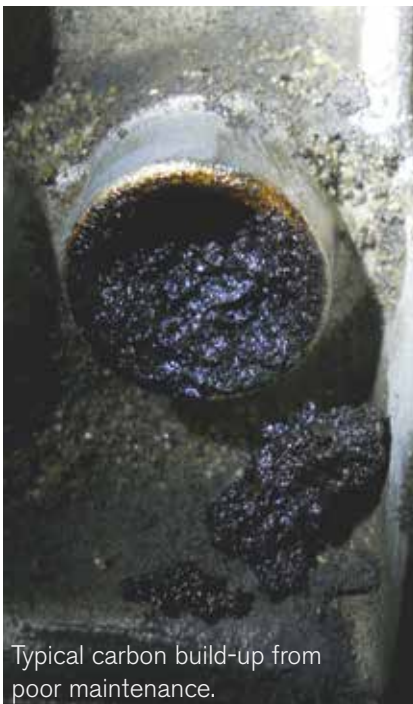
Typical carbon build-up from poor maintenance.

the oil filler cap is a good indicator of how much carbon is probably clogging the breather system. If the oil cap looks like a barbecue grill at the local public park, you can bet this car has not been serviced regularly. Other factors that can contribute to breather system carbon build-up are poor fuel quality, lack of service, and a cooling system thermostat that's stuck open. Of course higher-mileage cars will eventually clog up even if they are well serviced.

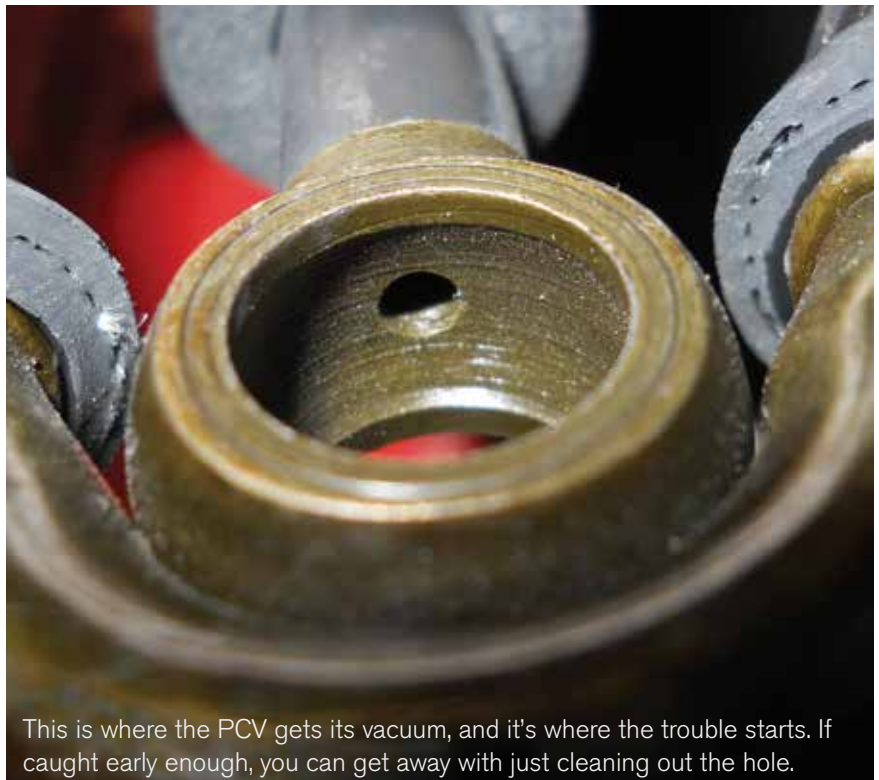
This is where the PCV gets its vacuum, and it's where the trouble starts. If caught early enough, you can get away with just cleaning out the hole.

If the car has low miles, you may be able to get away with cleaning out the hole in the banjo fitting. You can do this by just removing the power steering pump to access the bolt and fitting. But many of the cars you'll see in your shop will have well past 100K and will need to have the whole PCV system replaced.
