# VOLVO TECHTIPS

Information for the Independent Volvo Specialist

## 「CRANKCASE VENTILATION」

CVVT TIMING BELT SERVICE  
VIDA FOR INDEPENDENT SHOPS  
AGING PROBLEMS

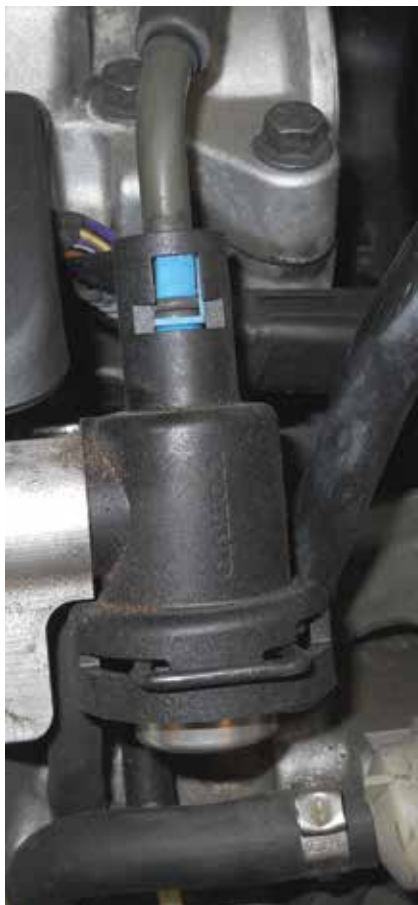
Pull the hose off the fuel pressure regulator.

One issue seen on this series is a failing fuel pressure regulator. Your customer will complain of hard starting when the car is cold, or after it sits for a while.

You can confirm that the symptoms are indeed caused by this issue by removing the cover over the throttle body and looking at the fuel pressure regulator. It's best to leave the car sit overnight so you can examine it cold, or at least give it a few hours to cool down. Pull the regulator's vacuum hose. If you find evidence of fuel, replace the regulator — don't forget to relieve the residual fuel pressure before removing the screws.

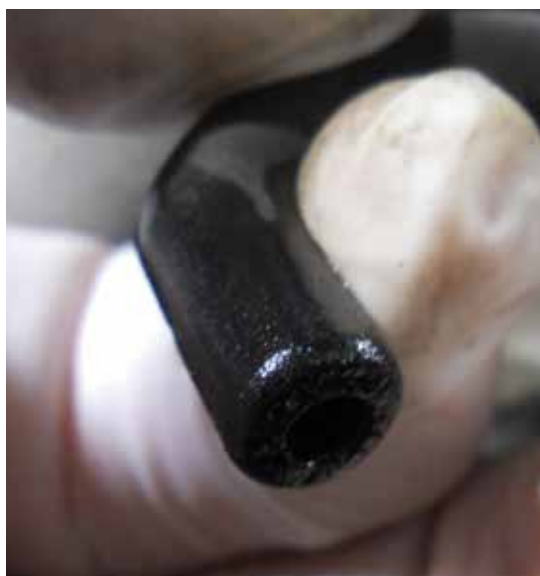
If you find gasoline, replace the regulator.

You can also test the regulator by attaching a pressure gauge to the fitting at the end of the fuel rail. Start the engine, allow it to warm up, then shut it off and let it sit for at least 20 minutes. A good regulator should be able to maintain 29 psi (200 kPa) for at least 20 minutes after the ignition switch is turned off. Although that's the factory recommended test, we have had mixed results — we've found that it won't always identify a failing regulator.

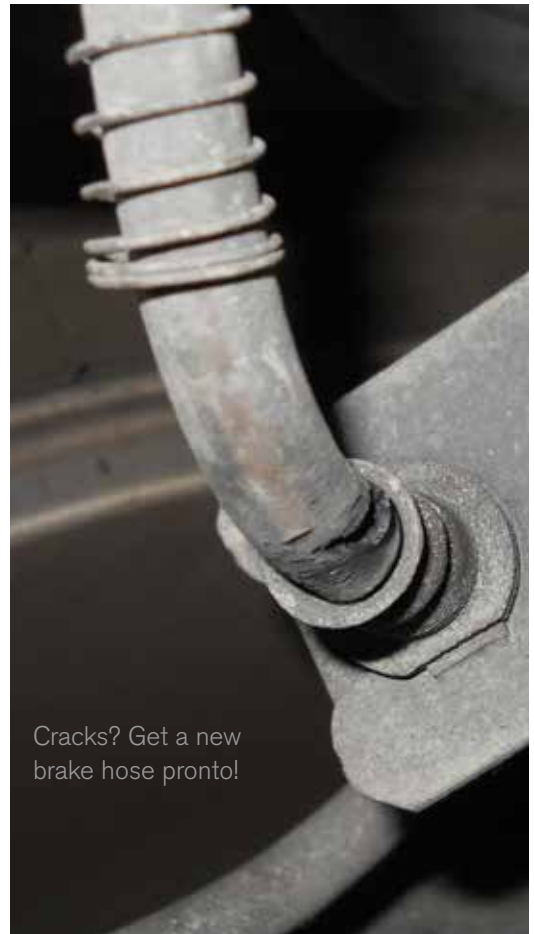
Cracks? Get a new brake hose pronto!

Checking brake hose condition should be a regular part of your safety inspection on all vehicles, not just Volvos. We have seen many high-mileage Volvos with cracks in these hoses, and also with bubbles or bulges in the outer skin, which is due to ruptures in the inner hose. Needless to say, whether the hose is cracked or bubbled it should be replaced as this is a dangerous condition.

To properly inspect these hoses, remove the wheels and pull back the spring that shields the top part of the hose. Look carefully at the hose right above the strut bracket and there's a good chance you'll see cracks and/or bulges. You should recommend that all four hoses be replaced, and doing a full brake system fluid flush and refill with an approved DOT 4 fluid makes sense. Use only the high-quality Volvo OE replacement parts here because your customers' safety is in your hands.

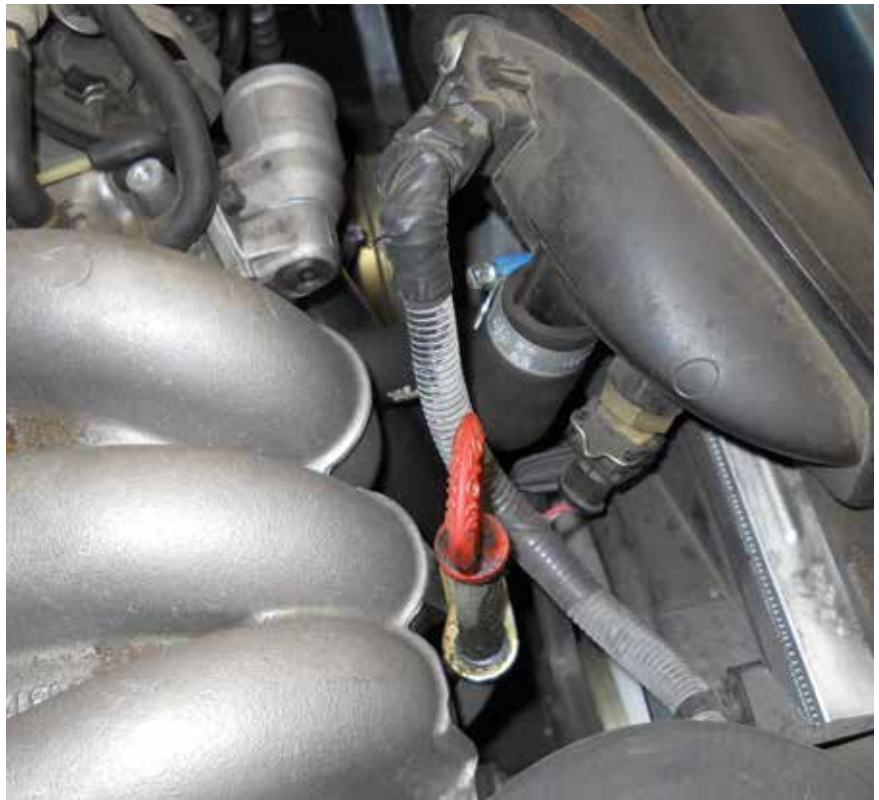
Make sure you check this hose during your regular inspections. When it breaks, the car will stall at idle.

A lack of fuel control, hard starting, and DTCs, usually P0171, may be caused by a leaky AAC (Assisted Air Control) valve hose. Cracking hoses are normal signs of aging and we suggest that you check this hose

on every '99 through '04 S/V40 that comes in. If you look closely at the bottom of this hose on the intake manifold side, you will likely see cracks, which could eventually lead to causing an unmeasured air leak. Even a small crack admits "false" air and can set codes, so the rule of thumb is, if it's brittle, replace it. Use a Volvo OE hose and new clamps if you want the repair to last as long as the first one did.

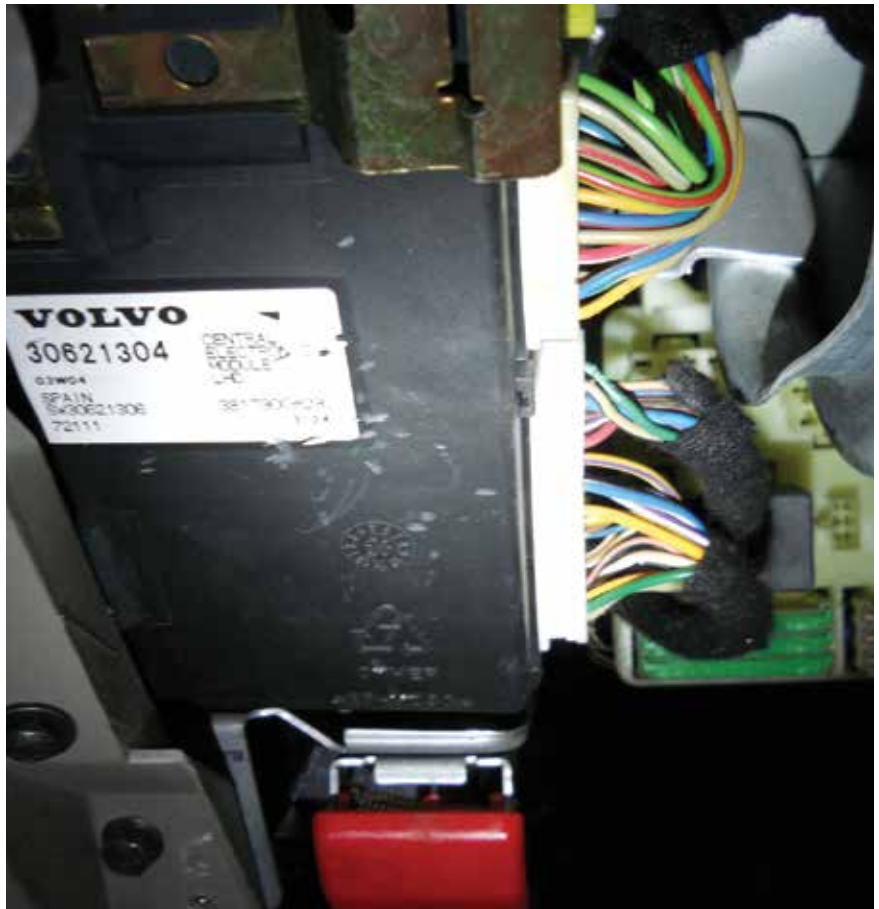
The Central Electronic Module completes the circuit to the low beams.

On the '99 through '04 S/V40 series, Volvo used the CEM (Central Electronic Module) to power the low-beam headlights. The headlight relays are built into the module, and over time the circuit board tends to overheat and compromise the soldered connections (also, the relays themselves tend to get weak and fail — sometimes you can give the CEM a tap and it will bring the low beams back on line). Technicians have been known to open up the CEM and poke around with a soldering gun, and try to replace the relays. Some are successful, but most of the time the problem comes back in a few months. So if you find a CEM that has worn out, make sure you replace it with a new one from Volvo, but make sure you check the basics first. Some technicians prefer to diagnose electrical problems “backwards,” from the load to the main power and grounds, which is often faster. Start with the low-beam bulb — is the bulb itself good? If the answer is yes, move on to the connector for power and ground. If you have ground and no power, the problem is most likely the CEM, but make sure you check the fuses and the inputs and outputs at the module's connector before replacing it. The good news is that unlike all other Volvos that use a CEM, this one does not require a

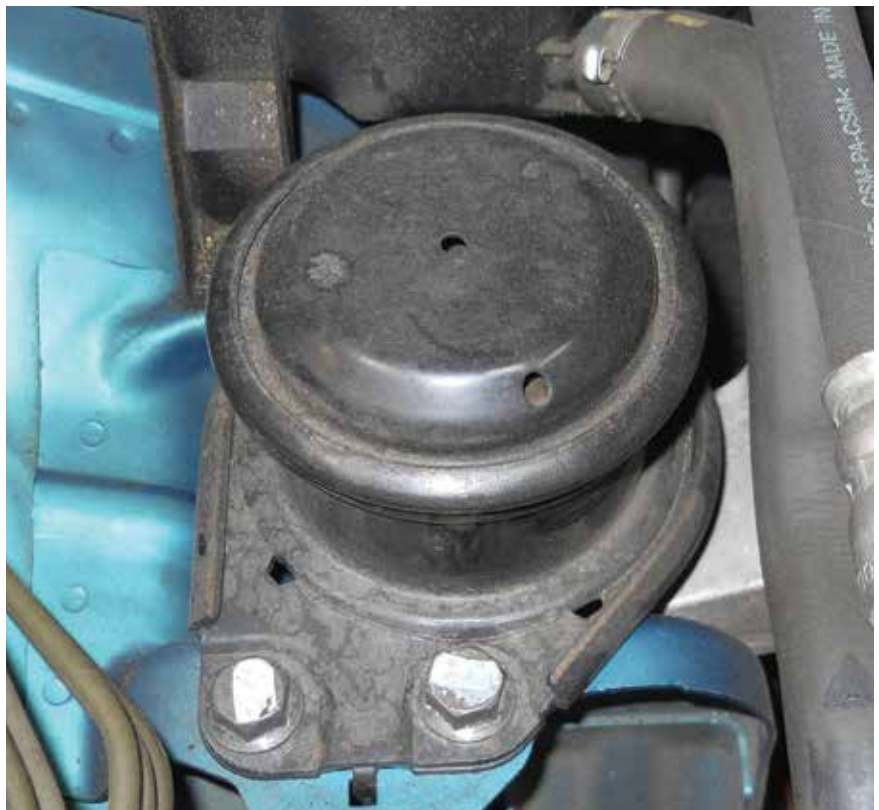
Hydraulic motor mounts make for smoothness — until they lose their fluid.

If a customer complains of heavy vibration when the car is in gear at a stop, the cause may be a collapsed motor mount. Volvo used hydraulic liquid-filled motor mounts on the right and left sides (#30 and #7 in the diagram below) on the early 40-series cars, and over time they may develop small cracks that allow the fluid to seep out. The hydraulic mounts are the main culprits in the vibration the driver feels, but if they have failed you should inspect the other mounts also.

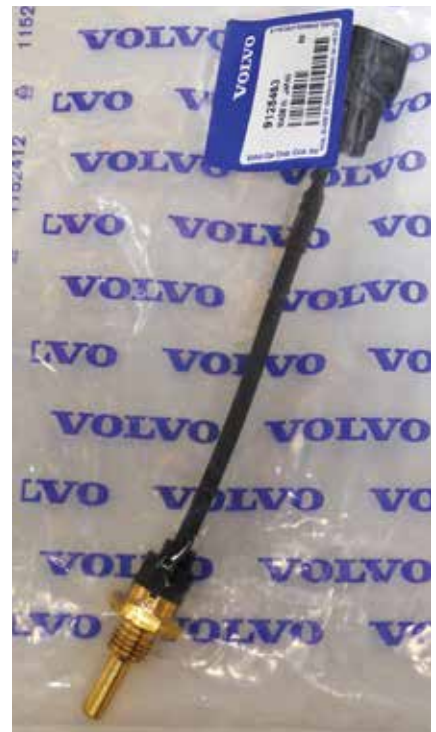
As with all other cars, Volvo ECT sensors can fail. Replace the thermostat and gasket along with it.

An out-of-range or totally failed CTS (Coolant Temperature Sensor, also known as the ECT for Engine Coolant Temperature sensor) can be an issue on S/V40s, and it doesn't always set a code. When the sensor acts up, it can cause poor running, hard starting, and poor fuel economy. The best way to check for this is to watch the live data and make sure the

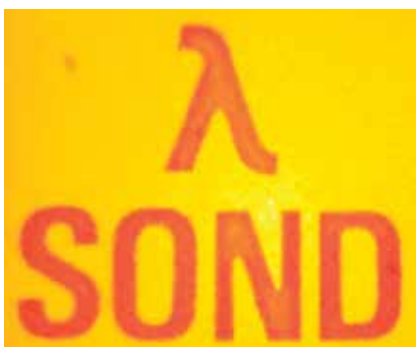
Ancient history: The Lambda Sond warning light on a 1981 Volvo 242 Turbo.

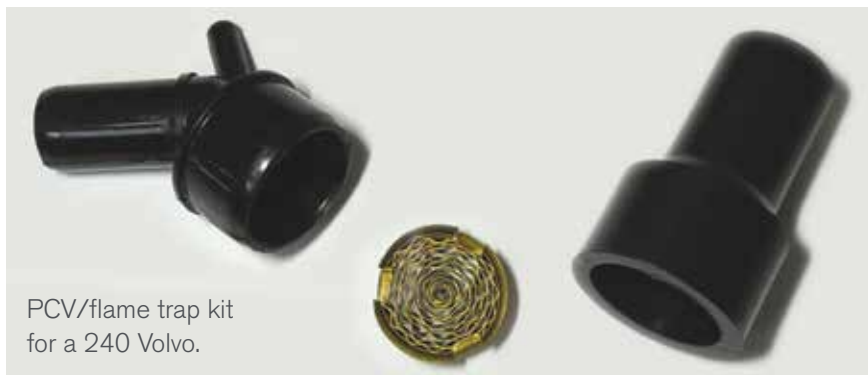
PCV/flame trap kit for a 240 Volvo.

When the Volvo engineers created the B23 and B230, they moved the flame trap fitting to a more serviceable location. That was a good thing because when these systems clogged up, they would naturally cause high crankcase pressure. That would slightly affect emissions, but the real problem was seal failure. More than one rear main seal has popped out because of this. So, if you happen to see one of these early Volvos in your shop for service, make sure you don't forget to check that flame trap.

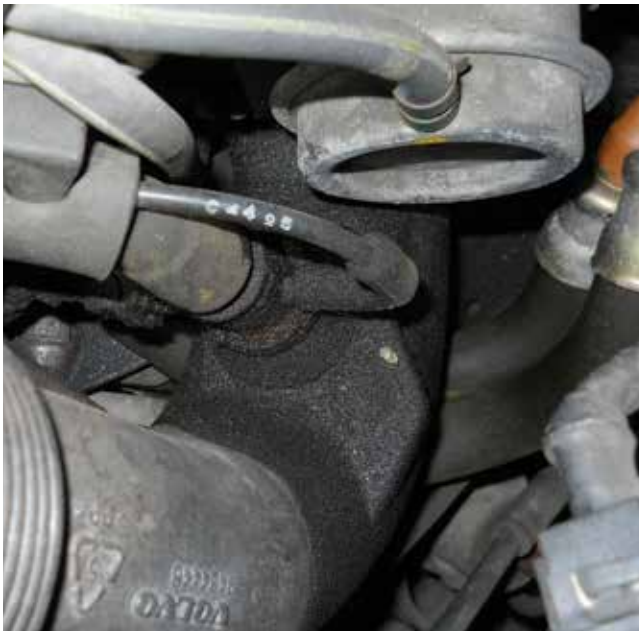
Here's the heater element for the PCV system on a 1997 850 Turbo. The electrical connector can fill with oil and cause a short.

These days, we see clogged breather systems causing more far-reaching damage on the networked fly-by-wire cars, such as the PCV heater on the intake hose leaking oil into the connector and causing a short. This won't turn on the MIL (Malfunction Indicator Lamp) for the heater, but it will sometimes set a code for an oxygen sensor because they share a ground.

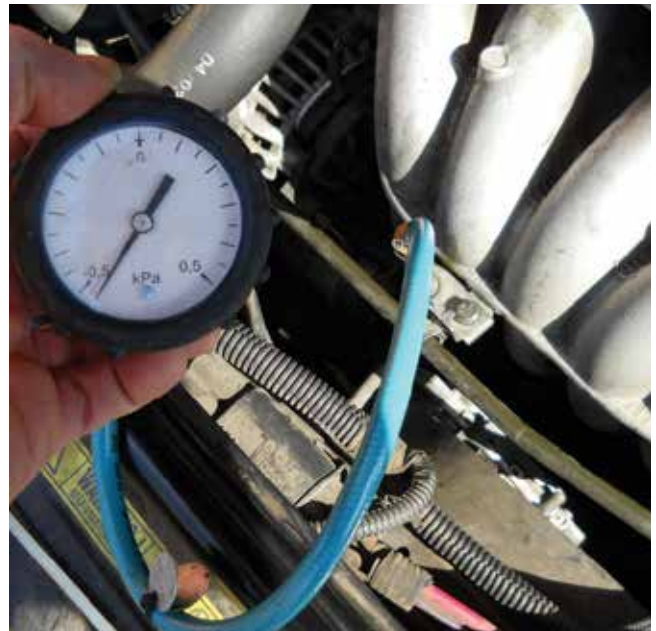
Here's the reading at idle on a 2003 Volvo V70 after the breather system was replaced. Before the repair, the car had a fuel trim code and showed positive pressure on the gauge.

It is wise to visually check the PCV vacuum hoses, and also perform a crankcase pressure test during an inspection. There are several ways to do this. The old-school guys will tell you to take off the oil filler cap while the car is idling and

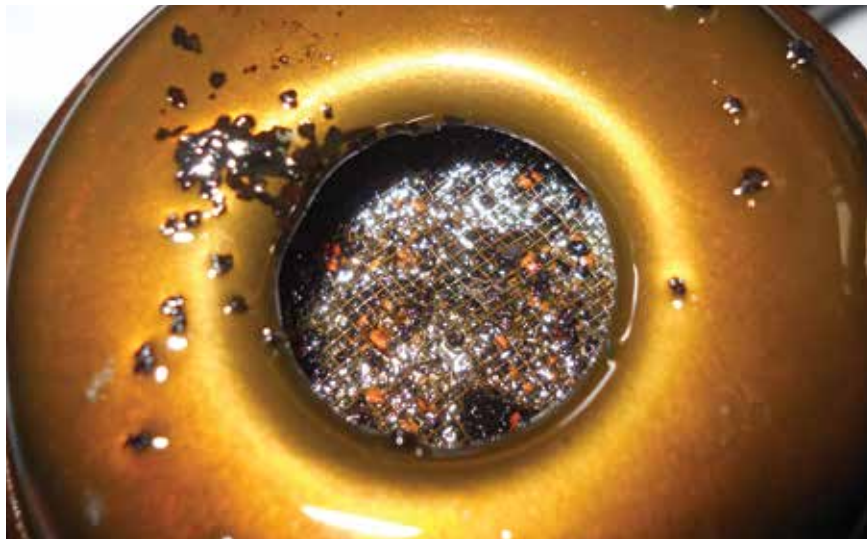
A clogged oil pickup screen caused low oil pressure at hot idle.

A car in for service recently demonstrated the damage a clogged breather system can cause. The oil pressure light came on at idle when the car was hot. After confirming that the breather was clogged, the oil pressure sending unit was removed and a mechanical gauge connected to confirm the low oil pressure.

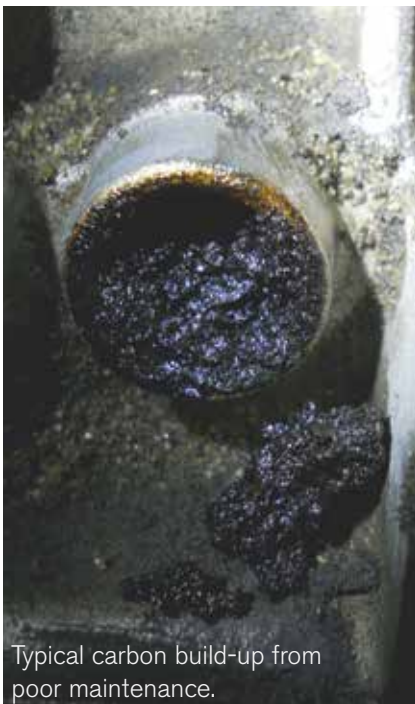
Typical carbon build-up from poor maintenance.

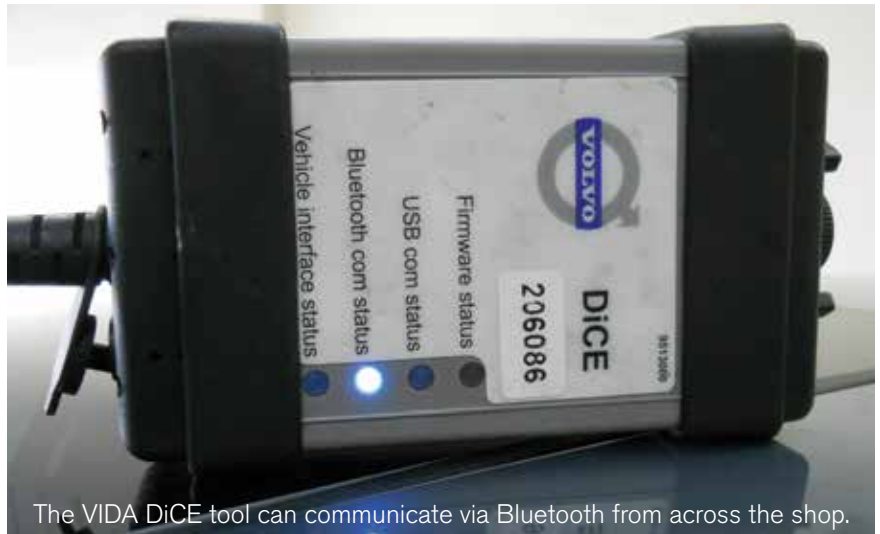
The VIDA DiCE tool can communicate via Bluetooth from across the shop.

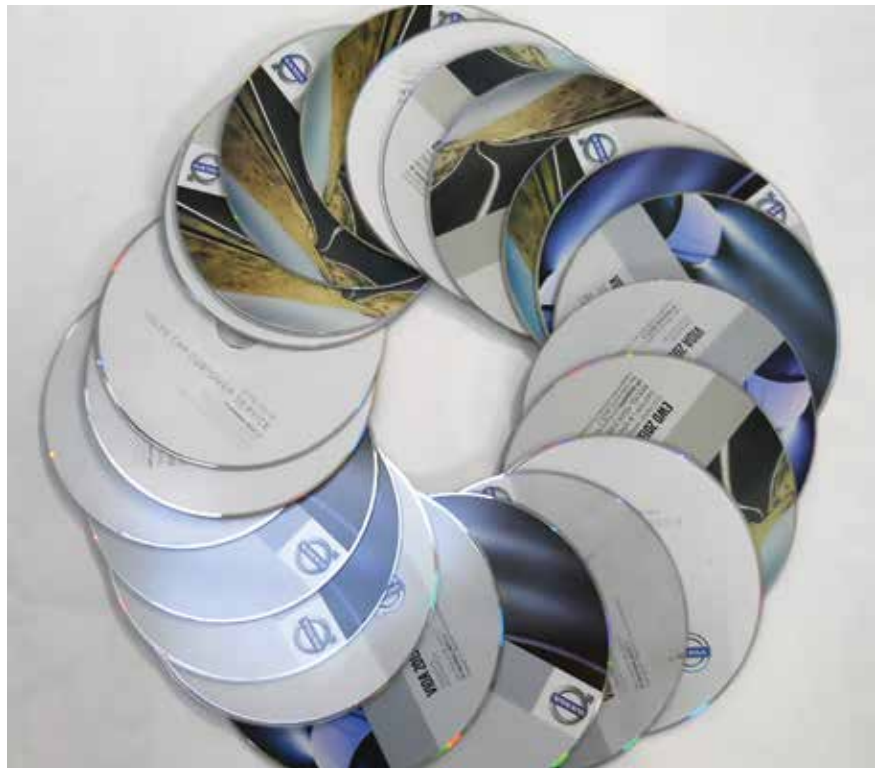
VIDA 2015 is online only, so there's no more waiting for discs in the mail!

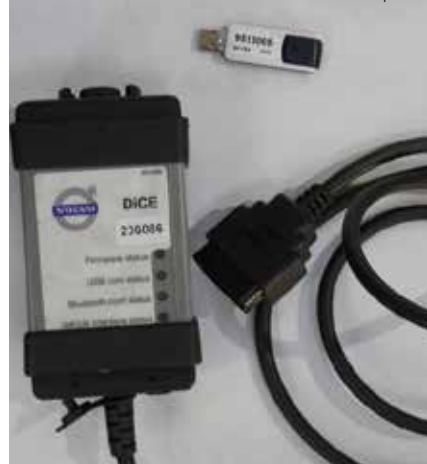
The DiCE tool and Volvo Bluetooth adapter.

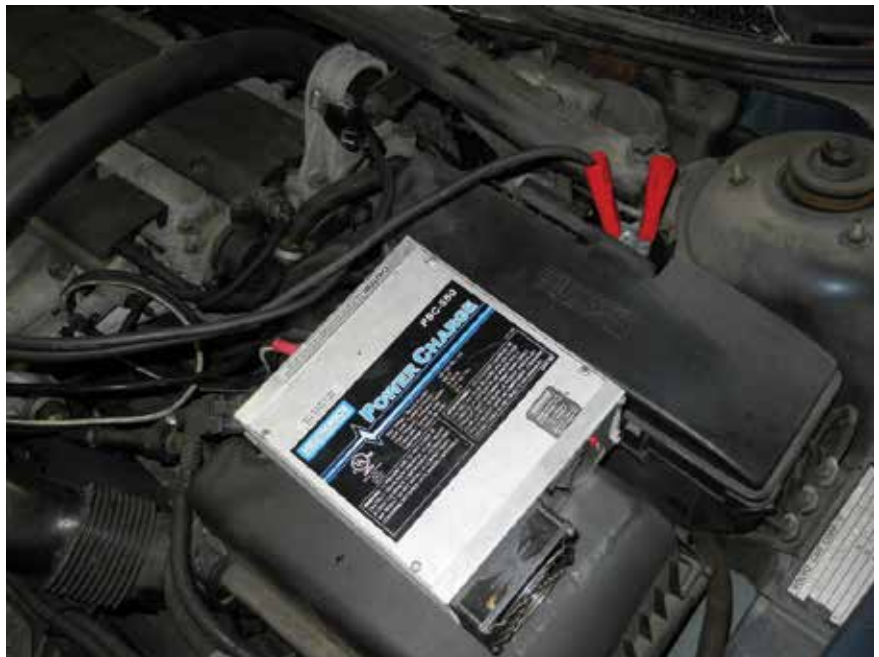
While using VIDA to communicate or download software to a Volvo, you need to provide stable voltage to the car's network. The Midtronics battery charger/maintainer is what Volvo recommends.

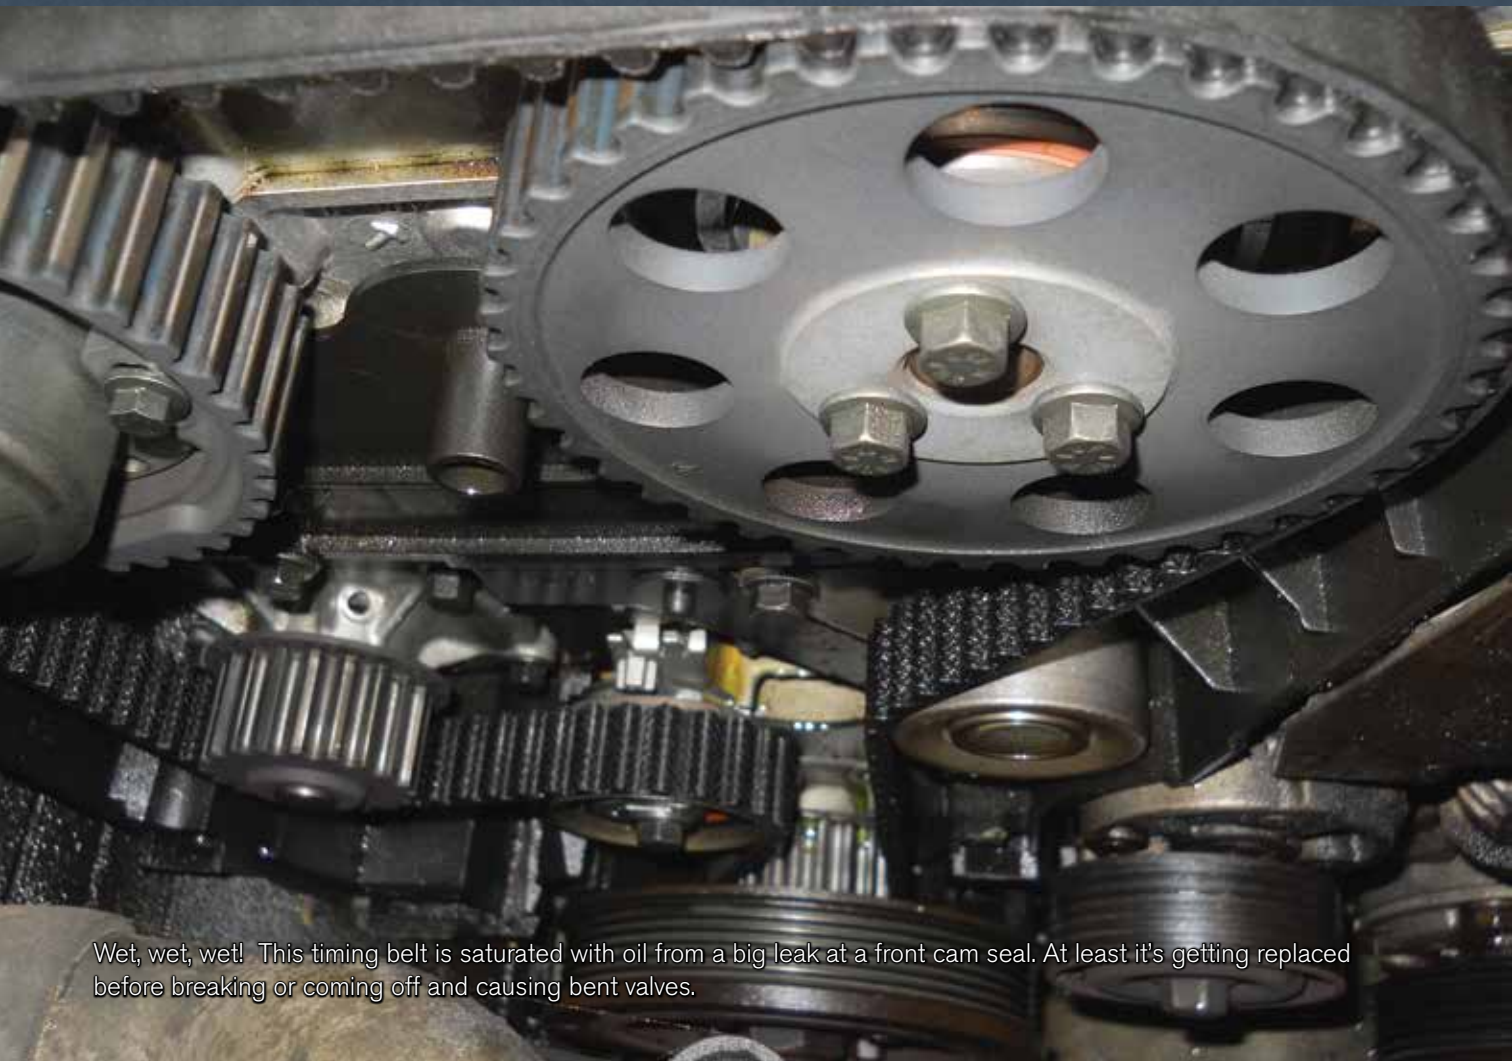
Wet, wet, wet! This timing belt is saturated with oil from a big leak at a front cam seal. At least it's getting replaced before breaking or coming off and causing bent valves.

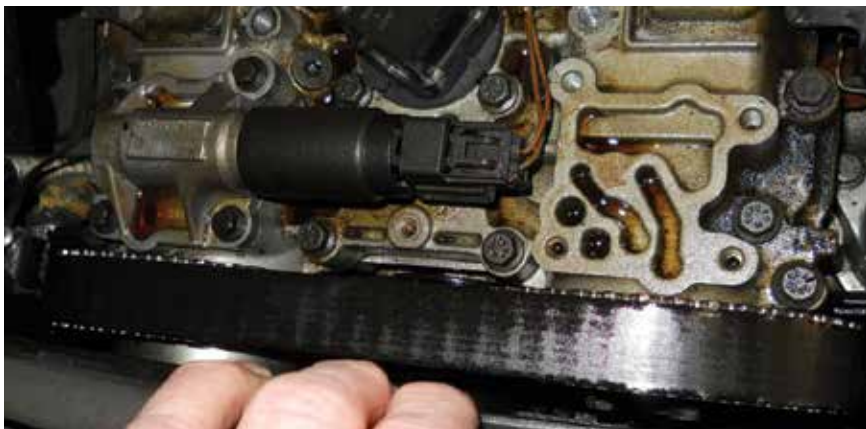
No, this is not an oil-cooled timing belt.

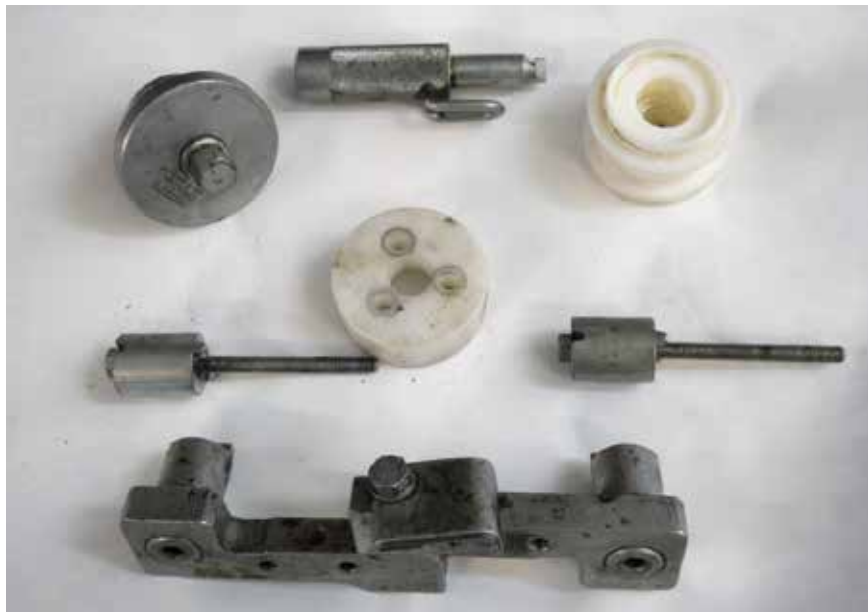
This is a well-used set of camshaft tools.

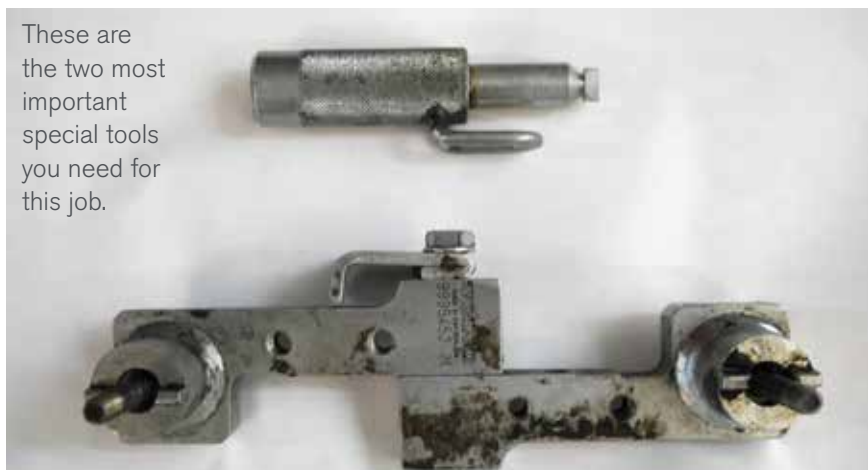
These are the two most important special tools you need for this job.

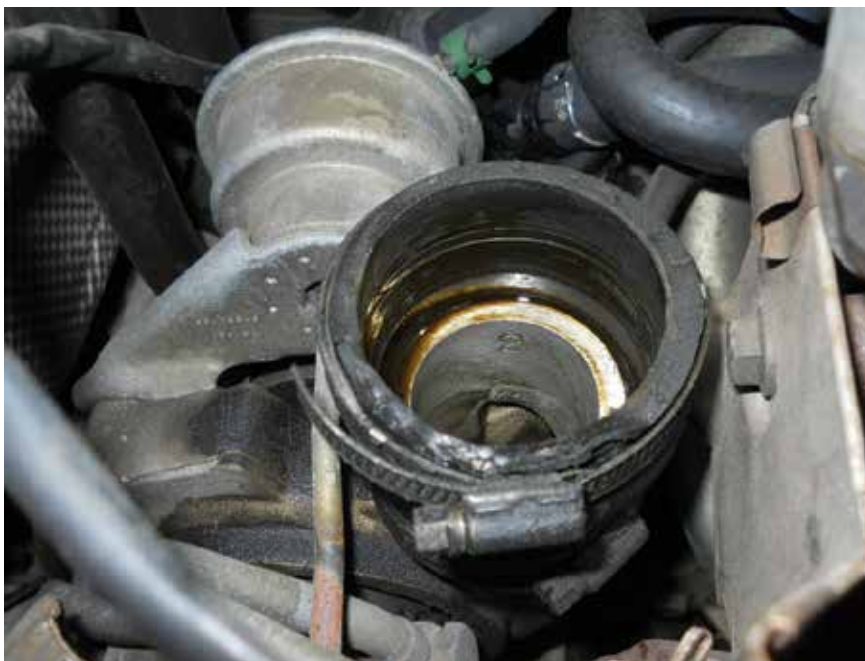
This short intercooler hose on top of the turbo will crack if the hard plastic pipe that connects to it is moved too far without loosening the clamps.

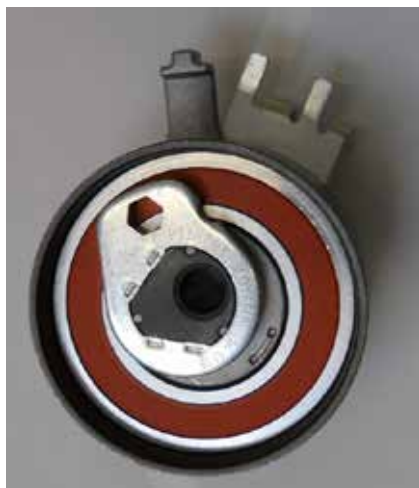
Here's the mechanical tensioner from a Volvo B5254T engine.

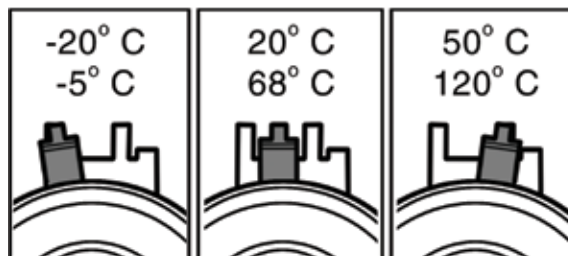
Fine tuning the eccentric indicator.

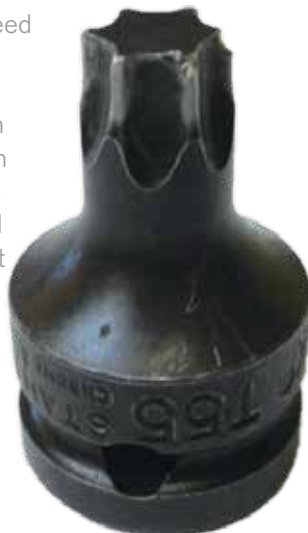
You'll need a short T55 bit to get in between the cam hub and the strut tower.

the center plug on the end of the CVVT hub and torque it to 26 ft. lbs. Loosen the three screws on the CVVT sprocket or sprockets and with a torque wrench and a T55 bit in the cam plug, hold the gear at 19 ft. lbs. and at the same time with a second torque wrench tighten the three outer gear screws to 7.5 ft. lbs. This is to make sure that the CVVT hub is at its end position.

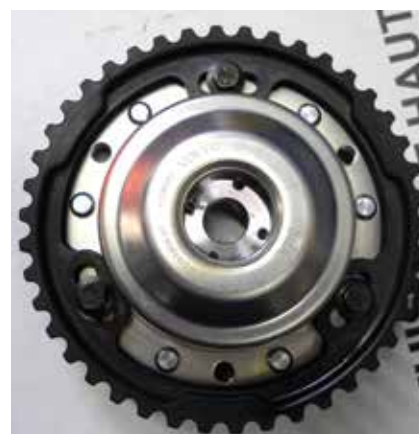
The new CVVT hub has no timing marks, but with the cam lock installed you don't have to worry about that.

Examine the new CVVT hub for defects, make sure the seal on the inside lip is okay, slide it on the end of the exhaust cam, thread the bolt in, and tighten it lightly. You will notice there is no timing mark on the new gear, but don't worry about the position right now. Make sure the mark on the crank sprocket is still lined up with the notch on the oil pump. Loosen the three screws that hold the sprocket to the CVVT unit, turn the sprocket so that the bolts are centered in the slots, and tighten the three screws slightly.
