# VOLVO PATTERN FAILURES, PART 2

As the Odometer Turns

AS THE ODOMETER  
TURNS SOME SERVICE  
ISSUES SHOW UP MORE  
OFTEN THAN OTHERS.

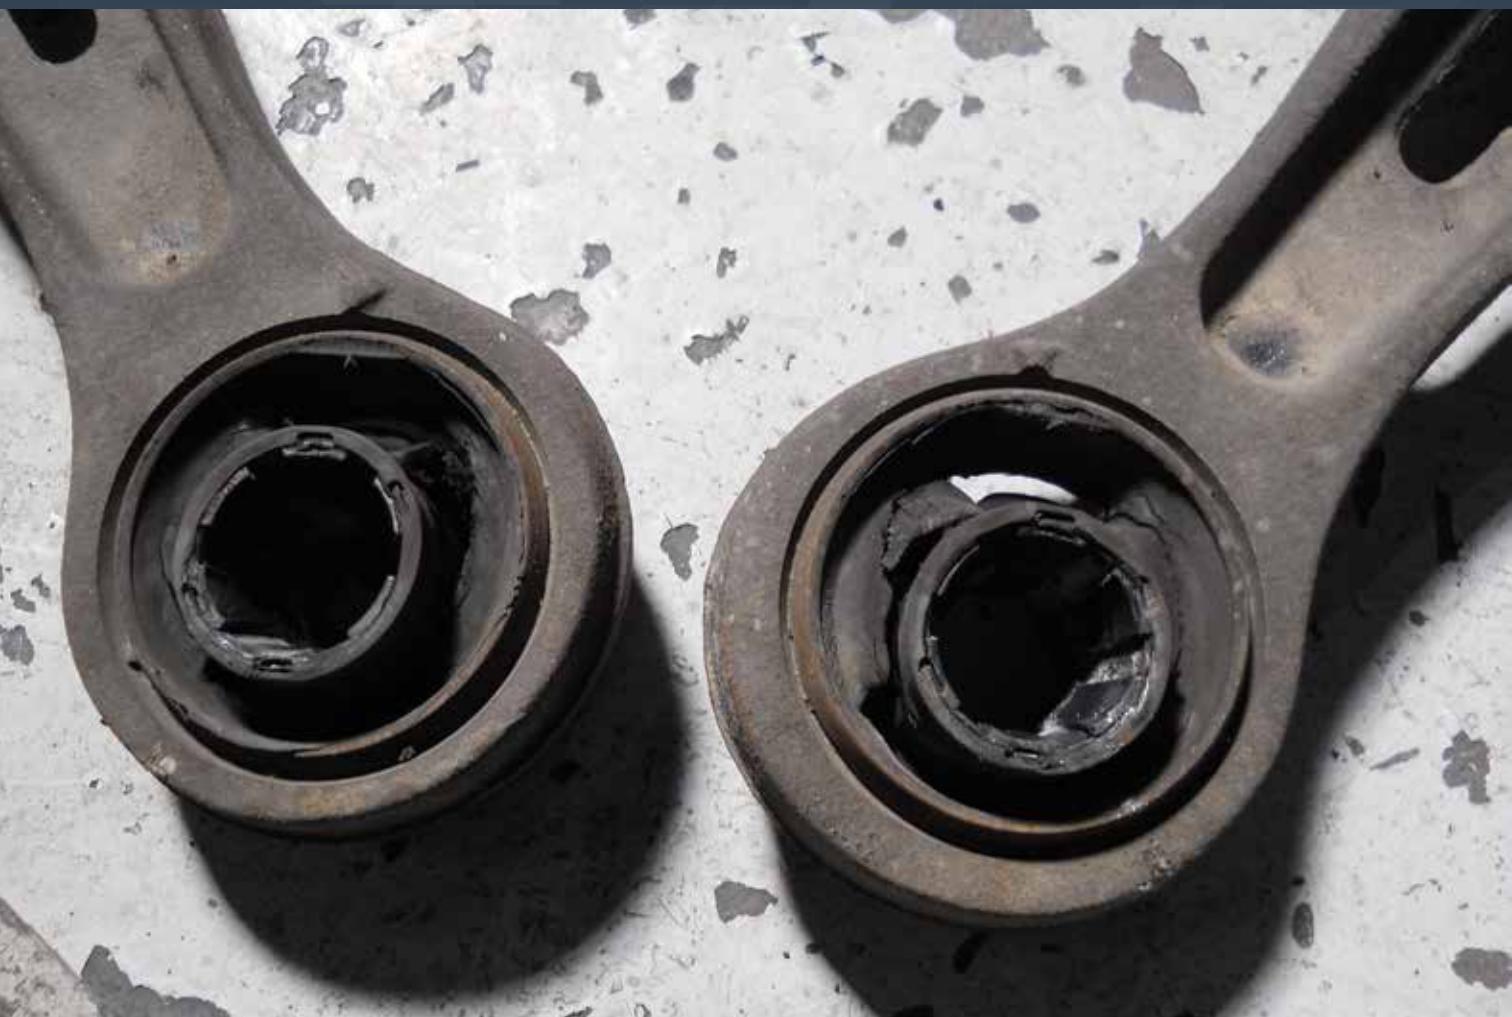
Opposite page: Here is the a front lower control arm bushing on a 2003 S60. You can see the separation inside the bushing. This kind of wear can have a negative effect on handling, braking and tire wear.

In the photo you can see the front lower control arm bushing is completely separated and torn. In this case, it's time to advise the customer that their Volvo needs to have them replaced. As with all suspension components, you should always advise to replace the bushings on both the left and right sides. This will help prevent alignment and pulling issues.

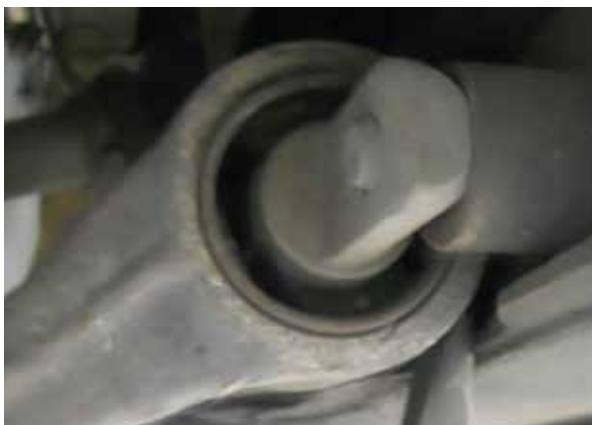
This is the standard test procedure for checking the control arm bushings on a Volvo. When they are really bad you can feel the wheels jerking back when stabbing the brake pedal at low speeds.

There are several ways to check these bushings for wear. One way is to put the car in gear with your foot on the brake and have someone watch the front wheels while you release and apply the brakes while moving forward. If the bushings are badly worn, the wheel will jerk back and forth quite a bit. On XC70 and XC90 models the movement can be as much as a few inches. This is also a great way to show the customer how much worn bushings can affect braking performance and steering control.

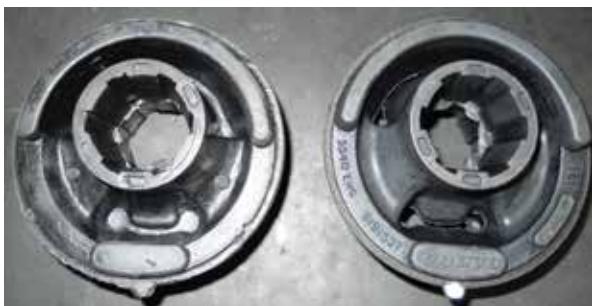
You can really see and feel the difference between the Volvo OE bushing and the aftermarket ones. Make sure you use only Volvo factory replacement bushings. Volvo now has a 2-year unlimited mileage warranty on replacement parts.

On this job it is very important to use only OE Volvo bushings. Aftermarket bushings often become torn or

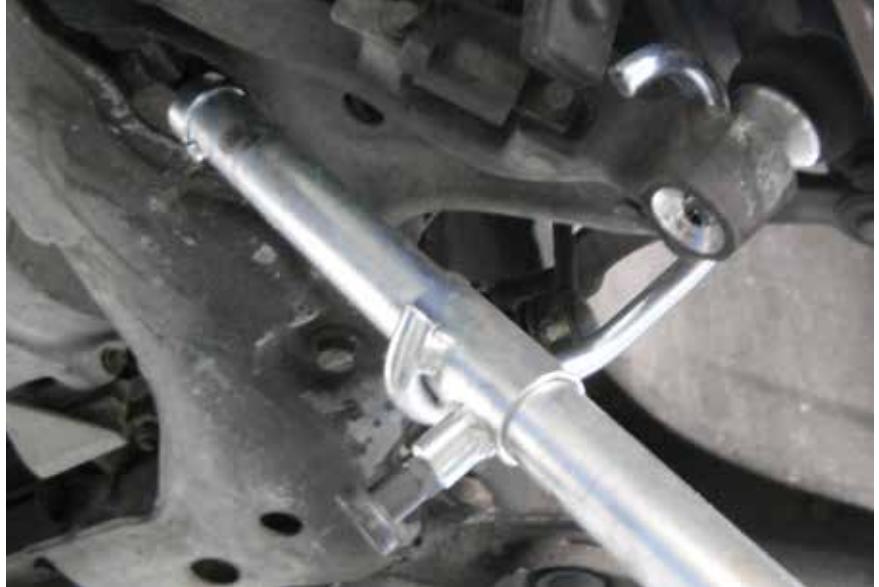
The safest and easiest way to pull down Volvo control arms is by using Volvo special tool #999 7076. Once you use this tool you will wonder why you did it any other way.

The problem most techs have is prying down the control arms enough to clear the ball joint during removal and installation. The trick to safely and easily lower the arm under tension is to use the Volvo special tool (999 7076).

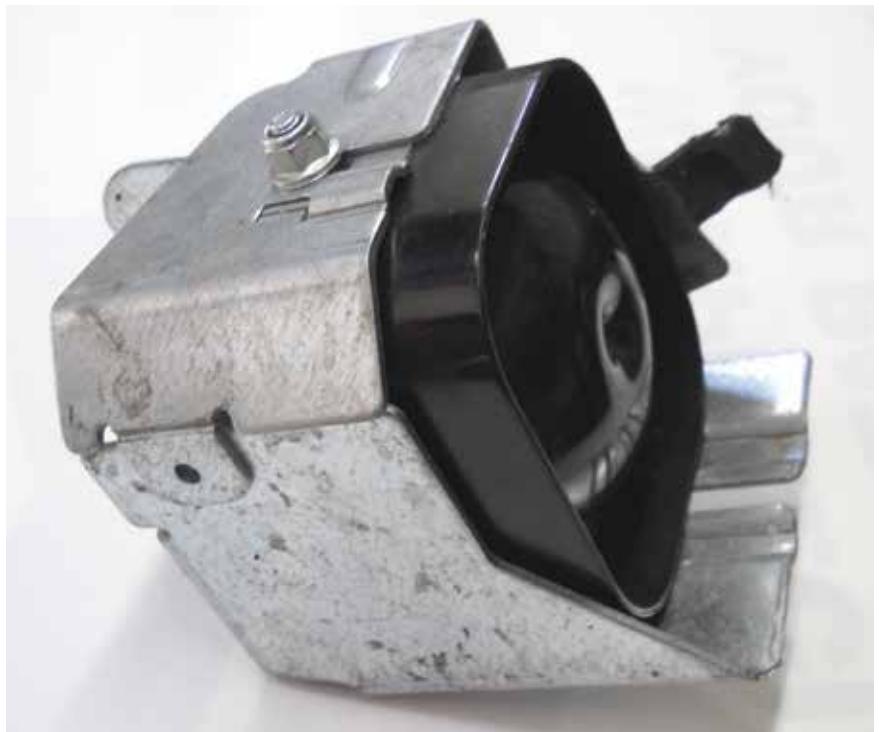
In the image you can see the alarm module removed from a 2001 Volvo V70XC. The internal rechargeable battery has failed causing intermittent alarm malfunctions.

If the alarm does not go off when you trigger it, you should start by checking the siren fuse inside the fuse box on the driver's side of the dash. In most cases the siren module's internal battery has deteriorated to the point that it can no longer hold a charge for long periods of time, causing the alarm system to perform erratically. The module is located inside the right front fender. To replace it you will need to remove the right front wheel and inner fender liner.

The siren module is held on by one security bolt that will have to be drilled or cut off. You will need to get new fender rivets from your Volvo parts department in order to reinstall the fender liner correctly.

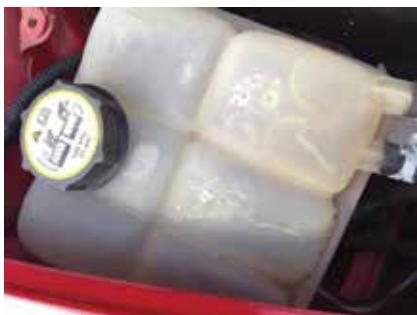
The coolant tanks on the P1 cars tend to crack along the gap in hood where sunlight can expose it to UV rays.

When a Volvo is in for service, check for cracks or leakage on top of the coolant reservoir. After about 90K miles some tanks become brittle and develop cracks and leaks on top. When you replace the tank you should also recommend a new reservoir cap and a coolant change. Make sure you use only Volvo factory coolant in these cars. Using a vacuum lift system for filling the system on these engines is not recommended because of the lower radiator hose; its hard plastic and rubber construction can separate under vacuum. The customer won't always notice that they are losing coolant until the low coolant light comes on. If the tank's weakness results in one of the nipples breaking off at the wrong time, like on a long driving trip, an overheating condition can occur.

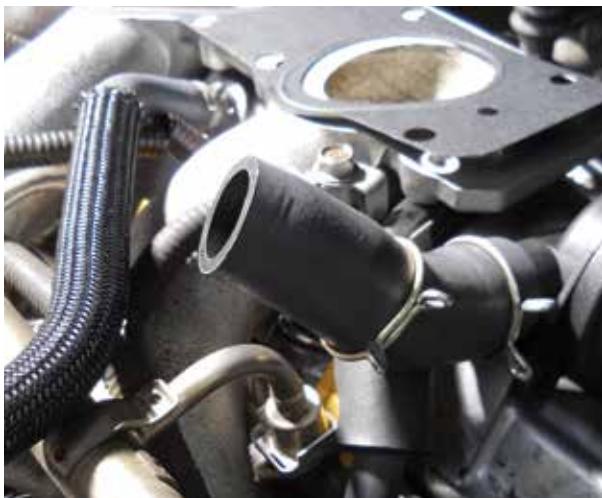
Make sure you order the PCV valve and hoses when you perform the valve cover job. The hoses always crack, and replacing the valve is always a good idea when repairing oil leaks.

The two hoses replaced during this repair are often rock hard and crack during removal, so include them in every V-8 valve cover job. It's also a good time to replace the spark plugs if needed.

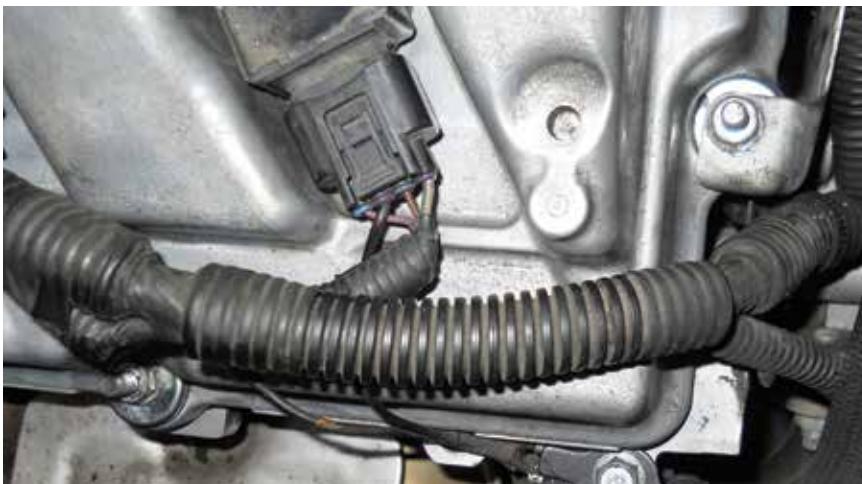
When replacing the valve cover gaskets on Volvo V-8s, take care not to damage the ignition ground wires. They are delicate and can break easily.

You should be careful with the wire harness for the ignition coils, especially the ground wires on the valve cover bolts. They tend to break if you are rough with them. Use a 10mm wrench to hold the bolt while you remove the ground connector. Here is a list of the Volvo part numbers you will need to order to do the complete job:

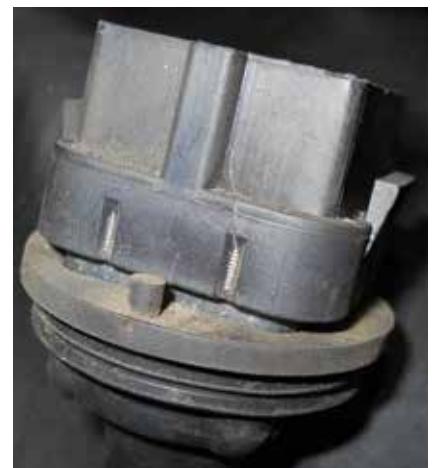
As the coils age they start to develop cracks in the plastic housings, which can let moisture in and leak secondary voltage out.

When you are checking out a Volvo that has a misfire problem, make sure you inspect the coils closely. The coils can develop tiny cracks around the plastic housing on top. This is a sure sign of a bad coil. If you pull the rubber insulator boot down on a weak coil, sometimes you will see carbon tracks from voltage leakage. If your diagnosis shows that a car has a defective coil and the car has over 60K miles, it's best to replace all the coils.
