VOLVO AGING ISSUES

THIS ARTICLE IS PART OF
A CONTINUING SERIES
COVERING COMMON
PROBLEMS THAT CAN
ARISE ON VOLVOS WITH
HIGHER MILEAGE.

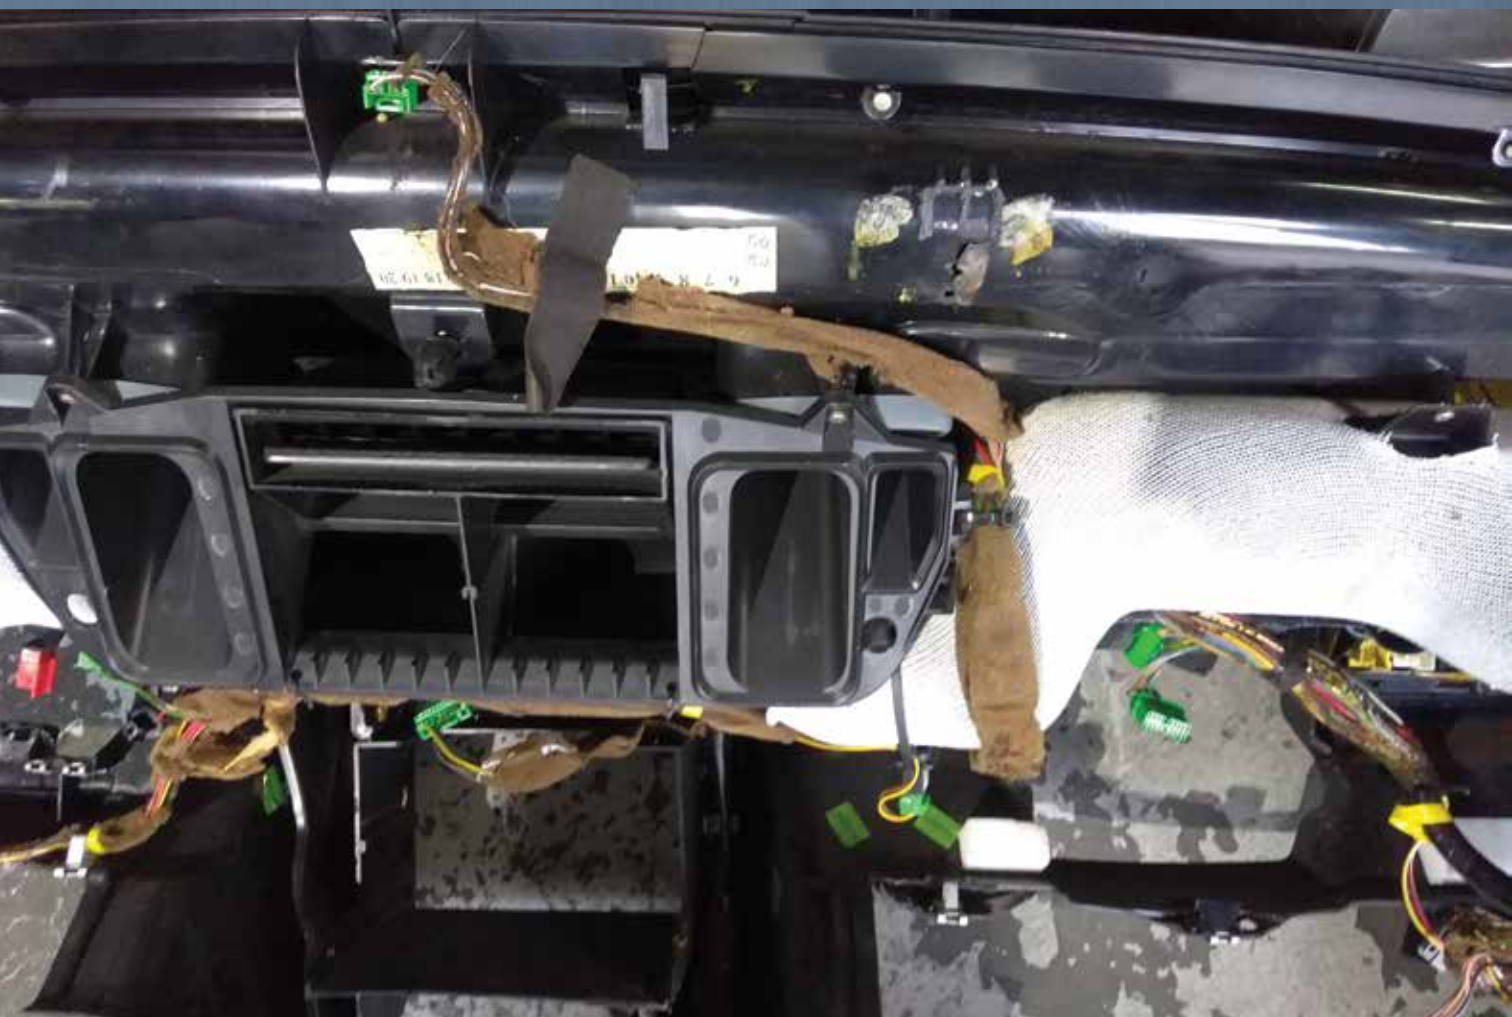
Opposite page: If you have an 850 that makes a loud crack or pop noise from the front of the dash board when the car hits a large bump, you may have a broken dash assembly mount on your hands.

But if you get one of these Volvos in your shop with a customer that complains about a loud "POP" or "CRACK" noise coming from the dash area when the car hits a pot hole or large bump, this Volvo may have a broken dash board mount or mounts where the main dash board assembly connects to the firewall.

Over the years of sun and heat exposure, the plastic at the front of the dash begins to get brittle and starts to crack.

When the dash mounting points break, you will know it; when you drive the car over a hard bump the noise is very sharp and loud.

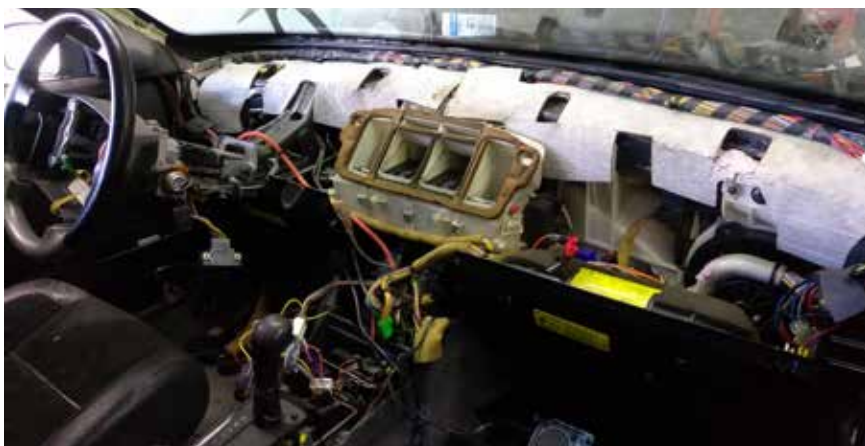
Your customer will have to really love their Volvo to fix this one. It will be expensive and require removing and most likely replacing the whole dash assembly.

The whole dash assembly will have to be removed including the steering wheel and both air bags, and in most cases the main dash assembly will have to be replaced.

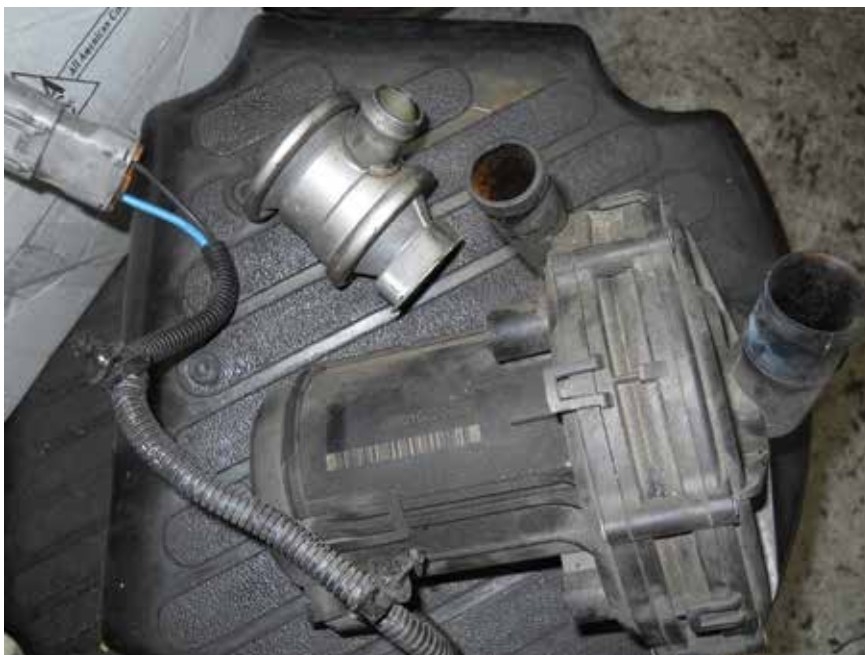
When the SAS check valve fails it usually damages the air pump by allowing exhaust gases and moisture to be sucked directly into it.

stored one or more codes related to the air pump system (SAS), there is a good chance that this car might need a new air pump and air pump check valve. As these 850s get older, the diaphragm in the air pump check valve can crack and leak internally.

When the SAS check valve diaphragm is damaged, it can allow some exhaust gases to leak through it and flow backwards through the inlet hose that comes from the air pump. As we all know, engine exhaust can contain quite a bit of water vapor as part of the normal combustion process, especially when the car is cold.

The problem occurs when exhaust gases and water vapor are allowed to leak into the electric air pump. When this happens, the water can soak into the air pump's motor and windings,

causing the pump to short out and rust internally.

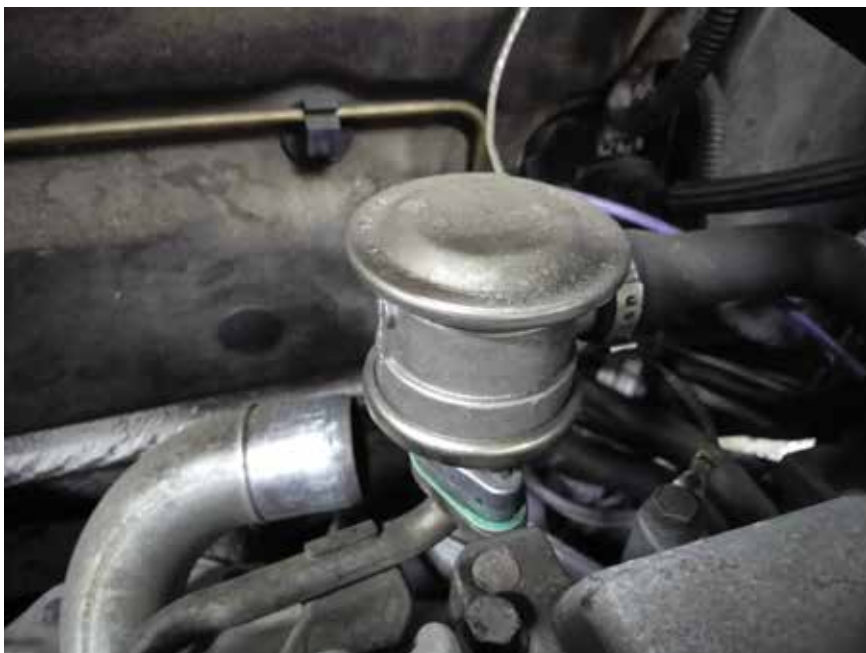
The rust residue inside the air cleaner housing is a sure sign that the SAS valve is leaking.

The easiest way to check for this problem is to take the top off the air cleaner housing and check the inlet hole for the air injection system. In most cases you will see traces of rusty water around the hole, and in some cases, on the air filter element itself.

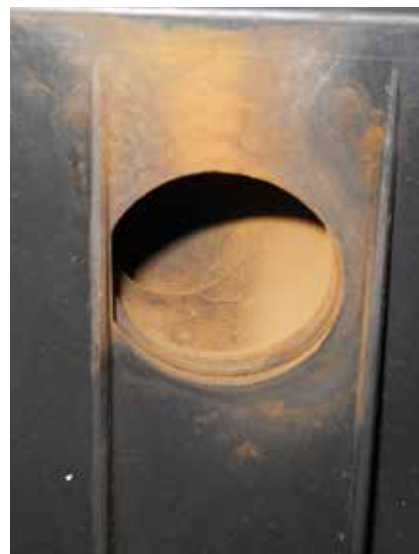
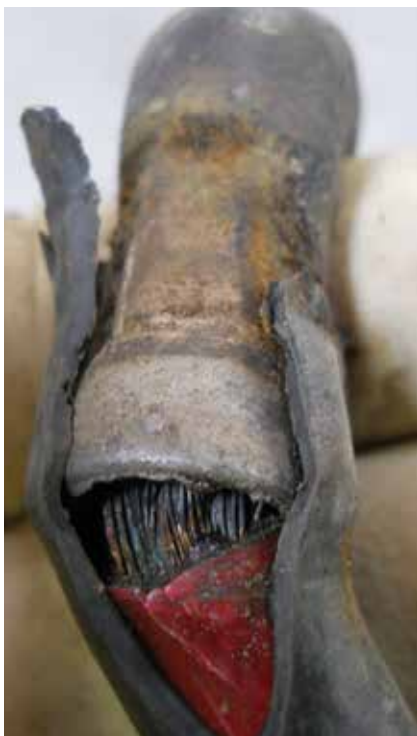
The positive battery cable can corrode inside the clamp's crimp, causing intermittent high resistance.

What happens to these cables over time is, moisture can build up inside the cable and start to cause corrosion to develop inside the battery clamp where the cable is inserted and crimped. You usually can't see this corrosion because the cable connection is covered with heavy-duty heat shrink. This corrosion causes resistance, the resistance causes heat, the heat causes the clamp to expand, which causes a poor connection, and the poor connection causes voltage drop.

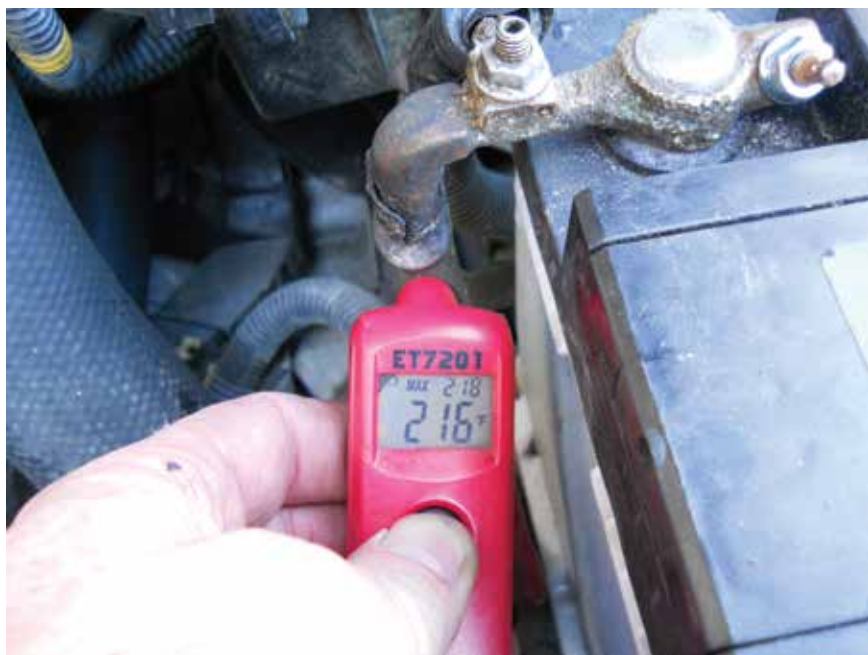
Be careful not to touch the positive clamp during testing on one of these cars, because if the car is running and warmed up, it not uncommon to measure temps over 200 degrees F at the clamp when these cables act up.

When you get one of these Volvos in the shop, you will notice that when the car is cold it may be charging normally, but as the car warms up two things will happen: the charging voltage will slowly begin to drop, and the positive battery clamp will begin to heat up. So be careful not to touch the positive clamp with your bare hands when these cars are running and warmed up. This is because the high resistance in the battery's cable and connector can cause the battery clamp to get very hot!!

Along with a volt meter, you can use a non-contact infrared thermometer to measure the positive battery clamp voltage and temperature as the car

warms up. If the car has one of these failing positive cables, you will see the voltage slowly drop as the clamp temperature rises.

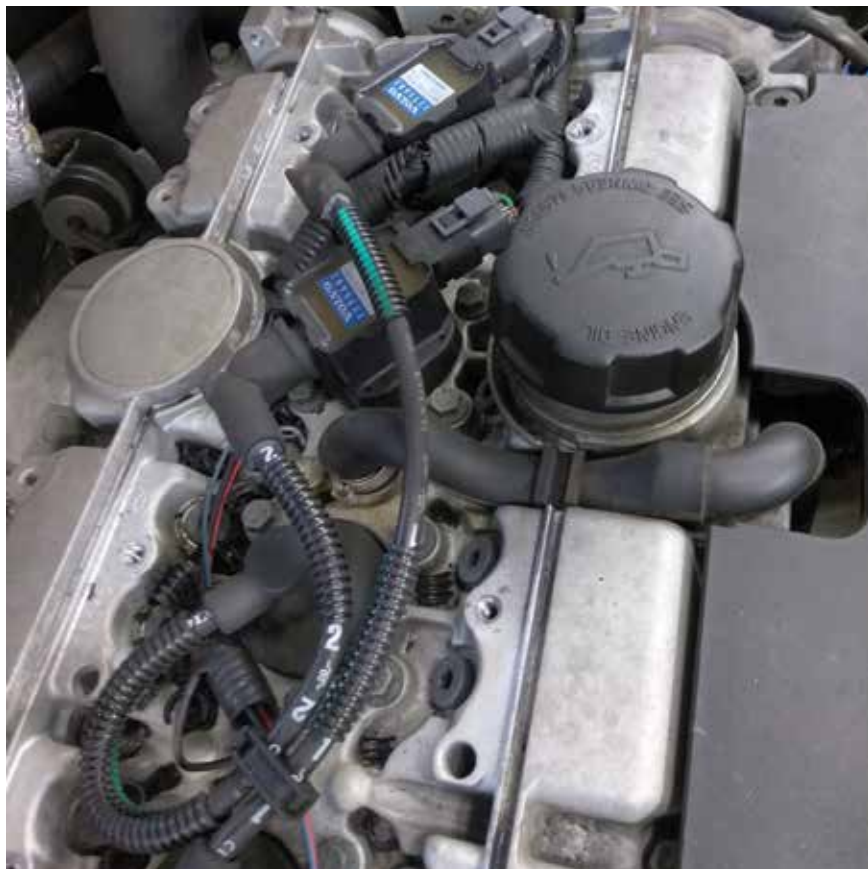
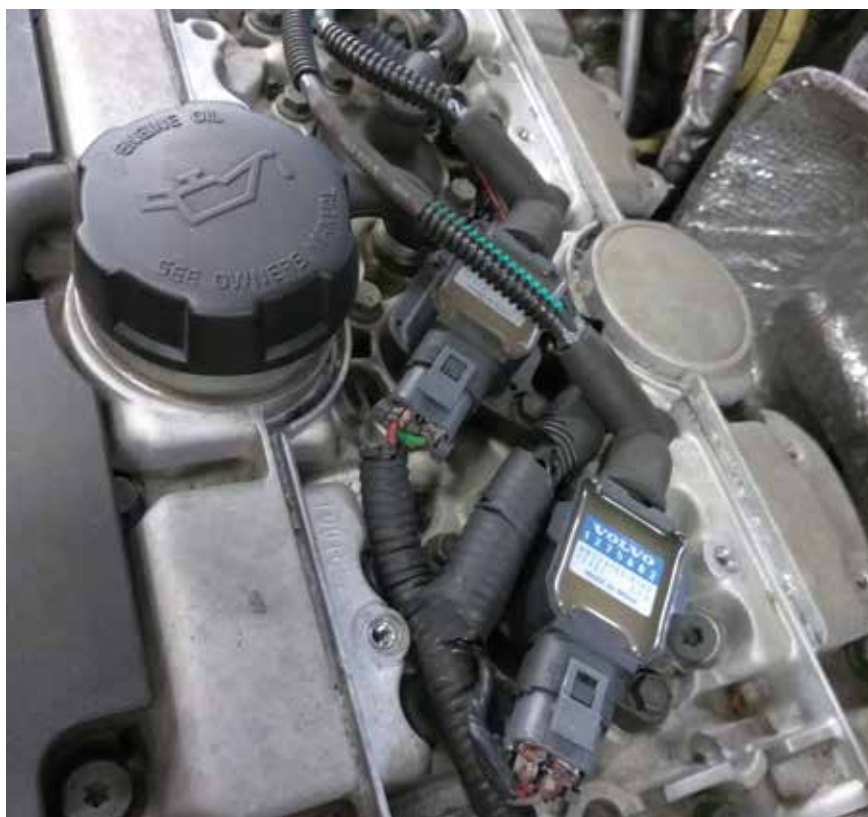
If you get one of these 1999-2004 S/V 40s in your shop with a camshaft reset valve code (ECM-61 or POO14) stored in the ECM, make sure you make inspecting the wire harness part of your initial diagnosis.

This short wire harness starts at a connector at the fire wall and connects to the two ignition coils and the VVT solenoid.

If you get one of these 1999-2004 S/V 40s in your shop with a camshaft reset valve code (ECM-61 or POO14) stored in the ECM, make sure you make inspecting the wire harness part of your initial diagnosis.

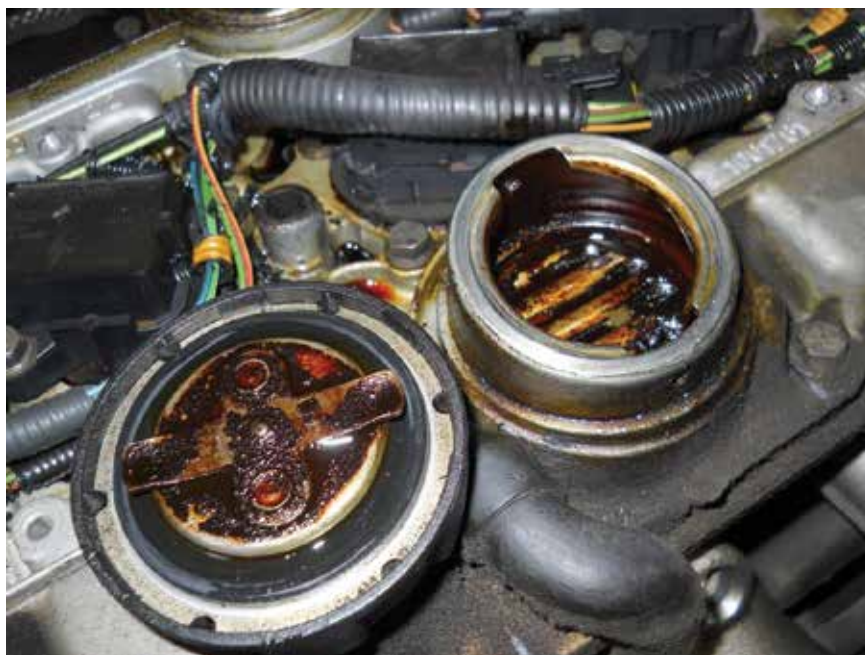
There is an old school trick to find out if the car has had its engine oil changed on a regular basis or not. Just look at the bottom of the oil filler cap, if it's clean, this Volvo has been loved, if it has a lot of baked on crud built up on it, this Volvo probably has not been loved on a regular basis.

Of course there is an old school trick to find out if the car has had its engine oil changed on a regular basis or not, just look at the bottom of the oil filler cap. If it's clean, this Volvo has been loved; if it has a lot of baked on crud built up on it, this Volvo probably has not been loved on a regular basis.

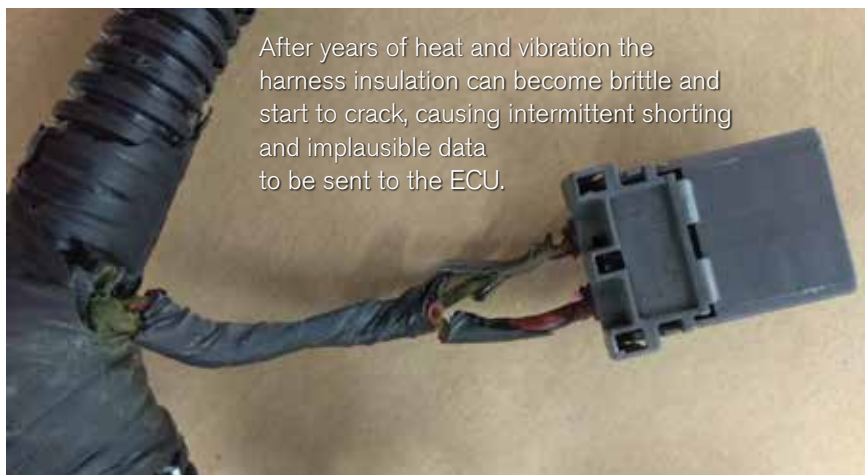
After years of heat and vibration the harness insulation can become brittle and start to crack, causing intermittent shorting and implausible data to be sent to the ECU.

This is because the upper engine wire harness on these Volvos runs over the top of the cam case and operates in a very hostile environment. After years of heat and vibration the harness insulation can become brittle and start to crack, causing intermittent shorting and implausible data to be sent to the ECU.

So inspect those wires and connectors, you will usually see that the wire insulation right near the coil connections is rock hard and crispy.

The replacement harness from Volvo has blue connectors at the coils and the original harness has black. ●
