# EVAP System Diagnosis

**EVAP emissions sources are tricky to find. Here are a few tips to try before connecting that smoke machine.**

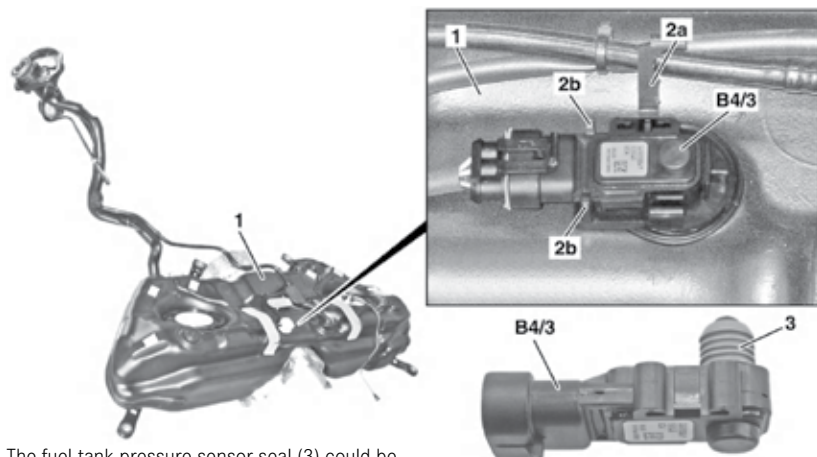
The fuel tank pressure sensor seal (3) could be deteriorated, or the sensor (B4/3) may have become stuck, and is sending a false positive signal to the ME control unit. Take care to not turn or tilt it when removing the faulty FTP sensor, as this may damage the locking tab (2b), which is needed to secure the replacement sensor.

No matter what the reason you are performing the purge cycle test, if there's a leak of more than 3 mm, you will likely hear a loud hiss. If you can hear it, but the ME control unit does not see the leak and set a trouble code, replace the fuel tank pressure (FTP) sensor. The FTP sensor is likely stuck in a manner that sends a good (plausible) signal despite the leak.

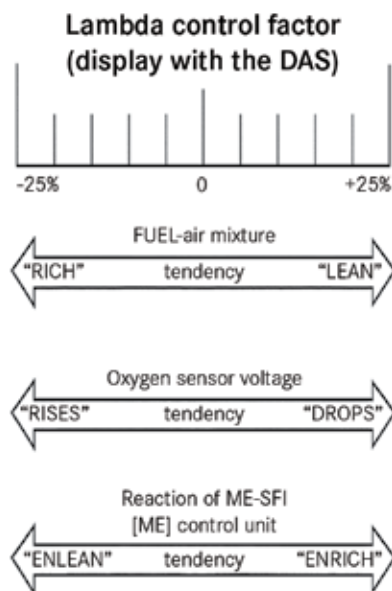
A faulty FTP sensor or defective purge valve can cause the air/fuel mixture to become too rich or lean, depending on fuel level and engine speed, and require excess adjustment from the ME control unit in order to keep the engine running efficiently.

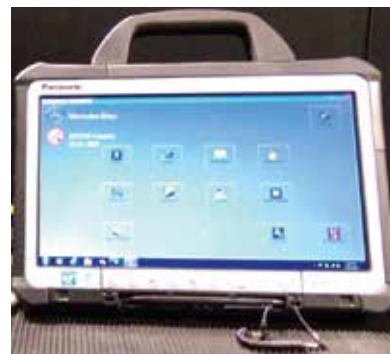
With XENTRY you can read current configurations of various systems on Mercedes-Benz vehicles, access and troubleshoot any system or control module, stream real-time sensor data, conduct sensor actuation and testing, read and clear fault codes, and perform online or offline initialization and coding of sensors and modules.

Before setting up the smoke machine or checking to make sure the gas cap is tightly closed, conduct an EVAP leak test using the Mercedes-Benz XENTRY or previous Star Diagnosis tool. Because you connect under the dash, you won't likely have altered one or more of the conditions that could be a primary leak source. Also, if the vehicle fails the leak test, you'll have verified that the fault code is not due to an intermittent problem or ME control unit issue.
