## RARE VOLVO AGING PROBLEMS

### NOT-SO-COMMON NOISE FROM THE XC90 4.4L V8 2004-2014

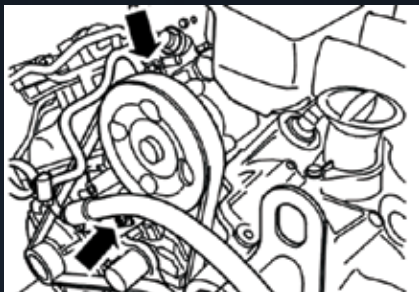
### REMOVING THE SERVO OIL LINE

Remove:

- The nut of the clamp
- The screw on the oil feed pipe

Plug the openings and wipe up any spills.

Bend aside the servo oil line.

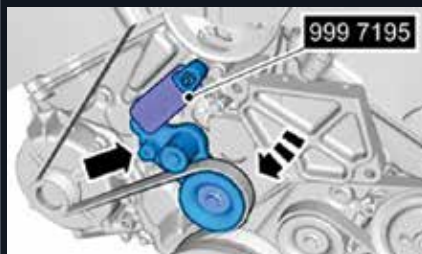
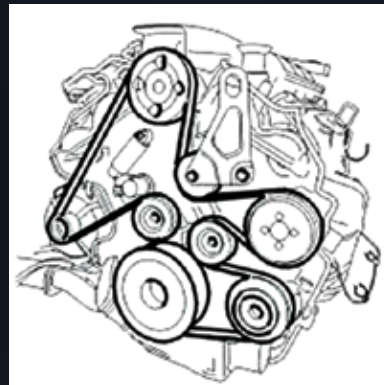
### REMOVING THE AUXILIARY BELT

**Caution! Relieve the load on the belt tensioner by turning it clockwise to max. 230 Nm and lock the tensioner with relevant tool.**

**Caution! Ensure that 230 Nm is not exceeded when the belt tensioner is relieved. The torque takes more than 20 seconds to carry out without risk of affecting the belt tensioner.**

999 7195 Holder (See: Tools and Equipment\999 7195 Holder)

Lift off the auxiliary belt.

Hint: Note the routing of the belt to facilitate reinstallation.

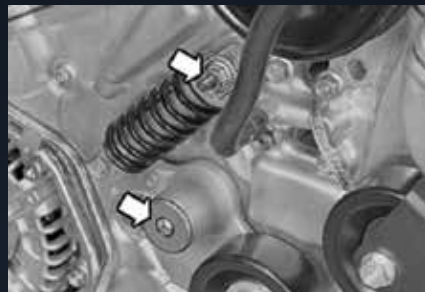
### REMOVING THE BELT TENSIONER

Remove:

- The screw of the tensioning and damping element
- The center screw to the belt tensioner. 999 7279 Wrench
- The belt tensioner

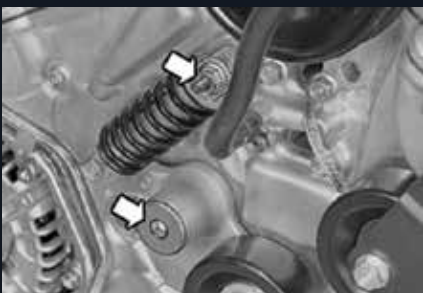
### INSTALLING THE BELT TENSIONER

Install:

- The belt tensioner
- The center screw to the belt tensioner
- The screw of the tensioning and damping element; tighten

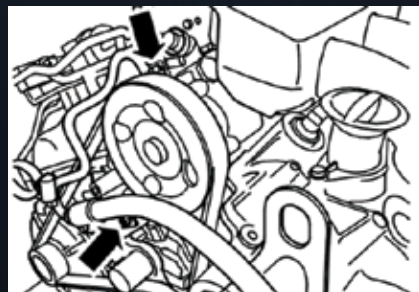
### INSTALLING THE SERVO OIL LINE

Install:

- A new gasket
- The servo oil line
- The nut on the clamp; tighten
- The screw on the oil feed pipe; tighten.
- Wipe up any spills.

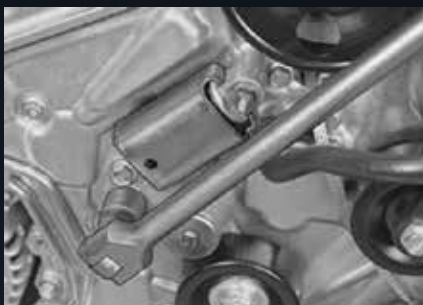
### INSTALLING THE AUXILIARY BELT

Rotate the belt tensioner clockwise to max. 230 Nm and remove tool: 999 7195 Holder.

**Note!** Make sure the belt is properly seated in the groove.
