VOLVO ANGLE (BEVEL) GEARS

SERVICE, DIAGNOSTICS,
REPAIRS AND RE-SEALING

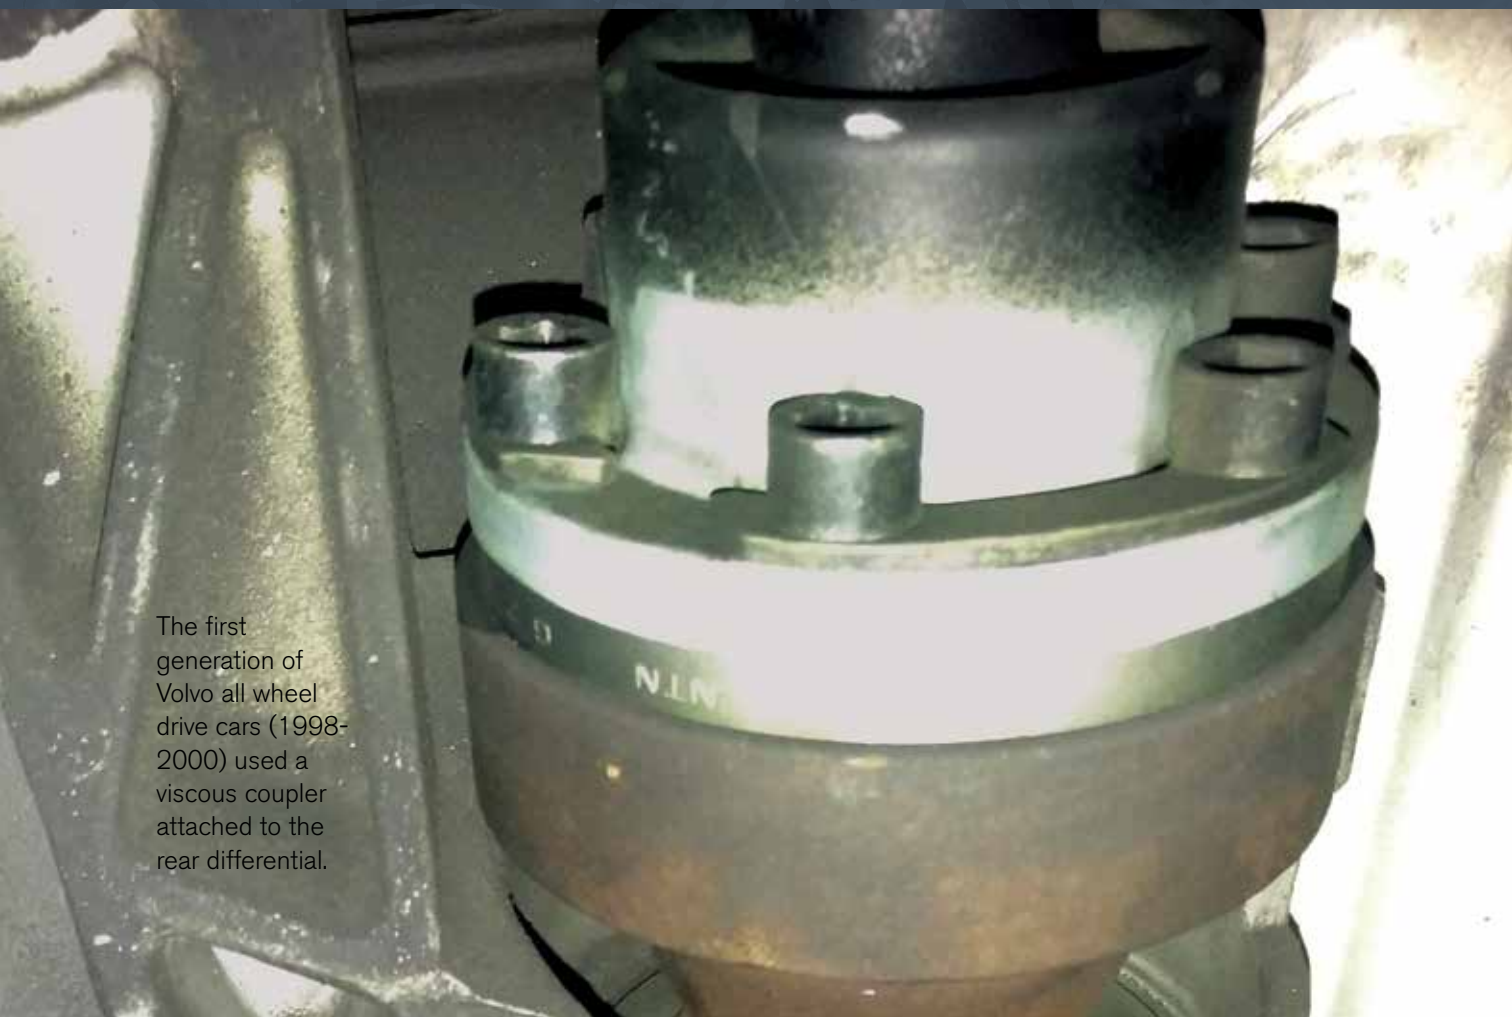
The first generation of Volvo all wheel drive cars (1998-2000) used a viscous coupler attached to the rear differential.

The first versions of the Volvo all-wheel-drive systems used the angle gear to transfer power from the transmission through a center driveshaft that connected to a viscous coupler unit and rear differential.

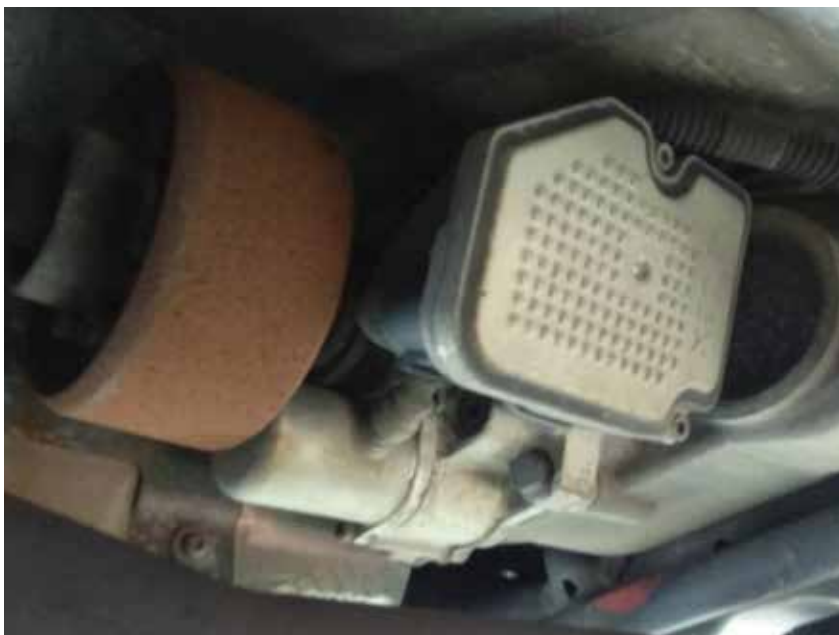
Volvo started using various versions of the Haldex electronically controlled rear differential starting in 2001 instead of the viscous coupler type.

All later Volvos use various versions of the Haldex electronically-controlled rear differential, but still stuck with the same type of angle gear for the front differential.

The later Volvos with the Haldex rear end are a lot more effective at active traction control and more forgiving of things like mismatched tires and wheel slip, either of which could cause damage to the angle gear on cars that came equipped with the viscous coupler type rear end.

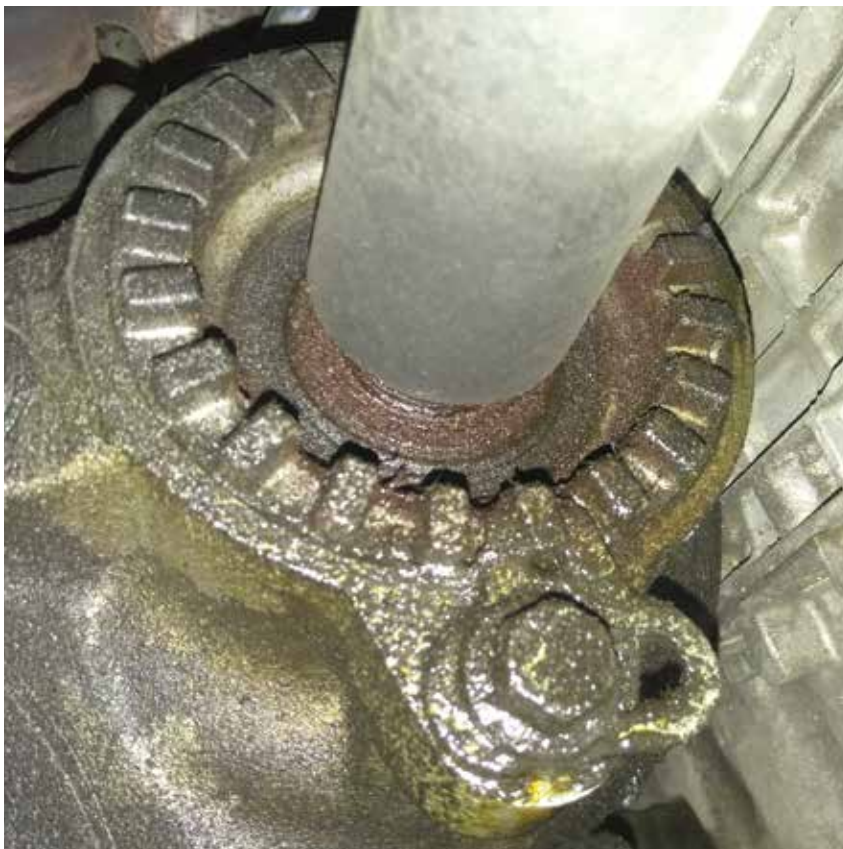
If you see gear oil leaking from the angle gear it should always be taken seriously, since Volvo's angle gears only hold about .85 quarts of gear oil when they are full. So it won't take much time for the angle gear to run dry.

The Volvo angle gears or bevel gears tend to develop leaks from three different places — the vent valve (an updated vent valve is offered by Volvo to fix this problem and is covered in Volvo TNN46-08), the bearing adjuster nut or crown nut seals and, in some cases, the angle gear can start to leak from the case halves or input seals between the angle gear and transmission. In that case, you will have to remove the entire angle gear and re-seal it (the complete re-seal procedure is covered in Volvo TJ 18513). OR you can just replace the entire angle gear assembly with a Volvo remanufactured assembly, available from your local Volvo dealership's parts department.

The most common oil leaks seen on Volvo angle gears come from the large o-ring seal on the large aluminum bearing adjustment nut that holds the output bearing on the right side of the gearbox. The o-ring gets brittle and shrinks over time. If there are traces of gear oil seeping from the bottom of this large bearing nut, you will have to replace this seal. This is one of the easiest and most common of the angle gear reseal jobs — that is, of course, if you have the right tools.

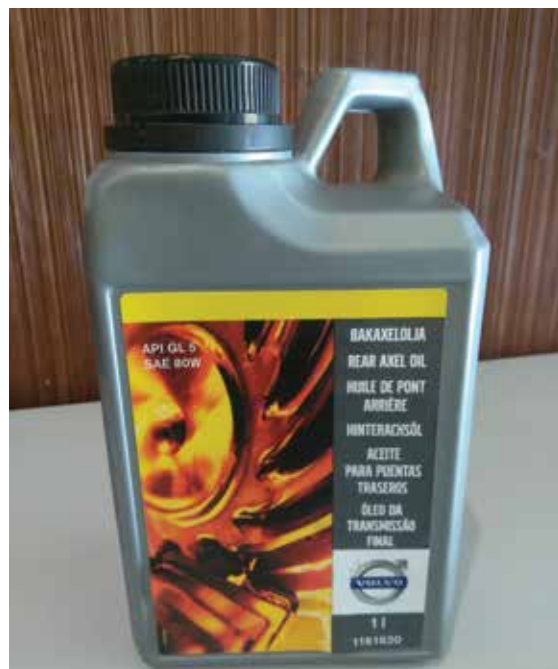
If you're refilling or just topping off the angle gear oil, remember to make sure to use the correct Volvo fluid for the year and model Volvo you are working on. Check with your local Volvo parts department for the correct fluid.

Since Volvo's angle gearbox has only a fill plug and no drain plug, you will have to drain and fill through the same plug. You can use a vacuum drain tool or any fluid evacuator with a small hose to drain as much of the old gear oil as possible. Make sure to insert the hose as far as you can into the filler hole; you will have to force the tube past the gears to reach the fluid at the bottom.

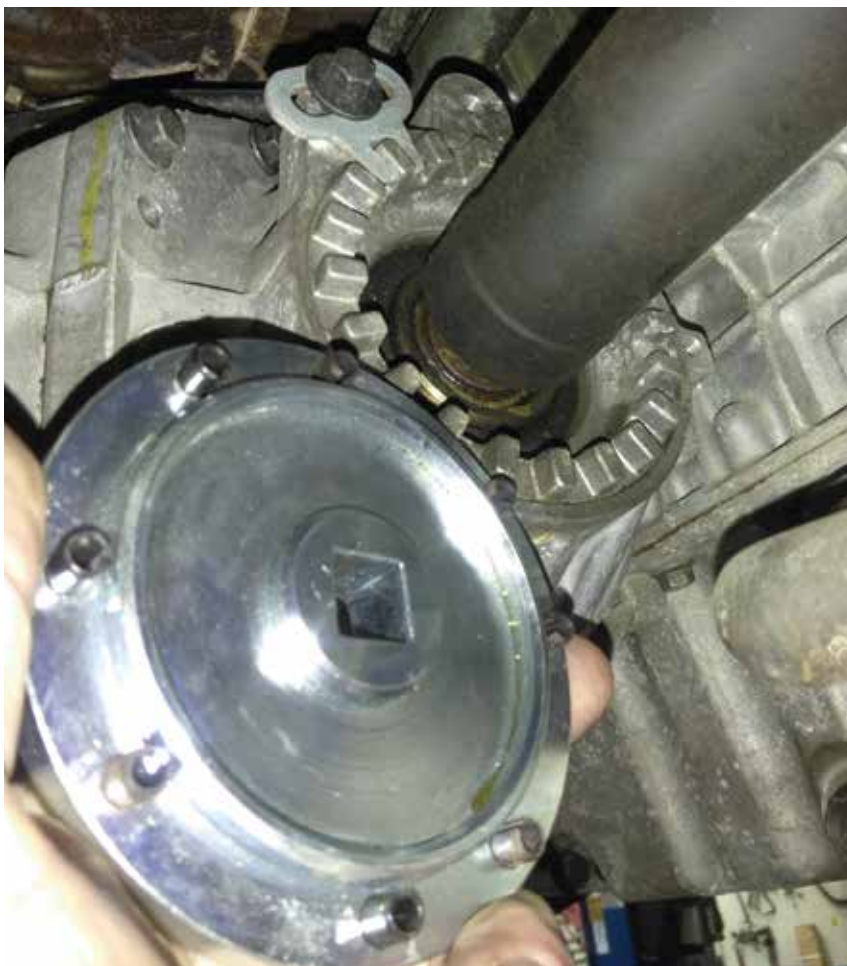
The one tool you should have in the shop when working on the Volvo angle gear is Volvo special service tool 9995371. This tool is the only way to get the pre-load adjustment nut off without damage.

The most important tool to have when working on the angle gear is Volvo special service tool 9995371.

Remove the 12mm bolt that holds the crown nut in position, and use a long ½ inch ratchet or breaker bar to turn the nut counterclockwise to remove it (DO NOT USE AIR TOOLS).

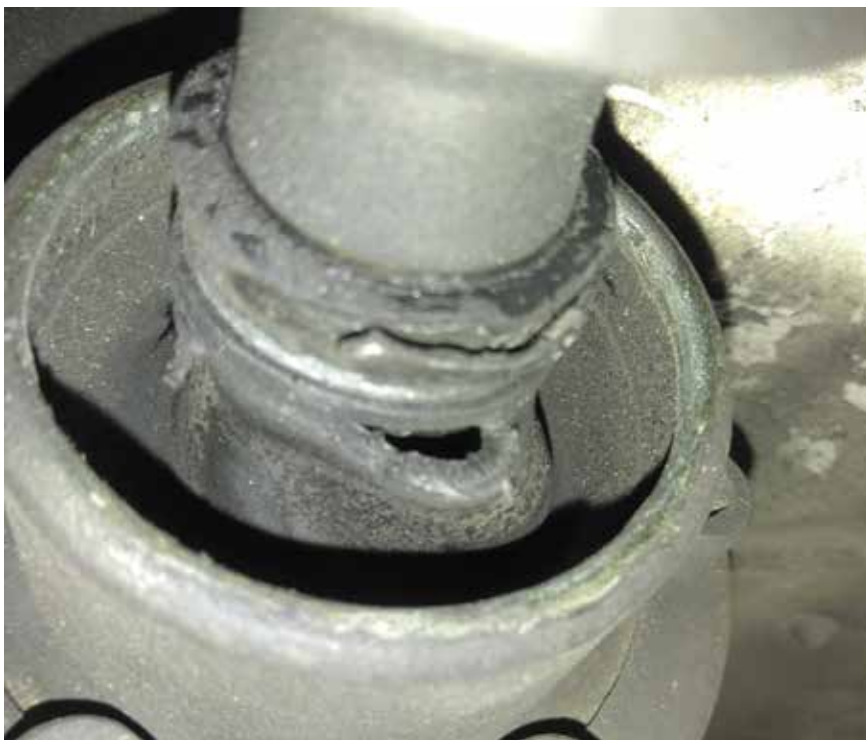
During your regular inspections, check the slip yoke boots for damage. If a boot is torn or damaged, the slip yoke or yokes will probably need to be replaced soon.

You can check the drive shaft slip yokes for play just by grabbing the shaft near the slip yokes and pushing up and down. There should not be very much play. Make sure to check the slip yoke boots for damage. If a boot is torn or damaged, the slip yoke will probably need to be replaced soon.

In a lot of cases, you will have to replace the entire drive shaft assembly because Volvo has a new updated version. But in some cases you can just replace one slip yoke and boot with a kit that Volvo sells. ●
