VOLVO TECHTIPS

Information for the Independent Volvo Specialist

VOLVO ANGLE (BEVEL) GEARS SERVICE

**VOLVO EVAP SYSTEMS
VOLVO AGING ISSUES
USING VIDA**

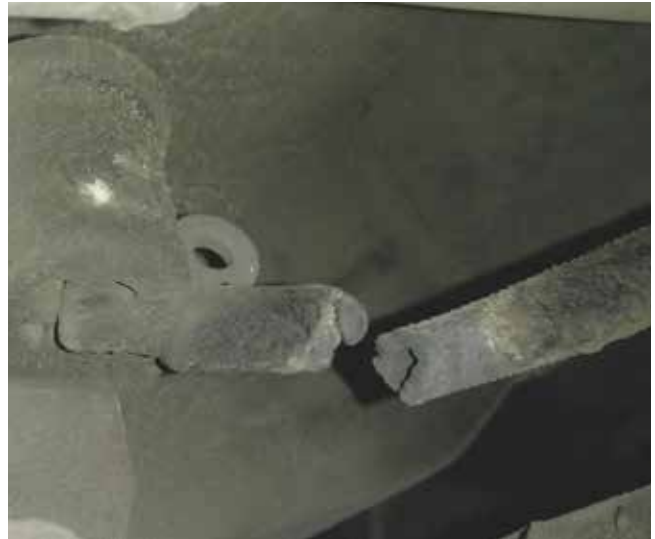
Cracked hose at roll over valve.

- Cracked hose at roll over valve
- Cracked J hose at canister
- Sticking or leaking EVAP canister purge valve
- Clogged fuel tank vent at filler neck (usually with spider webs)
- Leaking gas cap or cracked gas cap seal
- Leaking fuel tank seals

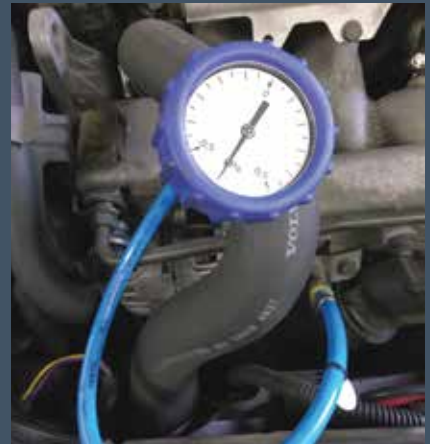
A good way to test the Volvo canister purge solenoid valve is to use a hand-held vacuum pump and apply vacuum to the connector side of the valve. If the valve bleeds off the vacuum, replace it.

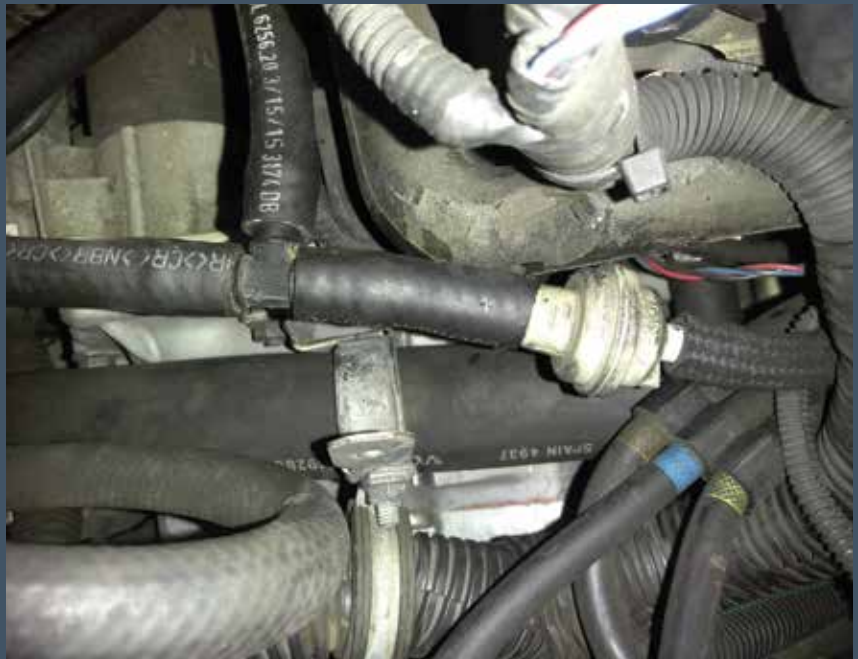
During the visual inspection under the hood, the technician noticed that a lot of the hoses for the EVAP purge valve and the brake vacuum pump check valve had recently been replaced.

During the visual inspection under the hood, the technician also noticed that a lot of the hoses for the EVAP purge valve, and the brake vacuum pump check valve had recently been replaced.

The hose that was used was aftermarket bulk fuel hose and was not designed to be used for this application. This kind of hose was designed to carry liquid under low to medium pressure; it was not made to stand up to engine vacuum, and is prone to get soft and kink in high heat conditions.

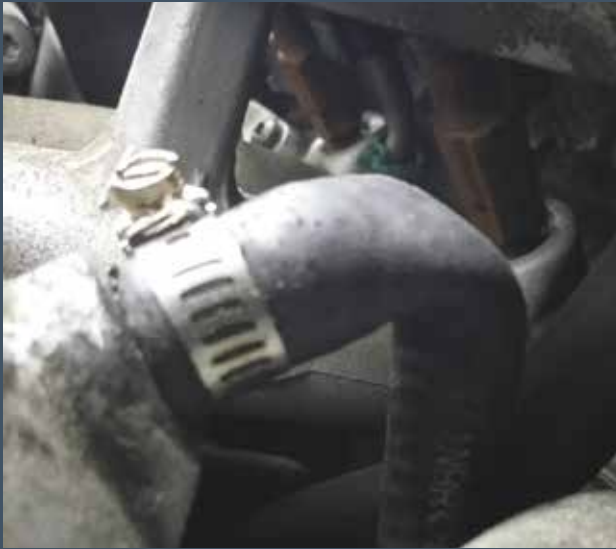
The first sign of trouble was at the hose that connects to the intake manifold. Since the hose was replaced with the wrong type of material, it would soften and collapse as the engine warmed up.

The first sign of trouble was at the hose that connects to the intake manifold. Since the hose was replaced with the wrong type of hose, it would soften and collapse as the engine warmed up, causing the flow to the EVAP and Brake Vacuum Assist to be cut off.

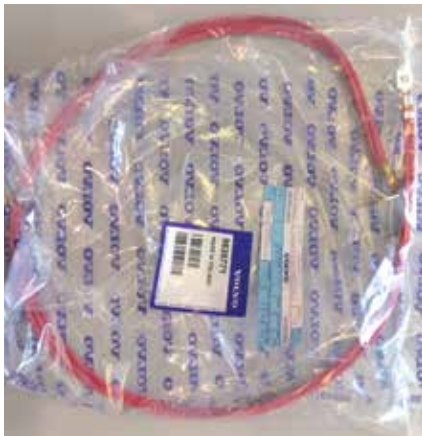
The cable can be replaced separately from the engine harness; the Volvo part number for the cable is 8628771.

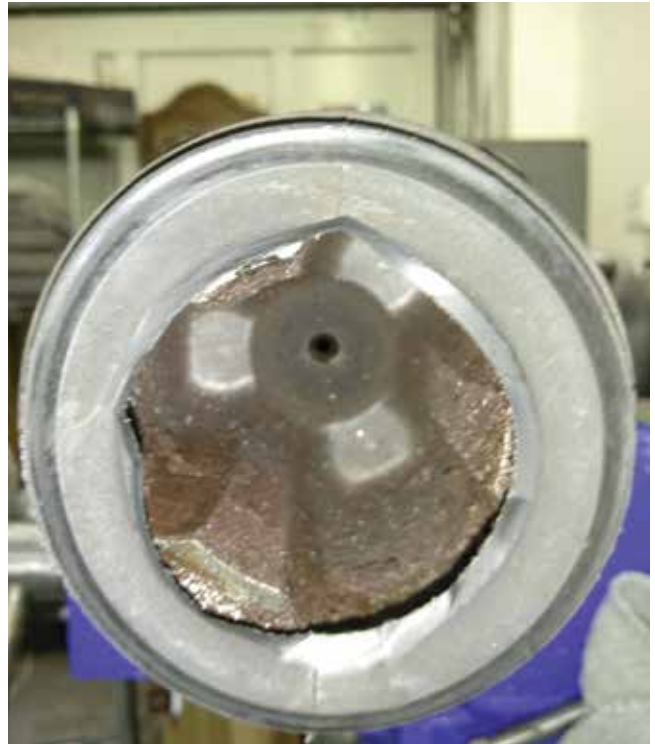
A lot of shops have replaced these axles and, after cutting open the CV boot, have found out that all the grease had somehow disappeared without any signs of leakage or damage to the boot.

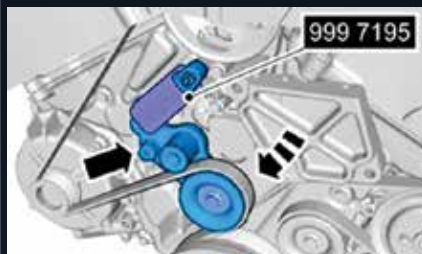
Lift off the auxiliary belt.

Hint: Note the routing of the belt to facilitate reinstallation.

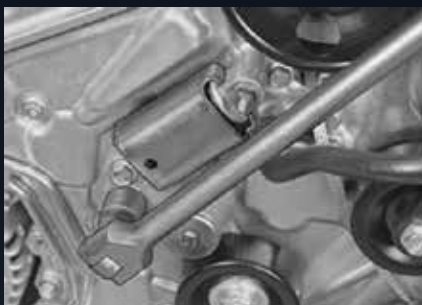
Rotate the belt tensioner clockwise to max. 230 Nm and remove tool: 999 7195 Holder.

Note! Make sure the belt is properly seated in the groove.

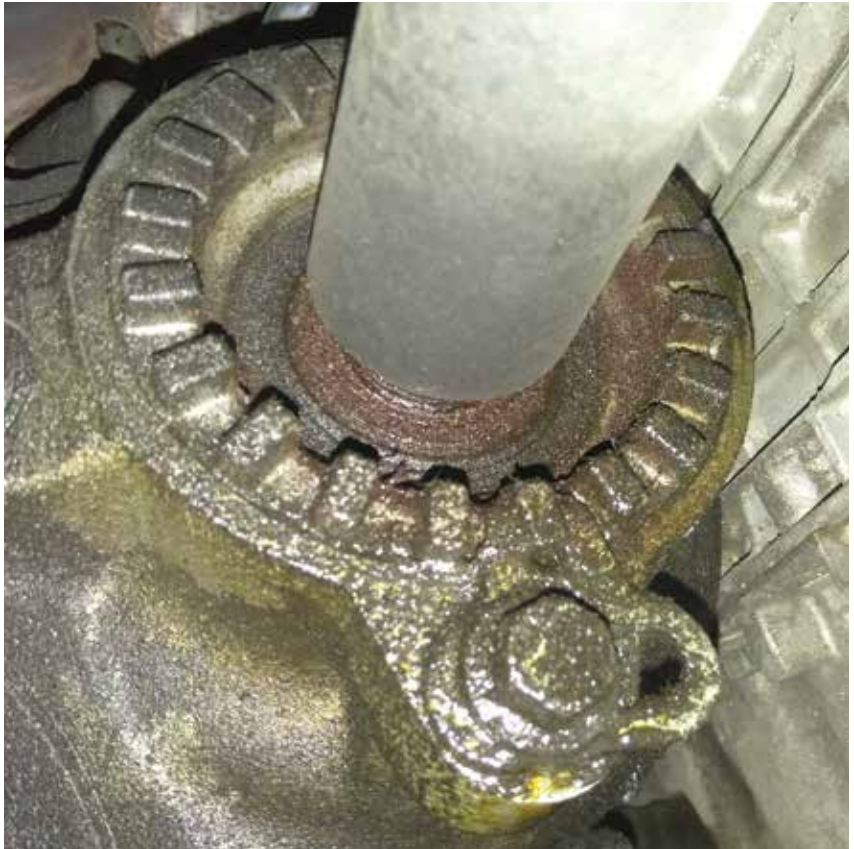
If you see gear oil leaking from the angle gear it should always be taken seriously, since Volvo's angle gears only hold about .85 quarts of gear oil when they are full. So it won't take much time for the angle gear to run dry.

The most common problems that shops deal with on these units have to do with gear oil leaks. Gear oil leaks from the angle gear should be taken seriously, since Volvo's angle gears only hold about .85 quarts of gear oil when they are full.

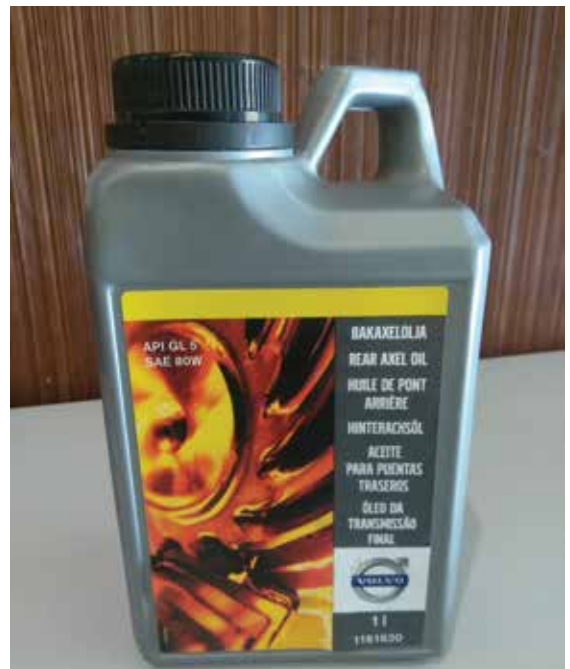
If you're refilling or just topping off the angle gear oil, remember to make sure to use the correct Volvo fluid for the year and model Volvo you are working on. Check with your local Volvo parts department for the correct fluid.

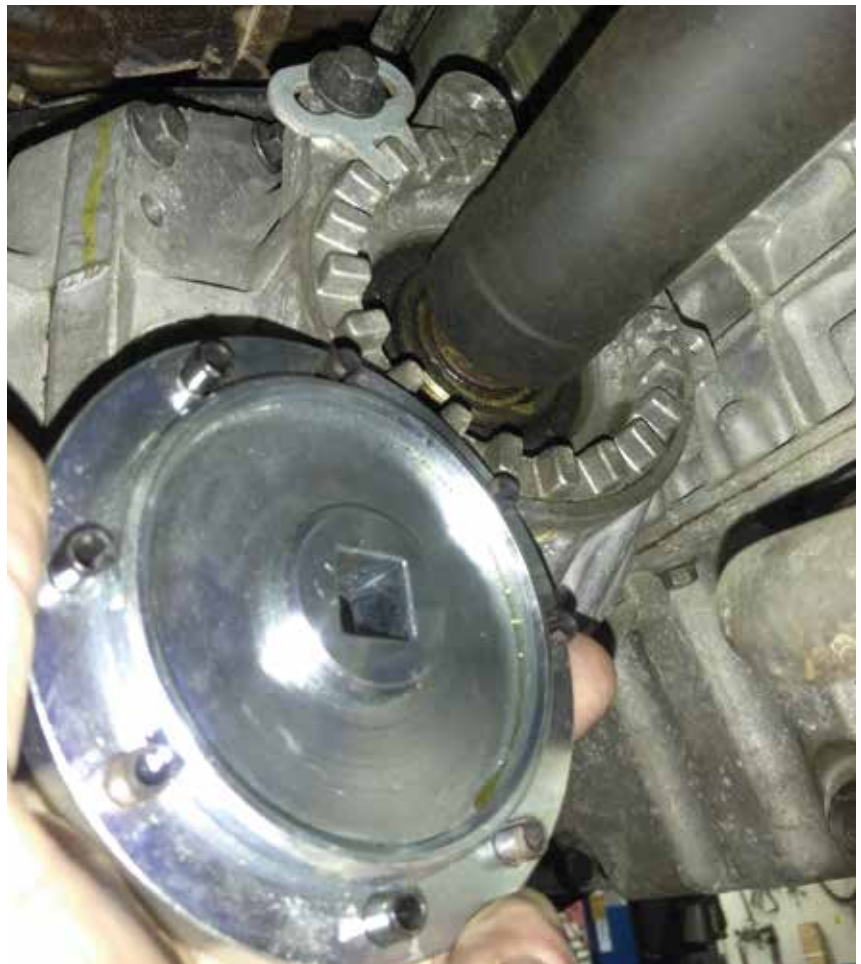
The one tool you should have in the shop when working on the Volvo angle gear is Volvo special service tool 9995371. This tool is the only way to get the pre-load adjustment nut off without damage.

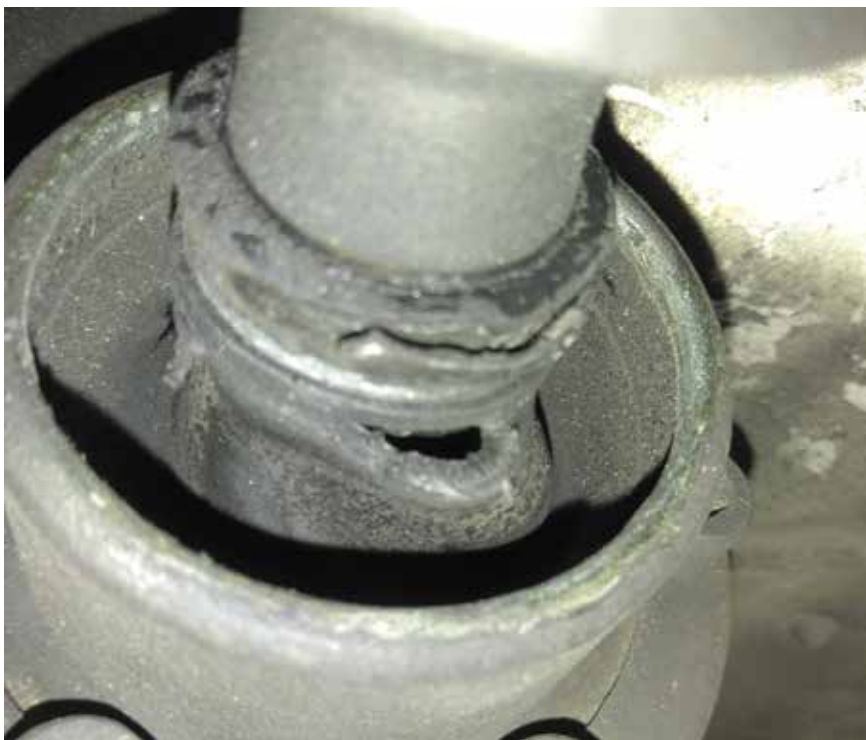
During your regular inspections, check the slip yoke boots for damage. If a boot is torn or damaged, the slip yoke or yokes will probably need to be replaced soon.

In a lot of cases, you will have to replace the entire drive shaft assembly because Volvo has a new updated version. But in some cases you can just replace one slip yoke and boot with a kit that Volvo sells. ●

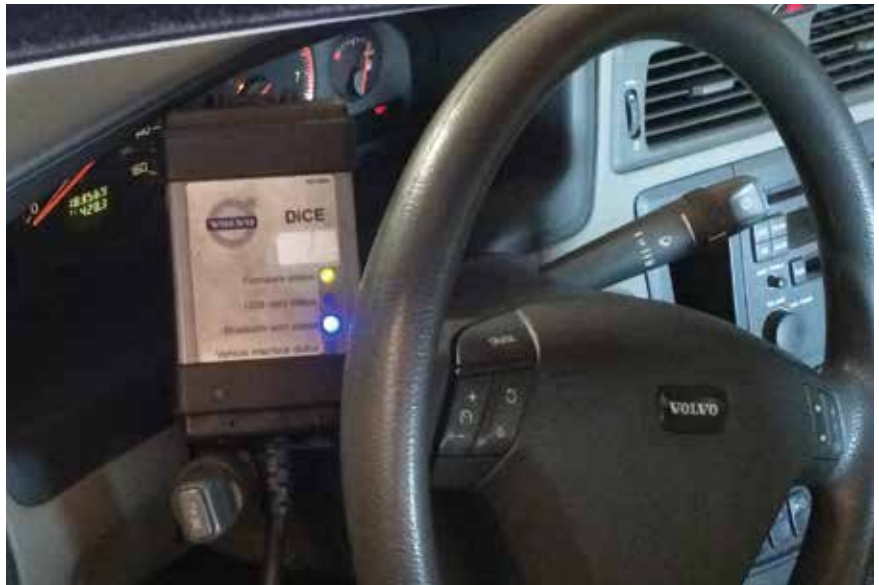
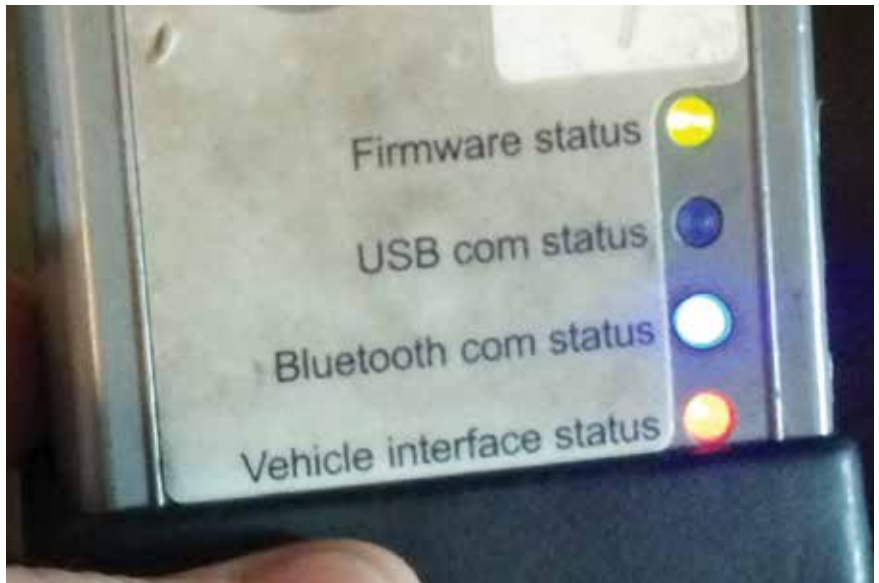
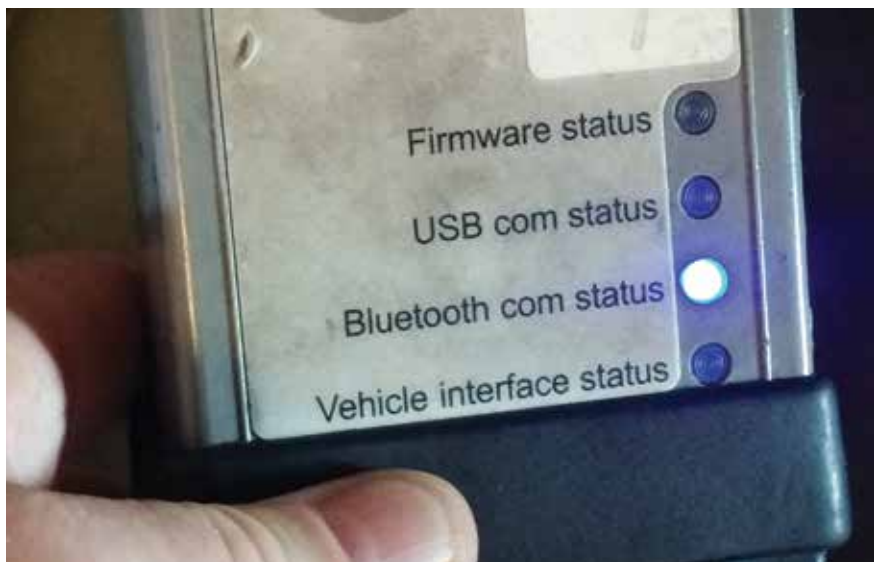
DICE is easily connected and DiCE units can be used on multiple vehicles concurrently.

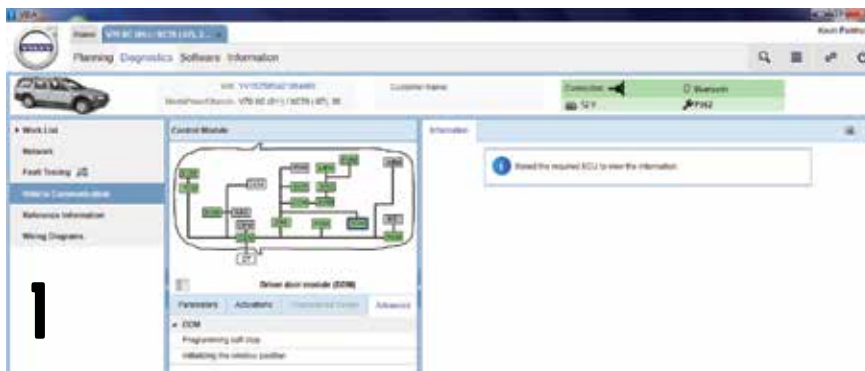
1

Figure 1-4: After software has been downloaded, in most cases you will need to initialize window controls.

After software is downloaded, you should check to make sure everything is working correctly. You may need to reset the clock and possibly resync windows under Vehicle Communication, DDM (Drivers Door Module). To do this, go to the Vehicle Communication tab. Then select DDM. Once the DDM comes up, select Advanced and scroll down to initializing the window positions. You should initialize both windows.
