February 2018 | V2 N1

TURBOCHARGING PORSCHES

VW DRIVER ASSISTANCE SYSTEMS ENGINE OIL LEAK FASTENERS

AUDI SUSPENSION SYSTEMS AUDI SUNROOF SERVICE

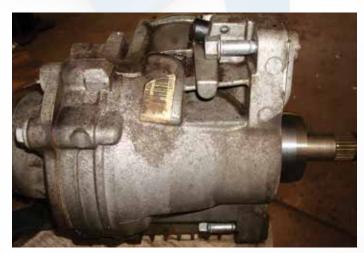
Engine lift bar

Bevel gear bolts before assembly

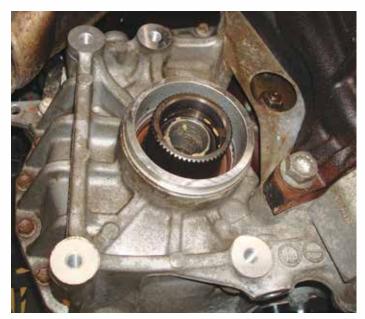
Torque converter nuts

Notice the white painted stud on the converter. Do not remove or disturb the torque converter. Do find a way to gently hold the converter in position. I used a wooden rod with spacer attached with bolts to the bell housing. This will ensure the correct position if the transmission needs to be rolled or moved to another position. If for any reason the torque converter is removed, the seal must be replaced.

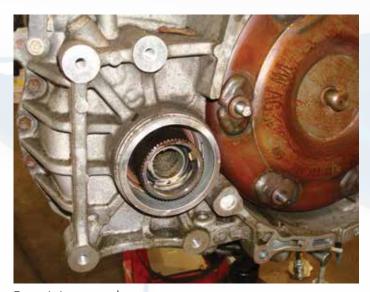
Transmission mount and bolts

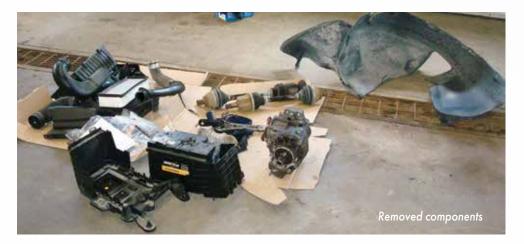
Transmission removed

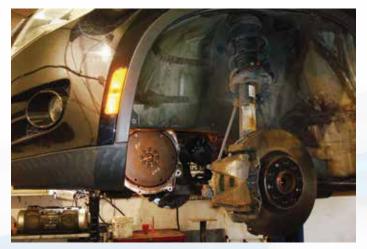
Torque sequence

Transmission drive plate

The PTFE seal requires time to set up. Use the printed/repair information/specifications to torque using the proper sequence/value for the model you are working on.

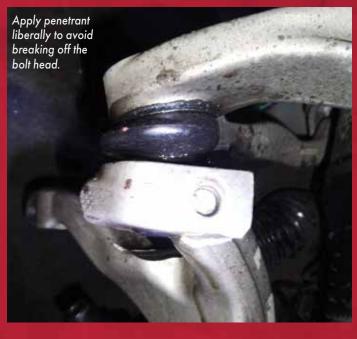
If the upper control arms become stuck during removal, lightly striking the steel base of the ball joint will help break the arms loose. Corrosion on the upper control arm mounting points can become severe.

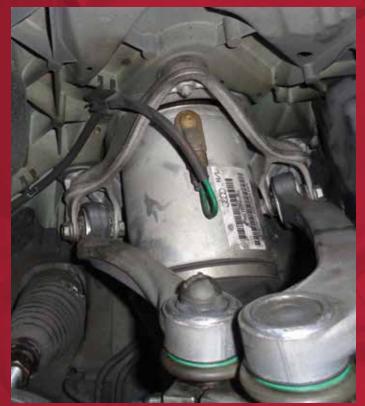
When working on or around the air springs, it is important to deflate the air spring. Damage can occur, particularly if twisting and moving the strut assembly. This can break the seal.

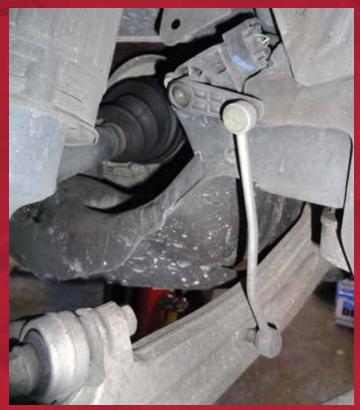
Ride height sensors usually have a locating bracket on the control arm. This minimizes the risk of improper installation.

The ride height sensors provide the primary input the suspension control unit uses to determine how much air pressure each air spring needs. The vehicle ride height sensors (G77) are a critical piece of the suspension system. They are located on both front lower control arms, as well as in the rear of the vehicle. If any of these sensors are damaged or misaligned, the suspension control system can malfunction. The most common damage to these sensors is from impact due to being close to the road surface, improper installation, or even technicians forgetting to re-install them. The sensor arm is plastic. Be careful not to damage it during removal and installation.

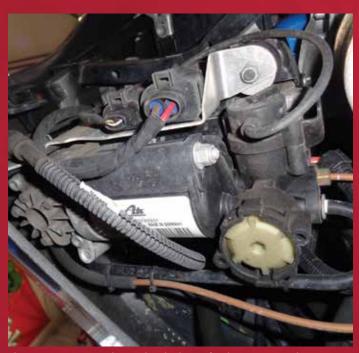
The air compressor is located in the lower fender area or undercarriage toward the rear of the vehicle.

The air compressor or air supply unit is used to fill the air struts. It may be located in the rear undercarriage or, more commonly, behind the driver's fender liner. This system uses a 12 V electric motor to drive a small air compressor. These air pumps have a safety system designed into the pump. A temperature sensor shuts down the pump if it runs for too long, preventing an overheat situation. The most likely cause of the air supply unit overheating is a leak in the system. The vehicle usually stores faults if it senses an overheating air compressor. This is part of the reason Audi installs the air pump in locations that receive air flow; the pump does get hot and can eventually become degraded after extended use.

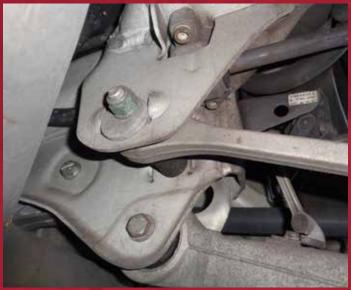
Rear toe adjustment can be found at the rear upper control arms on most models.

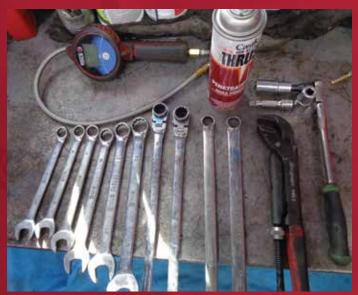
Making sure the rear toe angle is in specification is critical for tire life and stability. Almost every Audi model has adjustable rear toe angles.

Audi vehicles generally do not require specialty tools for making alignment adjustments.

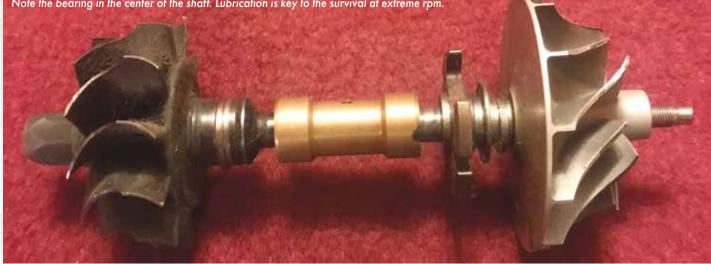
Allowing a hot, turbocharged engine to idle for a minute or two, especially on a hot day, is a great idea. This allows the cooling system to take away some of the excess heat and gives time for fresh oil to circulate and cool the turbo to some degree. It also assures that the turbocharger has plenty of time to spool down from running at 100,000 rpm. Note the bearing in the center of the shaft. Lubrication is key to the survival at extreme rpm.

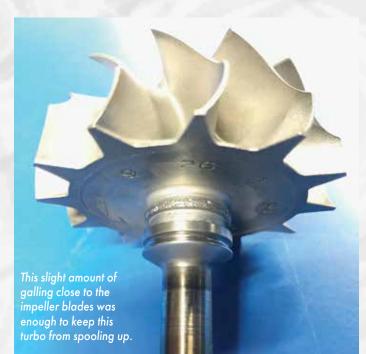
Notice the dedicated exhaust pipe, which will dump excess exhaust pressure to the atmosphere.

To regulate this runaway boost a wastegate is used. This is a very simple device, nothing more than a valve very similar to the valves found in a cylinder head. As the boost increases, the valve, which is controlled electrically or by using a pressure line from the intake manifold, is lifted and exhaust gases that normally go to spin the turbine wheel of the turbocharger are dumped back into the exhaust or simply dumped out to the atmosphere.

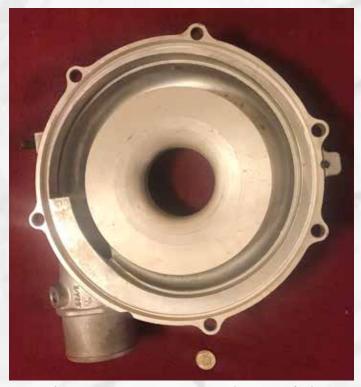
Bigger is better...sometimes. Can you imagine the amount of exhaust flow necessary to get this huge turbo to wind up? Ultimate horsepower comes at the expense of substantial turbo lag.

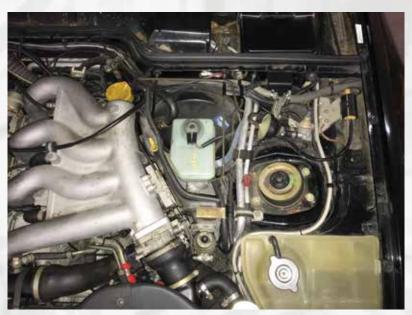
Now you see it, now you don't. Many components on the top of this 944 engine have to be removed before you can even get a glimpse of the turbo!

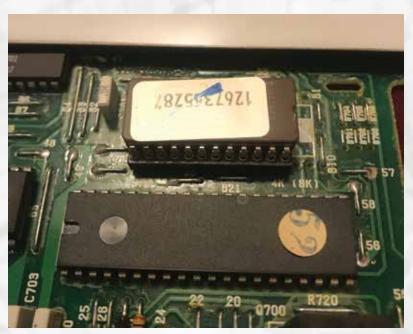
Replaceable and programmable EPROM sits in the brain and signals valves controlling the turbocharger.

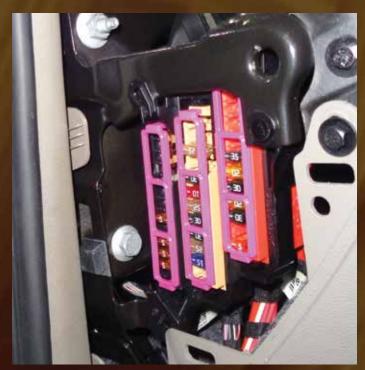
The primary interior fuse block, located at the base of the A-pillar is very susceptible to water damage if there are leaks at the sunroof drains.

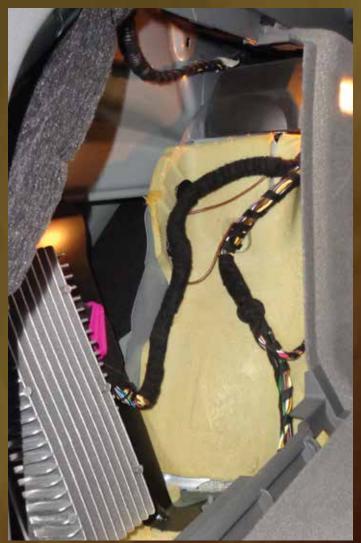
The audio amplifier location on an Avant model, located at the base of the C-pillar. This is prone to water ingress from clogged rear sunroof drains.

Problems with the rear sunroof drains are less common but can still be an issue, particularly with Avant models. If a rear sunroof drain becomes blocked, the most common outcome is water damage to modules located in the lower rear corners of the Audi. These are not cheap!

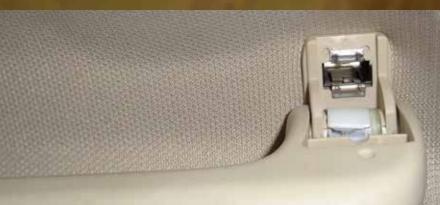
If you have to remove the grab handles to gain access to the drain tubes, be careful! The securing clip is easily damaged and very difficult to re-secure once bent.

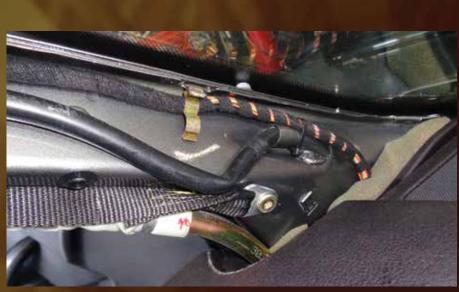
This pinched drain tube was caused by a previous repair and appeared to be a clogged tube until closer inspection. Note: This image is not on an Audi vehicle but still good information.
